Yearly Environmental Report 2011

BELWIND phase 1

Subject	Author	Revision	Date
Verification for public distribution	BW	2.0	01/05/2012

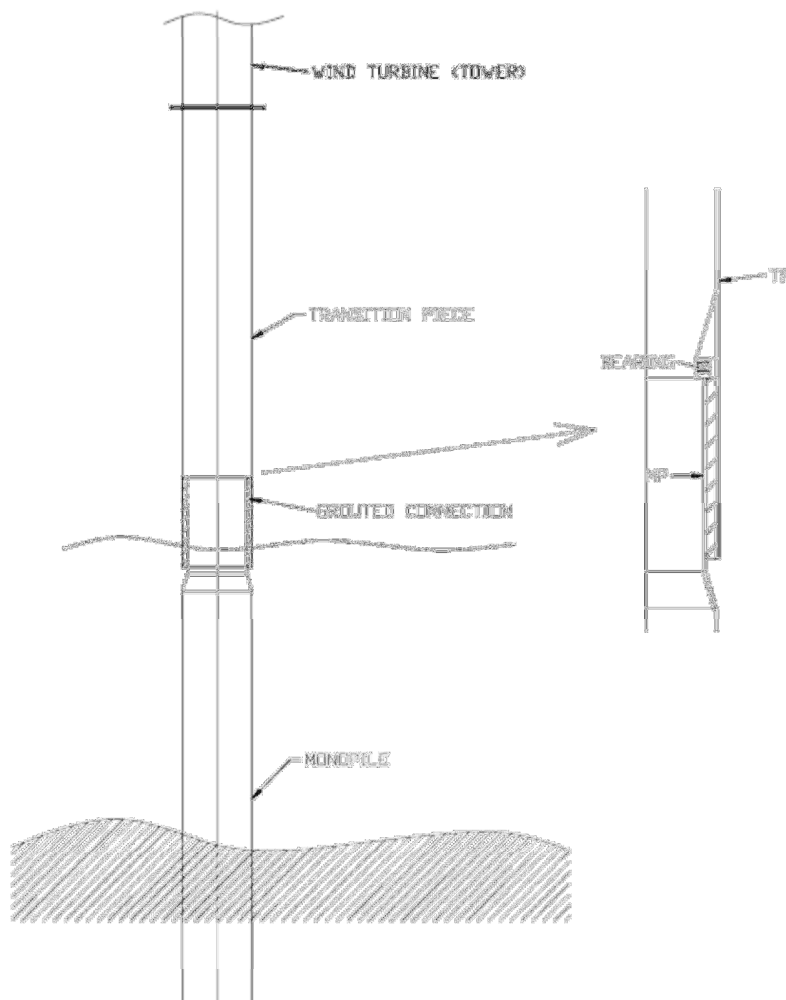
Figure 3: The Belwind Foundation

On Belwind, it has been observed that this grouted connection (despite being industry standard) has started slipping. This is obviously a serious concern.

The Finalization of the bearing solution to overcome the slippage of the grouted connection ran until late march 2011. After that a painting campaign was finalized and on 2 turbines the cathodic protection system was improved by diving works.

Therefore a solution has been engineered, using elastomeric bearing. In other words, rubber blocks were fitted between the TP and the MP to support the wind turbine, and thus to relieve the load from the grouted connection.

All bearings have been installed, and no problems have arisen. The system works properly, and the grouted connection issue is solved. In the spring of 2012 the measuring system (load cells + displacement sensors) will be installed on the bearings of C01, which will allow us to get an accurate insight into the behavior of the bearing and the grouted connection.

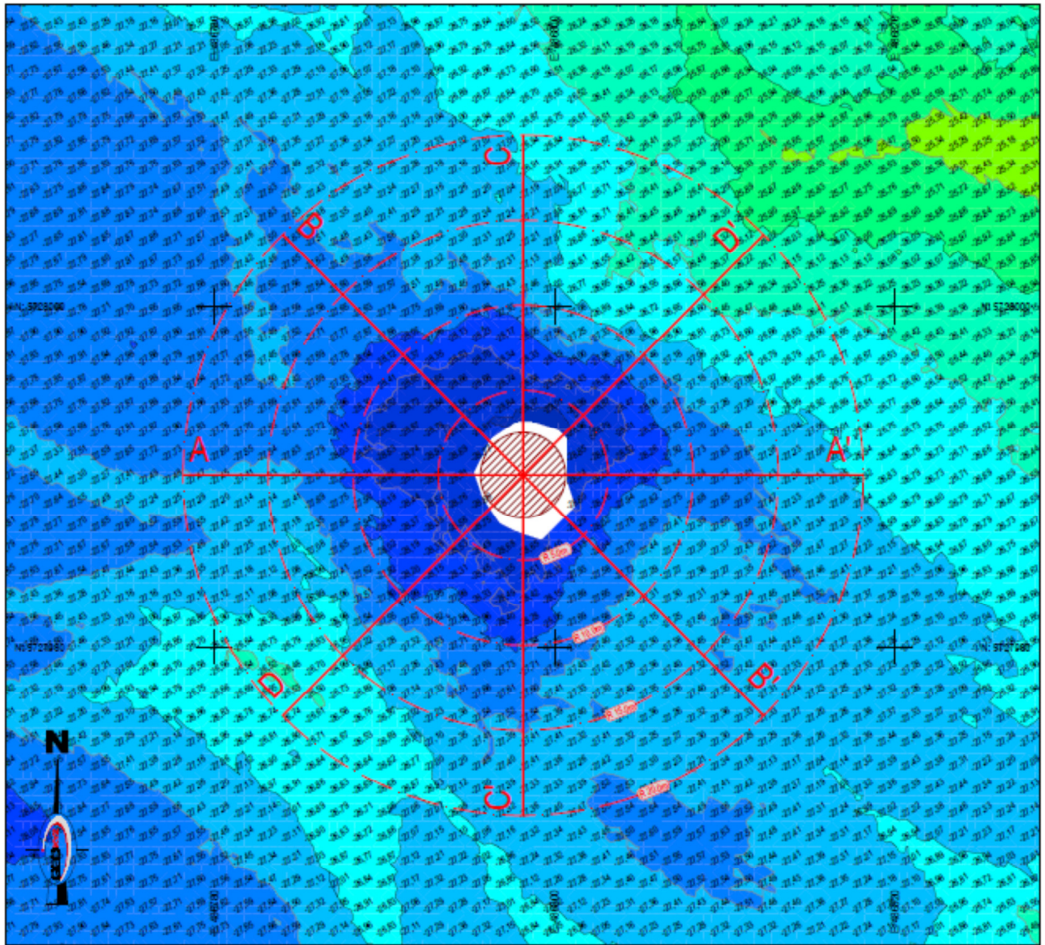
Figure 4: Topographic map of the bathymetry around MP

2011 Survey results show slight differences between the as-built situation and the current situation, but the variations are within acceptable tolerances. The scour protection level remains above the minimum "design fixation level" everywhere. Attention is also drawn to the accuracy of the surveys. Despite best efforts, the accuracy is only within the dm range, and strongly depends on the references and datum. Therefore, no conclusion can be drawn based on differences below 0.5m.

Below is the topographic charts of F05 in its present state, with the cross sectional view for comparison to the as-built situation, as an example.

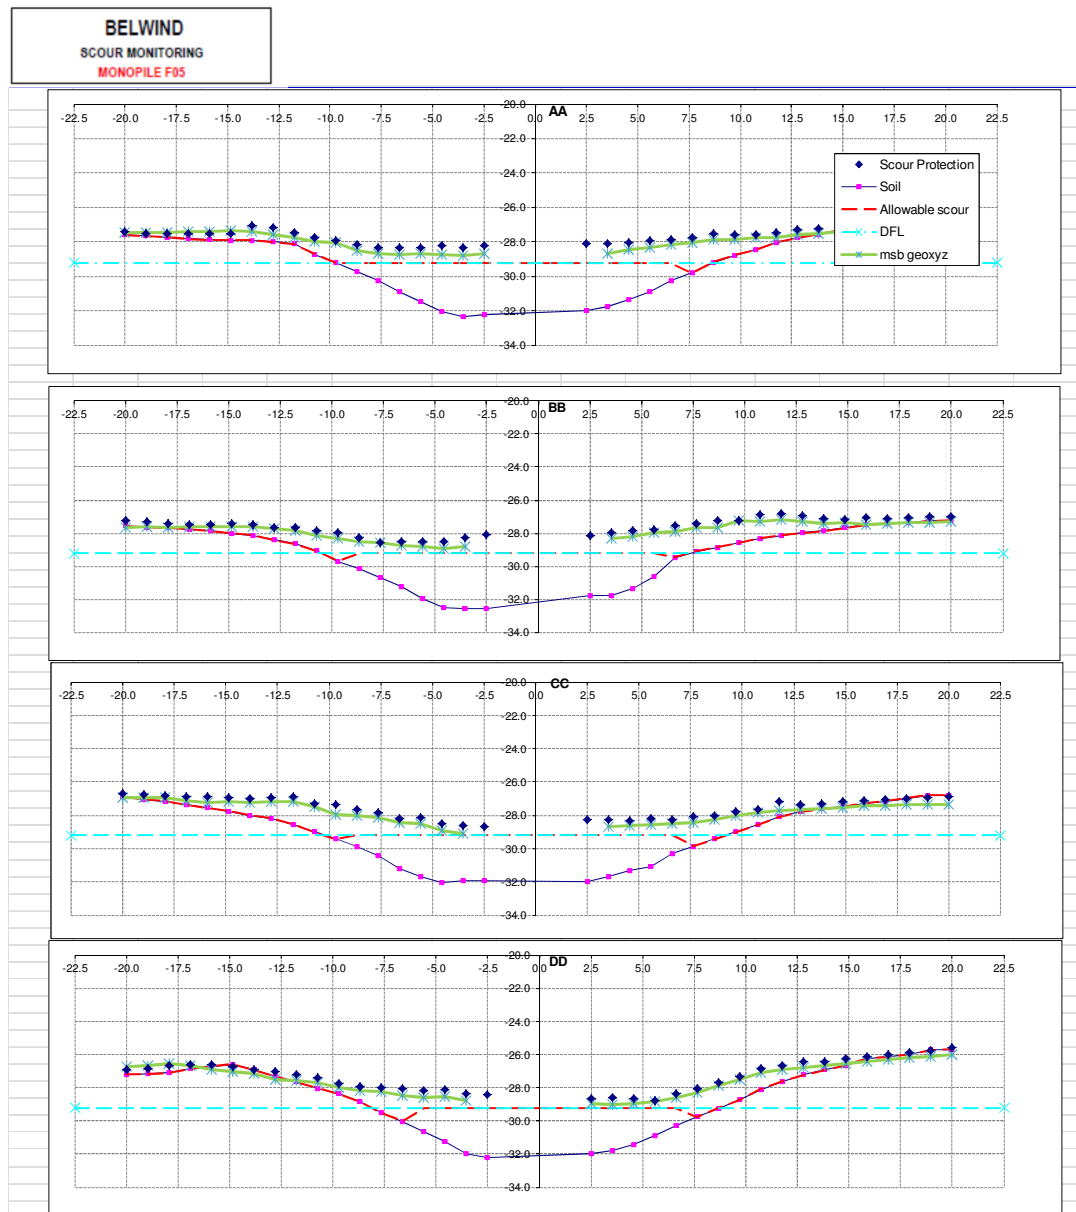
Figure 5: Scour monitoring around MP

The burial of the infield cables is checked together with the scour protection. At present the depth of burial is monitored indirectly: the seabed profile is surveyed, and compared to the as-built data, supposing that the cable does not move. This results in a profile view of the cable and the seabed, so the depth is clearly shown. The depth of burial of the infield cables is less critical than the export cable, because no shipping is allowed in the wind farm, so there is far less risk of anchoring or fishery damage. Nevertheless, a good burial protection remains important, and action will be taken if needed. So far, no significant difference between current situation and as-built has been noticed.
