Annual work report 2017

Offshore wind energy power plant

Belwind

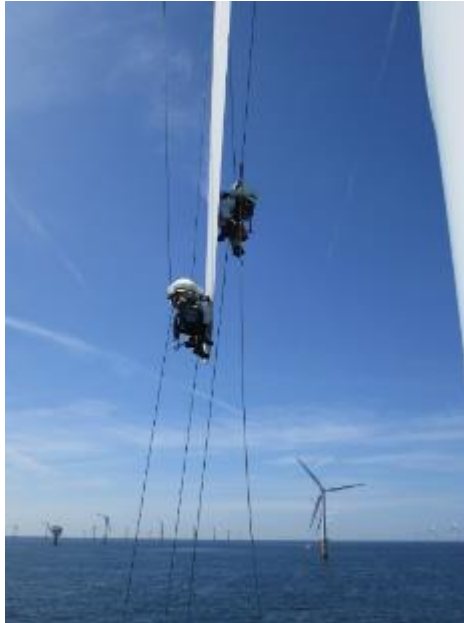
Figure 7: Rope workers at work on BW

- Blade inspections: All blades from all WTG's were inspected by the use of drones. Due to some delay in UK, the inspections started later than expected, being the beginning of April. As the drones and the cameras are constantly evolving and more detailed analyses can be done, MVOW concluded that there was a big amount of blade damages in different categories.

- **Rope workers:** Rope workers are working on rather small damages and all lightning damages (see Figure 7);
- **Sky climbers:** Sky climbers are used for the bigger damages (see Figure 7 13).

The blade project came to an end in September. In total 27 full blade repairs were done (7x cat 4 and 20x cat 3). As immediate actions were taken, all blade damages are under control.

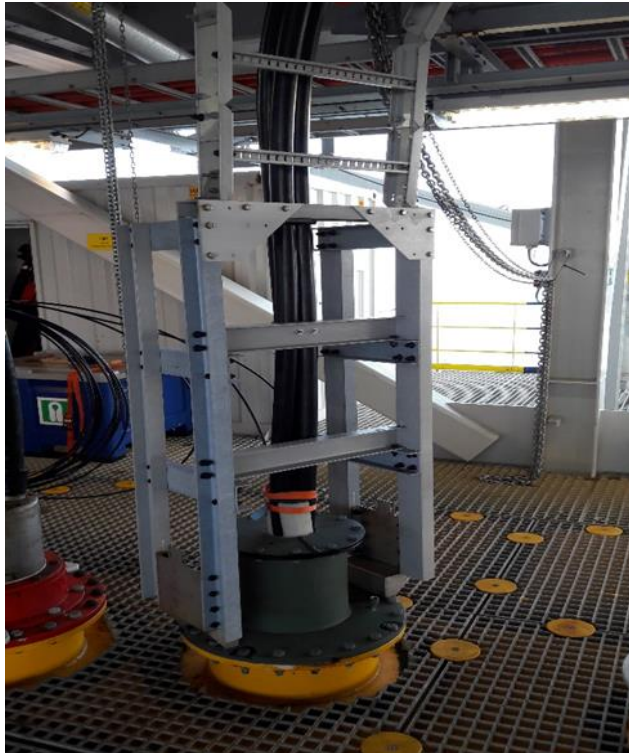
Figure 9: Coupling cable on Belwind OHVS

- Coupling cable between BW OHVS and NBW OHVS has been pulled in on BW OHVS and is installed in the first quarter of 2017 (see Figure 9).
