**Screening for Biofouling and Corrosion of Tidal Energy Device Materials:
In-situ results for Admiralty Inlet, Puget Sound, Washington**

Northwest National Marine Renewable Energy Center Technical Memorandum

University of Washington, Seattle, WA, United States

April 8, 2010

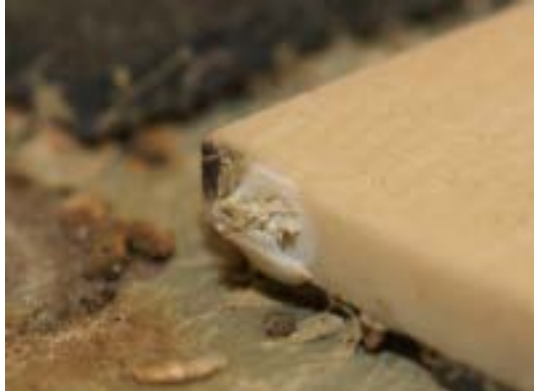
2009, Figure 2.1), part of a general trend that biological fouling is more common on edges/in crevices, than on smooth surfaces.

Figure 2.1 – Barnacle attached to edge of glass fiber composite sample

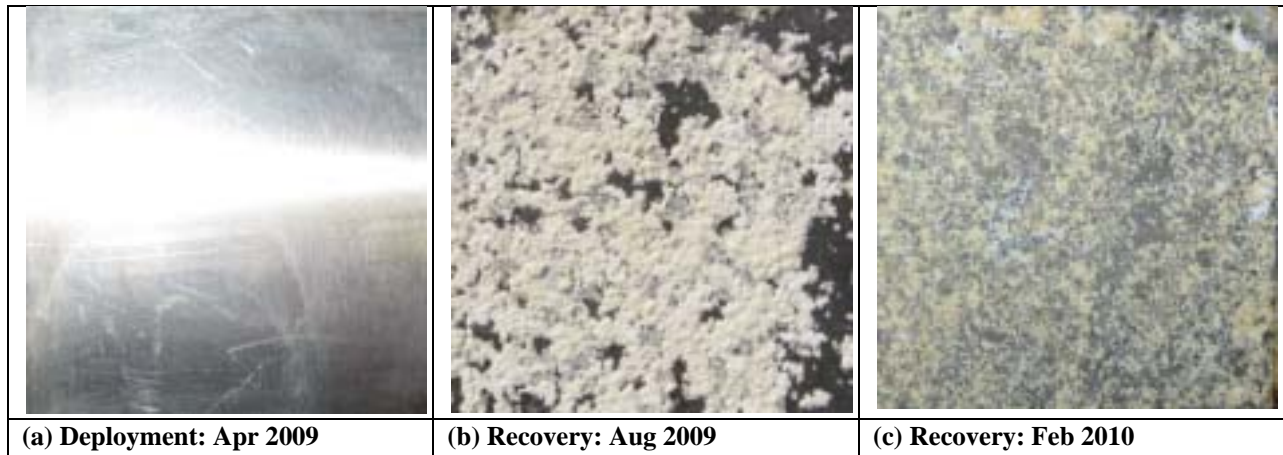
As expected, aircraft grade aluminum does not perform well in the marine environment. More than 90% of the exposed surfaces on all aluminum coupons oxidized during each 3-4 month deployment, as shown in Figure 2.1. After 10 months deployment in the marine environment, the surface is almost entirely oxidized and embrittled to the point that one corner of the coupon broke away during routine handling.

Deployment	Recovery	Duration	Changes
Aug 2009	Nov 2009	3 months	>90% surface and edge corrosion.
Apr 2009	Aug 2009	4 months	>90% surface and edge corrosion.
Apr 2009	Feb 2010	10 months	>95% surface and edge corrosion. Coupon edges embrittled.

Figure 2.2 – Aluminum (6061) coupon corrosion (Apr 2009 - Aug 2009 deployment)

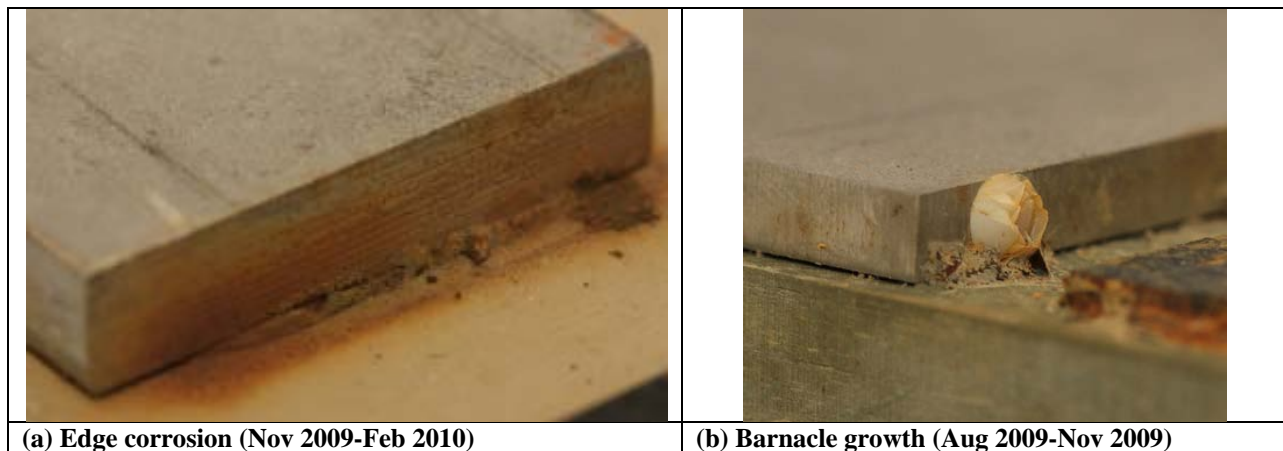
Both 314 and 316 grade stainless steel general show minimal corrosion or biofouling after prolonged exposure to the marine environment. One sample developed superficial corrosion along the contact surface between the stainless steel and fiberglass panel and a barnacle attached to one edge, as shown in Figure 2.2.

Deployment	Recovery	Duration	Changes
Aug 2009	Nov 2009	3 months	Minimal fouling on surface. One barnacle on edge.
Nov 2009	Feb 2010	3 months	Superficial corrosion on one edge, concentrated at fiberglass/steel interface.

Figure 2.3 – Stainless steel (316) edge corrosion and biofouling

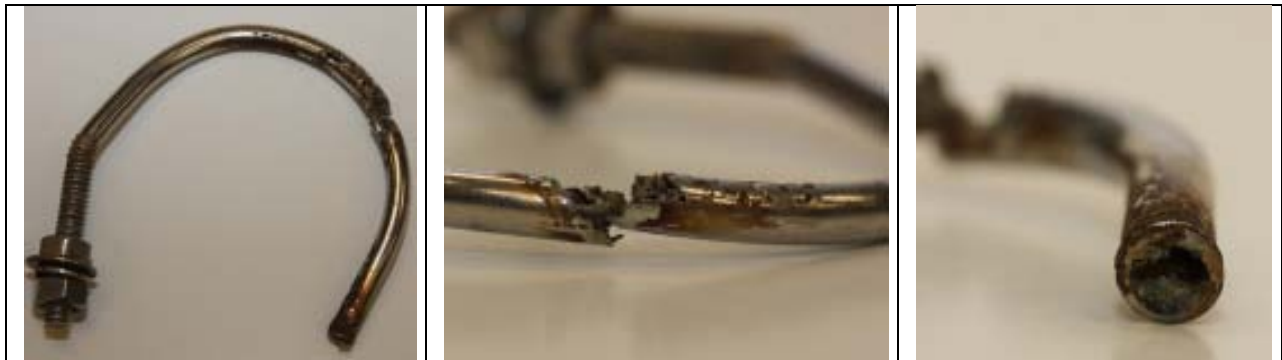
Other 316 grade hardware used to secure instrumentation to the measurement tripod developed more severe corrosion during some deployments. In most cases this appears to be caused by depriving the stainless steel of oxygen (e.g., occluding the surface). During the April-May, 2009 deployment, approximately half of the stainless fasteners corroded to the near the point of mechanical failure, with the common cause being the use of nylock nuts (stainless nuts with a nylon insert in lieu of a lock washer). Interestingly, corrosion was often more pronounced on the head of the bolt than the end with the nylock nut. On subsequent deployments, nylock nuts were replaced by stainless steel nuts and lock washers and no further widespread corrosion has been observed. In another instance, seine twine (tarred nylon cord) was looped around a 316 grade U-shaped bracket. After three months in the water, the bracket had been oxidized to the point of failure, as shown in Figure 2.4.

Figure 2.4 – Stainless steel (316) hardware corrosion due to oxygen deprivation by seine twine

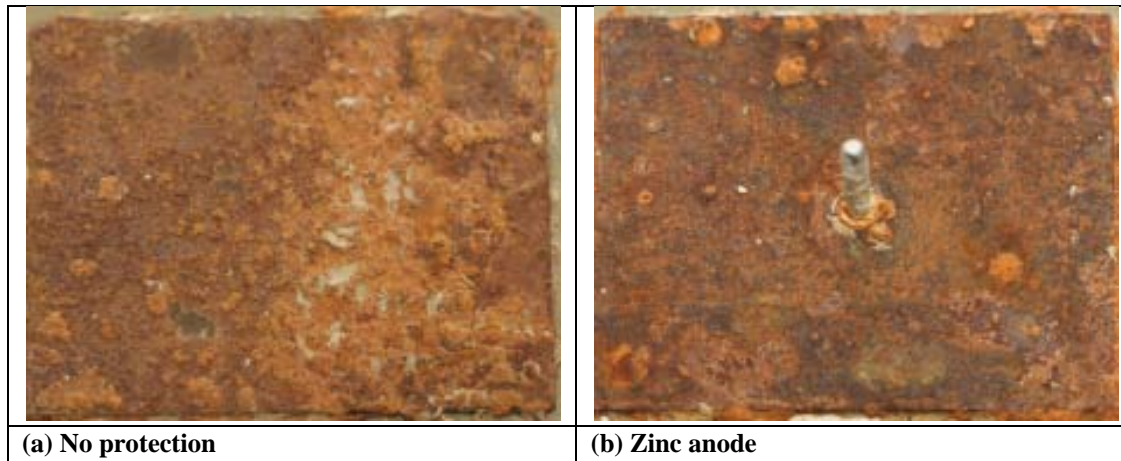
Common steel is included in a single deployment matrix (Aug-Nov 2009). In addition to bare steel, protection by a zinc anode screwed into the center of the coupon is tested. The surfaces of both coupons were almost entirely oxidized upon retrieval. Anodic protection reduced, but did not eliminate, oxidation of the common steel. The surface corrosion was similar in character (e.g., oxidation blisters), but not as pronounced and the zinc anode showed significant reduction upon retrieval.

Deployment	Recovery	Duration	Protection	Changes
Aug 2009	Nov 2009	3 months	No protection	Heavy surface oxidation (100% coverage). Bioaccumulation within oxidation blisters.
Aug 2009	Nov 2009	3 months	Zinc anode	100% surface oxidation, but not as pronounced as unprotected surface.

Figure 2.5 – Common steel (1018) coupon corrosion (Aug - Nov 2009 deployment)

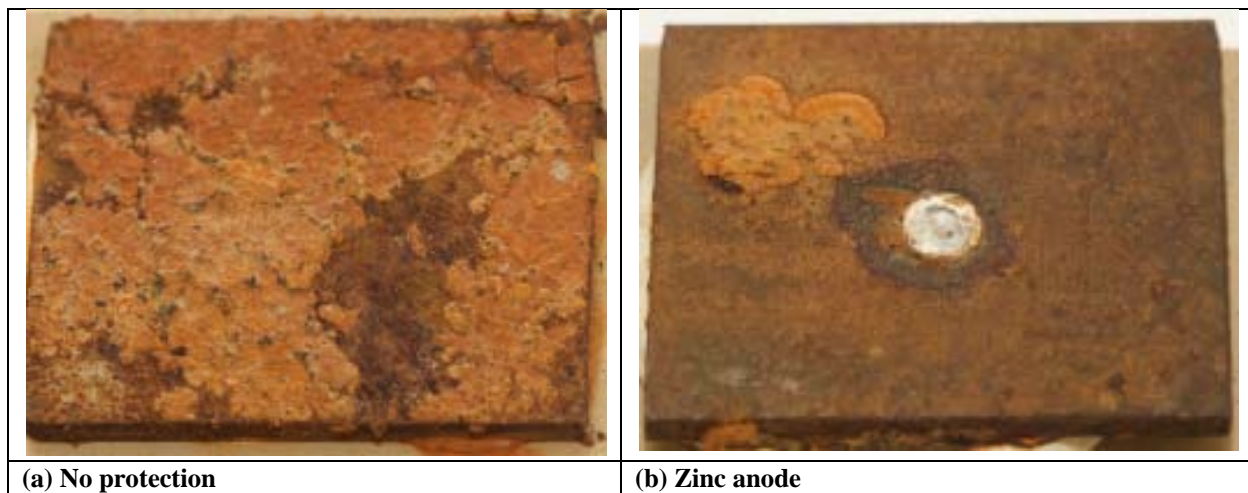
Structural steel is included in a single deployment matrix (Nov 2009-Feb 2010). As with common steel, in addition to a bare surface, protection by a zinc anode screwed into the center of the coupon was also tested. The protection significantly reduced, but did not entirely eliminate, oxidation of the structural steel. The anode was missing upon tripod retrieval and presumed to have been dislodging during retrieval operations.

Deployment	Recovery	Duration	Protection	Changes
Nov 2009	Feb 2010	3 months	No protection	Heavy surface oxidation (85% coverage).
Nov 2009	Feb 2010	3 months	Zinc anode	Corrosion on 15% of surface and edges.

Figure 2.6 – Structural steel (539) coupon corrosion (Nov 2009 - Feb 2010 deployment)

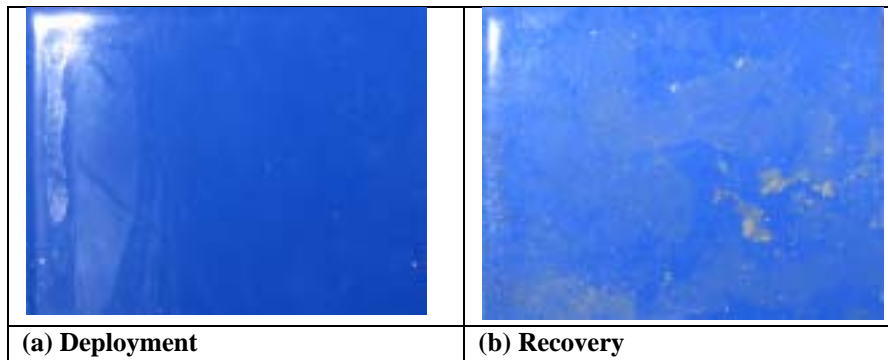
Intersleek is an inert, foul-release coating proprietary to International Paint. The manufacturer supplied two pre-coated rubber mats, each consisting of Intersleek 970 over a coat of Intersleek 737, though in different colors. The Intersleek coated surfaces and edges exhibited minimal fouling, with the exception of the blue painted mat (Figure 2.3), which was mildly fouled upon recovery.

Deployment	Recovery	Duration	Color	Changes
Aug 2009	Nov 2009	3 months	Red	Minimal fouling on surface and edges.
Nov 2009	Feb 2010	3 months	Blue	Minor fouling on ~15% of surface.
Apr 2009	Aug 2009	4 months	Red	Minimal fouling on surface and edges.
Apr 2009	Feb 2010	10 months	Red	Minimal fouling on surface and edges.

Figure 3.1 – Intersleek coupon fouling (Nov 2009 - Feb 2010 deployment)

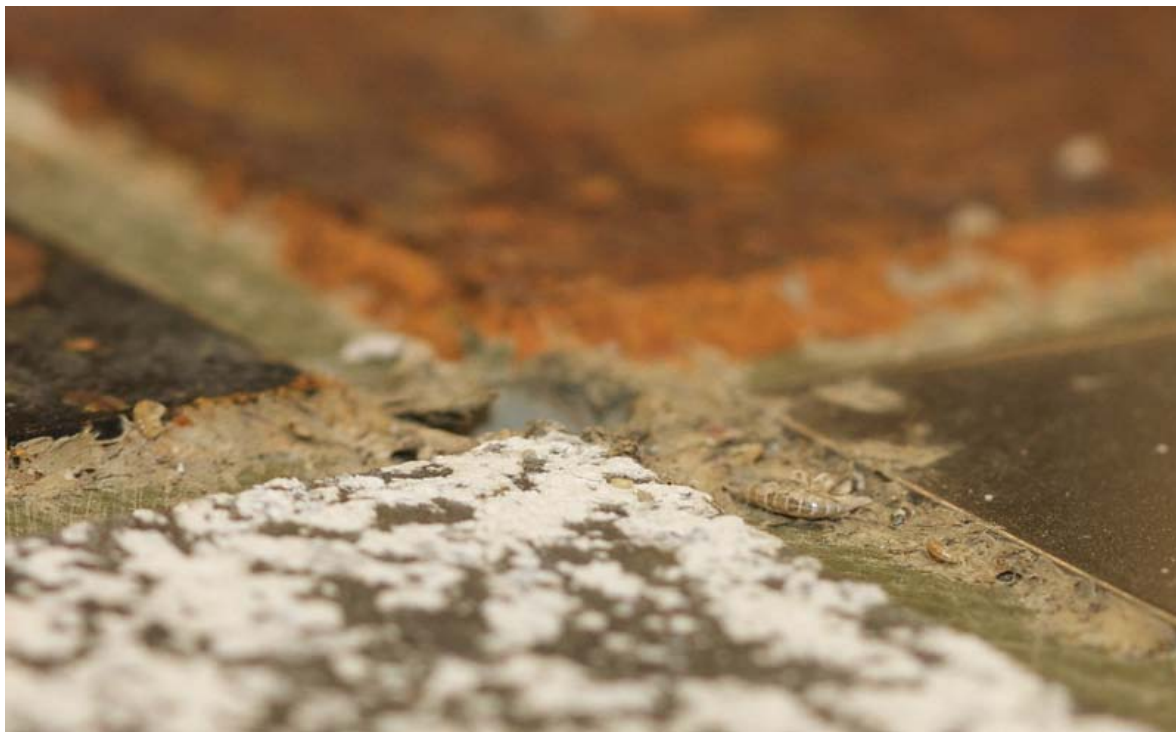
4. Biological fouling is seasonal. In particular, the crevices between all coupons and the substrate plates were heavily fouled with sediment and krill after the April-August and August-November, 2009 deployments (Figure 4.2), coinciding with annual period maximum of biological productivity.

Figure 4.2 – Fouling and sediment deposition along edges and in crevices
