WAVE ENERGY
IN SOUTHERN EUROPE

DELIVERABLE 2.4 MONITORING OF SEAFLOOR INTEGRITY

WP 2.4
Deliverable 2.4 Monitoring of seafloor integrity

D2.4 Monitoring of seafloor integrity

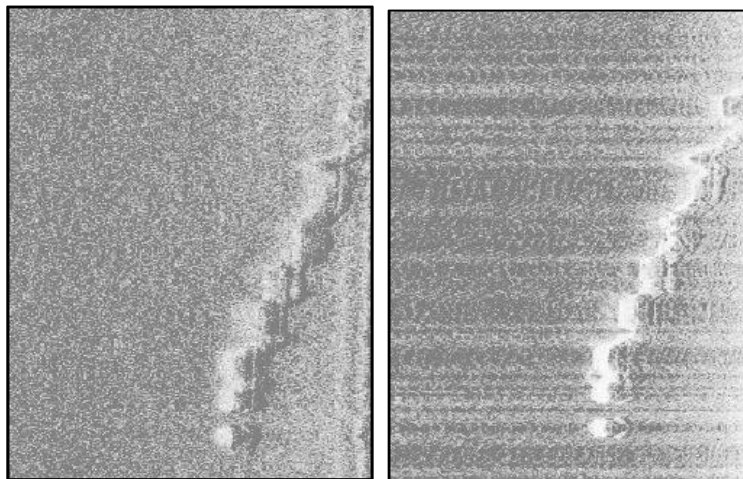
However, the wave height of 1.5-2 m prevented the collection of adequate data: due to the risk of entanglement with the mooring lines, the transducer was towed at a greater distance from the seafloor than the distance planned; moreover, the waves pulled the transducer, consequently introducing artefacts in the data acquisition, especially in the band of high frequency of 500 kHz (Figure 15).

Figure 15. Records in the same area of 100 kHz (left) and 500 kHz (right). Note that the effect of the swell (tugs) is more pronounced at the 500 kHz register.

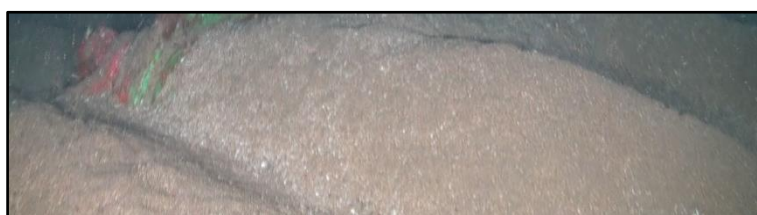
The video recordings show that three years after the installation of the device, in June 2016, there is not any evidence of recent movements of the anchors causing physical disturbance in the area (Figure 21). Actually, the ripple marks in the area are not altered either in the closest vicinity to the anchors.

Figure 21. Ripple marks close to the B2 anchor.

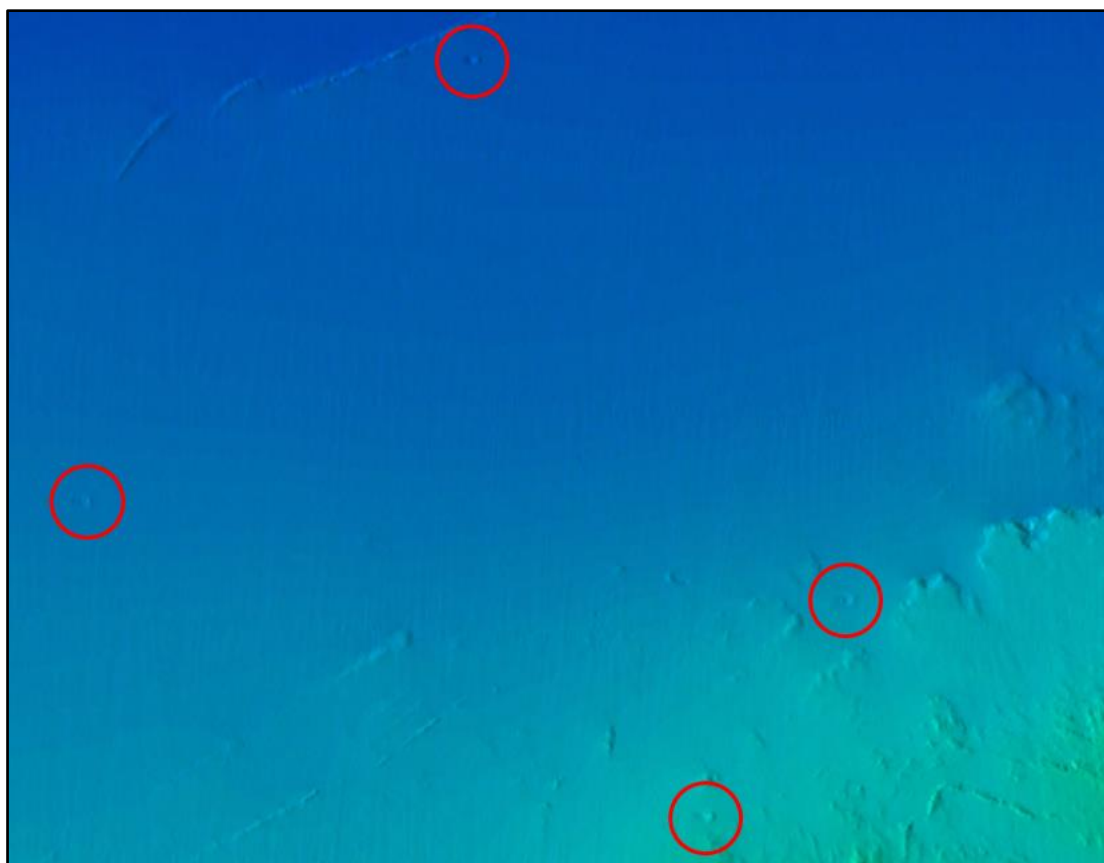
However, in a bathymetric survey carried out in September 2017, footprints apparently caused by the anchors could be seen (Figure 22). The footprints caused by the anchoring of anchors B1 and B2, which are close to the outcrops, are nearly 8 m in radius, whereas the footprints caused by F1 and F2 are roughly 12 m. The anchoring was carried out in June 2016, what may indicate that the disturbance caused in the process was still visible one year after. On the contrary, three years after the anchoring, the video recordings do not show such an alteration of the seafloor even with the energy convertor in operation.

Figure 22. Footprints (inside the red circles) probably caused by the anchoring operation in a bathymetry obtained in September 2017 (the anchoring was carried out in June 2016).

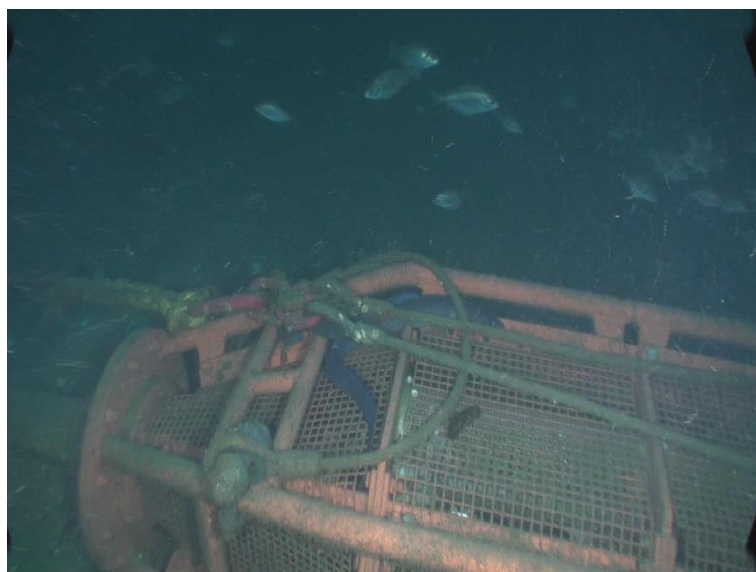
As described for the anchors, the connector is also partially buried into the sediment, not showing any indication of recent movements and physic alteration of the sediment. Furthermore, alike the anchors, the connector seems to be acting as a fish attractor, as a shoal of poutings was swimming around it and an European conger was resting on it (Figure 26).

Figure 26. A shoal of poutings (*Trisopterus luscus*) around the connector and at least one European conger (*Conger conger*) on the connector.

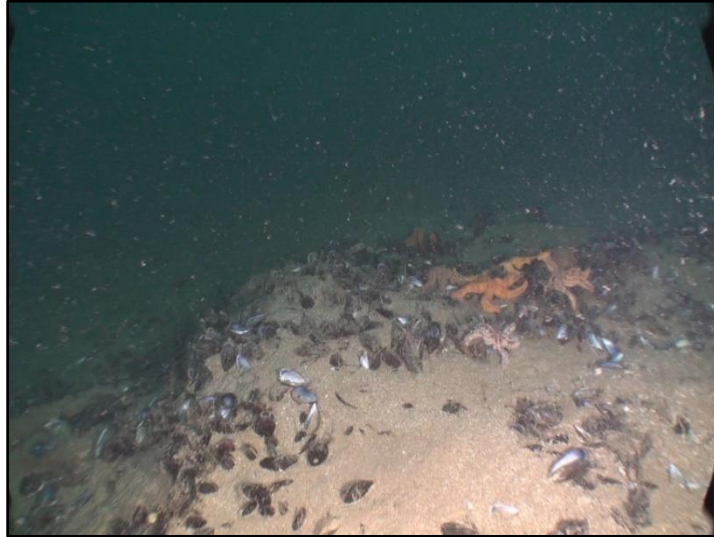
The only singularity found in the recordings close to the anchors is a sediment mound covered by mussel shells (*Mytilus edulis*) in the vicinity of B2 anchor (Figure 27). Over them, there were also starfishes (*Marthasterias glacialis*). Pieces of ropes and chains

lied into the sediment of the mound, which may indicate that it was an accumulation of sediment covering spores of them, over which mussels had grown. However, the anchor was close to rocky beds (in the eastern side of BiMEP). Hence, the mound could also correspond to an outcrop covered by sediment. Therefore, it cannot be concluded whether it was caused by rope sections with *M. edulis* fallen from the installation and accumulated on the seafloor or whether it corresponded to an outcrop close to rocky beds.

Figure 27. Sediment mound with mussel shells (*Mytilus edulis*) near B1 anchor. Some starfishes (*Marthasterias glacialis*) can be observed probably preying on the mussels.

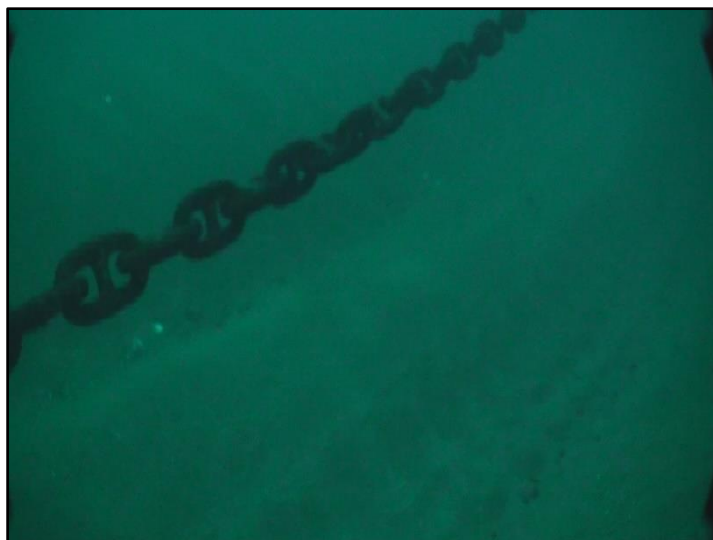
Regarding the moorings, the first sections of the chains move on a stripe of up to roughly 2.5 m width at both sides (Figure 28). These sections cover a length of 15-20 m from the point where the chains reach the bottom. Along these stripes, the smoothing effect of the chains is evidenced by the total or partial remotion of ripple marks in the area (Figure 29). After those 15-20 m the chains lie on the ripple marks, buried by the crests (Figure 30) and physical alterations are not observed.

Figure 28. Sediment disturbed by the movement of the chains in B2 (up) and tracks made by the chain after it raises from the sediment (below).

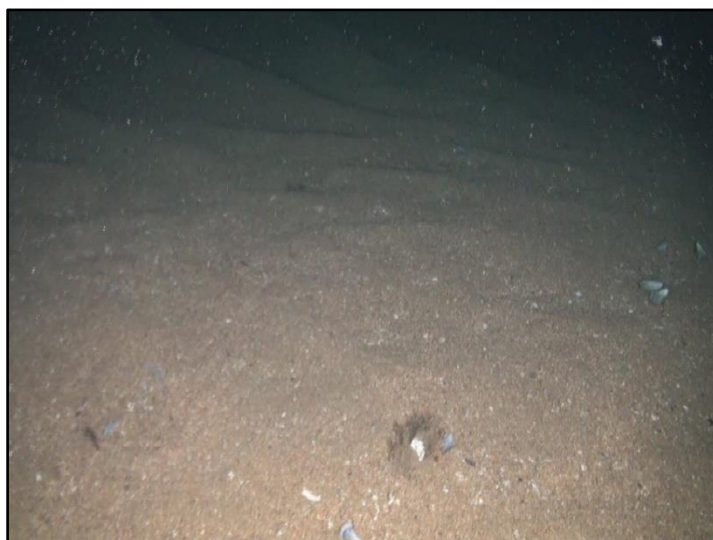
Figure 29. In the background, ripple marks on the sediment. In the foreground, they have been partially removed due to the movement of the chain.

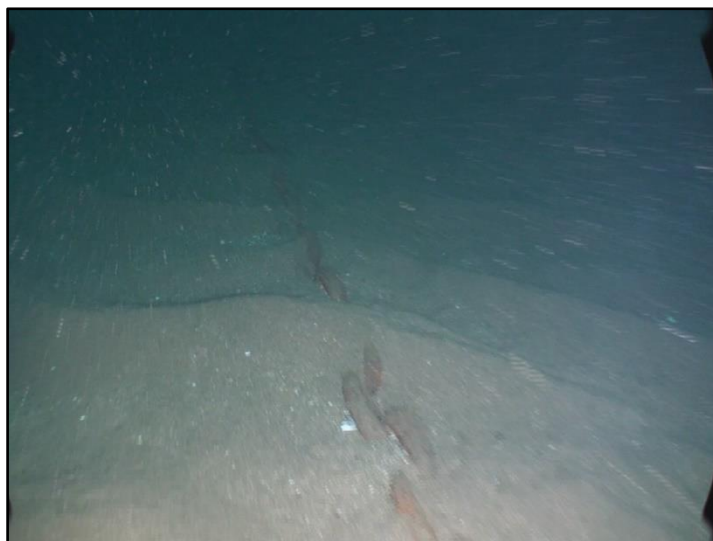
Figure 30. Chain from B1 anchor partially buried into the ripple marks.

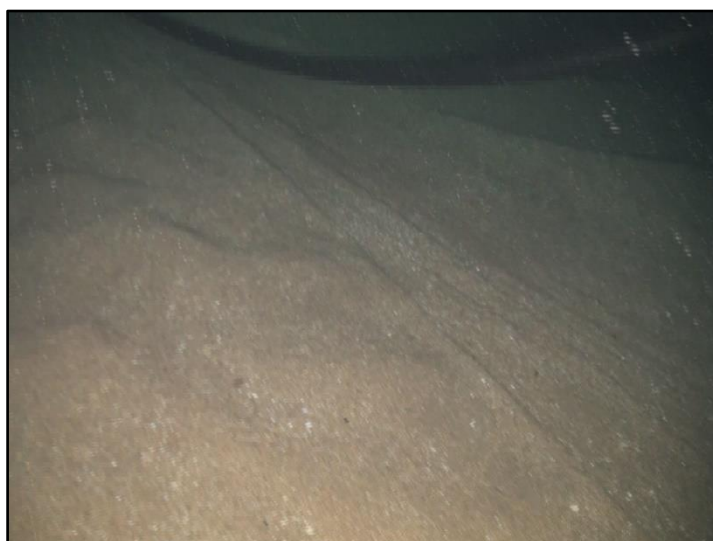
Figure 31. Footprints made by the cable on its vertical oscillation and altered ripple marks at the side.

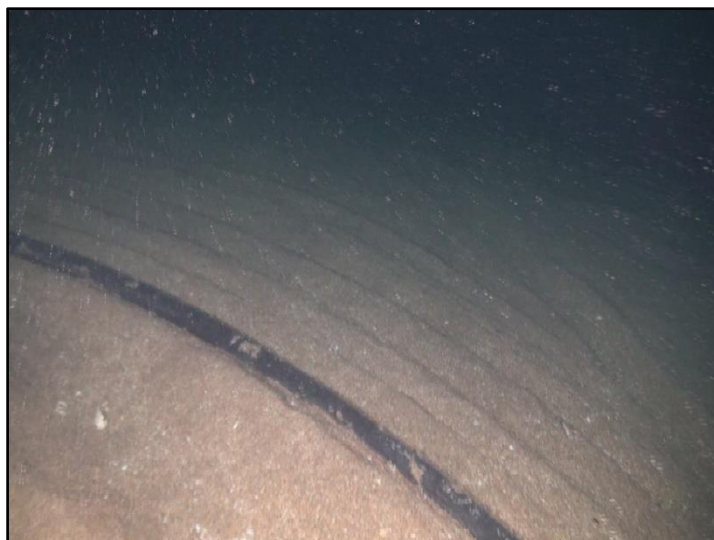
footprints can be appreciated as lines that run parallel to it (Figure 32), indicating that the cable moves over a stripe of roughly 5-10 m width.

Although the width of the stripe caused by the movement of the cable could not be measured, from the footprints observed in the abovementioned turn, it could be estimated that it moves in a band of a minimum width of 5-10 m, along the first 10 m from the landing point of the cable. Hence, it can be estimated that the affected area could reach at least 50-100 m².

Figure 32. The wire turns roughly 90°. Some footprints at the side of the wire indicate different lines the wire has been placed previously.

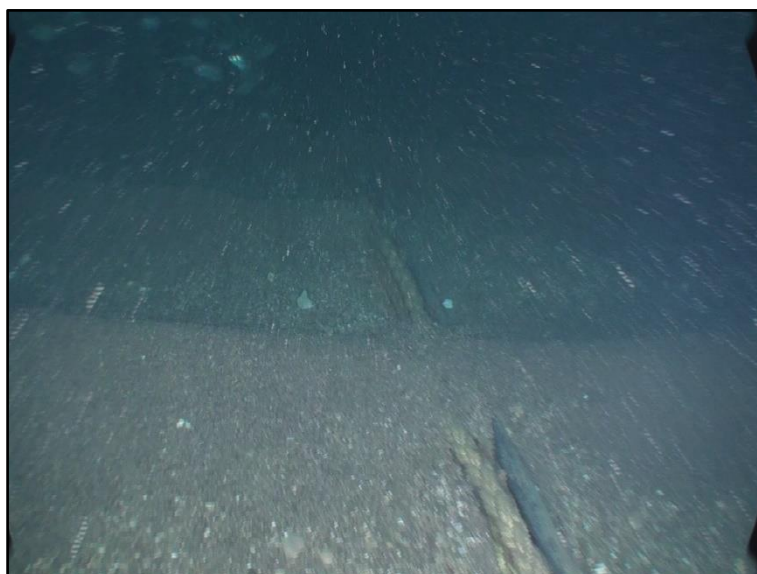
Figure 33. Rope and wire to connector lying on the ripple marks, buried by the crests.

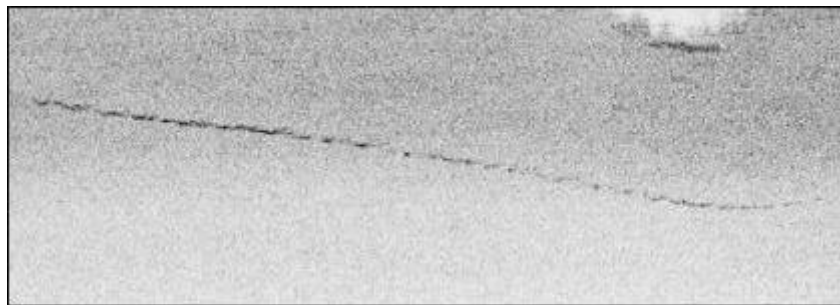
Along the route of the cable, it is dug out in an E-W direction from the connection point to the turning point towards the south. The connector has been identified at point 510157, 4813248. The cable runs from the connector towards the SE, burying itself until it disappears (Figure 36 and Figure 37).

Figure 36. Sonar record (100kHz) where the unearched cable can be seen on a sandy bottom.

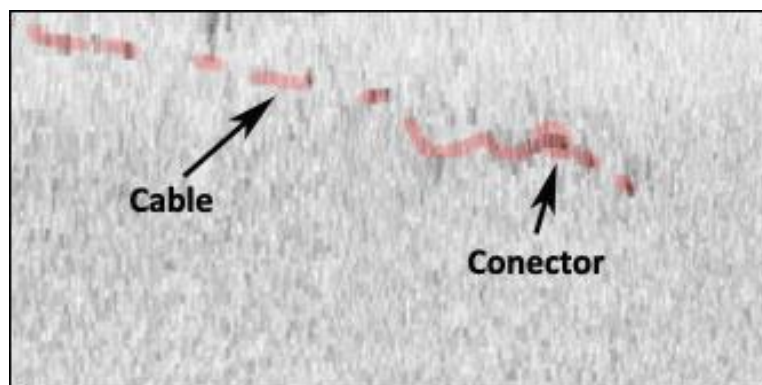
Figure 37. Sonar log (100kHz) with cable and connector detail.

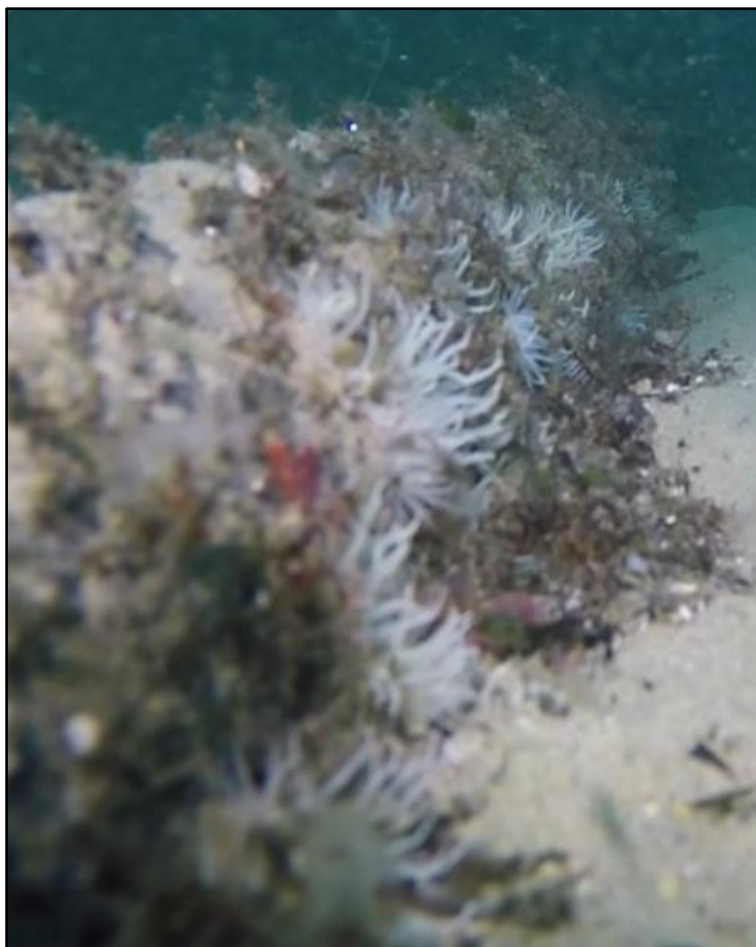
Figure 43. Electrical cable covered by sand and colonized by algae and anemones. (GoPro camera).

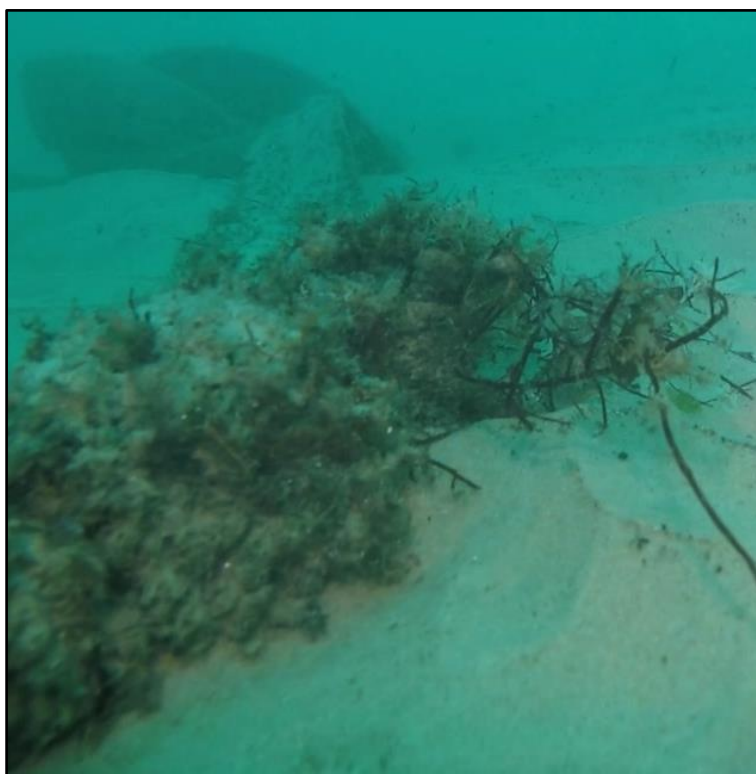
Figure 46. Synthetic strap colonized by algae. (GoPro camera)

- iii) A piece of a synthetic strap found on the seafloor, although possibly insignificant with regards to impacts, is evidence that wave energy projects as well as any anthropogenically driven activity at sea may represent some type of littering. In the case of objects that are easily seen (such as the strap), this is easily mitigated by looking out for drifting/sunk objects when performing diving inspections to the devices or their supporting structures.

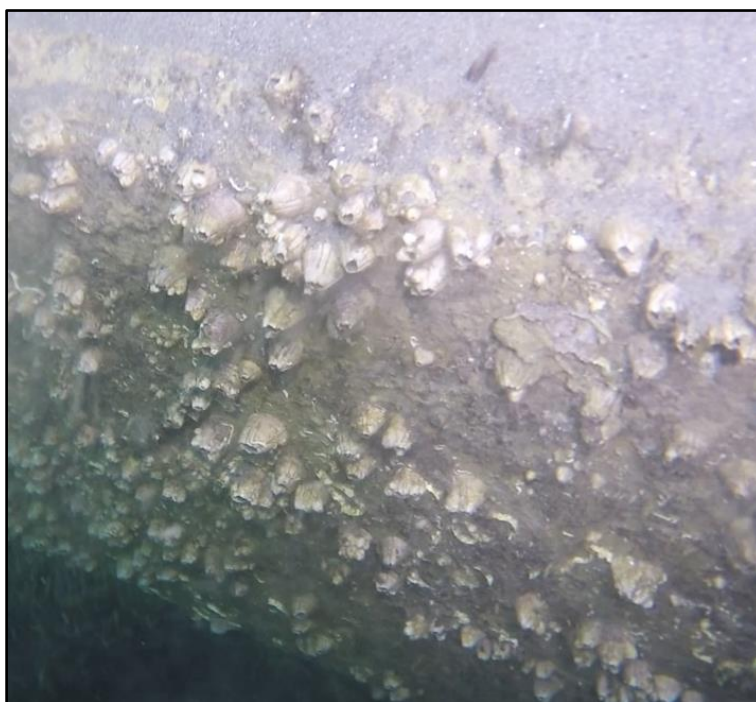
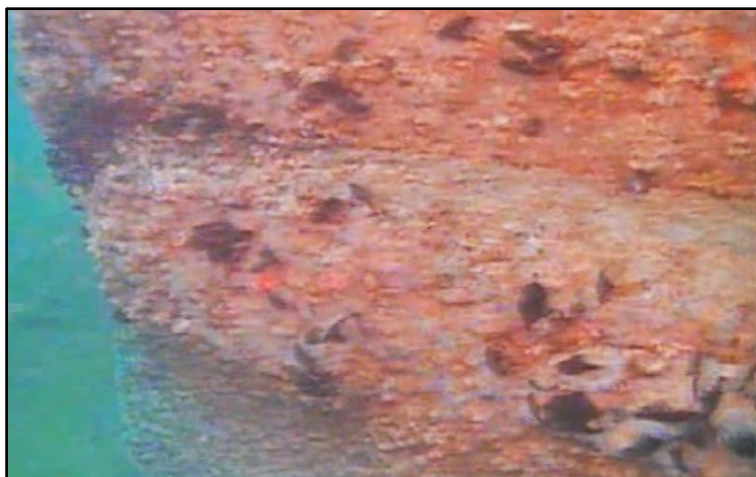
All of the artificial items were colonized by organisms, also known as biofouling. The cables were especially colonized by algae and anemones (e.g., WR_T1 11:11 to 11:15; Figure 43) the foundation was greatly colonized by acorn barnacles, calcareous tubeworms and, in a much lesser extent, by mussels (e.g., WR_T4 14:56

Figure 47. Colonization of the WaveRoller foundation: Top picture: lower section of the foundation colonized massively by barnacles (*Perforatus perforatus*) and calcareous tubeworms (cf. *Spirobranchus* sp.) (GoPro camera); Bottom picture: Mid section of the foundation colonized by barnacles and sparsely by mussels (*Mytilus galloprovincialis*) (Onboard camera video).

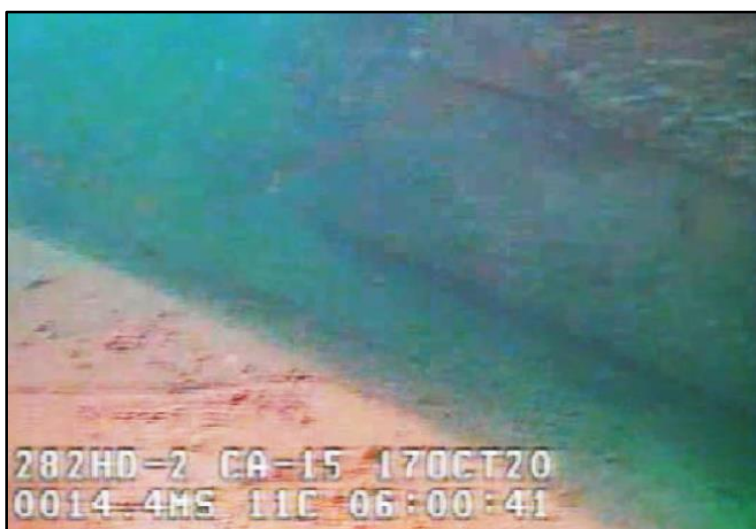
- ii) Also close to the foundation (~1 m from it), a small sand “dune” was found (WR_T4 14:56 to 14:57; Figure 48).

The “dune” could have been formed by sediments depositing behind the device as a consequence of its presence. The WaveRoller foundation was lifted for removal, which was later cancelled, hence, it was set back on the seafloor. Setting the foundation on the seafloor in a very close, but not the exact same area occupied previously might give the idea of a “dune”.

Figure 48. Sand “dune” found near to the WaveRoller foundation (Onboard camera video)
