**Annual work report 2017**

**Offshore wind energy power plant**

# **Nobelwind**

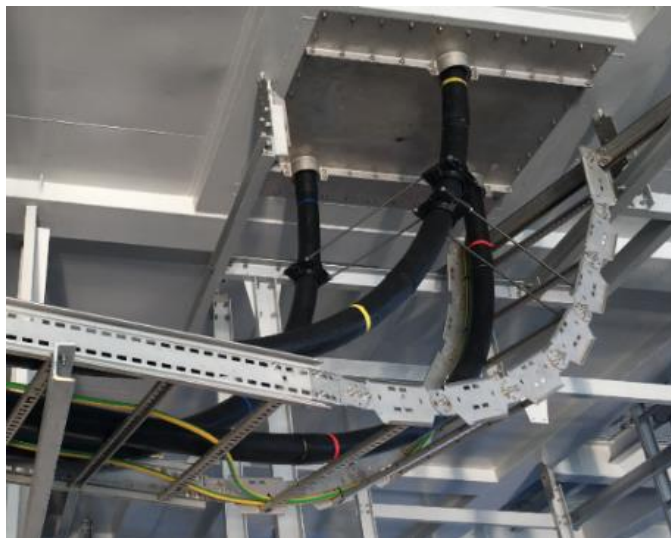
*Figure 5: Fixation 220 kV export cable*

- Fixation of 220kV export cable: The 3 phases are not correctly fixed as there is a 3m gap between the GIS room and the first fixation (see Figure 5). NBW has agreed with Semco that NBW will install the additional/missing supports as soon as the platform is deenergized. Semco will, if necessary, send extra materials.
