Geotechnical Support Services - Hywind Scotland Offshore Windfarm Landfall Site Walkover - Geotechnical Evaluation Statoil ASA

Assignment Number: A100142-S01
Document Number: A-100142-S01-TECH-001

Landfall Site Walkover - Geotechnical Evaluation

Client: Statoil ASA
Document Type: Technical Note
Document Number: A-100142-S01-TECH-001

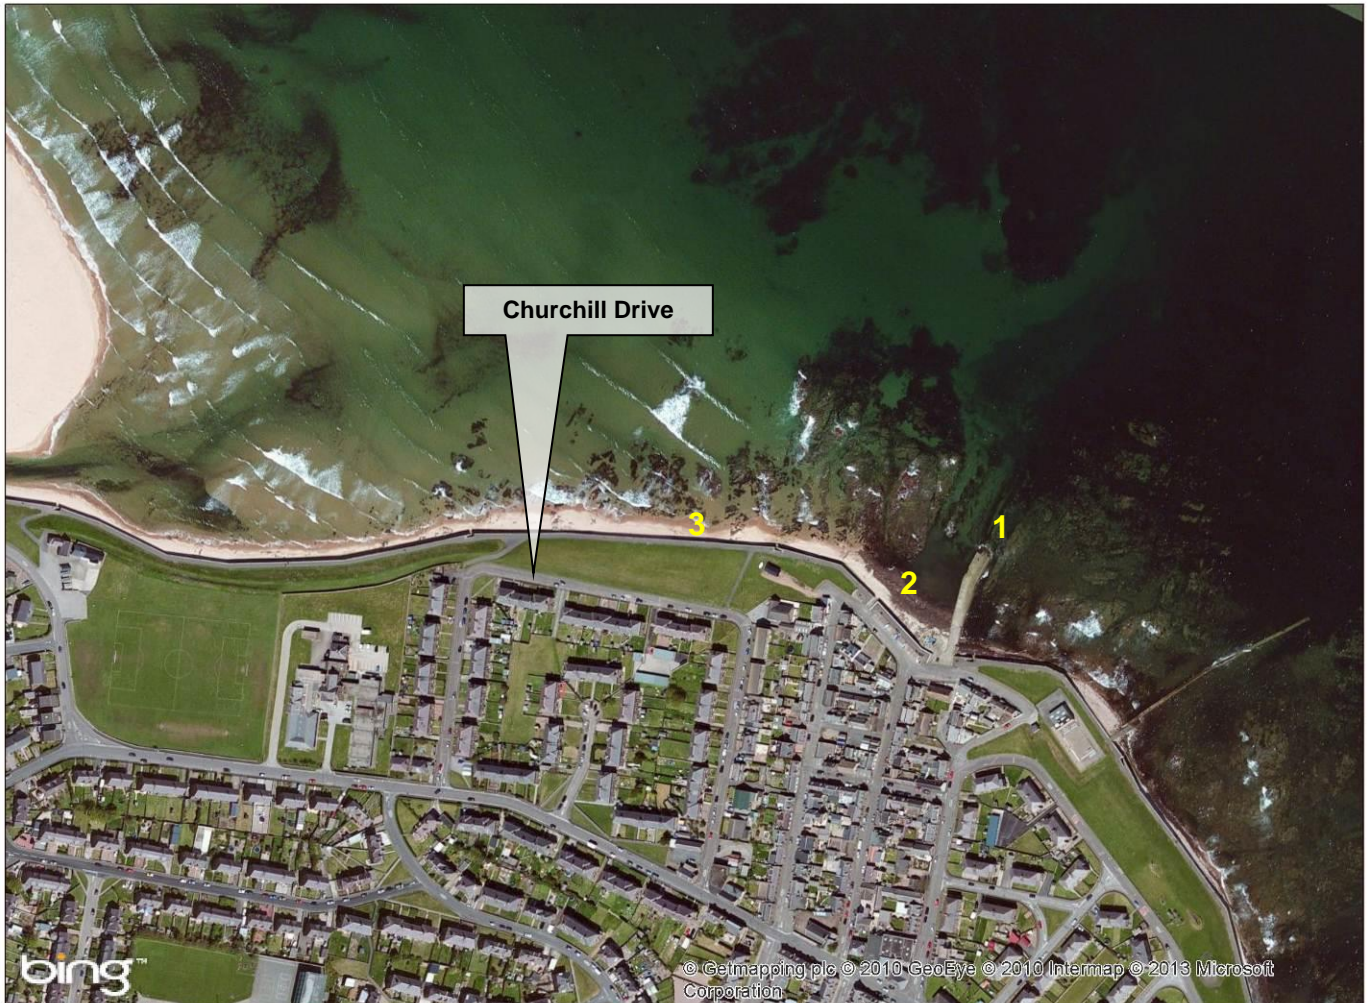
Figure 5: Landfall Site 1 – numbers refer to photos

Item	Comments
Site Description	<p>Sandy and rocky beach that extends out 50 – 100m from the promenade (photo 3). Rocky outcrops are less evident closer to the mouth of the river as indicated in Figure 5. Extensive sand beach on north side of river adjacent to golf course. Note, the northern side of the river was not part of the investigation, so further discussion of this area is not presented.</p> <p>On the eastern margin of this area, there is a small concrete jetty/breakwater used by local fishermen (photos 1 and 3). A 20 – 30 m wide inlet for landing fishing boats lies on the</p>

<p>western side of the jetty and is laid with silty sand sediments. The thickness of such is unknown, but likely to be shallow (< 1m thick over rock/gravel). The jetty has formed a breakwater to protect the boats tied alongside and hence the energy within the bay is significantly reduced; hence the ability for sand and silt to deposit.</p> <p>West of this inlet is a rocky shoreline that extends out approximately 150 m. An openly corroded and exposed concrete water discharge pipe/conduit (< 400mm diameter) lies just west of the inlet that was constructed out to sea. Water still discharges at the base of the seawall where the pipe exits. The sandy area to the west was not investigated further, as this unlikely to be an available option due to local recreational/fishermen constraints.</p>
Geology	Granite basement rock that is well jointed, but very competent.
Geomorphology	<p>Shoreline consists a shelf of basement rock that becomes more sandy west toward the river mouth. The beach area is very gently sloping. The river channel across the beach during the day of the site visit extended towards the east and entered the sea where the rocky substrate becomes more apparent.</p> <p>The land behind the beach and above the promenade is an engineering embankment covered in grass. Behind this is residential housing and a football field.</p>

Shore Protection	Concrete seawall approximately 3 - 4 m high.
Land Instability	None. Beach area has concrete seawall that mitigates coastal erosion and no evidence of slope movement in the soil banks adjacent to the beach promenade was observed.
Landuse	<p>Residential/Recreational.</p> <p>Small fishing jetty may have commercial activity.</p>
Landfall Approach	<p>Conventional open-cut trenching/cofferdam would be feasible at the sandy beach; however this is highly unlikely to be allowed due to local fisherman activity and recreational use of the area, as open-cut trench cable pull operations would cause major disruption.</p> <p>However, conventional open-cut trenching/cofferdam would not be feasible on the rocky beach without major construction activities being adopted (e.g. drill and blast and mechanical excavation). Additionally, consideration to building a conduit across the rocky foreshore out to sea to protect the cable would be very conspicuous and unlikely to be given consents. Laying the cable on the rock would make it exposed to high energy environmental loadings, abrasion and dangerous exposure of a high voltage cable to recreational users of the shore.</p> <p>A potential option is to use a long HDD (horizontal directional drilling) approach from the flat grassed areas adjacent to the promenade parallel to Churchill Drive. The length of the HDD would only need to be a few hundred metres out to a safe location offshore (away from fishing and recreational activity). However, this would need further evaluation from an HDD contractor.</p>

Statoil indicate that this Site is currently an unlikely option due to current coastal shore use by local fishermen and recreational users. However, technically this would be the best placed to perform a conventional low risk and cost-effective landfall cable pull operation either on the sandy beach or up the inlet of the fishing bay, as this zone is protected by the concrete jetty.

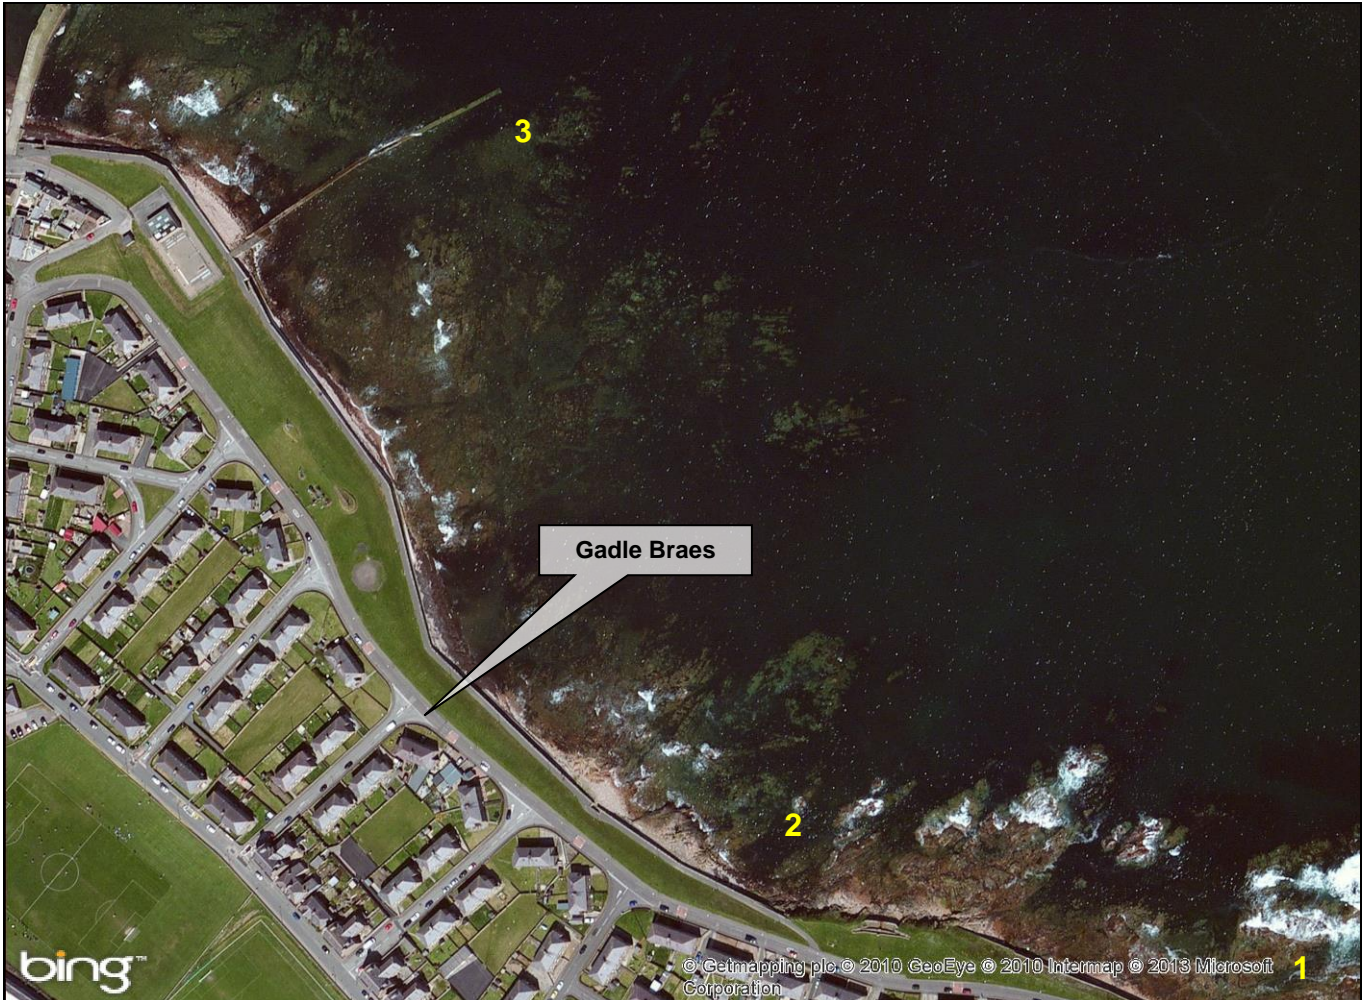
Figure 6: Landfall Site 2 - numbers refer to photos

Item	Comments
Site Description	<p>The shoreline at this site is a rocky shelf that extends out approx. 100 – 150 m from the base of the concrete seawall. Pockets of coarse gravel/cobbles/boulders fill low spots on the rocky shelf. No beaches exist along this area, except for small accumulations of coarse gravel/cobbles.</p> <p>The site is approximately 700 - 800m long lying between a concrete water treatment outfall conduit in the west (see Figure 7) and the start of an industrial estate to the east. The concrete conduit extends out approx. 150 – 160 m from the base of the seawall, which is connected to a fenced off water treatment plant owned by Scottish Water.</p> <p>Above the seawall is the continuation of the promenade from Site 1, but this ends approx. 2/3's along the site to the east where it rises to the road (Gadle Braes). The land uphill of the seawall consists of a grassed bank that has a residential road built along its crest. A</p>

<p>children’s playground and a memorial site also exist along this promenade.</p> <p>Some disused wire cables anchored to the seawall and partially covered in concrete on the rock shelf are exposed. Use is unknown.</p>
Geology	Granite basement rock that is well jointed, but very competent.
Geomorphology	<p>Shoreline consists of a shelf of basement rock that is irregular in outcrop (i.e. rough terrain) and appears to have more mobile cobbles and boulders lying toward the western section near the water treatment conduit. The rock jointing has allowed some narrow gravelly/cobbly inlets to be formed through erosion, but these are limited in width to < 10 m across.</p> <p>The grassed bank above the promenade is an engineering embankment with residential housing and a football field beyond.</p>
Shore Protection	Concrete seawall approximately 4 - 5 m high.
Land Instability	None. Beach area has concrete seawall that mitigates coastal erosion and no evidence of slope movement in the soil banks adjacent to the beach promenade was observed. Only erosion of the soil near the memorial site was evident, but this is more attributed to surface run off and pedestrian traffic to the shore.

Landuse	<p>Residential/Recreational.</p> <p>Some industrial areas lie in the eastern part of the site and behind the houses.</p>
Landfall Approach	<p>Conventional open-cut trenching/cofferdam would not be feasible on the rocky beach without major construction activities being adopted (e.g. drill and blast and mechanical excavation). Additionally, consideration to building a conduit across the rocky foreshore out to sea to protect the cable would be very conspicuous and unlikely to be given consents. Laying the cable on the rock would make it exposed to high energy environmental loadings, abrasion and dangerous exposure of a high voltage cable to recreational users of the shore.</p> <p>The best option would be to use a long HDD approach from a flat grassed area adjacent to the promenade parallel to Gadle Brae (most likely to the western margin near the playground where the grass embankment is wider and of a shallower slope). The length of the HDD would only need to be a few hundred metres out to a safe location offshore. However, this would need further evaluation from an HDD contractor.</p>

The foreshore is too rocky and coarse to pull a cable up to a land connection; therefore underground techniques such as HDD would need to be adopted to consider a safe and effective cable connection, rather than construction above ground which is much more visible and will leave a permanent mark on the shore.

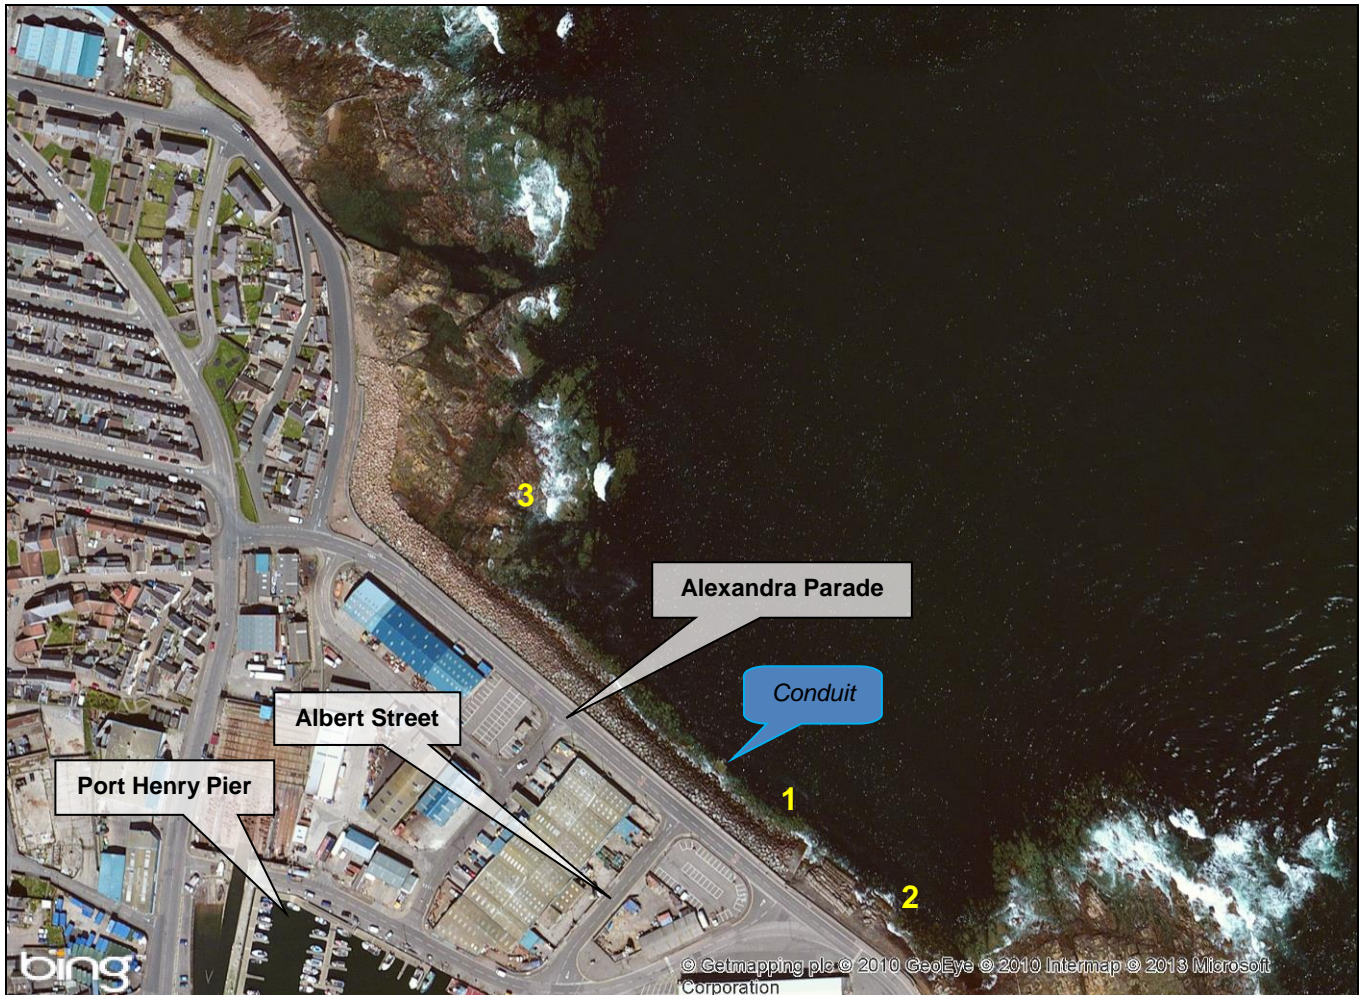
Figure 7: Landfall Site 3 - numbers refer to photos

Item	Comments
Site Description	<p>This site is bound by a natural rocky shore and in between is a man-made erosion protected coastline in front of an industrial estate. The shore protection consists of large 2 - 3 m³ granite boulders and some formed concrete protection structures in front of a high 4 - 5 m concrete seawall. Behind the seawall is Alexandra Parade. A concrete conduit structure exits below the rip rap protection approx. at the halfway point between the natural rock outcrops to the west and east (aligned with Albert St). The conduit has two exit points, but a close-up inspection was not performed at the time. It is unsure what the conduit discharges or is used for, and if there are other access points to it. Note, the area of Alexandra parade and the Port Henry Pier is constructed on engineered fill, as originally this area was a narrow seaway passage separating Peterhead township and Peterhead Peninsula.</p> <p>To the west of the alexander parade is the rocky seashore adjacent to The Esplanade. The</p>

eastern side of the shore is partially covered in large rip-rap type granite boulders against the concrete seawall that is 3 m high from the rocky shore, but only 1.0 - 1.5 m high at pedestrian level on The Esplanade. Behind The Esplanade is residential estate.
Geology	Granite basement rock that is well jointed, but very competent.
Geomorphology	<p>The western shoreline consisting mainly of a shelf of basement rock is irregular in outcrop (i.e. rough terrain) and consists distinct rock jointing and dyke-type structures that has allowed some narrow inlets to be formed through erosion. These inlets are often filled with coarse gravel/cobble/boulder type sediments and are limited in width to < 10 - 15 m across.</p> <p>The manmade shoreline is straight, flat and well protected from the sea. The industrial area is heavily built upon with sheds, car parks, and loading bays.</p>
Shore Protection	Large boulders of granite rock (rip-rap) and a high concrete seawall approximately 4 - 5 m high.

Land Instability	None as the natural shore is a rocky shelf with slopes, and the man-made area consists heavy coastal erosion protection measures
Landuse	Residential/industrial.
Landfall Approach	<p>Conventional open-cut trenching/cofferdam would not be feasible on the natural rocky beach without major construction activities being adopted (e.g. drill and blast and mechanical excavation), or along the man-made section. Laying the cable on the rock would make it exposed to high energy environmental loadings, abrasion and dangerous exposure of a high voltage cable to recreational users of the shore. Additionally, on this western rocky shore section houses are located on The Esplanade opposite the seawall, which makes it difficult to locate any construction operations for the landfall without major disruption.</p> <p>However, there are a couple of options:</p> <ol style="list-style-type: none"> 1. Consideration of long HDD from the industrial estate under the seawall and out to sea. There are several flat areas that are empty (e.g. car parks) to set up the drilling equipment to push a conduit out to a safe exit point offshore. The length of the HDD would only need to be a few hundred metres out to a safe location offshore. However, this would need further evaluation from an HDD contractor as the site is built on engineered fill and the depth to natural rock may vary significantly knowing that this site was built upon a natural seaway channel. 2. Pull the cable up the existing concrete conduit that lies in the middle of the Alexandra Parade opposite Albert St. However, further consultation with Peterhead Council and/or Harbour Dept. would be needed to understand what the conduit is and if such an operation is feasible.

The foreshore is too rocky and coarse to pull a cable up to a land connection; therefore underground techniques such as HDD should be investigated to consider a safe and effective cable connection. Construction above ground is much more visible and will leave a permanent mark on the shore, is such an operation is considered.

Further understanding of the 'fill' area between Alexandra Parade and Port Henry Pier would be needed to understand what lies beneath the surface if underground cable pull operations are to be investigated further for this site.
