Annual work report 2015

Offshore wind energy power plant

Belwind

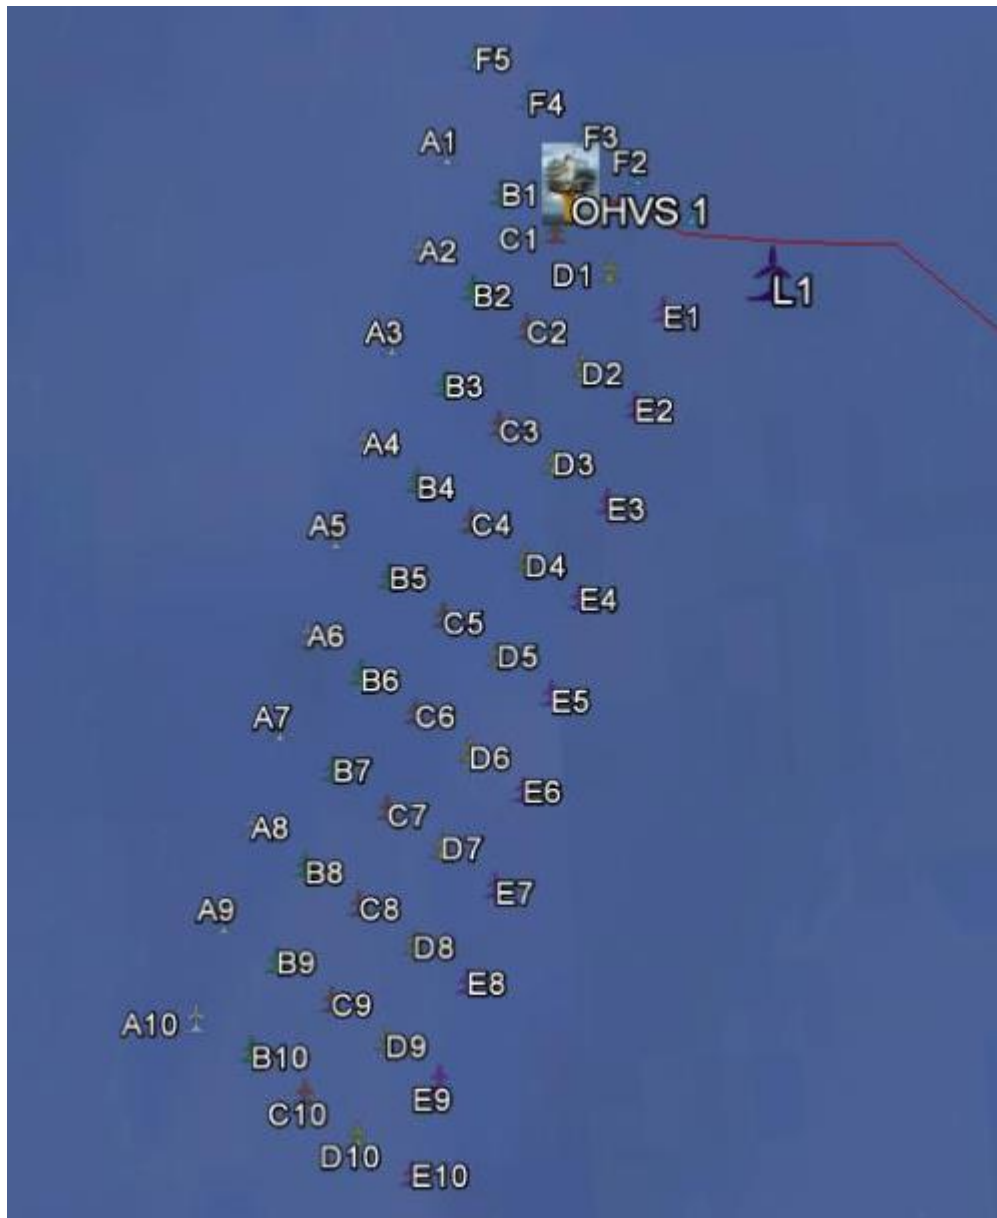
Figure 2: Locations of the wind turbines and the grid connection phase 1

The pilot phase, Belwind 1 or Belwind phase 1, consists of 55 wind turbines of 3 MW each (Vestas V90) and an offshore high voltage station (OHVS). Via a local grid (33 kV) the wind turbines are connected to the OHVS. The energy is transported to land by a 150 kV submarine cable. Phase 1 is erected and fully operational since January 2011.

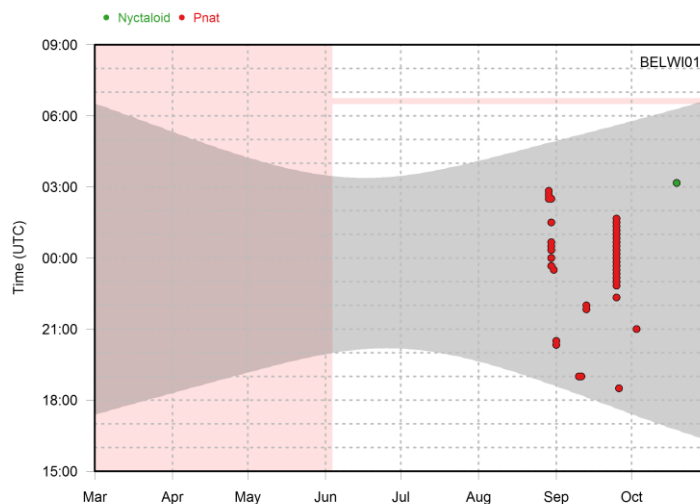
Figure 3: Bat presence near BW1 OHVS

On request of the MUMM, Belwind facilitated the installation of a bat monitoring equipment on the BW1 OHVS. From June till end October the system was installed on the cable deck level. The system was resupplied of energy by a solar panel and the 3G network of the windfarm was used to allow data communication directly between the system and the researcher's data capturing. Early result analysis shows that some bat activity was measured during darkness.

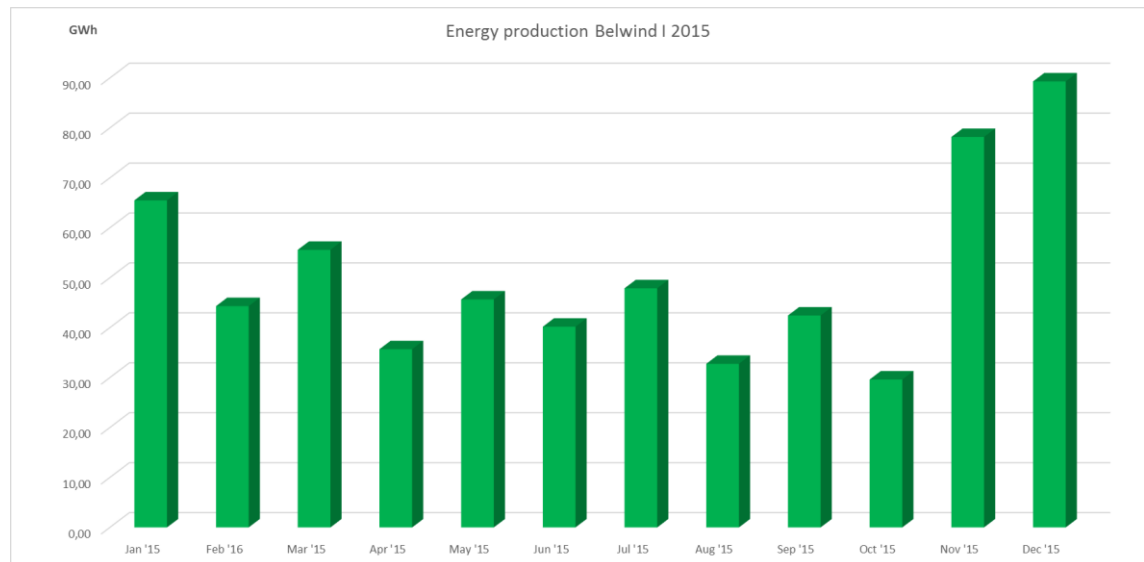
Figure 5: Monthly production 2015

The year 2015 was in terms of production the highest since the beginning of Belwind. The availability was kept high and the wind resource was more or less in line with the forecasted values.

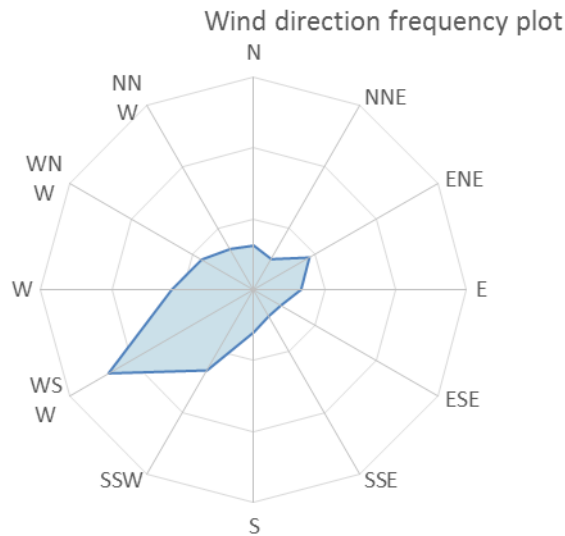
Figure 6: Energetic wind rose

The displayed wind rose is a graphical representation of the wind speed and direction measured all over the wind park.

For all wind speed categories, the wind directions SW and NNE-NEE prevail.

The global average wind speed in 2015 was slightly below the expected wind resource. The measured value in January, July, November and December was significantly higher than the estimated speed by the assessment studies, February, August and especially October were very low wind months.
