Annual work report 2016

Offshore wind energy power plant

Belwind

Subject	Author	Revision	Date
Public version of annual work report 2016	LVE	KVE/DVA	17/05/2017

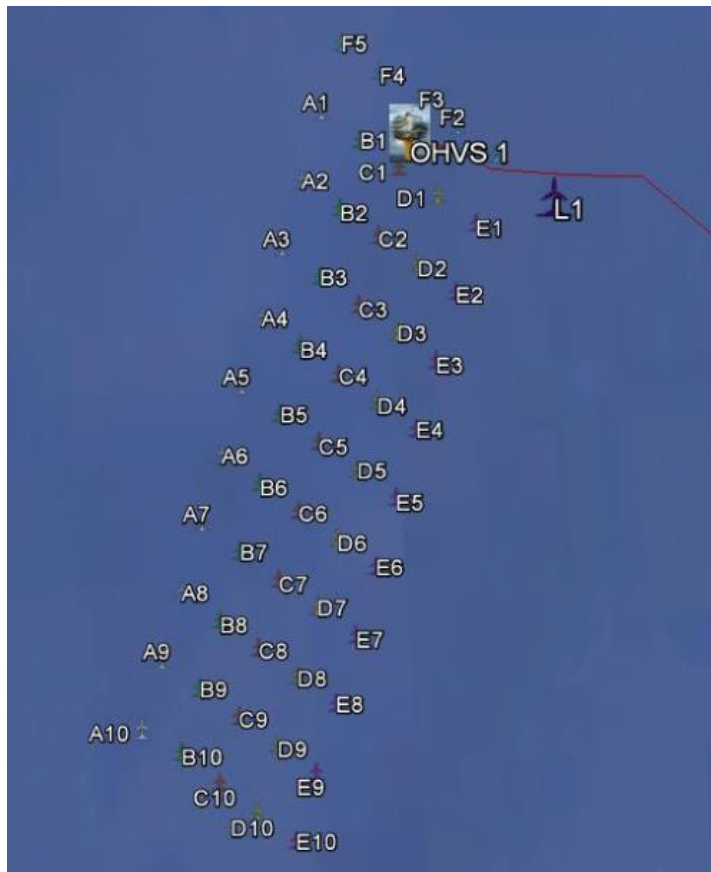
Figure 2: Locations of the wind turbines and the grid connection phase 1

The pilot phase, Belwind 1 or Belwind phase 1, consists of 55 wind turbines of 3 MW each (Vestas V90) and an Offshore High Voltage Station (OHVS). Via a local grid (33 kV) the wind turbines are connected to the OHVS. The energy is transported to shore by a 150 kV submarine cable. Phase 1 has been erected in 2009 and 2010 and is fully operational since January 2011.

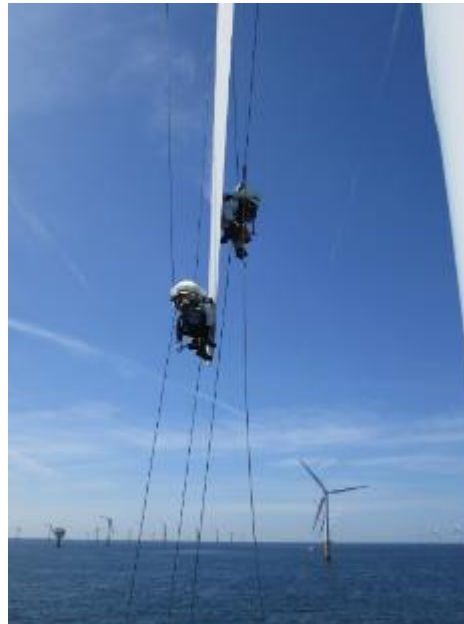
- Blade inspections: All blades from all WTG's were inspected by the use of drones. As the drones and the cameras are constantly evaluating, and detailed more detailed analyses can be done, MVOW concluded that there was a big amount of blade damages in different categories.

Figure 8: Rope workers at work on BW.

Rope workers: Rope workers are working on rather small damages and all lightning damages.

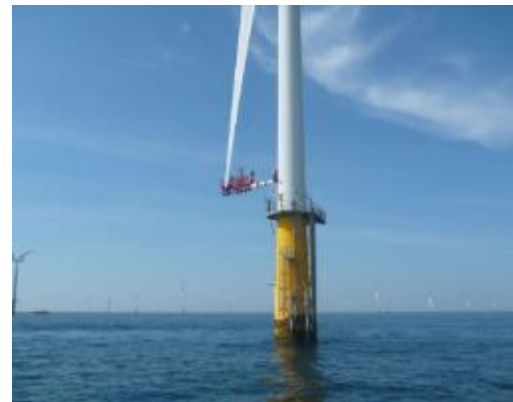
Figure 9: Sky climbers in use

Sky climbers: Sky climbers are used for the bigger damages

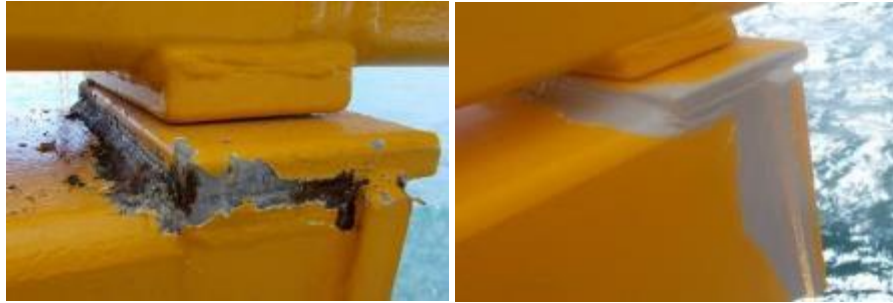
Figure 10: paint repairs foundation

- Paint repairs if necessary: on some foundations, some of the circumferential welds have been repaired as paint was flaking and not adhered any longer. Also smaller repairs were done on the ladders and railing on the topside.
