WIND FARM THORNTON BANK PHASE 1

ANNUAL ENVIRONMENTAL REPORT 2009

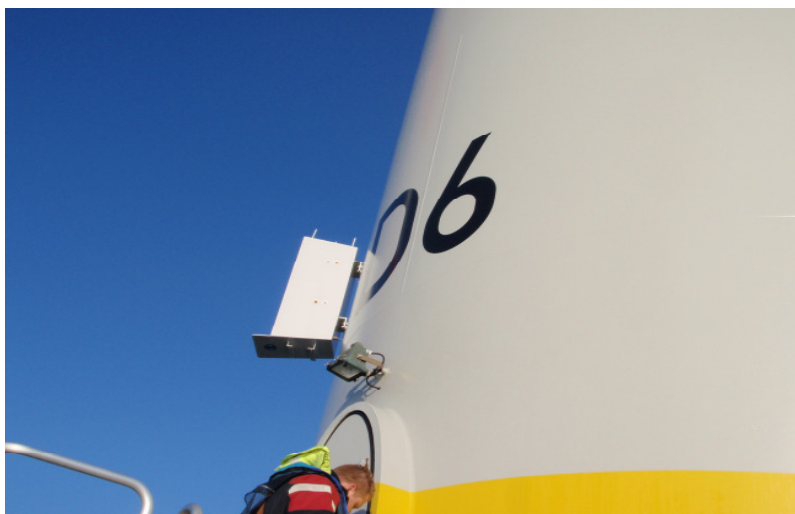
Figure 2 Fog horn on D6

All WTG dispose of lighting according to international IALA and ICAO standards. The corner wind turbines D1 and D6 dispose of fog horns that automatically operate at weather conditions of -2 miles visibility.

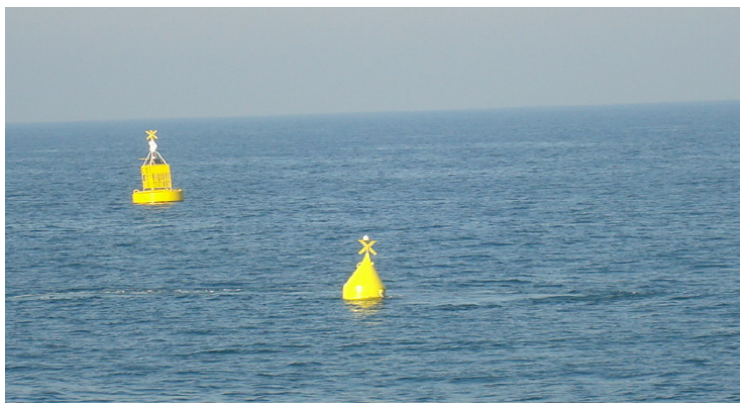
Figure 3 Measurement buoy of ADCP at Thornton Bank

The measurements consisted of flow measurements with an ADCP and a RCM-9, wave measurements with an ADCP and turbidity measurements with an OBS3A and a RCM-9.

From the analysis of the data, it appeared that the sediment concentrations occurring at the Thornton bank did not change during the works compared to the reference situation, which was measured before the works had started. Furthermore, it appeared that the concentrations occurring at the Thornton Bank were not changed after the works at the Thornton Bank had ended.

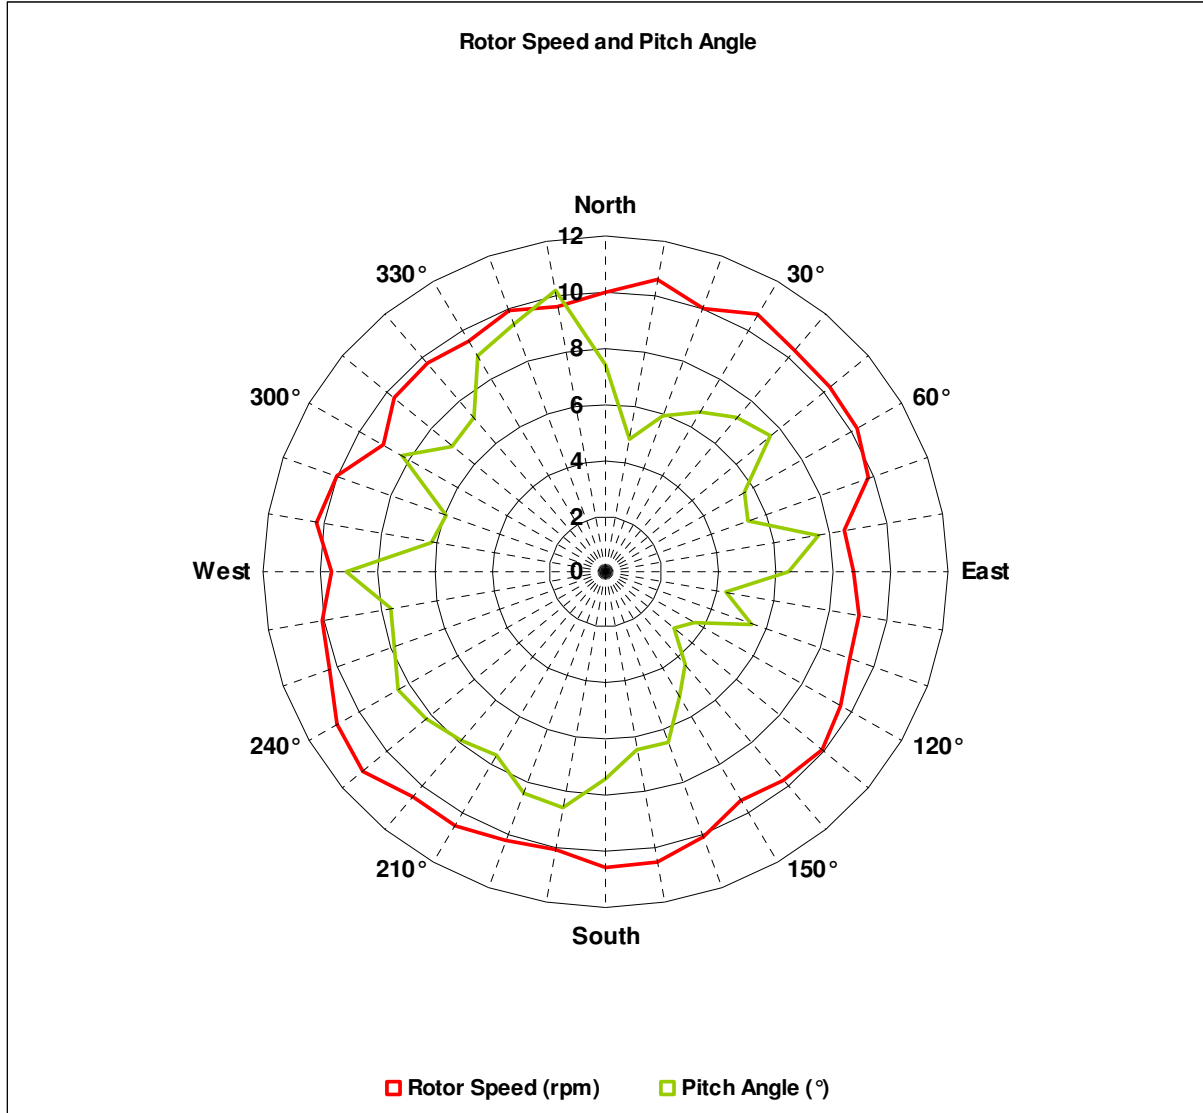
Figure 4 Rotor speed and pitch angle of D1 in 2009

In figure 4 a diagram represents the average rotor speed and pitch angle of D1 in 2009

In table 2, the average rotor speed and pitch angle are compared to the wind direction for the Repower 5M WTG in 2009.
