**THORNTON BANK  
OFFSHORE WIND FARM**

**ANNUAL REPORT 2012**

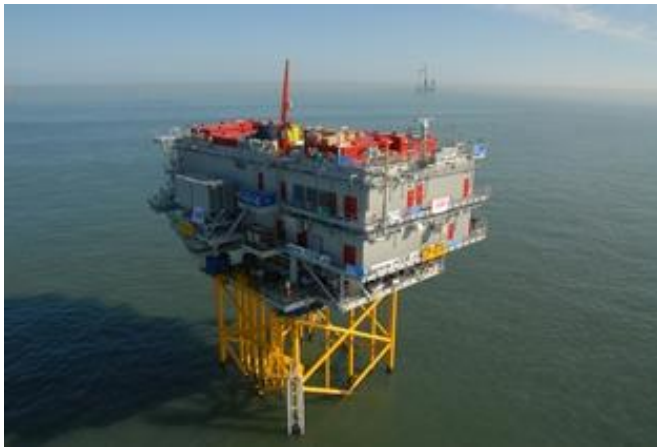
**Figure 2: the 4 storey 2000 T offshore transformer station (OTS) was installed on 16 March 2012**

The most important milestones were the installation of the offshore transformer station, the installation of 30 wind turbines of 6,15 MW and the laying of the second 150 kV export cable ,.

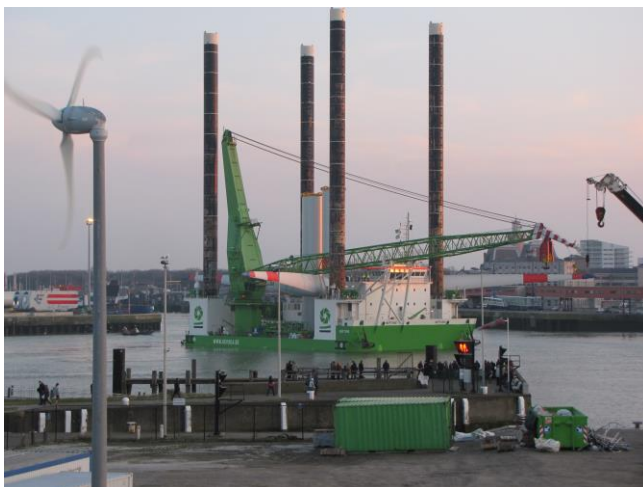
**Figure 3: "Neptune" sailing out with the first 6,15 WTG (nacelle, tower sections and blades) on 18 March 2012**

All construction and installation works at sea (wind turbines, cables, foundations,..) have been performed by different subsidiaries and subcontractors of the Belgian based marine works company DEME. At some days during the construction season, DEME mobilised more than 10 specialised vessels a day, of which the WTG transportation and installation jack-up vessel "Neptune" was the eye catcher.

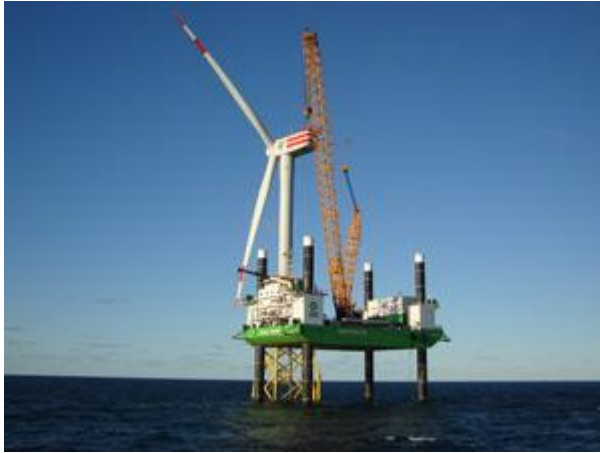
**Figure 4: “Neptune” installed the first of 30 WTG (6,15 M) on 21 March 2012**

The 2012 WTG installation activities have been completed with the 30<sup>th</sup> and final WTG of the 2012 installation campaign successfully installed on 27 July 2012, approximately two weeks ahead of schedule.

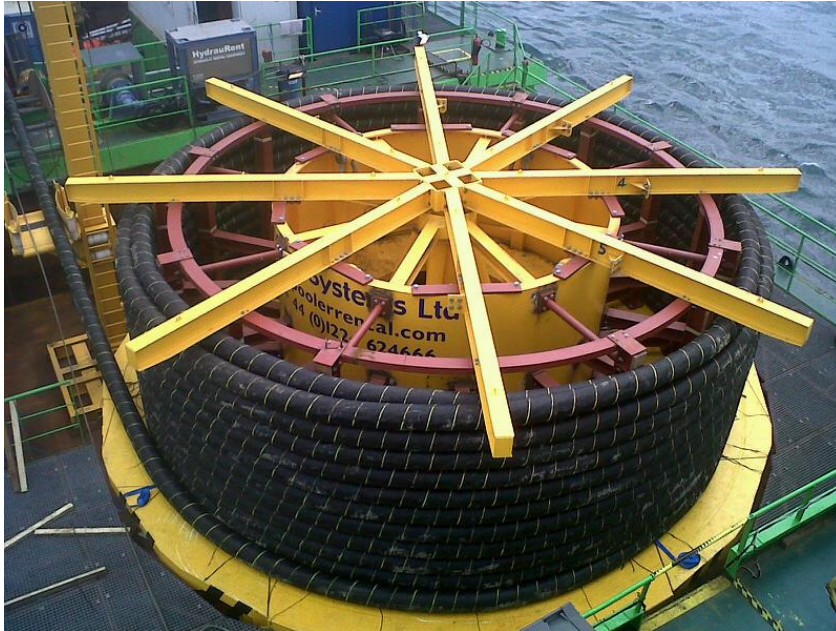
**Figure 5: export cable B on the cable laying vessel (3 July 2012)**

Installation of the offshore export cable B commenced in April 2012 and was completed by the end of May 2012. A delay in installation resulted from remedial works to rectify a cable loop. The loop breached the minimum bending radius and was located at the entrance to the J-Tube on the OTS foundation. Although the cable was operating as normal, further repair works were required to remedy damage to the outer protective covering of the export B cable. The damage was caused by a vessel anchor whilst the export cable was exposed awaiting burial.
