Annual Report 2015

Project name – Phase	Thornton Bank Wind Farm - Operational Phase
Document code	CPO-OPS-PA-BMM-GEN-RPT-0003
Document revision	0
Status	Released
Issued to	BMM

Subject: 11469 Multibeam analysis 2015 - Area A

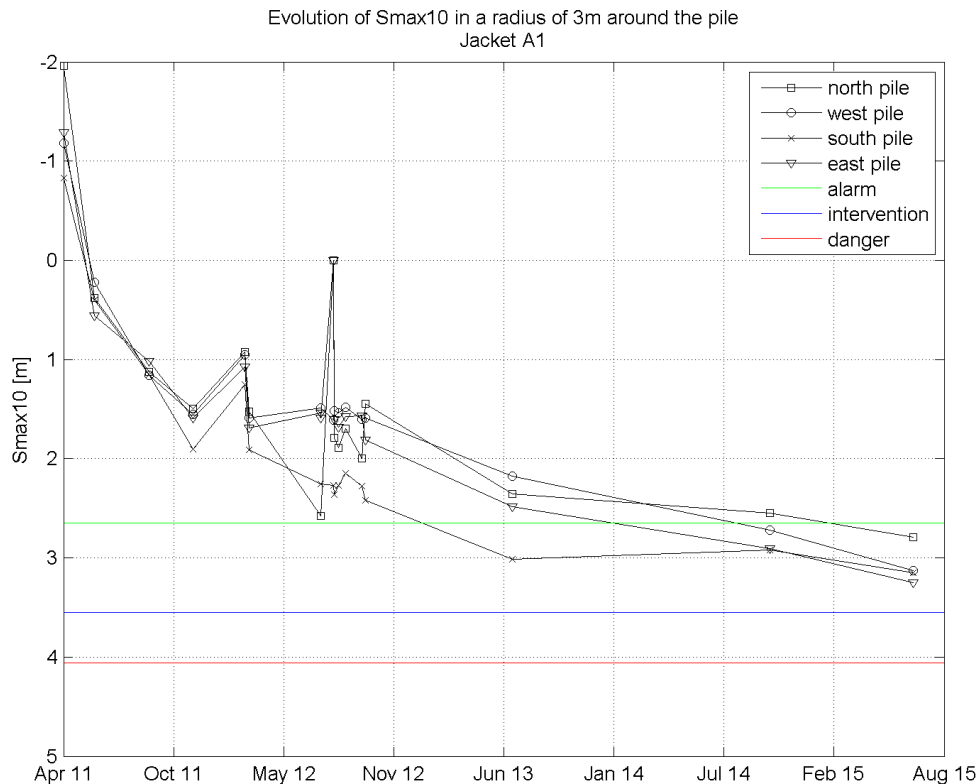
Figure 3-1: Evolution of the scour depth (S_{max10}) around the piles of Jacket foundation A1.

Figure 3-1 is based on all the available multibeam surveys (listed in Table 2-1), performed before, during and after installation, and illustrates the scour development S_{max10} (average of the 10 deepest points measured in an area with a radius of 3 m around the centre of a pile) around the 4 piles of jacket foundation A1 in function of time. The parameter S_{max10} is relative to PDTDL_ab. Positive values of S_{max10} indicate levels that are lower than PDTDL_ab, negative values of S_{max10} indicate levels higher than PDTDL_ab.

Furthermore, the level of the alarm, intervention and danger line next to the piles is indicated on the figure by the green, blue and red line respectively.

As shown in Figure 3-1, scour occurred around the 4 piles of the jacket foundation. In the previous memo (I/NO/14166/15.082/SUD/ v1.0) it was reported that the erosion process was not yet stabilized for jacket foundation A1 but seemed to go towards an equilibrium. However, the latest multibeam data indicate for this jacket foundation that the situation is not stable yet and some scour is still occurring.

As an example, the plot of jacket A1 is discussed here (see Figure 3-1).

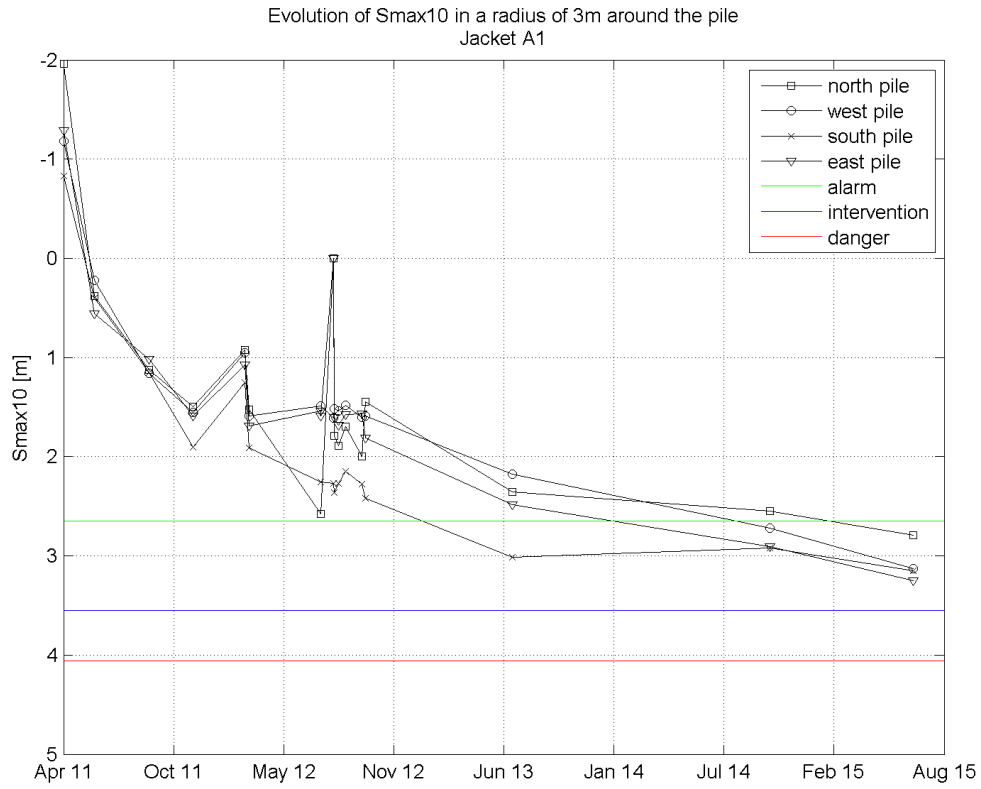
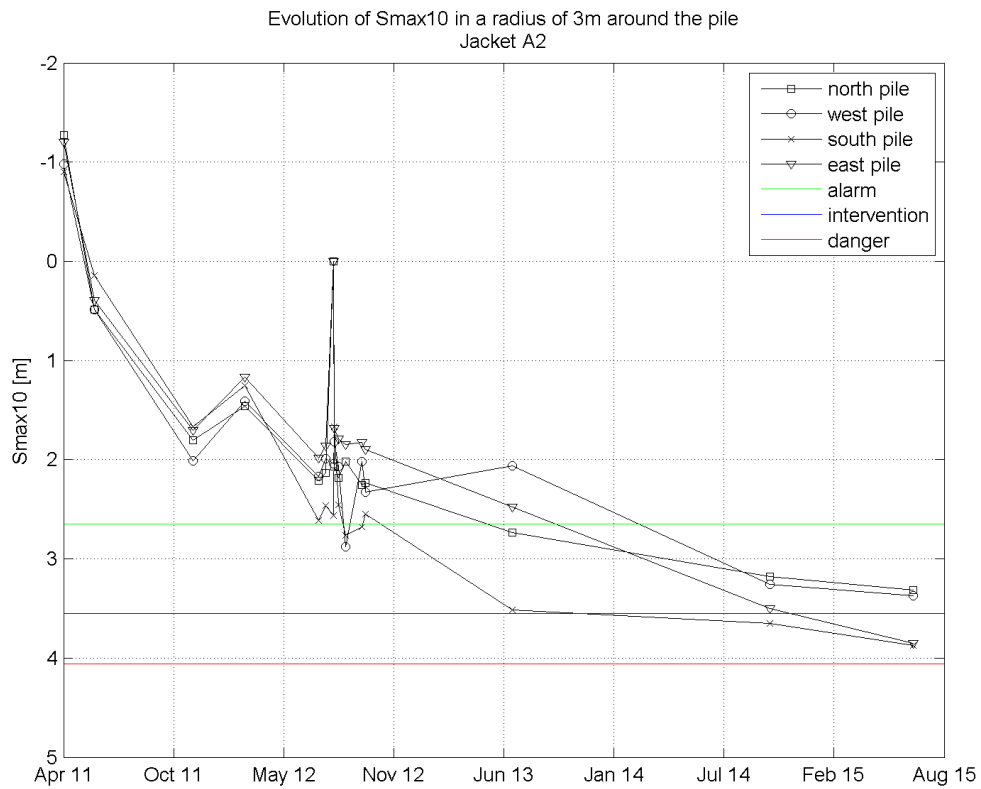
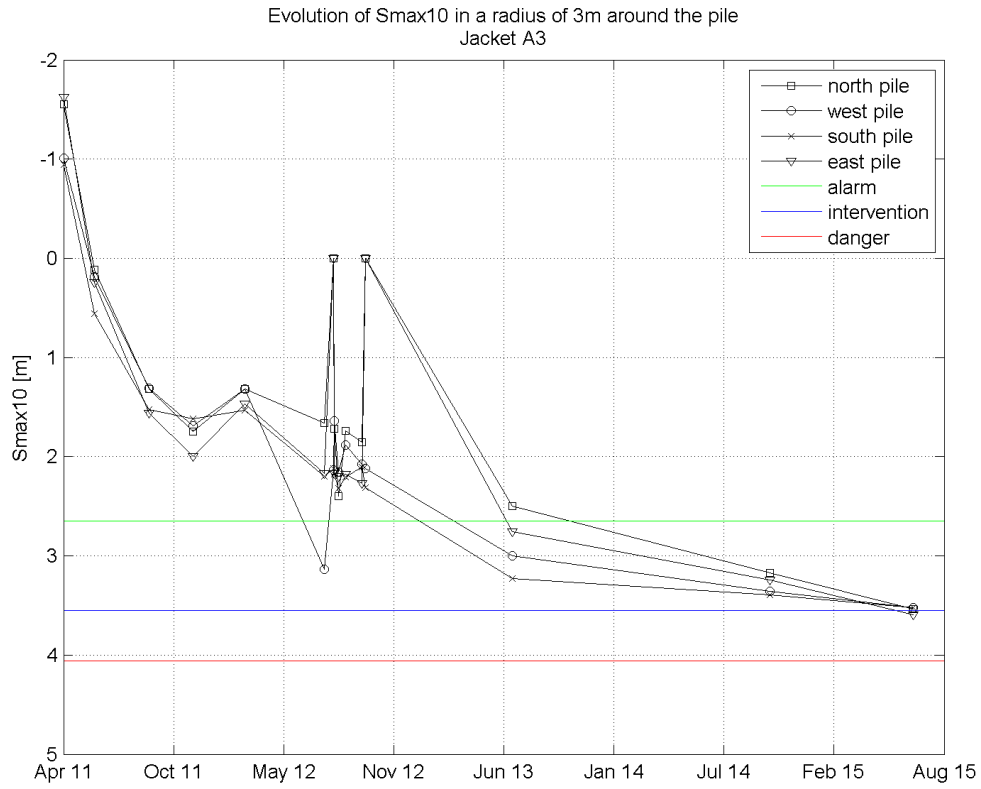
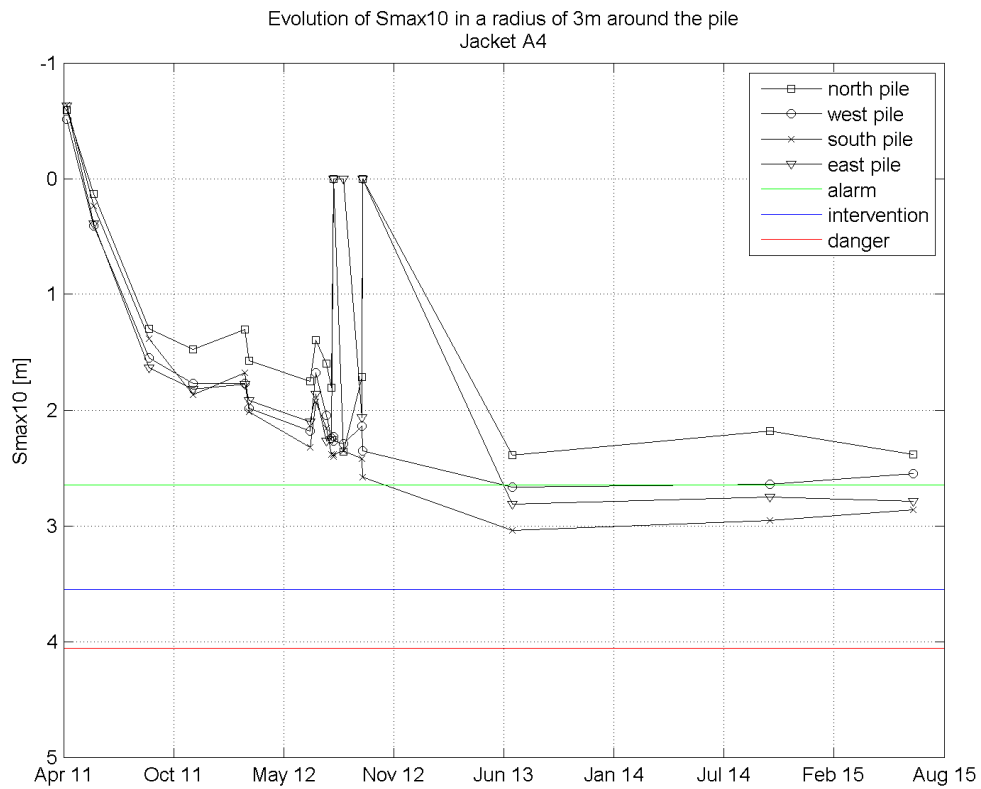
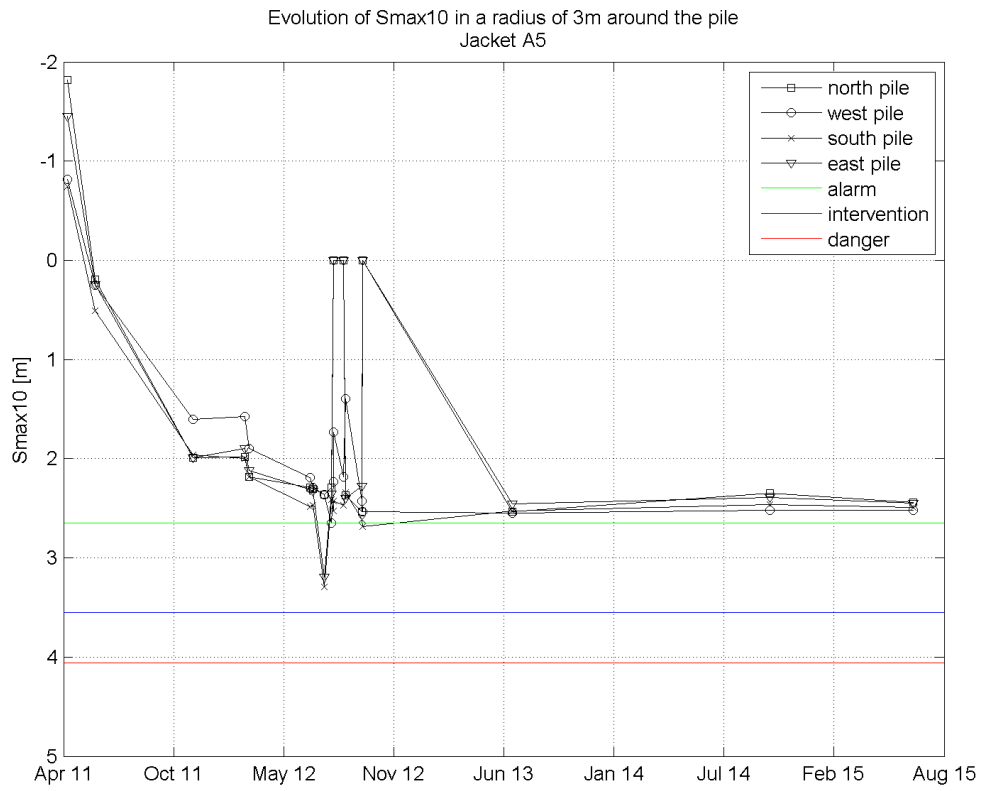
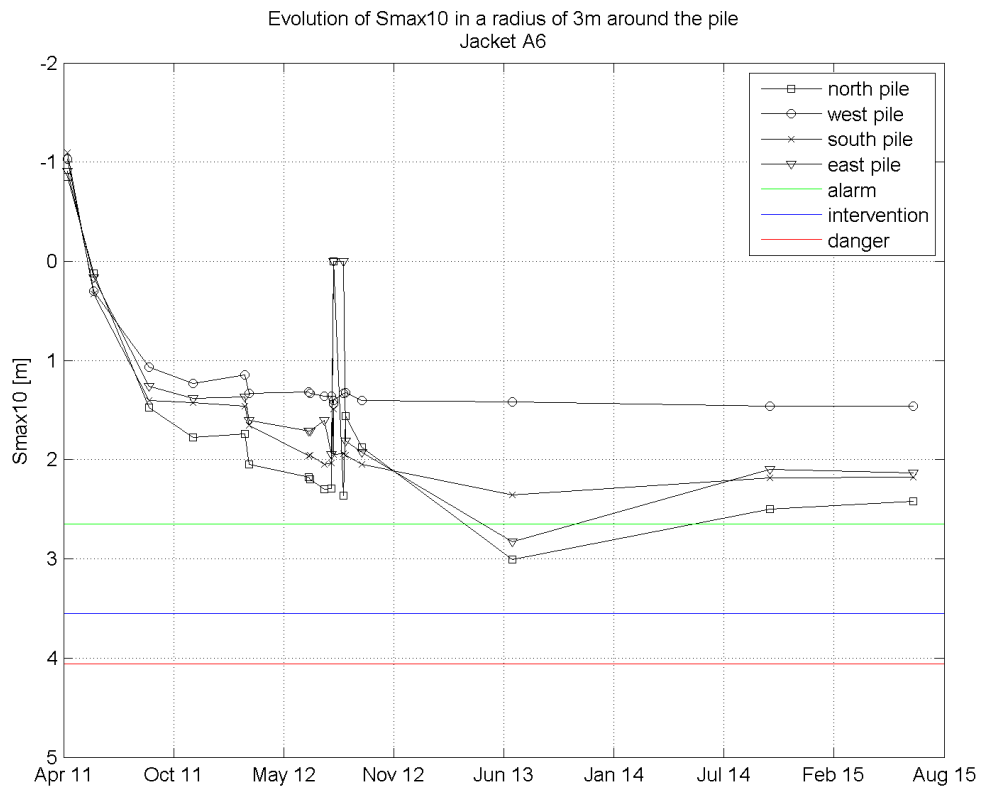
Annex A **Plots evolution scour depth**

Per jacket, a plot of the evolution of the scour depth in time is made. All plots can be found in Annex A.

The latest multibeam data show that the equilibrium scour depth has not yet been reached for all the jacket foundations in area A. Scour depth evolution is still observed around all the piles of jackets A1, A2, A3, B1, and D0. For jackets B2, B3 and C1 the scour progress is mainly limited to the eastern pile. These particular jackets are installed at rather shallow locations (PDTDL_ab < -22 m TAW). In general, and similar to the observations made in area B, the scour depth is inversely proportional to the installation depth. For the other turbine jackets, it is assumed that the scour depth has reached its equilibrium.
