Annual Report 2016

Project name – Phase	Thornton Bank Wind Farm - Operational Phase
Document code	CPO-OPS-PA-BMM-GEN-RPT-0004
Document revision	0
Status	Released
Issued to	BMM

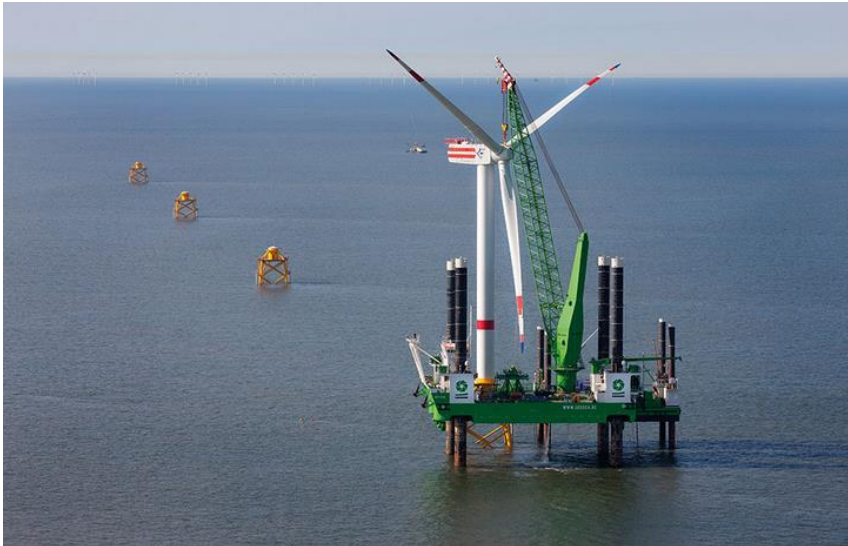
During 2016 some major components on the wind farm were exchanged. Following major component replacements were executed:

- February 2016 (DP2 SEP Neptune):
 - o Generator exchange on I5
- June 2016 (DP2 Flintstone):
 - o Cable OTS – D0 exchange
- August 2016 (DP2 SEP Thor):
 - o Main bearing exchange on A2 & G4
 - o Gearbox exchange on E2

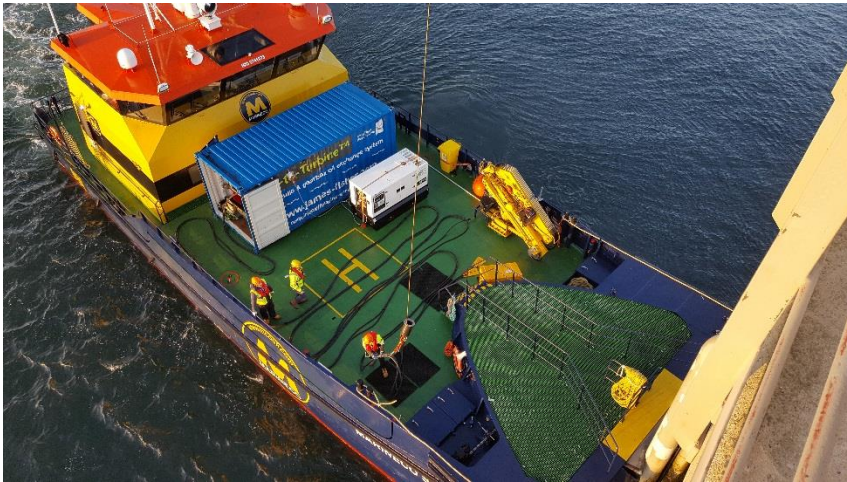
End October we trialed a new way for exchanging the gearbox oil. The procedure was made in close cooperation with Mr. J. Tavernier from FOD Leefmilieu. In this trial the new oil and used oil were contained in tanks which were located on a crew vessel, which was tied off on the gravity based foundation (in a blow off condition). This oil exchange was executed on three 5M turbines, i.e. D2, D3 and D6.

More details see annex 6: Oil exchange Oct 2016.

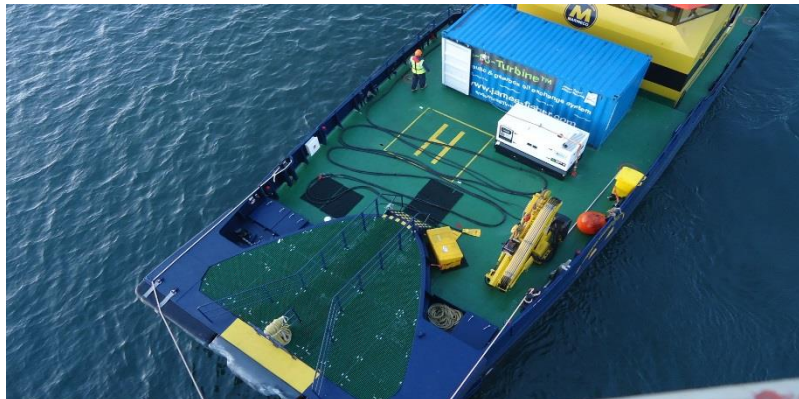
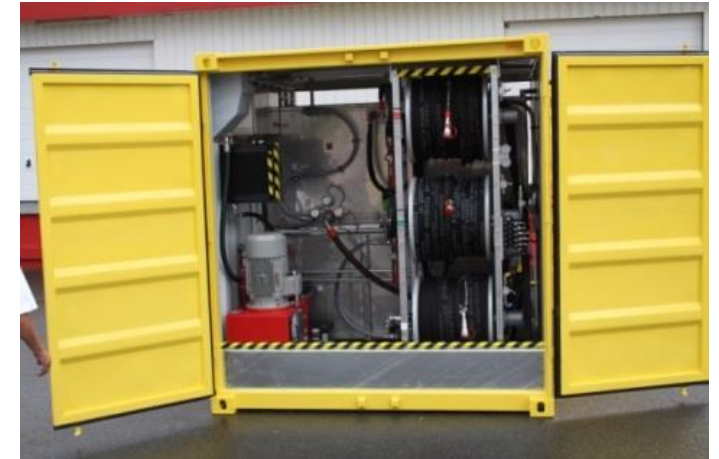
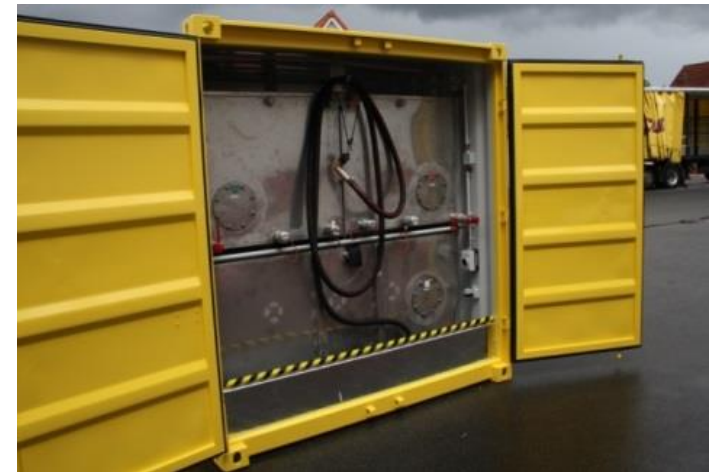
- 20ft container
 - 2 tanks elk 1500l (verse en vuile olie)
 - Pomp installatie
 - Haspels met 2x180m leiding (vullen en ledigen)
 - Installatie om de olie voor te warmen (30°C)
- Genset voor elektrische voorzieningen van de container
- Spillkits en blusmiddelen
- Nodige koppelingen voor leidingen en gearbox

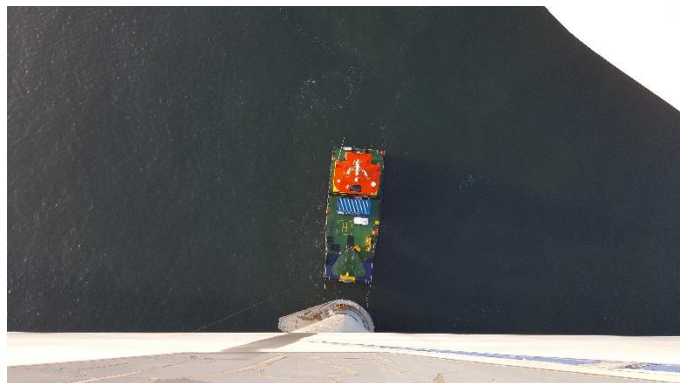
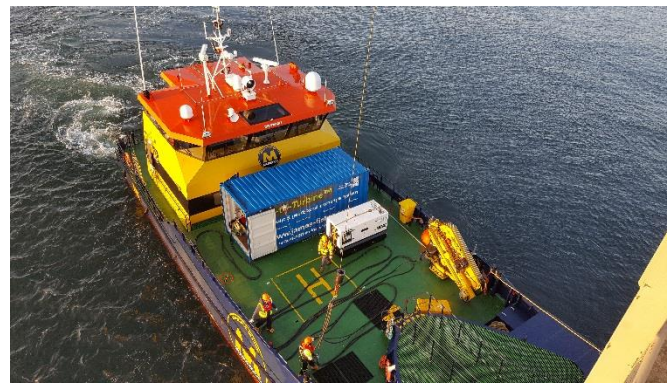
1. Voorbereiding en planning
2. Preparatie lading CTV en transport
3. Operatie zelf
 1. Ledigen gearbox
 2. Flushen gearbox
 3. Opvullen gearbox met verse olie
4. Ledigen en vullen tanks voor de volgende WTG

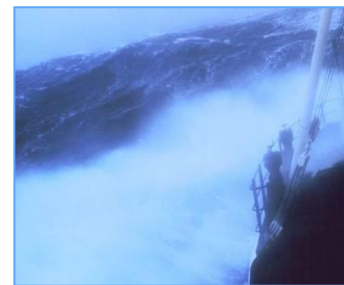
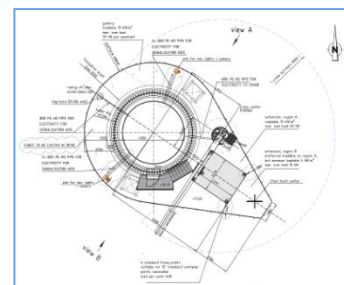
Gewicht

- Capaciteit van de CTV
- Beperkt tot lading voor een oliewissel.

- Feedback meeting is gebeurd (22/11/2016)
- Geen grote opmerkingen wel hier en daar kleine verbetering mogelijk voor een eventuele volgende campagne volgend jaar.
- Senvion bekijkt een andere methode voor de turbines op de jacket structuur.
