## Annual Report 2017

Project name – Phase	Thornton Bank Wind Farm - Operational Phase
Document code	CPO-OPS-PA-BMM-GEN-RPT-0005
Document revision	0
Status	Released
Issued to	BMM

Title                      Burial Assessment Study Export Cable A & B  
 Project                    C-Power - Wind Farm Thorntonbank  
 Client                     C-Power N.V. -  
 Tender  
 Document ref             I/RA/11469/17.202/TDB/  
 Document name         \\imdc-file.IMDC.LOCAL\K-AN\PROJECTS\11\11469\_P007814 -  
                               Major        Component        Replacements\10-Rap\WO\_009\_Burial  
                               Assessment Update\RA17202\_Burial Assessment export cable A &  
                               B\_v1.0.docx

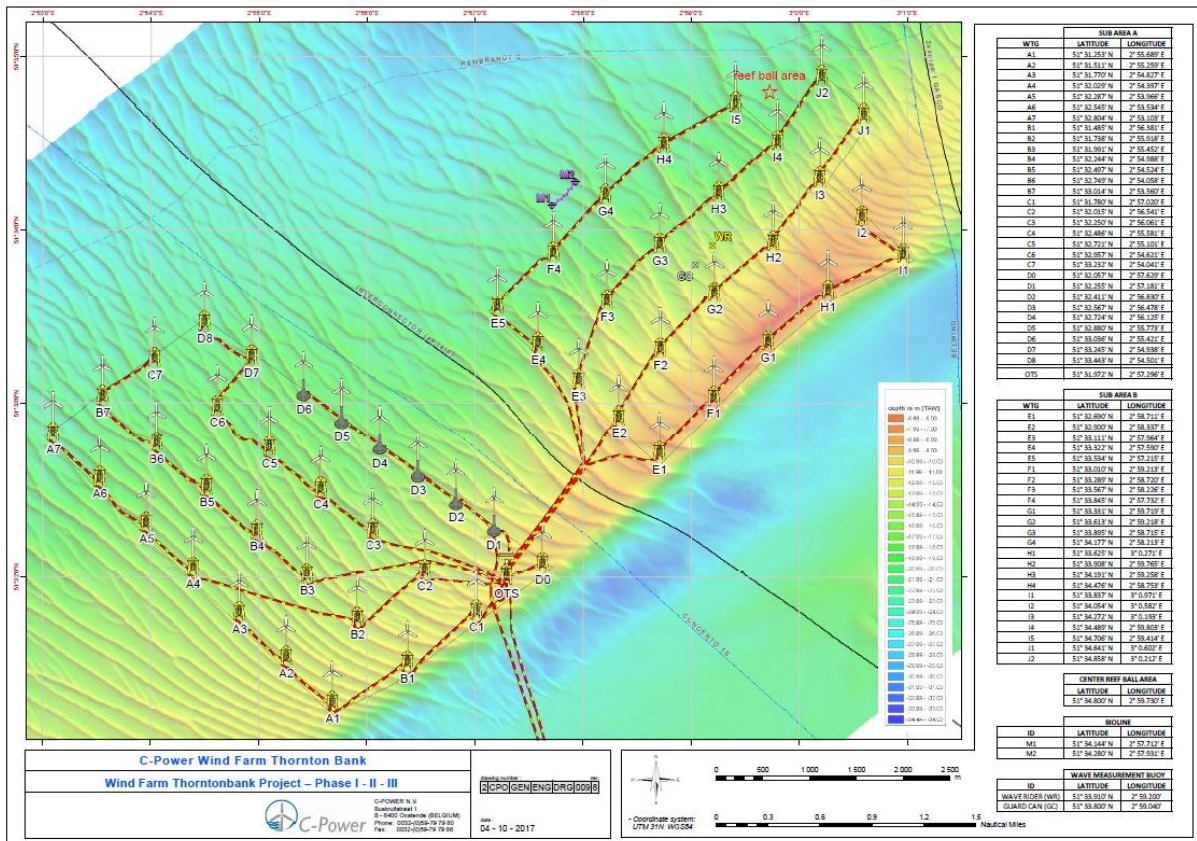
Figure 1: Lay-out of C-Power’s wind farm

The figure below shows the lay-out of the C-Power wind farm.

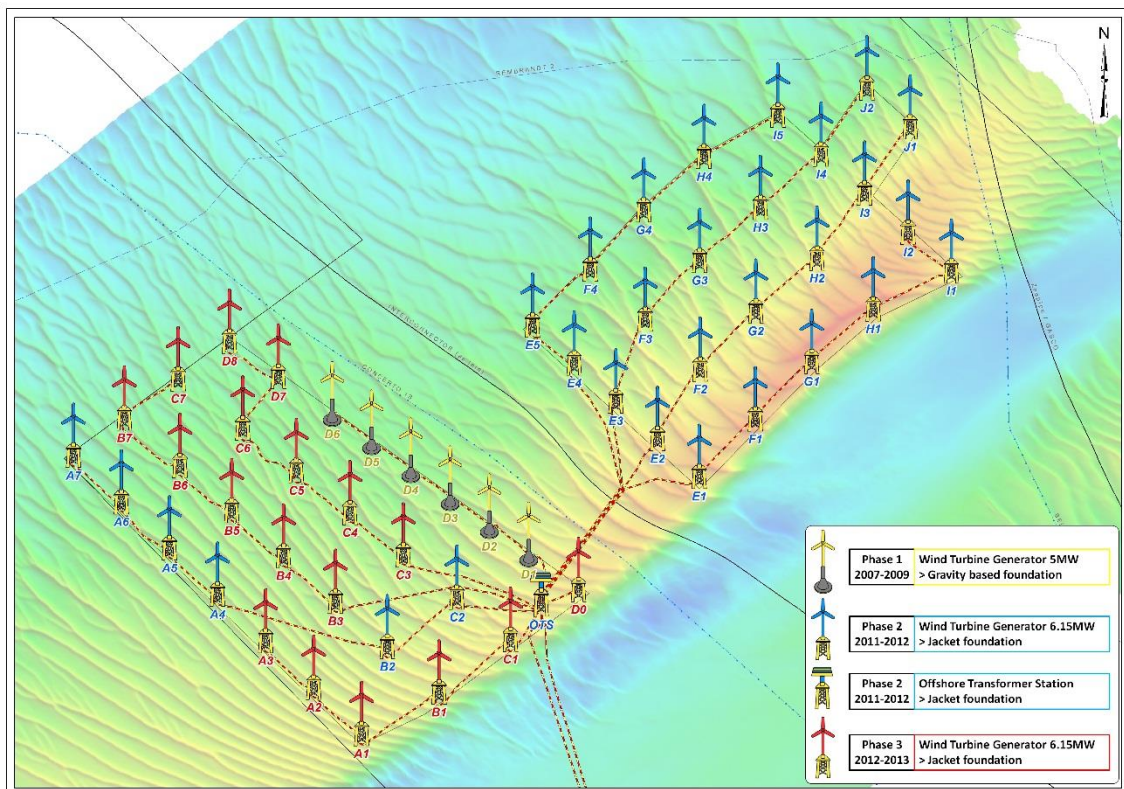
Figure 1-1: Overview of Construction Phase I – III

Figure 1-1 shows the different phases for the construction of the offshore wind farm. Six gravity based foundations were erected in the pilot phase of the Thornton Bank project between 2007 and 2009. These turbines have rock dump scour protection and are not further discussed in this memo.

In the period 2011 – 2013, the offshore transformer station and 48 additional turbines were installed on jacket foundations. These quatropods are designed to allow scour to a certain level. In this memo, the evolution of the scour depth is discussed based on the available multibeam data.

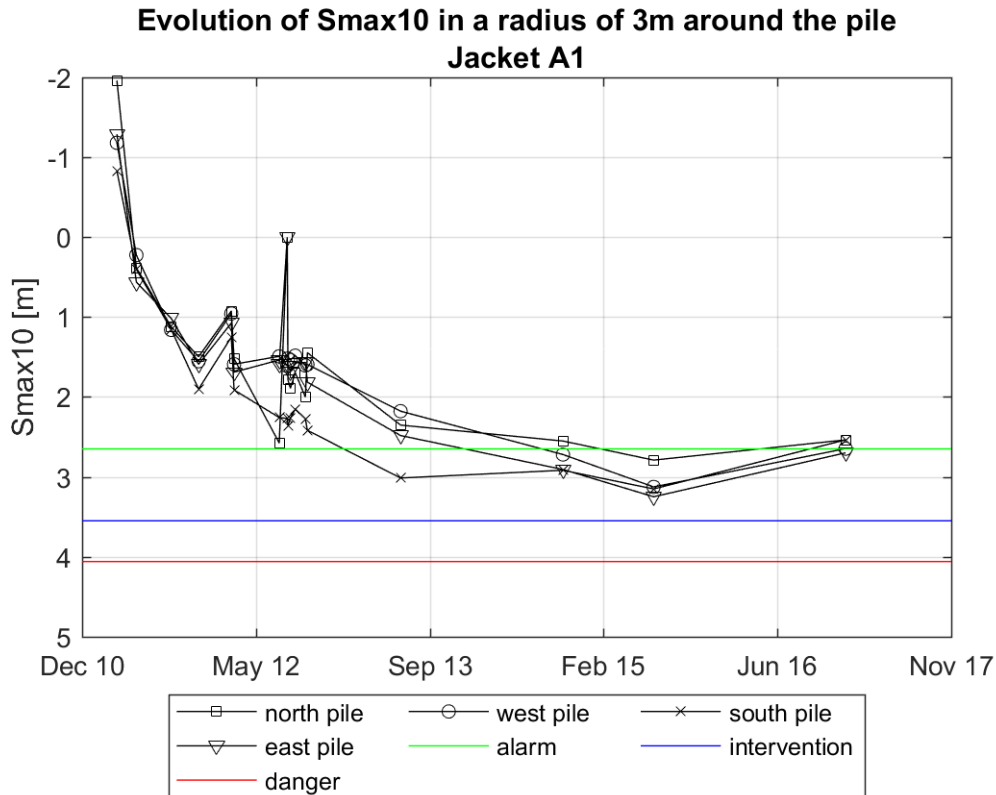
Figure 3-1: Evolution of the scour depth ( $S_{max10}$ ) around the piles of Jacket foundation A1.

Figure 3-1 is based on all the available multibeam surveys (listed in Table 2-1), performed before, during and after installation, and illustrates the scour development  $S_{max10}$  (average of the 10 deepest points measured in an area with a radius of 3 m around the centre of a pile) around the 4 piles of jacket foundation A1 in function of time. The parameter  $S_{max10}$  is relative to  $PDTDL_{ab}$ . Positive values of  $S_{max10}$  indicate levels that are lower than  $PDTDL_{ab}$ , negative values of  $S_{max10}$  indicate levels higher than  $PDTDL_{ab}$ .

As shown in Figure 3-1, scour occurred around the 4 piles of the jacket foundation. In the previous memo (I/NO/11469/15.415/TDB/ v1.0) it was reported that for jacket foundation A1 the situation was not stable yet in 2015, some scour had taken place during 2014 and 2015. The current data from 2017 show some accretion, reaching the level of 2014. The situation seems more stable now for this jacket.

Although compared to the previous surveys in general the scour depth seems to be stable or has even decreased in some locations, the scour depth remains close to or below the alarm line for many of the jackets. Therefore regular monitoring is still strongly recommended.

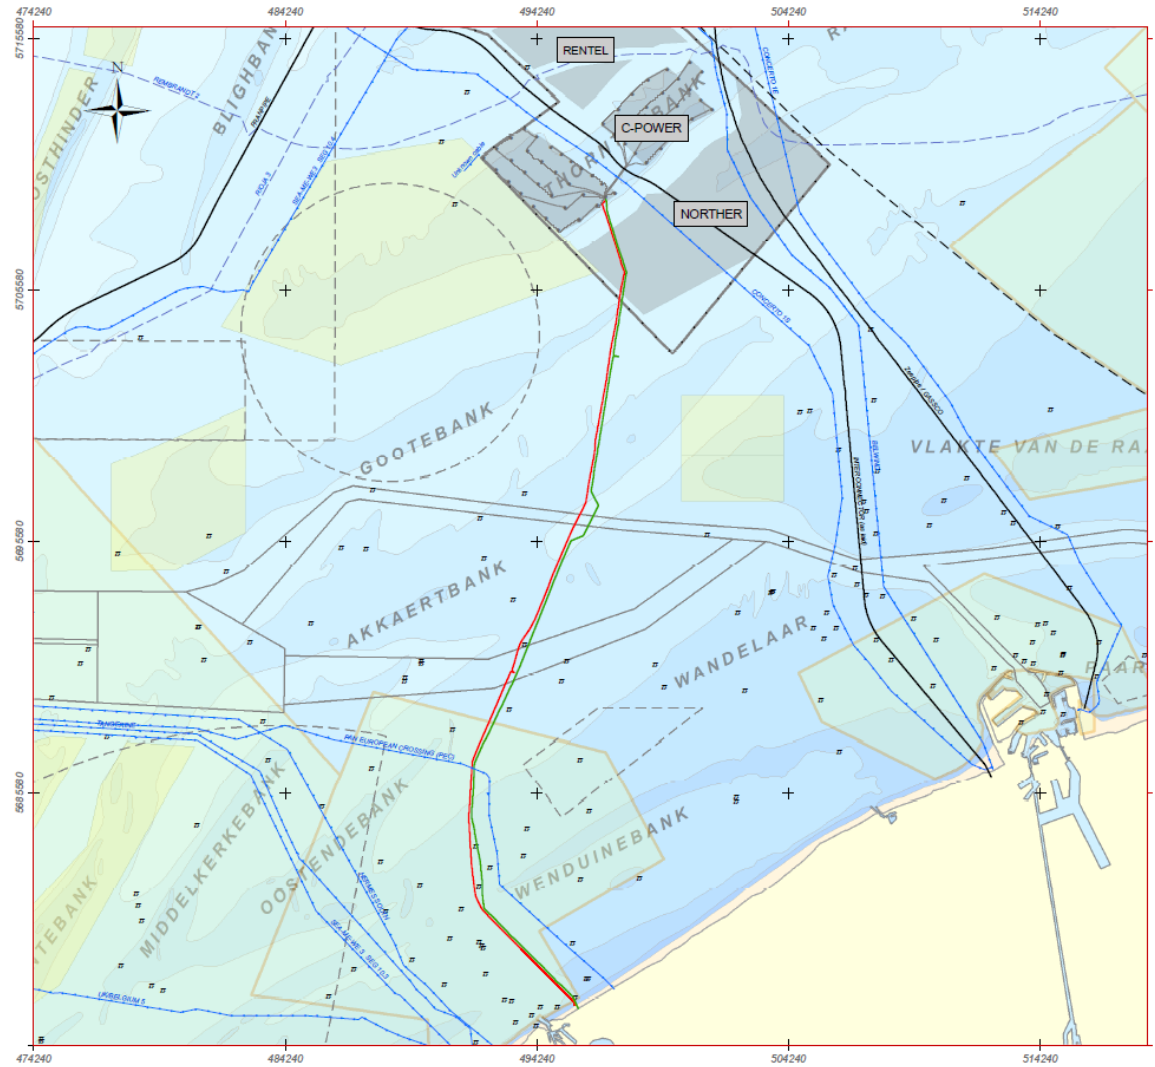
Figure 3-1: Export cable A (red) & B (green) trajectories from project area to shore.

Cable	From KP (OTS)	To KP (HDD exit point)
Export A	0.386	35 437
Export B	0.005	35 432

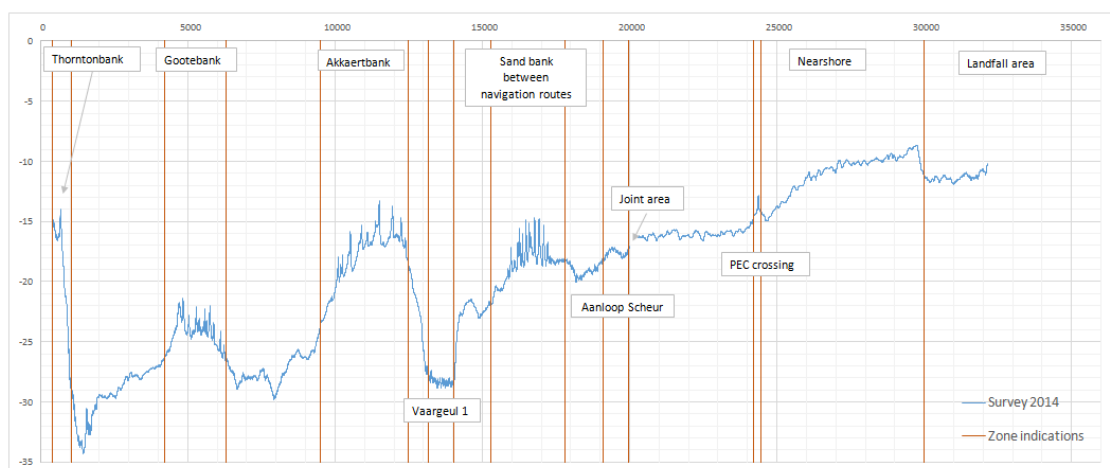
Figure 3-3: General cross section along the cable trajectory A

For a detailed discussion of the morphological features along export cable A, it is referred to the basis of design (IMDC, 2006). For ease of reference the main items are repeated in this section and illustrated on the figure below. It should be noted that export B is characterized by similar morphological features as its route is parallel to export A, shifted approximate 100 m East.

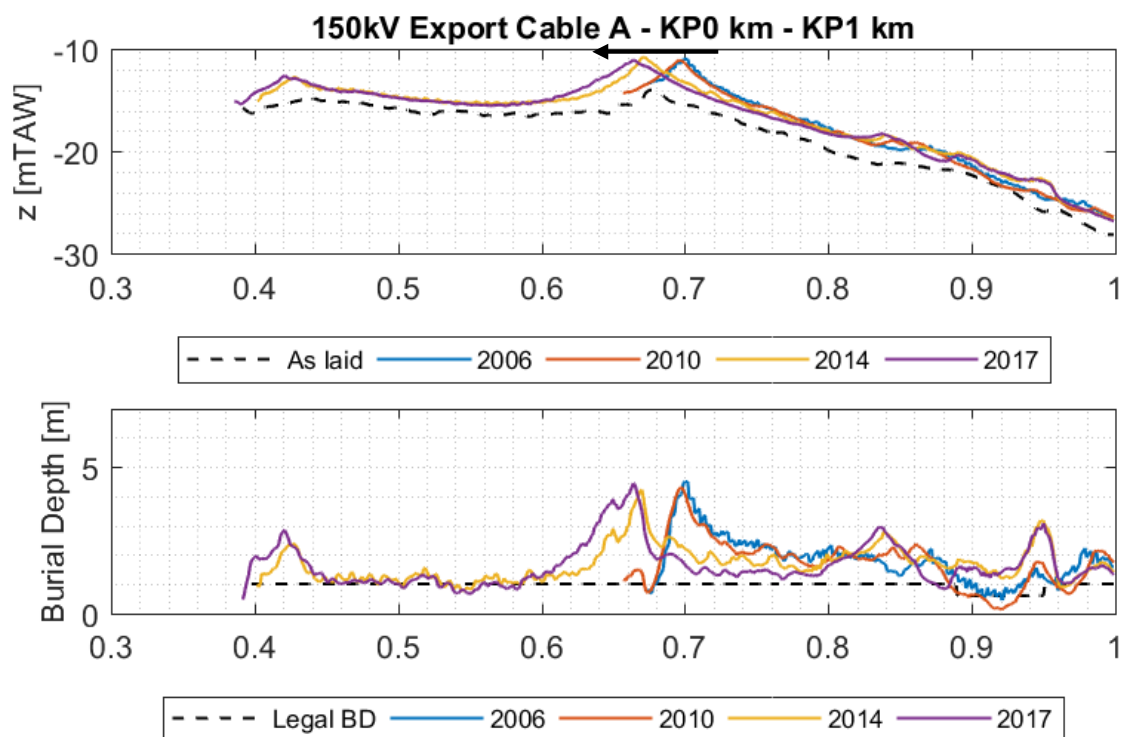
Figure 4-1: Detail of the Depth of Cover along export cable A, zone A1

The lines represent the seabed level (in the upper figure) and the depth of cover (DoC) (in the lower figure) based on the October 2006, September 2010, August/September 2014 and March 2017 surveys.

In Figure 4-1, it can clearly be seen that the top of the dune is moving towards the left (= towards the Thornton bank in north-western direction). The dune top has moved about 35 m in approximately 12 years, leading to an average dune movement speed of 3.2 m/year.

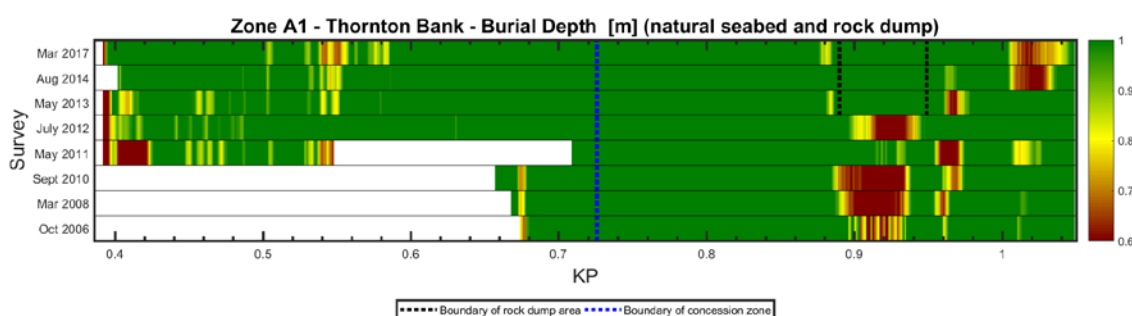
Figure 4-2: Depth of Cover evolution in time along Zone A1

As in the figures above, it can also in this plot be observed that cable zone A1 is located in a mobile area with sand dunes moving in one direction and erosion on the southern border of the Thornton bank.

Several observations can be drawn from this figure:

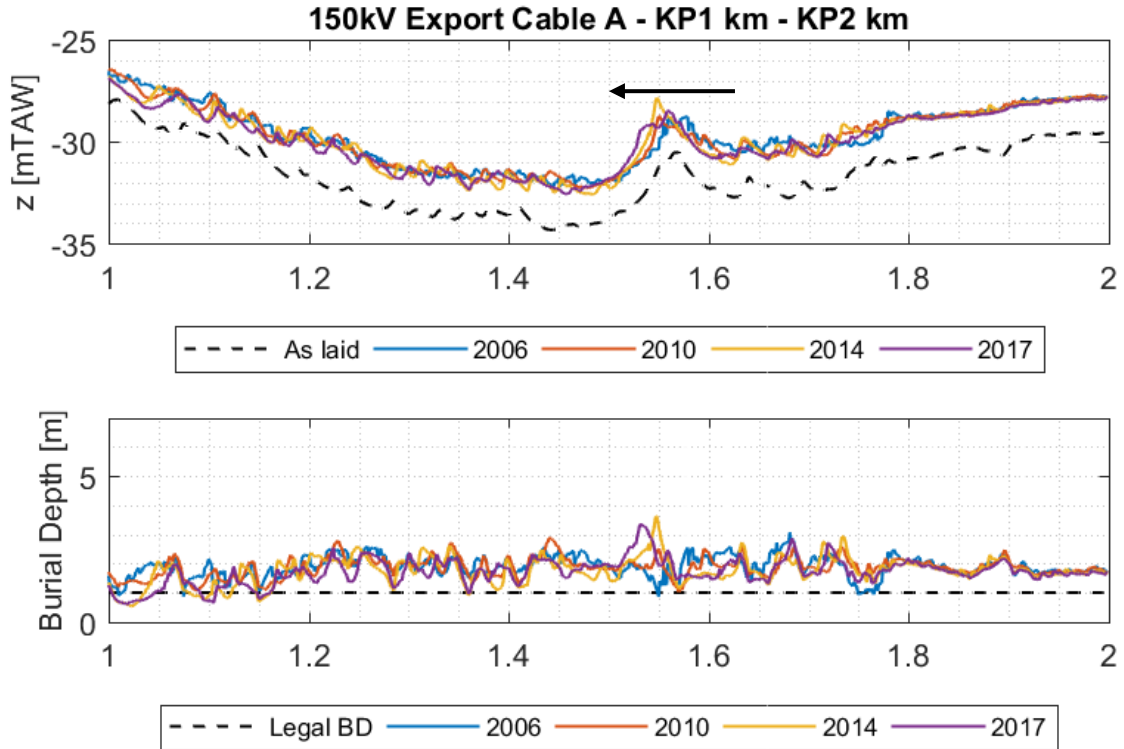
Figure 4-3: Detail of the Depth of Cover along export cable A, zone A2

Cable zone A2 (KP 1.05 to KP 4.2) is located in the swale between the Thornton bank and the Goote bank. There is a dune top present in this zone, which is moving towards the Thornton bank. A detail of this moving dune top is provided in Figure 4-3.

The dune has moved around 30 m in 11 years, resulting in an average dune movement speed of 2.7 m/year. Due to the presence of the dune, the depth of cover of the cable will not be stable in the future. However, the exact location and magnitude of the decrease of the depth of cover is difficult to predict since this is very much dependent on the dune movement speed which is not constant in time.

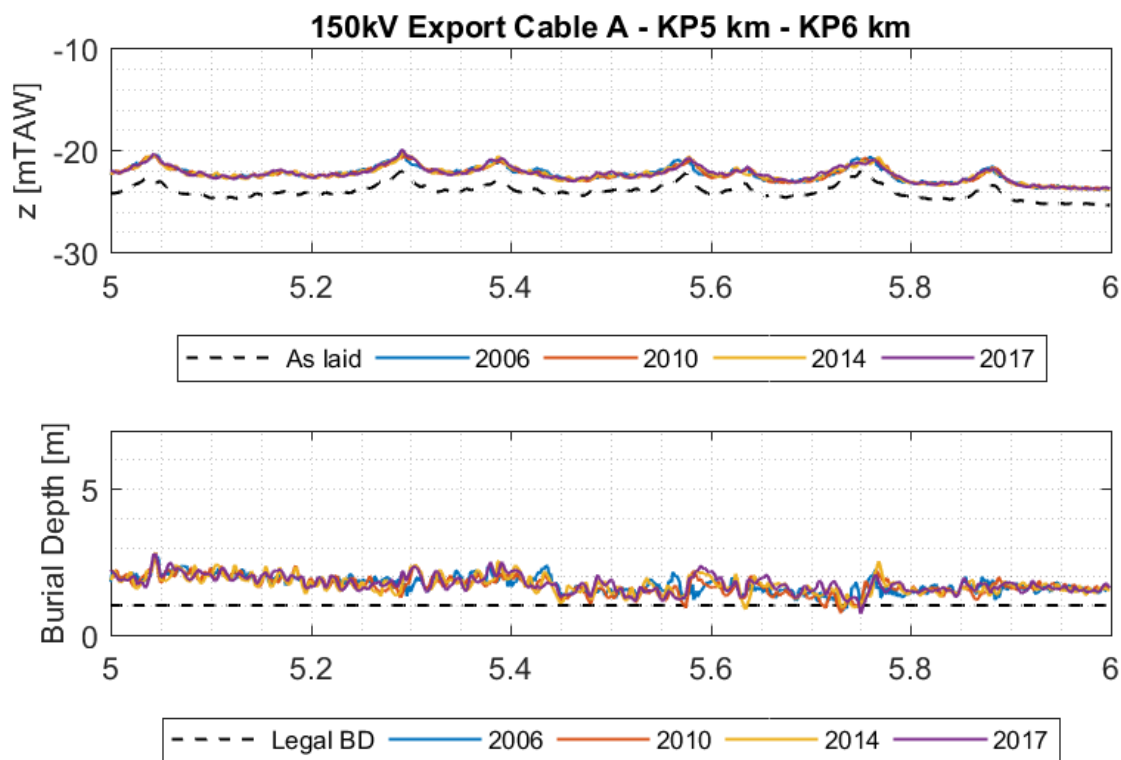
Figure 4-5: Detail of the Depth of Cover along cable A - zone A3)

At some points in cable zone A3, very local areas with a depth of cover of the cable less than 1.0 m are noticed over the years. Also in the future, local areas with insufficient depth of cover are to be expected. It has to be noted that due to the oscillatory behaviour of the dunes, these areas characterised by an actual DoC < target DoC occur not only locally, but they are also limited in time.

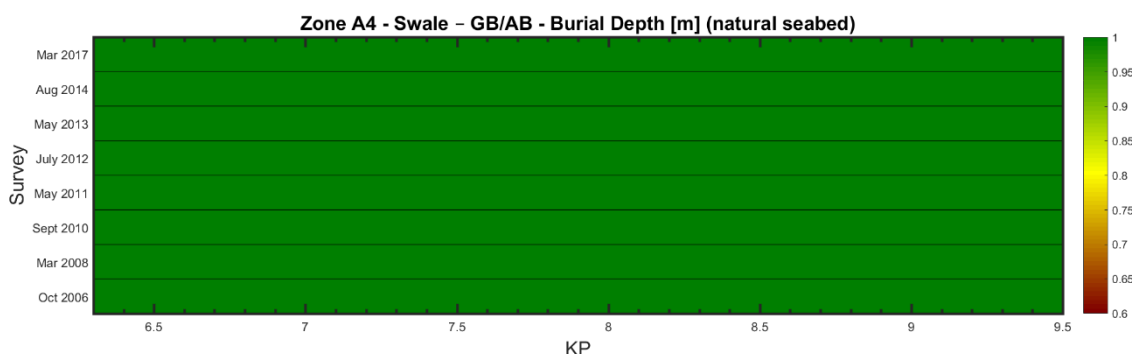
Figure 4-7: Evolution of the Depth of Cover along the cable trajectory along zone A4

Cable zone A4 (KP 6.3 to KP 9.5) is located in the swale between the Goote bank and the Akkaert bank. As can be seen on the plot in Annex I, the seabed level and thus the DoC remained relatively stable over time. Only slight seabed level variations of +/-20 cm are observed.

During all individual surveys the cable has been covered by more than 1.0 m. Minor seabed level variations can be noticed looking at the average depth of cover. Overall, a stable and sufficient depth of cover has been present during all surveys since 2006.

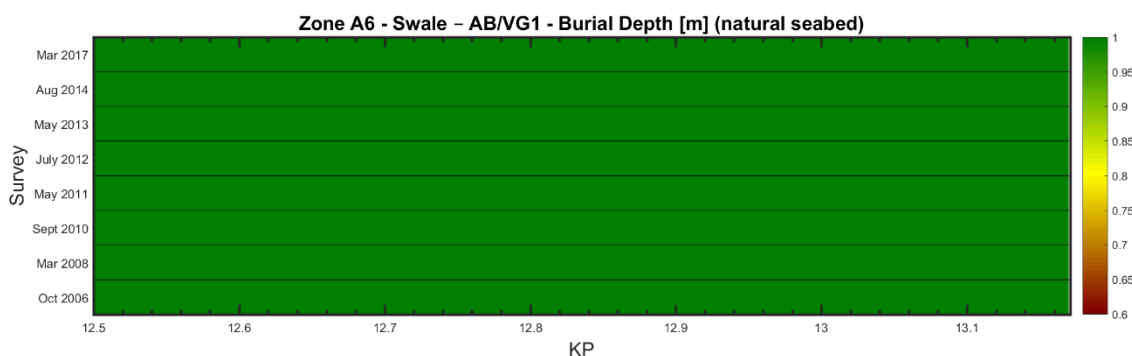
Figure 4-9: Evolution of the Depth of Cover along the cable trajectory along zone A6

Cable zone A6 (KP 12.5 to KP 13.171) is located in the swale between the Akkaert bank and the navigation channel 'Vaargeul I'. No sandbanks are present in this zone. The seabed level is relatively stable between KP 12.5 and KP 12.6. From KP 12.6 till KP 12.85, a trend of accretion can be observed and on average, ~30 cm accretion is measured.

The entire length of this cable zone has been covered by more than 1.0 m over the years. Minor seabed level variations can be noticed looking at the average DoC. Overall, a relatively constant and sufficient average depth of cover has been present during the surveys since 2006.

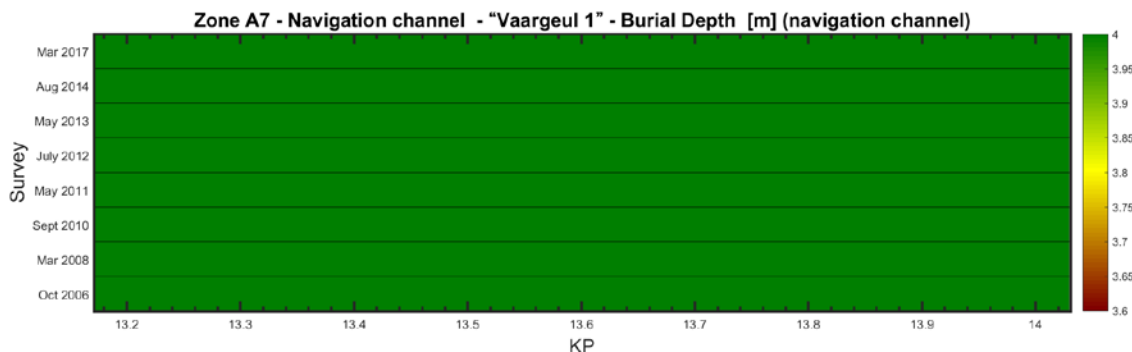
Figure 4-10: Evolution of the Depth of Cover along the cable trajectory along zone A7

In zone A7 (KP 13.171 to KP 14.031), the export cable A crosses the navigation channel ‘Vaargeul I’. An accretion trend exists in the navigation channel. This trend can be observed in the plot in Annex I, comparing the surveys from September 2010, July 2012 and August/September 2014. The drop in seabed level between March 2008 and September 2010 is caused by maintenance dredging works.

No area of the cable has been buried less than 4.0 m since 2006. Based on the average DoC, a trend of accretion can be observed since the survey in 2010. Overall, cable zone A7 shows a relatively constant and sufficient average depth of cover.

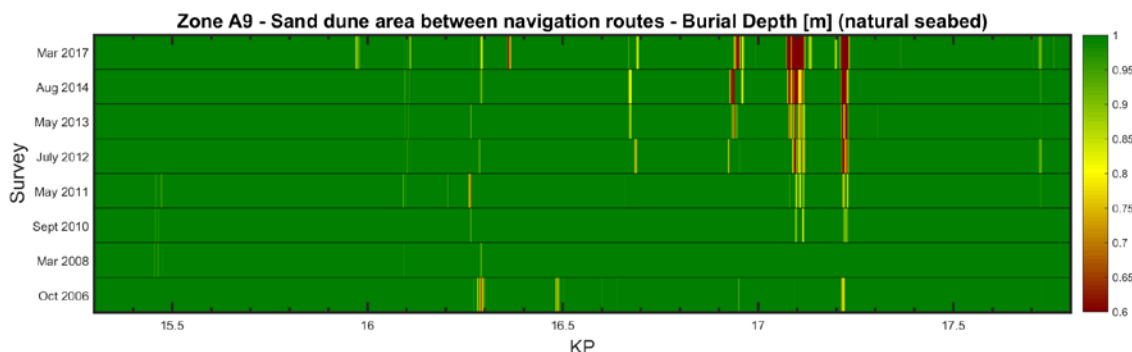
Figure 4-12: Evolution of the Depth of Cover along the cable trajectory along zone A9

Cable zone A9 runs from KP 15.3 till KP 17.8 and is located between the navigation channel ‘Vaargeul I’ and the navigation channel ‘Aanloop Scheur’. The area is characterized by mobile sand dunes. As in cable zone A3, observations show that the dune tops are oscillating instead of moving in one single direction. Due to this oscillatory dune behaviour and the limited DoC in this zone, the depth of cover of the cable is currently smaller than 1 m in local areas in the vicinity of dune tops. The exact location and magnitude of the decrease of the DoC in the future is however difficult to predict due to the oscillating nature of the dunes.

Almost 9% of the length of the cable zone is covered by less than 1 m of natural seabed and about 1% by even less than 0.6 m.

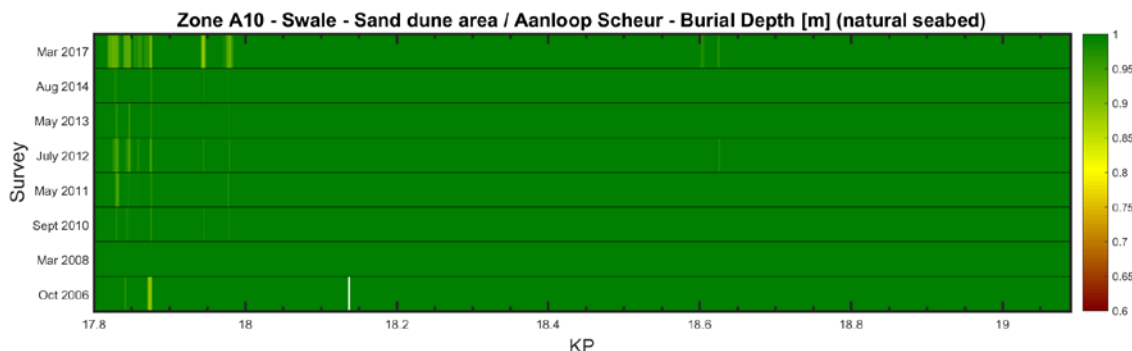
Figure 4-13: Evolution of the Depth of Cover along the cable trajectory along zone A10

On average, about 10 to 20 cm erosion is measured between 2006 and 2017. At some points in this cable zone, the DoC is below 1.0 m. Especially between KP 17.8 and KP 18.0 areas with a cable DoC below 1 m can be observed.

In total 7.3% of the cable section shows a depth of cover of less than 1.0 m, which is considerably more than in 2014. The DoC value however never drops below 0.8 m.

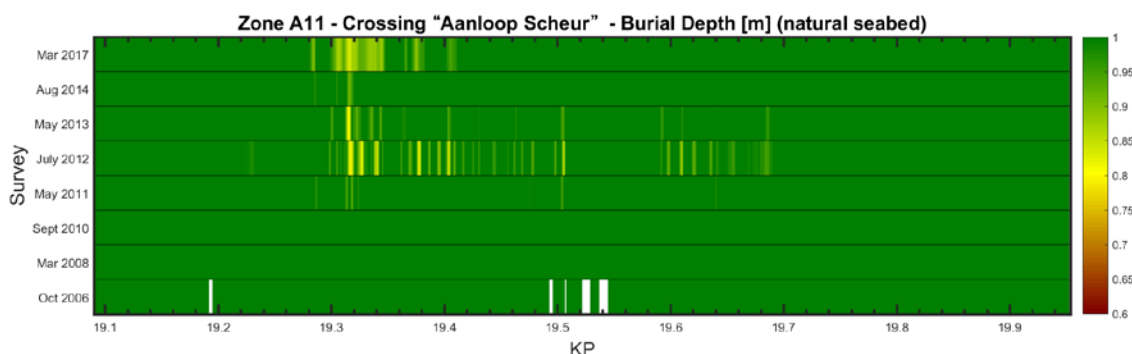
Figure 4-14: Evolution of the Depth of Cover along the cable trajectory along zone A11

In Figure 4-14, the cable DoC of the surveys between 2006 and 2014 are plotted over the cable zone length to show the evolution of the critical zones in time. Variations in percentage of cover below 1.0 m are observed over the different years. The DoC however rarely drops below 0.8 m, as is also the case for 2017.

Overall, the risk for an insufficient DoC in the future is considered to be low.

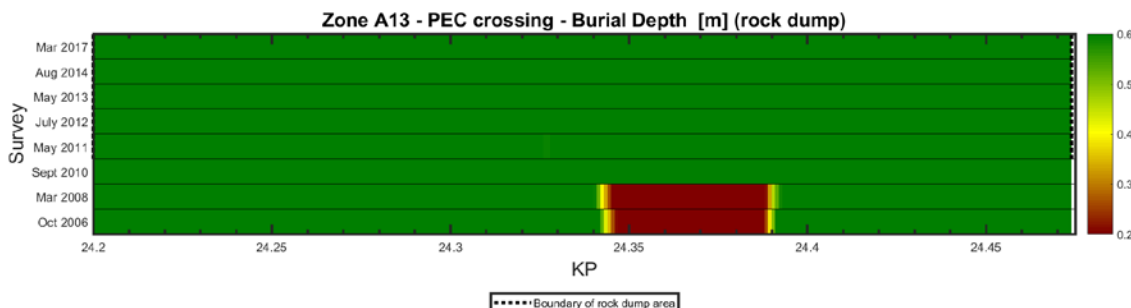
Figure 4-17: Evolution of the Depth of Cover along the cable trajectory along zone A13

In the results of the surveys in 2006 and 2008, the cable DoC between KP 24.35 and KP 24.39 has been less than 0.2 m. Since the remedial rock dump in 2010, the cable zone has been covered by more than 0.6 m over its entire length.

Table 4-18 shows the insufficient coverage until the remedial action took place. Since 2010, no areas with less than 1.0 m DoC have been observed and the cable zone is relatively stable.

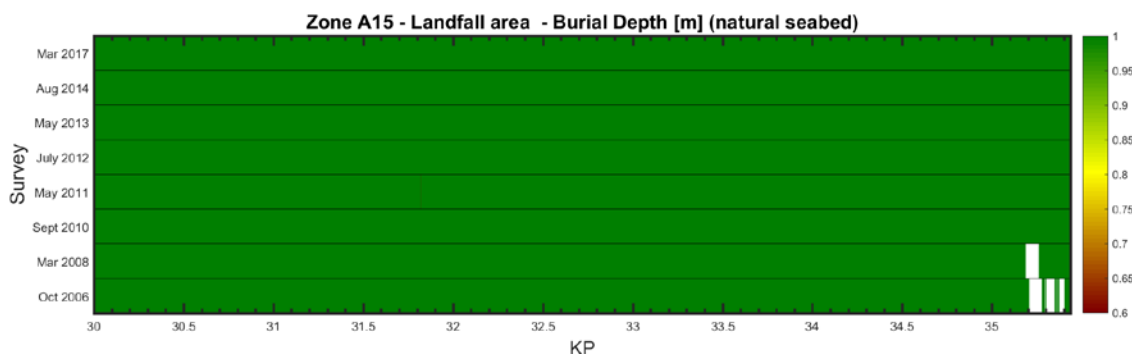
Figure 4-19: Evolution of the Depth of Cover along the cable trajectory along zone A15

The landfall area is defined as cable zone A15 between KP 30 and KP 35.437. A trend of erosion exists up till 2012. Between 2012 and 2017, further erosion ~5 cm was measured.

A decrease of the average DoC due to erosion can be observed. However, the DoC is still around 2.0 m.

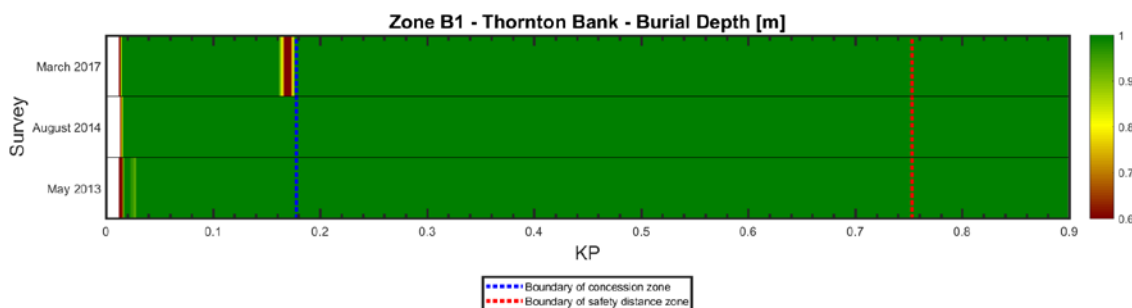
Figure 4-20: Evolution of the Depth of Cover along the cable trajectory in zone B1

The blue dotted line on the figure depicts the boundary of the C-Power concession zone. The red dotted line represents the safety distance around the concession area.

A local decrease of DoC below 0.6 m is observed near the boundary of the concession zone. Annex J shows that this local lowering of the seabed was already visible in 2014, although the DoC was still above 1.0 m during this survey. In total 0.7% of the cable is buried less than 0.6 m in section A1. The average DoC is well above 2 m.

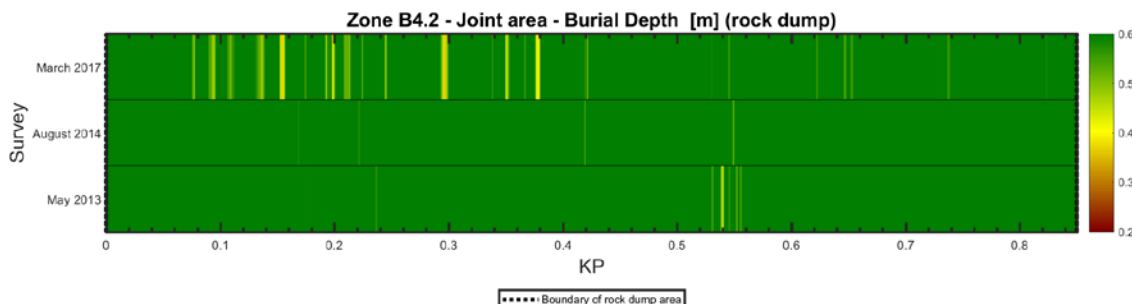
Figure 4-24: Evolution of the Depth of Cover along the cable trajectory in zone B4.2

The export cable B had to be repaired by the end of 2012 due to an incident during the cable burial operation. An omega joint was installed between KP 6.435 and KP 6.947. The joint area has local KPs. A rock dump with filter and armour layer is present.

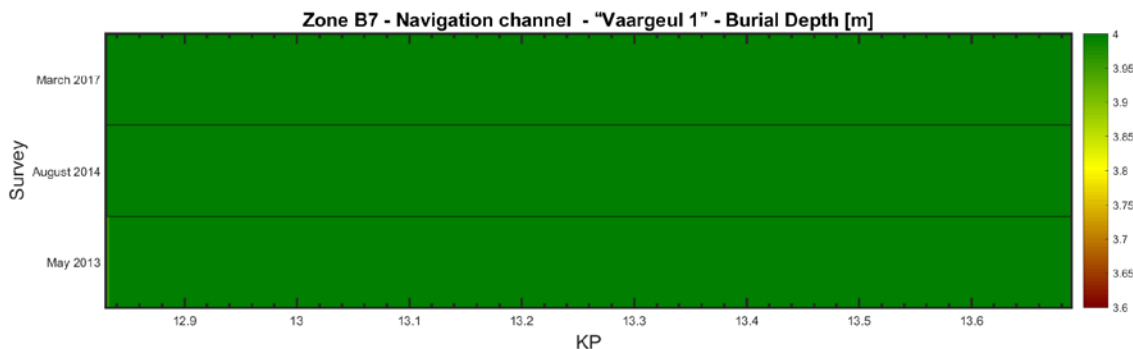
Figure 4-27: Evolution of the Depth of Cover along the cable trajectory in zone B7

Cable zone B7 is defined between KP 12.830 and KP 13.689 and crosses the navigation channel ‘Vaargeul I’. This navigation channel is in general prone to sedimentation and maintained by regular dredging. No areas with insufficient depth of cover are recorded so far and the seabed is found to be relatively stable.

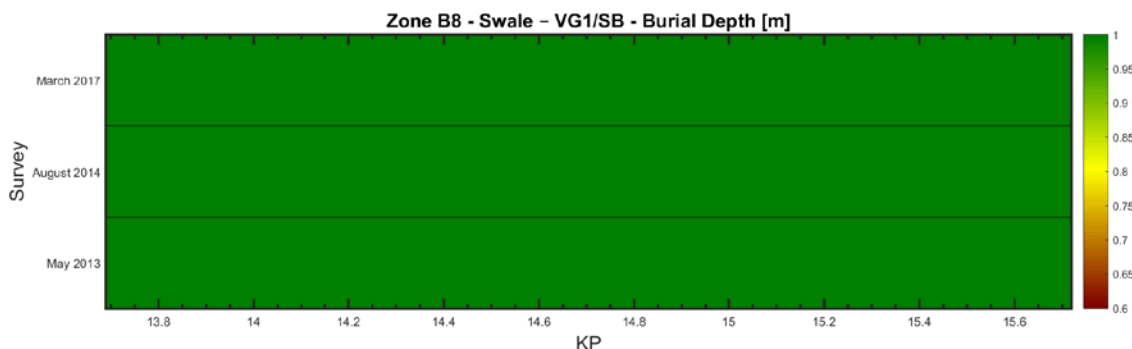
Figure 4-28: Evolution of the Depth of Cover along the cable trajectory in zone B8

Cable zone B8 is defined between KP 13.689 and KP 15.700 and is located in a swale. As can be seen in the plot in Annex J, a slight erosion trend is visible. The cable was originally trenched quite deep (DoC around 2.5 m) and no areas with a depth of cover less than the target DoC have been noticed so far.

No problems are found and the average DoC is larger than 2 m.

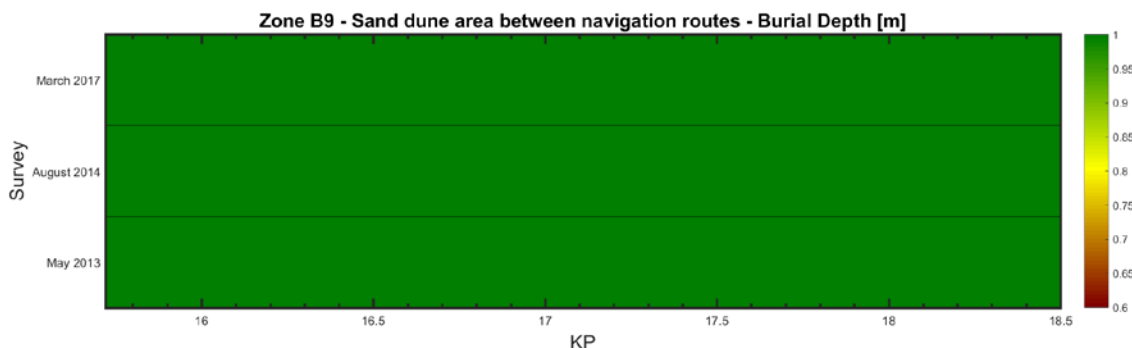
Figure 4-29: Evolution of the Depth of Cover along the cable trajectory in zone B9

The dune tops are not moving in one single direction, but are oscillating leading to a variable DoC in this cable zone. However, the cable was initially installed quite deep (> 2 m cable burial) and consequently no areas with insufficient DoC have been noticed so far.

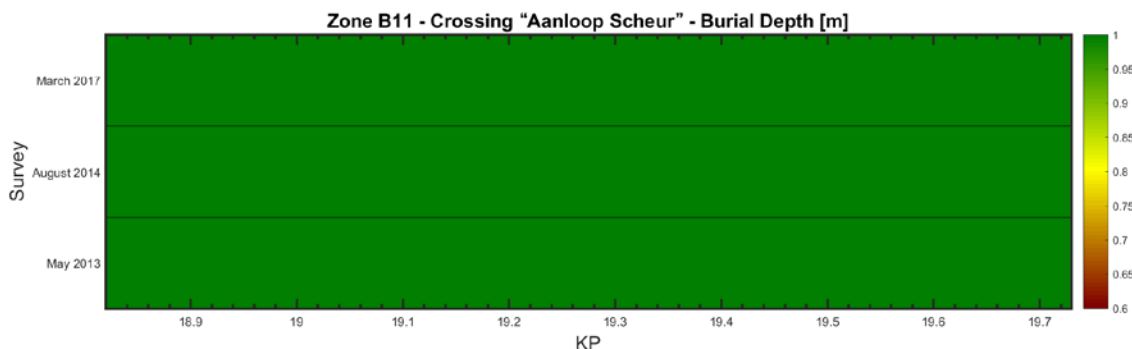
Figure 4-31: Evolution of the Depth of Cover along the cable trajectory in zone B11

The legal depth of cover of the cable for the crossing with the navigation channel ‘Aanloop Scheur’ is equal to 2 m. However, 1.0 m was accepted.

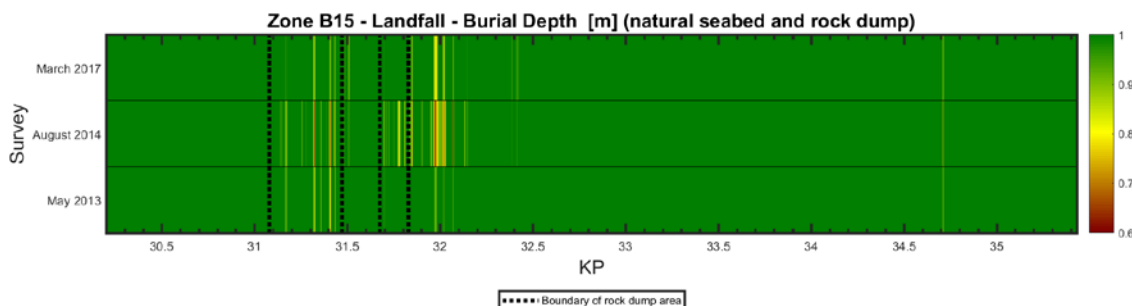
Figure 4-35: Evolution of the Depth of Cover along the cable trajectory in zone B15

Cable zone B15 represents the landfall area between KP 30.200 and KP 35.432. The seabed level is fluctuating leading to variations of the depth of cover of the cable (see plot in Annex J). From KP 31.080 till 31.472 and from KP 31.675 till KP 31.830, a remedial rock dump has been placed. In some areas, the DoC is below 1 m.
