## Annual Report 2023

Project name – Phase	Thornton Bank Wind Farm - Operational Phase
Document code	CPO-OPS-PA-BMM-GEN-RPT-ANNUAL-0001 – NON CONFIDENTIAL
Document revision	0
Status	Released
Issued to	Begeleidingscomité

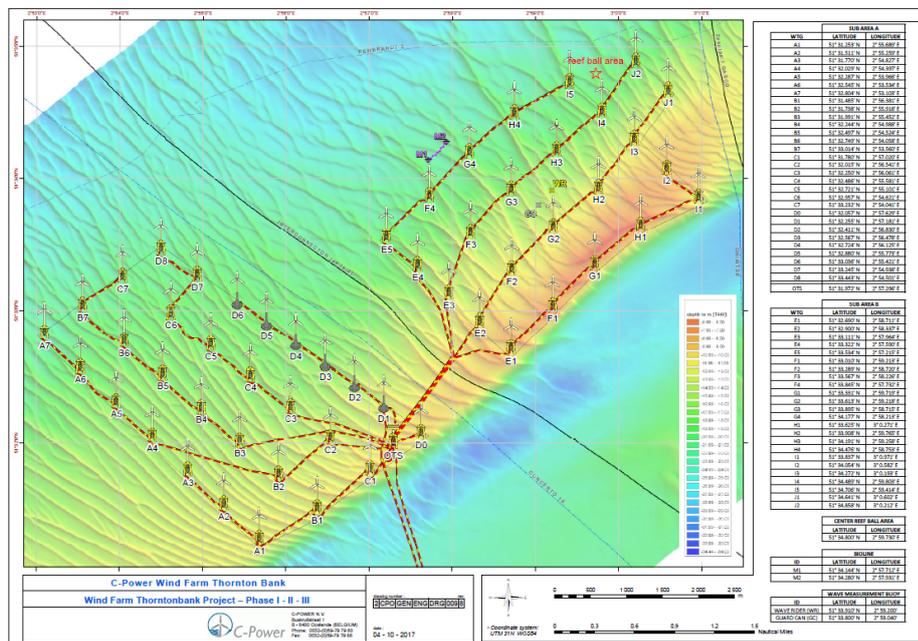
Figure 1: Layout of C-Power’s wind farm

The figure below shows the layout of the C-Power wind farm.

The measurement buoy in Area B of the C-Power wind farm (see also Figure 1) installed by Vlaamse Hydrografie in August 2017 is still in operation; data of this wave buoy are visible in "Meetnet Vlaamse Banken".

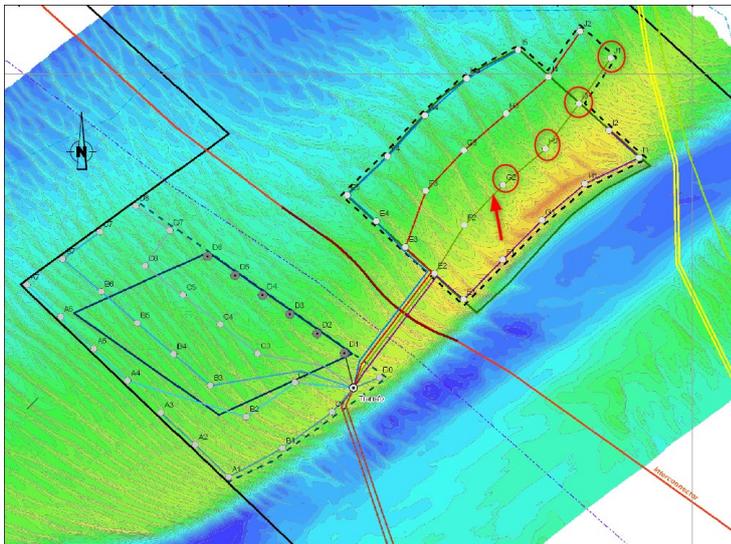
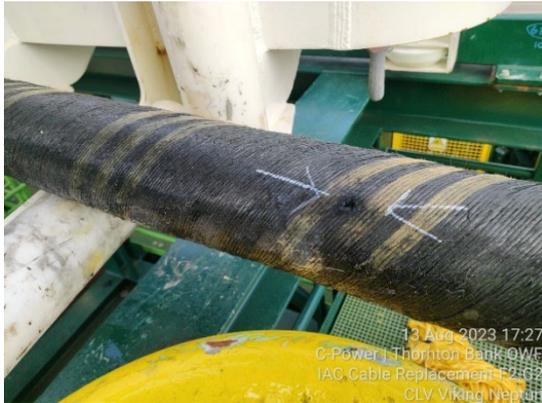
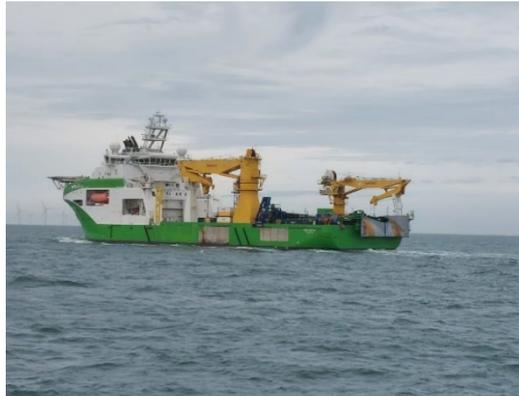
On 30 June a defect occurred on the infield cable F2 – G2. 4 turbines (G2, H2, I3, J1) were shutdown and remained out of service. We had a spare cable available in our cable warehouse and were able to mobilise a suitable vessel very quickly. This resulted in a fast exchange of the infield cable (between 11 and 15 August). After connection and re-commissioning works, the 4 turbines were back in operation on 27 August.

The part of the defective cable, where the fault was located, was sent for investigation to a laboratory but the cause of the defect could not be established.

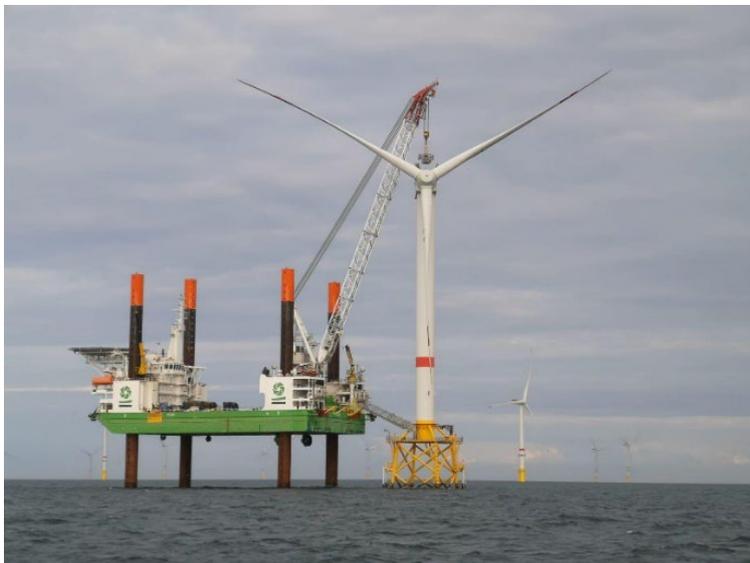
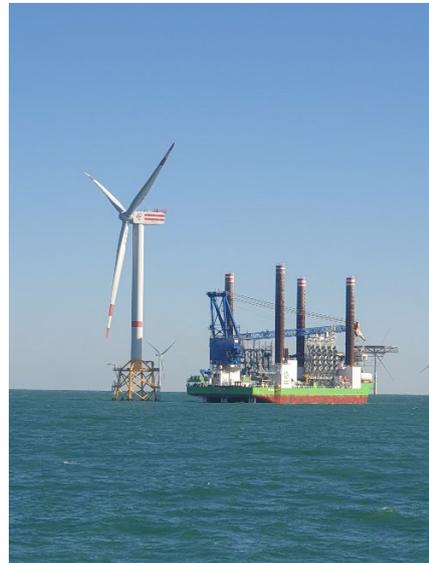
- Gearbox exchanges on 4 turbines (B6, D8, E6, G3)
- Generator exchange on C2

The exchanges were carried out in 2 campaigns: one in February and one in June with the Jack-Up Vessels Neptune (owner Deme) and Resolution (owner MPI).
