**SUMMARY REPORT ON ENVIRONMENTAL MONITORING**

**THE PEARSON COLLEGE-ENCANA-CLEAN CURRENT**

**TIDAL POWER DEMONSTRATION PROJECT**

**FINAL REPORT**

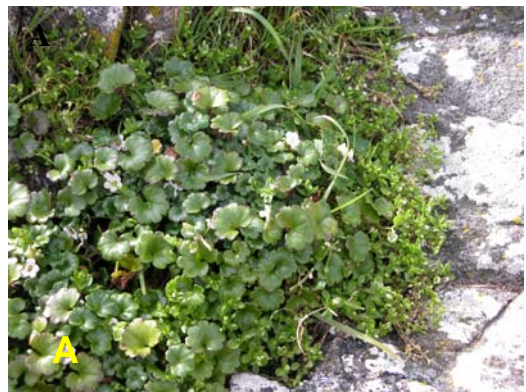
1. There was no anticipated impact to rare or endangered (SARA (Species at Risk) listed, BC CDC) terrestrial plant or marine algal and invertebrate species related to the barge landing and upland directional drill activity. The nearest location of the rare terrestrial plant, *Romanzoffia tracyi* (Photo A) to planned construction activity was in the rocks southeast of the Guardian house, outside the footprint of the construction area.

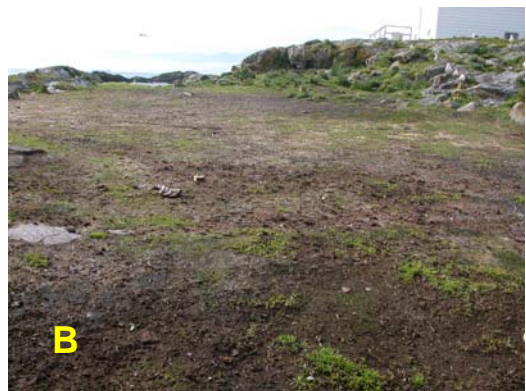
2. Impacts to upland vegetation (compaction, smothering, die off) from sea lion haul out (winter) in the proposed construction area were visible (Photo B). Spring growth of terrestrial plants in this area typically occurs once the sea lions vacate, therefore impacts from the proposed construction activity in April were considered very low.

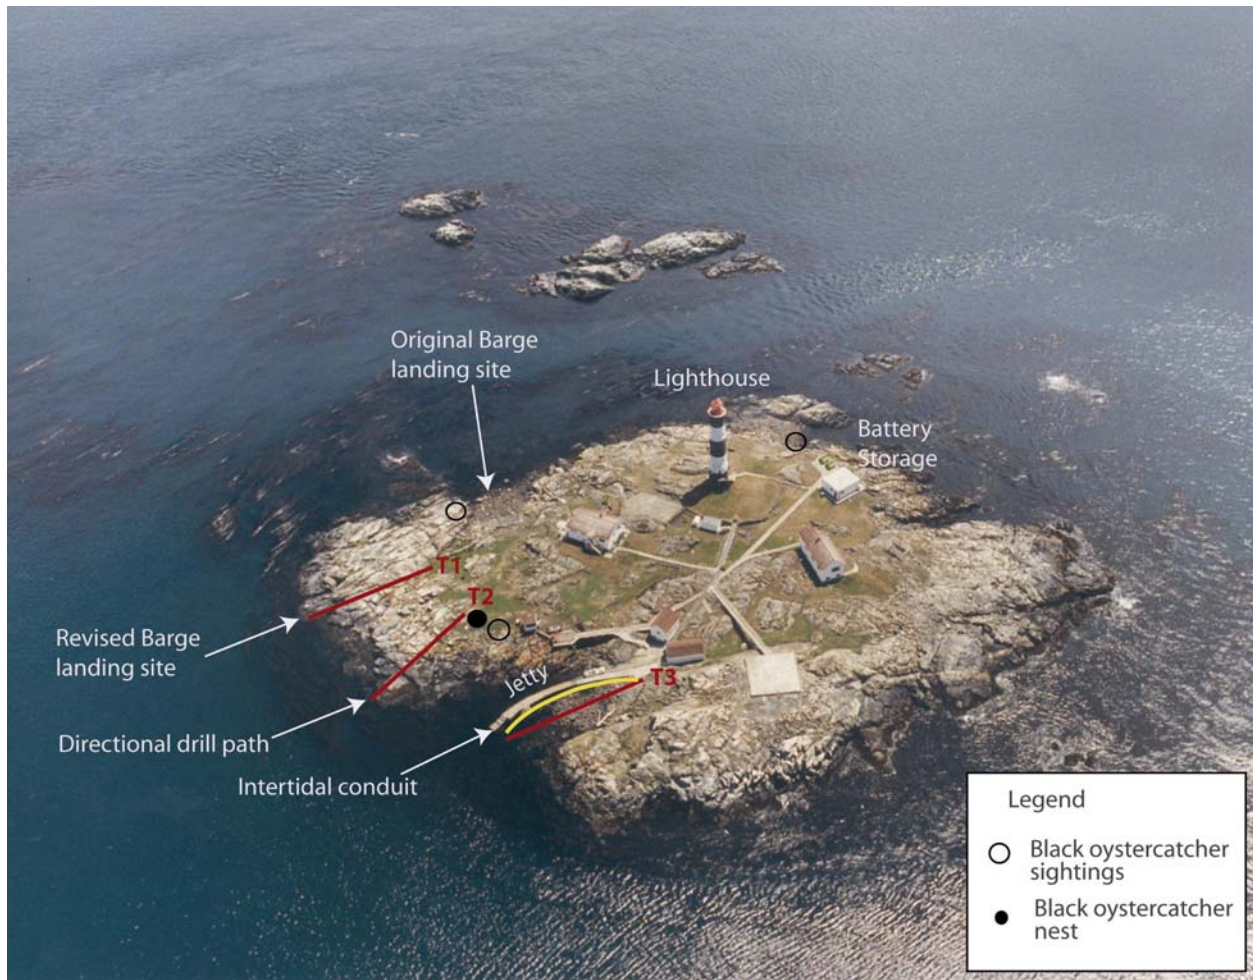
Figure 2. Location of intertidal transects (T1 – T3) and black oystercatcher sightings and nest.

Figure 2 shows the location of the intertidal transects (T1 and T2), and the oystercatcher nest.

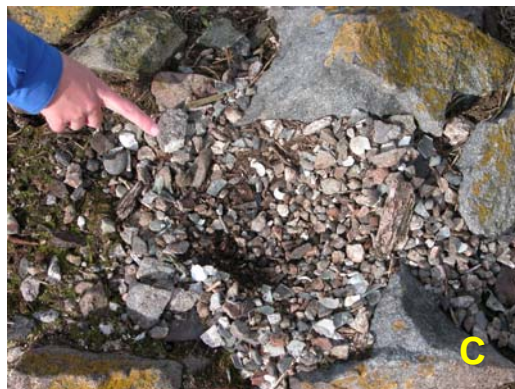
- Given directional drill activity was planned for April, observations on seabird (including Pigeon guillemots, glaucous-winged gulls, cormorants) behaviour were focused on black oystercatcher nesting activity. Three pairs of oystercatchers were identified during the site orientation (see Figure 2), each located near a site of potential disturbance (i.e., directional drill site, the barge landing site and the generator room). An oystercatcher nest (Photo C) was located 5m from the proposed directional drill site; however, there were no eggs present in the nest.

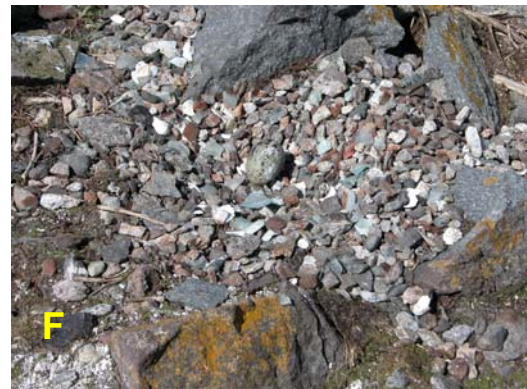
*glandiforme*, *Ulva* sp., barnacles (including clumps of *Pollicipes polymerus*, gooseneck barnacle) and limpets (Photo E). Algal growth was denser in the lower intertidal zone and included *Phyllospadix* sp., bladed kelps (*Hedophyllum sessile*, *Alaria* sp., *Laminaria* sp.), filamentous, foliose and coralline red algae (including *Odonthalia* sp., *Palmaria* sp. and *Lithothamnion*). California mussels (*Mytilus californianus*) and large *Semibalanus cariosus* barnacles were present along with sea cucumbers (*Cucumaria miniata*), chitons (*Katharina tunicata*) and limpets (*Tectura*). No rare or endangered plant or invertebrate species were noted. Canada geese, gulls and black oystercatchers, displaced during the collection of the transect information, moved back to their locations once work in the area was completed.

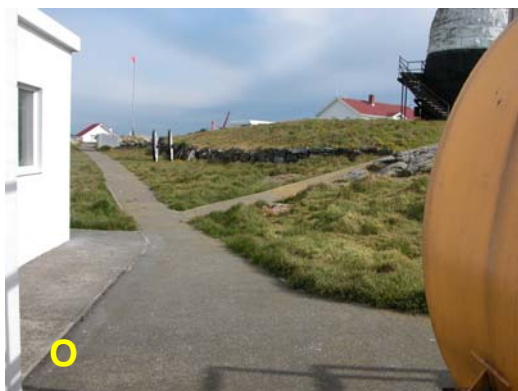
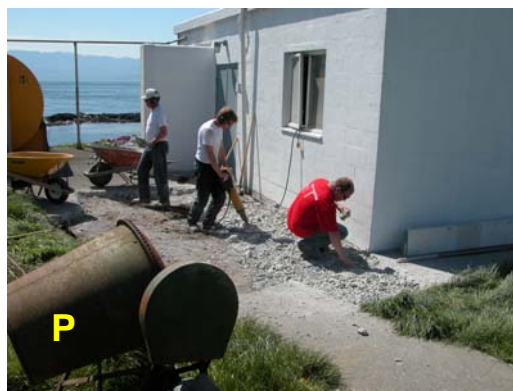
Photos O-P show the generator room prior to construction and during sidewalk demolition. Demolition debris from the sidewalk was stockpiled on the concrete pad seaward to the demolition area (Photo Q). The concrete mixer was placed in the middle of the demolished sidewalk, where run off was contained in a localized area during cement mixing activity. Construction material was also stockpiled on the grass immediately adjacent to the generator room, with a barrier placed between the vegetation and material to minimize potential impacts. Finer material was covered to prevent dispersion into terrestrial seabird nesting areas or into the marine environment (Photo R).

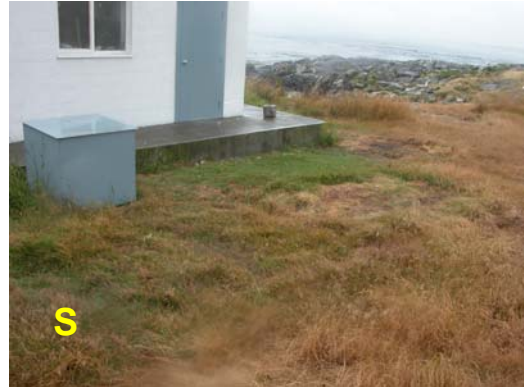
Photo S shows the completed generator (battery storage) room with construction materials in the surrounding area removed. Impact to the surrounding vegetation was very low (temporary smothering) and full recovery was anticipated. Gulls with chicks remained present in the upland area adjacent the generator room as did oystercatchers and Pigeon guillemots on the bedrock within the intertidal zone seaward of the generator room.

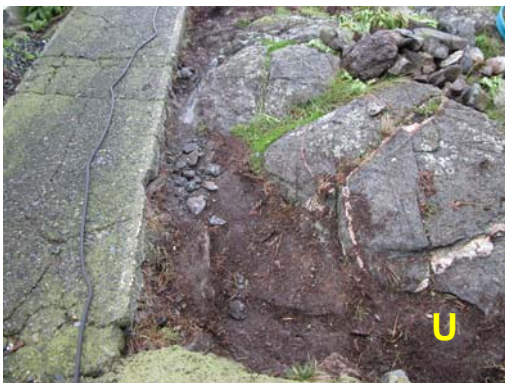
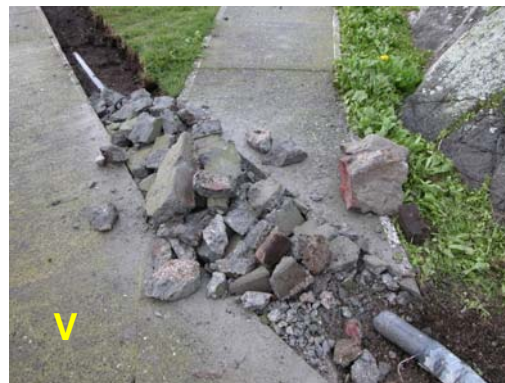
Although a large portion of the area along the sidewalk was fertile soil, it was anticipated that there would be a need to break up some concrete and bedrock immediately beside the sidewalk to accommodate the cables. Photo T shows the construction path immediately west of the sidewalk, while Photos U and V show close views of the bedrock and concrete demolition areas. Most of the concrete that was demolished alongside the sidewalk was placed back into the fill area while some was hauled away with other constructions spoils.

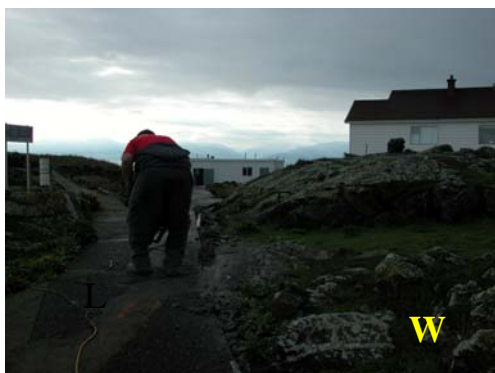
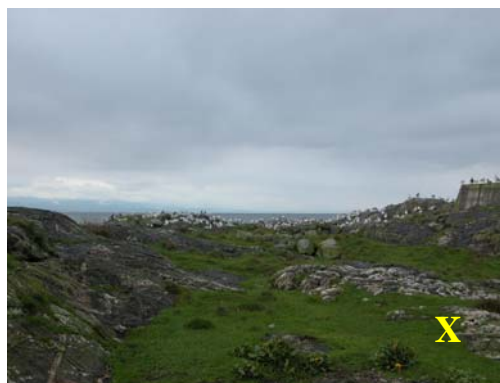
Observations on bird behaviour (gulls and cormorants) in the vicinity of the construction work were completed over a 45-minute period on November 8, 2005. Observations were made prior to, during (Photo W), and after jackhammer activity. There appeared to be little to no adverse effect on bird behaviour in that individuals and/or groups did not take flight immediately after work with the jackhammer started. Photo X shows both gulls and cormorants perched on the rock (immediately east of the construction area) during the onset of jackhammer use. A smaller, quieter and more mobile jackhammer than the one used for demolition work at the generator room, was employed.

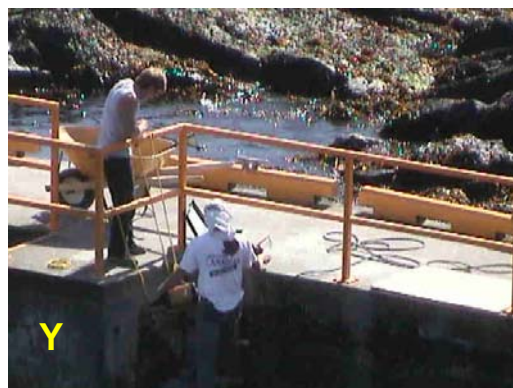
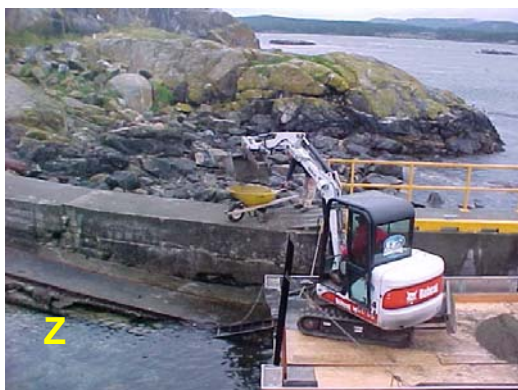
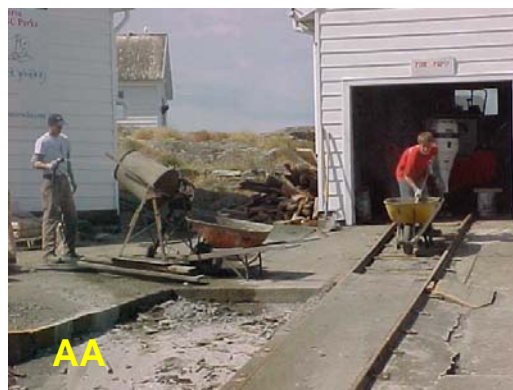
Construction along the jetty occurred between May 27 and June 21, 2005, commencing with drilling through the stairwell along the west side of the jetty (Photo Y). Construction material was brought on site with a barge and transported by hand to the construction staging area at the landward end of the jetty (Photo Z and AA). As the same construction company (Roma Construction) and foreman from the generator room work were used, the crew was aware of the environmental concerns in the

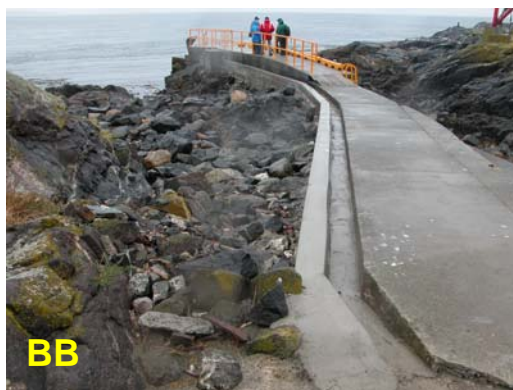
An inspection of the intertidal zone after construction was completed on July 8, 2005. Photo BB shows the completed concrete encasement along the jetty. Although rapid colonization of algal vegetation on the concrete structure was anticipated in the lower intertidal zone, only a diatomaceous film had grown on the lower portion of the concrete trough to date. Impacts to the immediate area were contained within 2.5m of the jetty and consisted of a few patches of concrete rubble (Photo CC), which were subsequently removed upon request. In the immediate upper intertidal zone on the east side of the jetty where the concrete mixer was located, a small 1m X 0.20m area of concrete runoff was observed (Photo DD); however, there was no impact to sensitive or critical habitat.

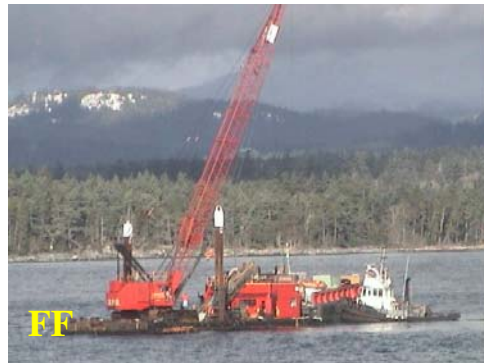
On November 29, 2005, a barge and drill rig was on site to start with the pile construction (Photo FF). Planned monitoring activity included observations on i) marine mammal and bird behaviour, ii) construction equipment positioning and, iii) dispersion of the drill effluent plume. LGL's report on marine mammal and bird behaviour and disturbances at Race Rocks (Demarchi and Bentley 2004) was reviewed and the marine mammal observer was prepped and ready to deploy.

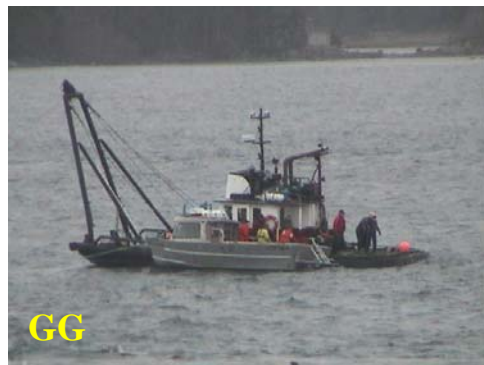
Between January 10 – 13, 2006, divers from Can-Pac, supported by Pearson College and a local tug (Blue Water Contracting, Photo GG) attempted to install the drill template. Due to a thick layer of overburden material (>1m), the template was not successfully installed and the work crew left the site. Work was scheduled to resume once an appropriate weather window and construction schedule was established.

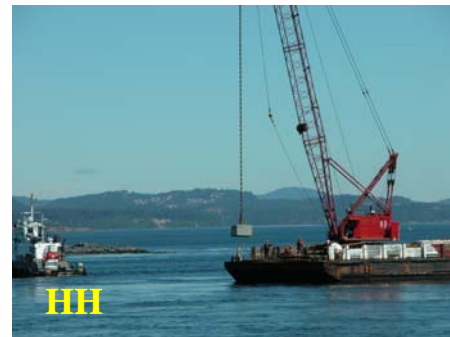
A barge from Fraser River Pile and Dredge anchored by six, 6 x 7 foot concrete blocks (Photo HH) (four 12.5 tonne and two 16 tonne) temporarily placed on the seafloor (anchor array shown in Figure 4), provided the drilling platform for pile installation. Monitoring observations were made both from the barge and Great Race Rocks and are described below.

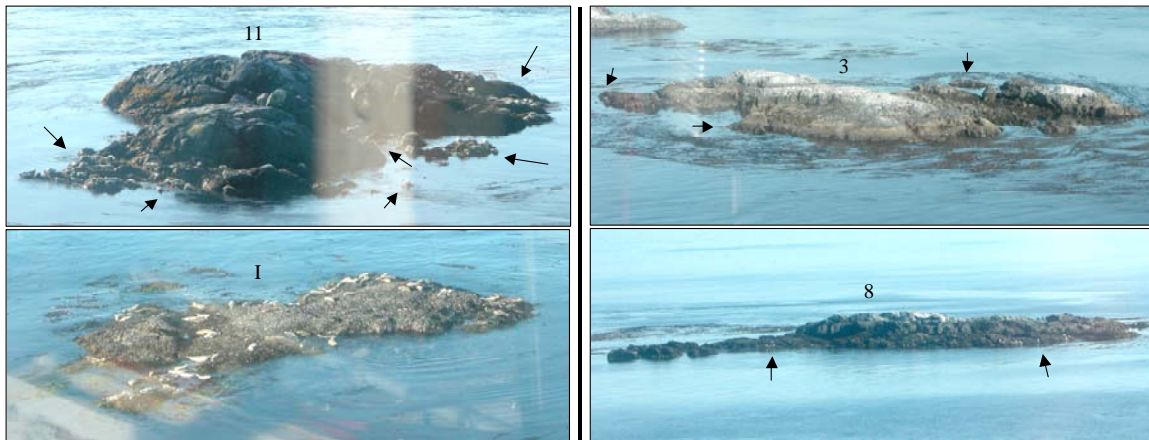
**Figure 6.** Photographs taken from the top of the lighthouse showing abundance of harbour seals (arrows) hauled out in the Reserve prior to drilling activity on July 21, 08:00 hours. Islets on the east side of Great Race Rock had the greatest abundance of seals (left, top and bottom photos), while regions west and north of Great Race Rock had significantly fewer seals (right, top and bottom photo). Numbers above each islet refer to their locations (see Figure 5).

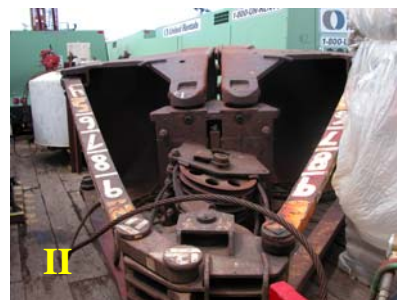
The clamshell dredge used to remove overburden (primarily boulder and cobble) from the pile site was a 3 cubic yard bucket (Photo II, marking in feet) weighing about 7000 kilograms and covering an area of approximately 1 x 3m when opened. The clamshell was used three times during the pile installation. The initial area of impact from the dredge spoils was anticipated to be approximately 10 – 15m<sup>2</sup>.

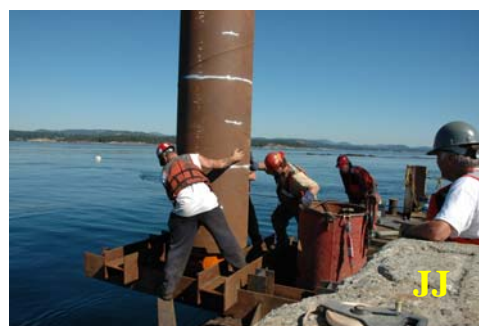
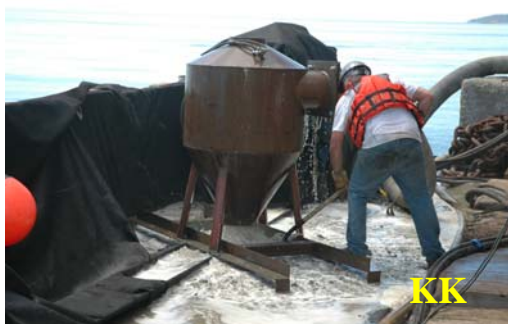
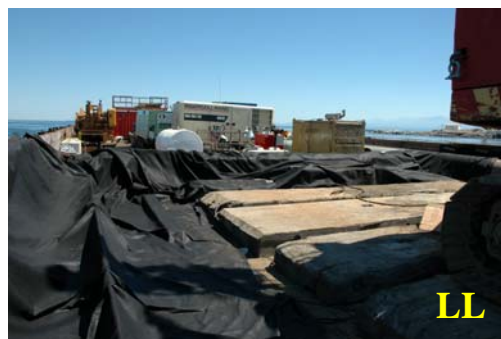
Following the positioning of the barge on July 16 (see monitoring observations in Section 3.2.3.1) the drill (in the caisson) was positioned on the bow (Photo JJ) and the cyclone (Photo KK), used to separate overburden material from drill effluent (water and fines), and filter cloth were set up on the deck of the barge (Photo KK, LL). Drilling activity started on July 21 and continued on July 24-25 following replacement of one of the compressors. Due to the collapse of the caisson and damage to the drill, the remaining drill activity took place August 2-4, 2006, after a replacement drill was located and installed.

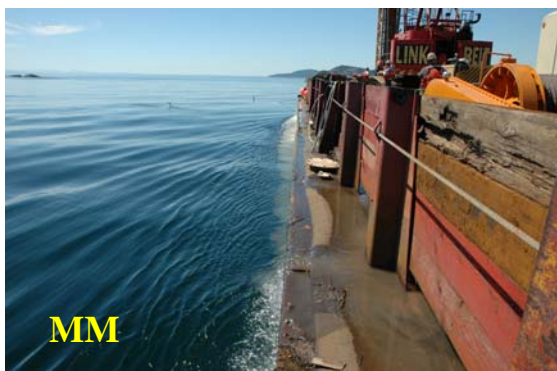
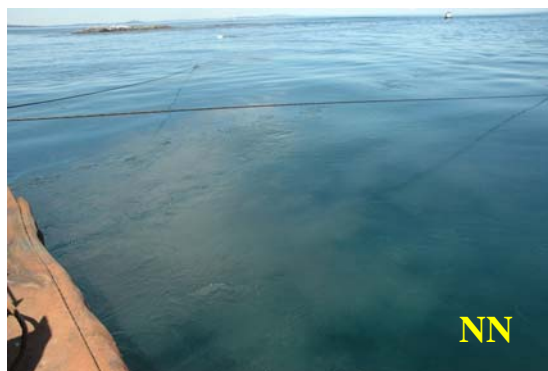
- Most of the drill effluent spilled off the starboard side of the barge (Photo MM) after passing through the filter cloth.
- A sediment plume was evident off the stern of the barge during a flood tide (Photo NN); however, the sediment plume dissipated very quickly.

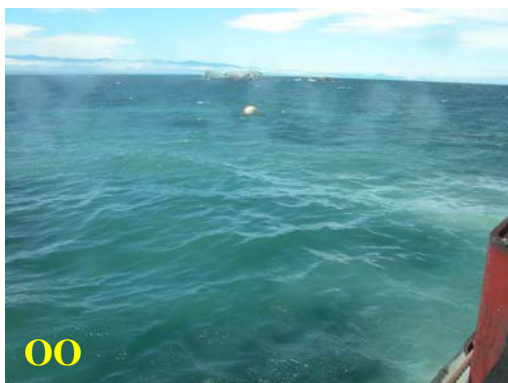
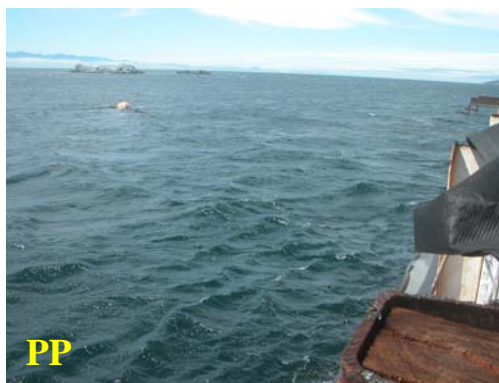
- A larger sediment plume was visible off the bow of the barge during a slack tide (Photo OO); however the sediment plume dissipated rapidly (within 35 minutes) (Photo PP) following a tide change.
- Filter cloth was functioning as intended in that only fines were observed in the drill effluent discharge.
- Harbour seals hauled out on the nearby islets did not appear to be impacted from the drilling activity in that seal behaviour did not change (e.g., moving from an islet to the water, head lifting) at any time during the observations of the drilling and effluent discharge activities.

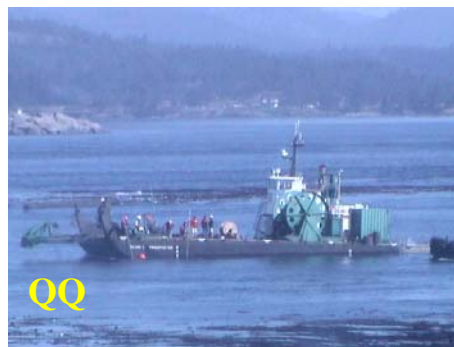
From August 14 – 18, 2006, four submarine cables were laid on the seabed from a smaller self-propelled barge provided by Island Tug (Photo QQ). Observations were made from aboard the barge (August 16, 17), from Great Race Rocks (August 14) and remotely (August 16, 31). Below is a summary of the observations.

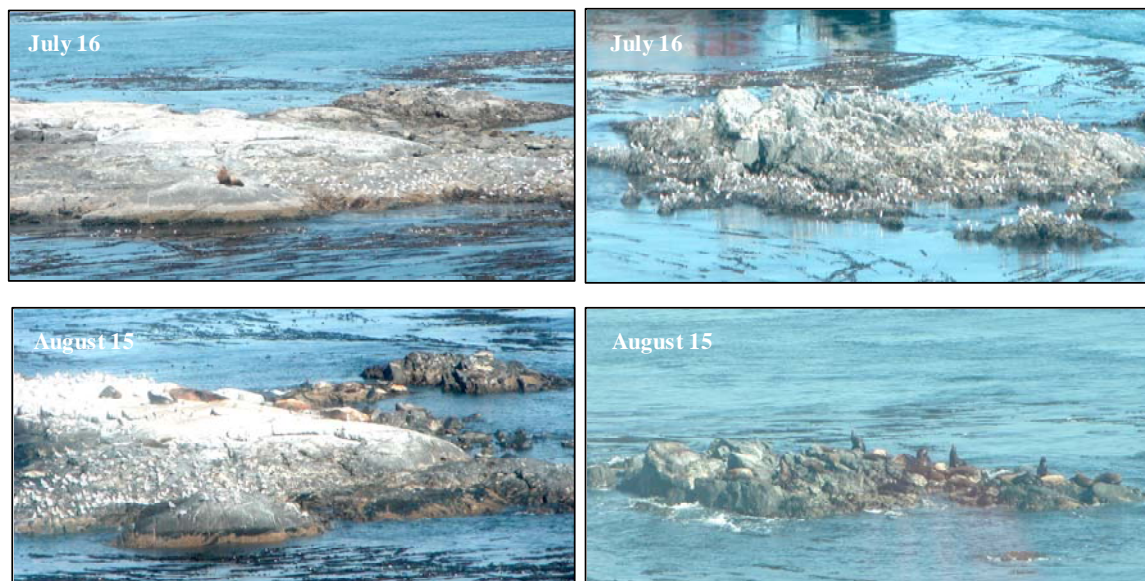
The abundance of sea lions in the Reserve had increased significantly over the three-week period with 45 animals hauled out on land (Figure 7). However, the most abundant marine mammal was the harbour seal at 148 animals (Table 2). Birds continued to be the most numerous group overall at approximately 480 gulls, followed by 23 pigeon guillemots and four pelagic cormorants (Table 2).

**Figure 7.** Photographs documenting changes in marine mammal abundance in Race Rocks Reserve over a three-week period. The top photographs show a single Steller sea lion hauled out on Islet 3 before disappearing two hours prior to the drilling rig entering the Reserve on the morning of July 16 (left), and gulls on Islet 6 on the same morning (right). Bottom photographs of the same islets three weeks later on the morning of August 15 show elephant seals and Steller sea lions hauled out (left), and California and Steller sea lions (right).

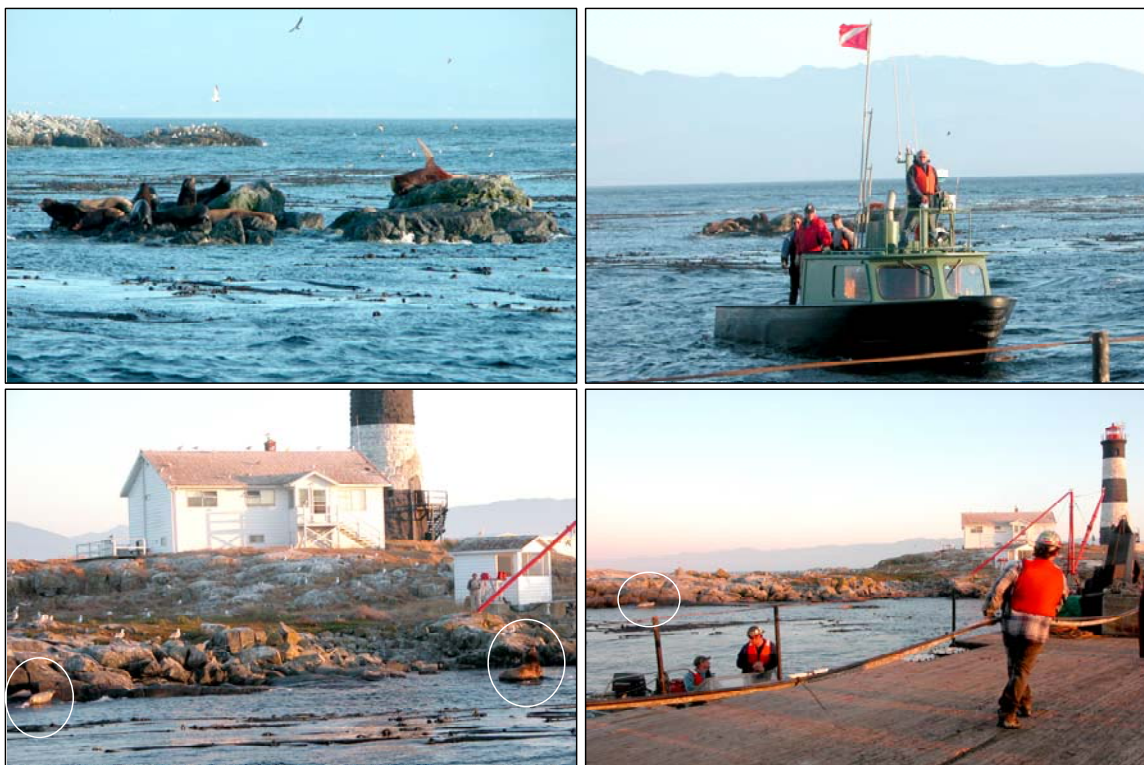
Sea lions on land and in the water in the vicinity of the turbine construction site were generally tolerant of the cable laying barge and attending work vessels (Figure 8, top). Three California sea lions were intentionally and repeatedly cleared off the jetty during the cable-laying phase, which only temporarily displaced the sea lions despite the presence of work crew. Harbour seals were present at all times throughout the Reserve and were mostly tolerant of human activity. Although a mother and pup harbour seal pair vacated their haul out when the cable laying crew approached the jetty, a second pair remained on land (Figure 8, bottom). Overall, foot traffic on Great Race Rock was the only observed disturbance (temporary) for birds and marine mammals in the Reserve.

**Figure 8.** Photographs taken from on board the self-propelled barge, documenting animal behaviour before and during cable laying activity in the Reserve, August 17, 20:00 hours. Upon entering the Reserve, California and Steller sea lions were hauled out on Islet 6 (top left photo), and showed no change in behaviour with the presence of the barge and divers in the water (top right photo). A mother and pup harbour seal pair (bottom left photo, left circle) and a California sea lion (bottom left photo, right circle) were hauled out on Great Race Rock east of the jetty during approach of the cable laying barge. The sea lion entered the water but remained in the vicinity while the seal pair did not move during transfer of cable along the jetty (bottom right photo).

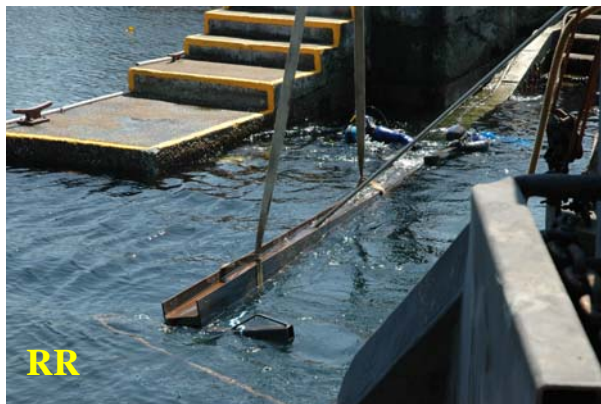
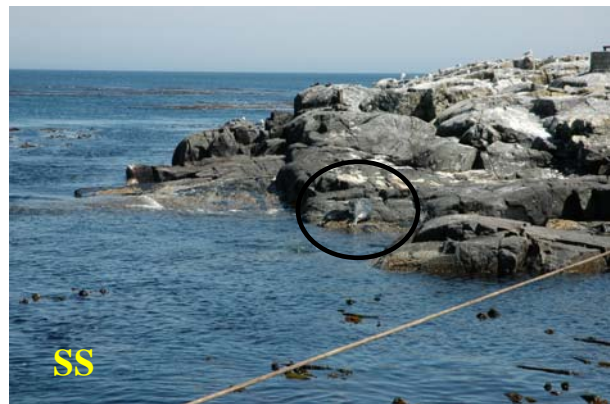
After the second cable was laid, a rail was installed by divers at the seaward end of the concrete shute (conduit) at the foot of the jetty (Photo RR). Although several sea lions and harbour seals were present in the nearshore water surrounding the jetty, both the presence of the cable laying vessel and the associated activities of pulling the cable through the shute into the upland, tying off the barge to Great Race Rocks, and installing the rail in the shallow subtidal did not appear to impact the marine mammals in the vicinity. Photo SS shows a harbour seal pup and mother (black circle) hauled out on the rock <50m from construction activity for the duration of the rail installation. These mammals were also observed in the same location August 17, 2006 (see previous section).

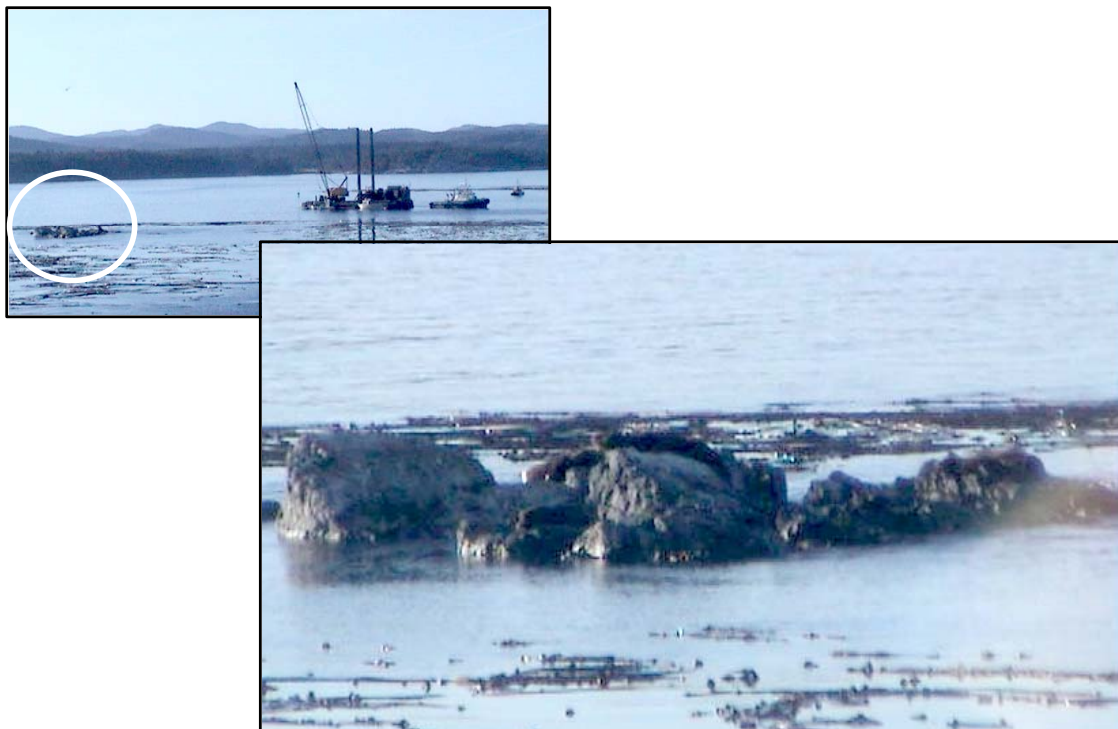
On August 31, during the installation of the pile extension, marine mammal and bird observations were collected remotely via the Race Rocks remote video camera. At 17:00 hours a remote survey of the area provided a general census of animal activity prior to construction, and remote snapshots were taken for photo documentation. At 17:15 hours the rig and tugs were on scene between Islets 6 and 8 and divers were in the water. Islet 7 was mostly submerged in a high tide, and California and Steller sea lions occupied Islets 3 and 6 near the turbine site (Figure 9) as well as the jetty region.

**Figure 9.** Remote image showing orientation of barge activity in relation to Islet 6, with a close up image of Islet 6 showing hauled out seal lions.

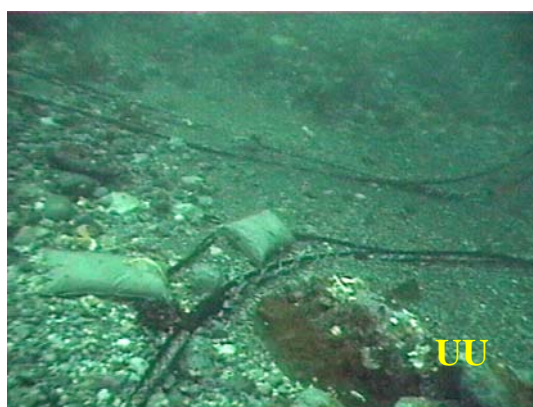
- An excavation area around the installed pile between approximately 12-16m in diameter (Figure 9) with clean pebble and cobble (Photo TT, looking west; Photo UU, looking at the power cables running southeast).

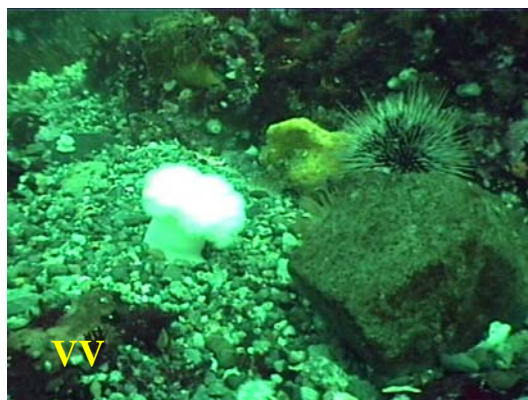
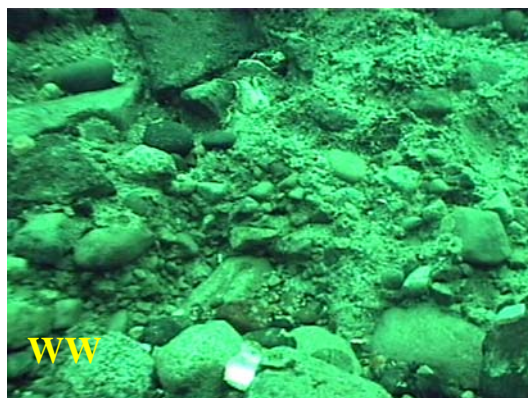
- A transition area between the pile location and non-impacted seabed where material (pebble and cobble) from the dredge spoil is dispersed over the natural seabed (Photo VV). This area extends approximately 20m east along the cable route and west along the direction of tidal flow.
- Settlement of *Epiactis* (brooding anemone) and *Metridium* on exposed bedrock and cobble.
- Some areas of exposed clay embedded with cobble and pebble on the north slope of the excavation area (Photo WW, close view).

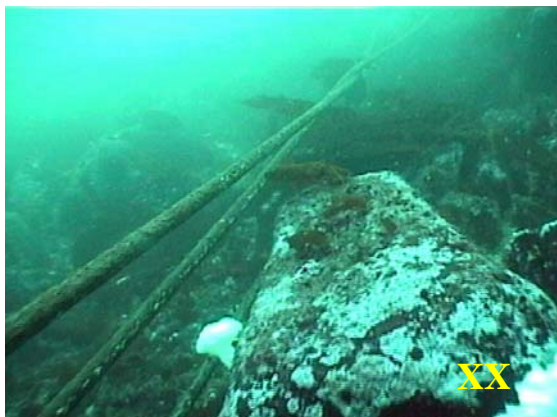
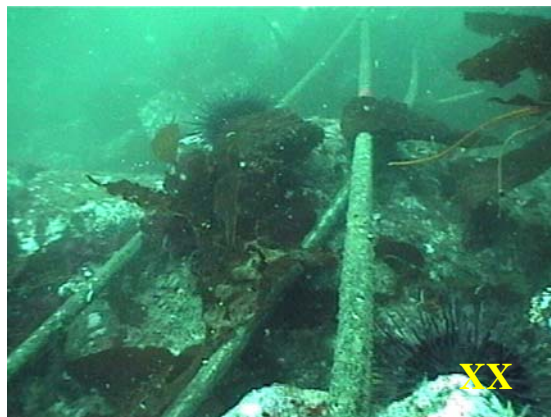
- Two cables crossed one another at various points along the cable route (Photos XX);

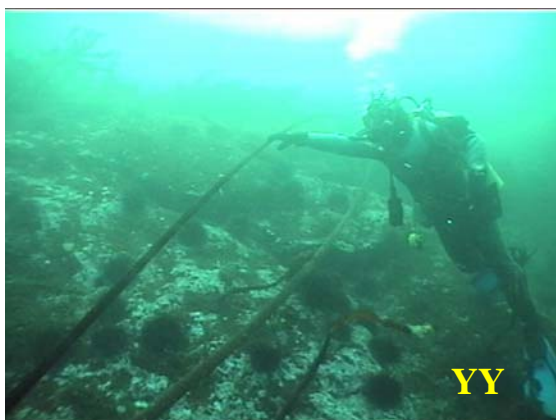
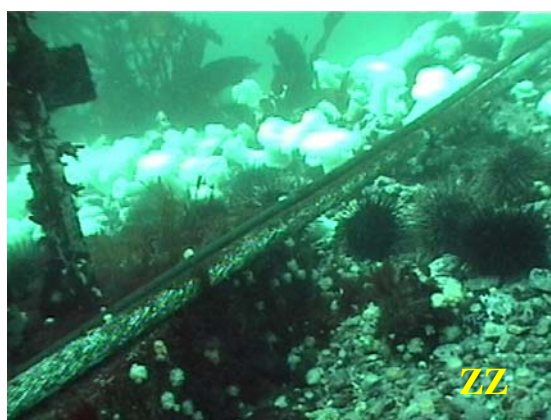
- At various locations along the cable route, the cables were separated from each other at distances greater than could be observed due to the visibility conditions (approximately 10m);
- Near the jetty, the fibre optic line attached to a cable “billowed” at several locations (Photo YY showing separation; Photo ZZ showing bundled power and fibre optic cables);

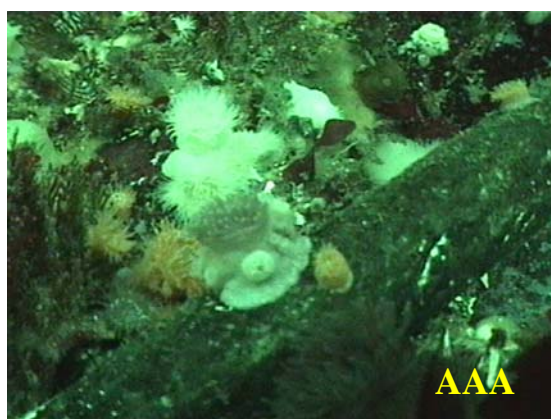
- *Epiactis* (brooding anemone) were present on the cable in a number of locations (Photo AAA).

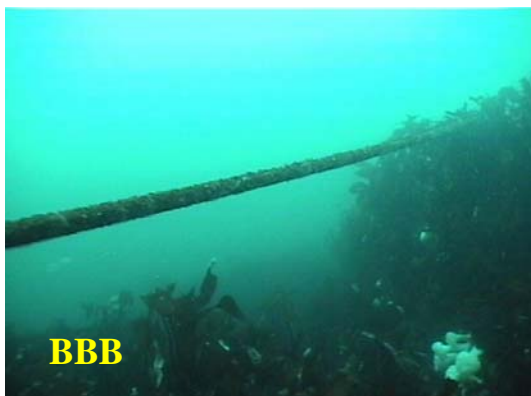
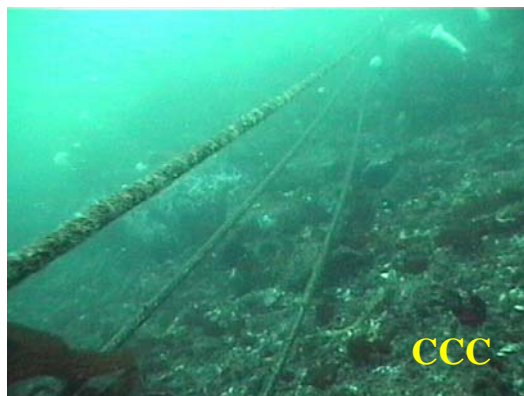
- Several of the cables observed remained off the bottom for a large percent of the length of the cable (30 – 50%) (Photo BBB, CCC).

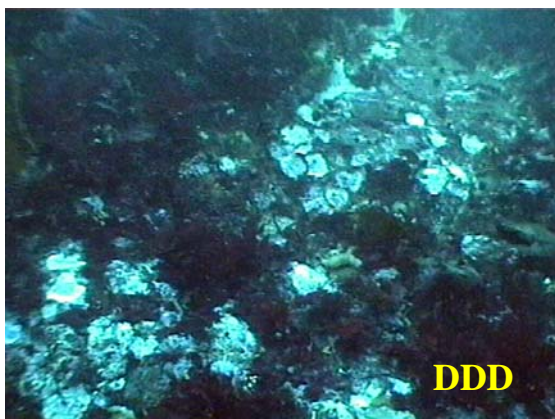
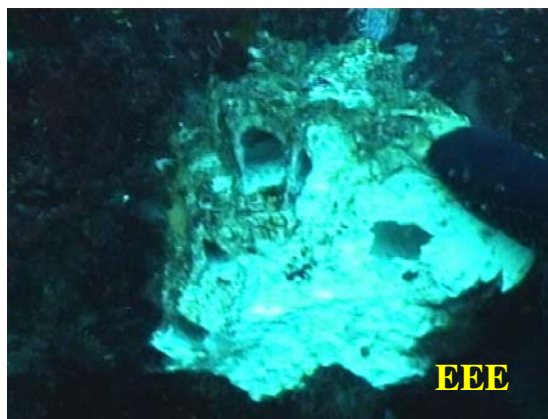
- The impact was in a very localized area and was restricted to *B. nubilus*. There was no visible impact to vegetation or other sensitive invertebrate species (e.g., sponges, hydrocorals).
