Energi E2 A/S

**Development of the Fouling
Community on Turbine Foundations
and Scour Protections in Nysted
Offshore Wind Farm, 2003**

**Report
June 2004**

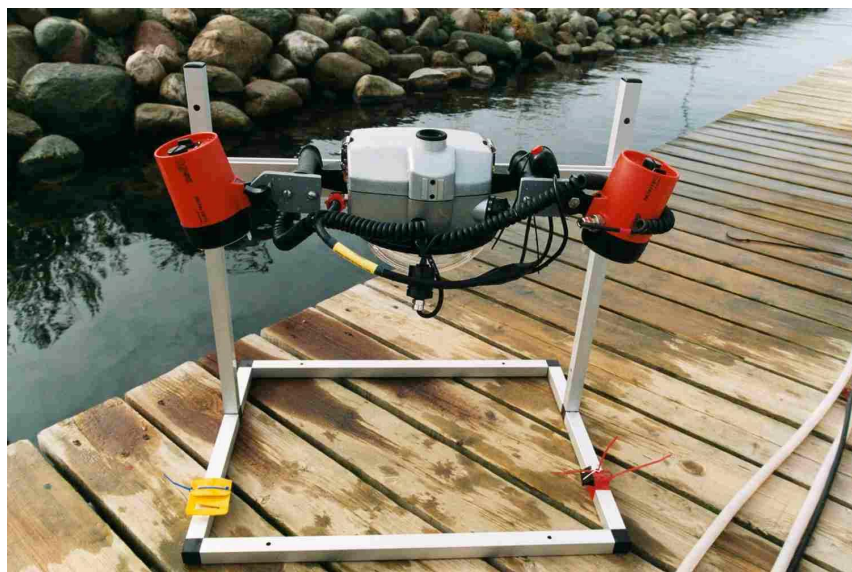
Figure 2.4 Equipment used for digital photography of the fouling community at Nysted Offshore Wind farm in September-October 2003

Video recordings along all survey lines were made with a hand held digital video camera. Still photographs were taken with a digital camera mounted on a frame with two strong flashlights (Figure 2.4). Before each picture was taken, the frame was placed firmly on the substrate in order to ensure that the image covered a well-defined area of 0.24m² (40 × 60 cm).

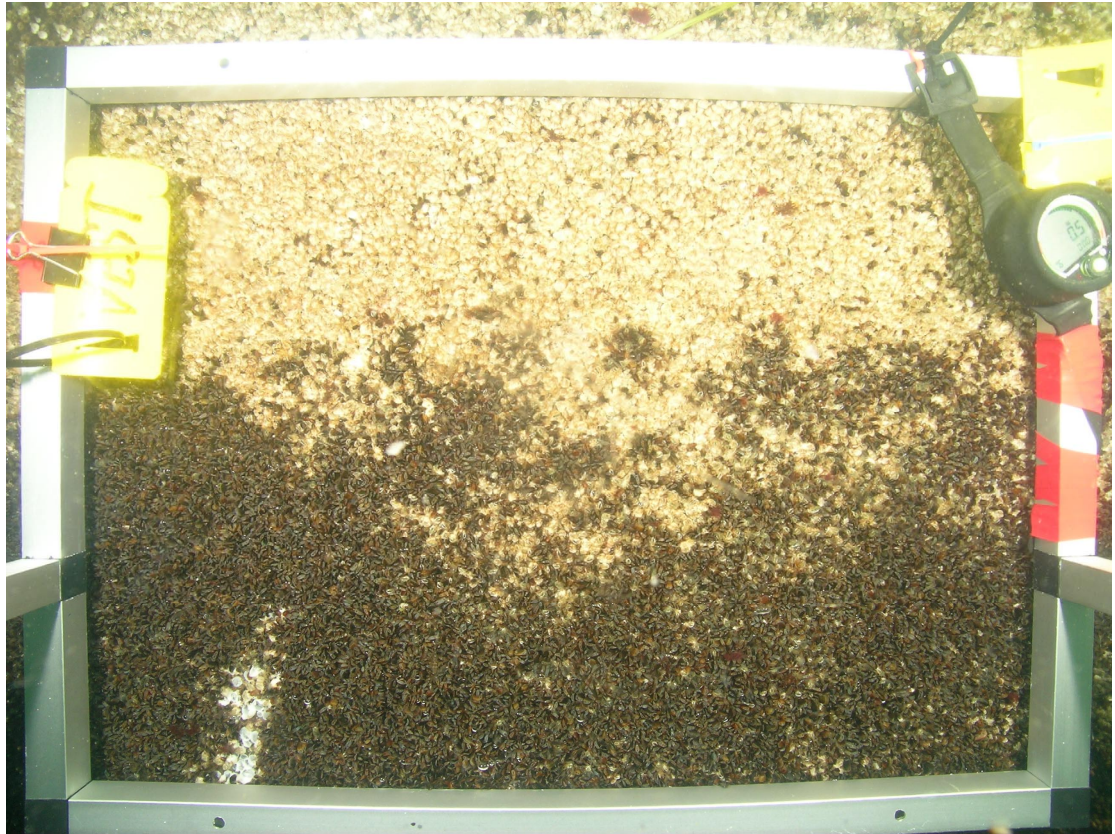
Figure 3.1 Barnacle zone close to the surface followed by a dense population of common mussels (*Mytilus edulis*).

The overall impression based on examination of the photos was that the development of the fouling community was similar at the turbines but different at the transformer station. The **shafts** (the vertical surfaces of the foundations) were in most occasions covered by a dense layer of small common mussels (*Mytilus edulis*). At the uppermost station 0.5m below the surface there was a narrow barnacle zone (Figure 3.1). Mussels covered the barnacles on the remaining part of the shafts and the coverage of barnacles is therefore underestimated in Annex 2.
