The result was an "artificial substrate colonization survey" (2020).

Main conclusions:

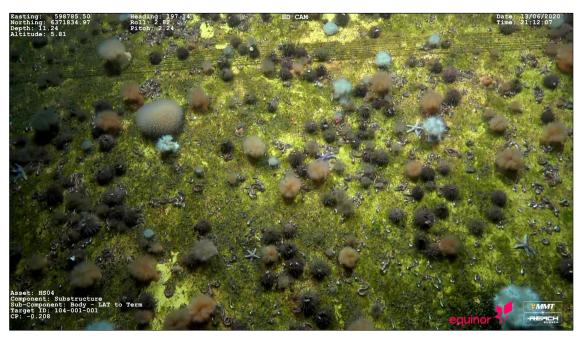
Figure 6 HS04 - Substructure. Grazing sea urchins at 11 m depth.

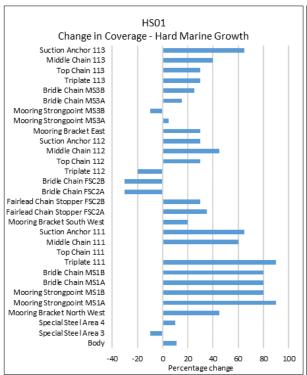
The thickness of hard marine growth has generally decreased, however, where the thickness has increased it has increased distinctly. Soft marine growth has partially increased and partially decreased in thickness (Figure 24 and Figure 25).

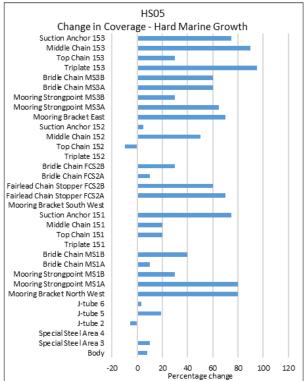
Change in Coverage - Soft Marine Growth Suction Anchor 153 Middle Chain 153 Top Chain 153 Triplate 153 Bridle Chain MS3B Bridle Chain MS3A Mooring Strongpoint MS3B Mooring Strongpoint MS3A Mooring Bracket East Suction Anchor 152 Middle Chain 152 Top Chain 152 Triplate 152 Bridle Chain FCS2B Bridle Chain FCS2A Fairlead Chain Stopper FCS2B Fairlead Chain Stopper FCS2A Mooring Bracket South West Suction Anchor 151 Middle Chain 151 Top Chain 151 Triplate 151 Bridle Chain MS1B Bridle Chain MS1A Mooring Strongpoint MS1B Mooring Strongpoint MS1A Mooring Bracket North West I-tube 6 J-tube 5 J-tube 2 Special Steel Area 4 Special Stee | Area 3 Body -40

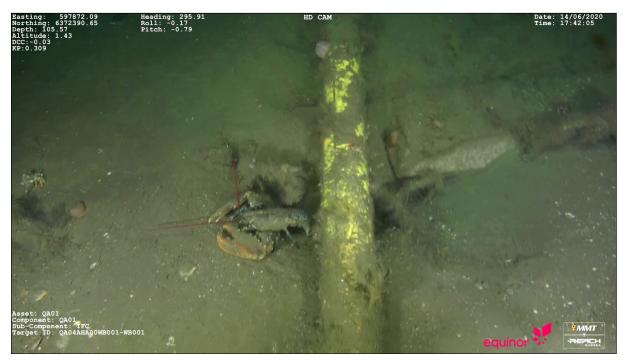
Figure 42 Homarus sp. on the Concrete Mattress.

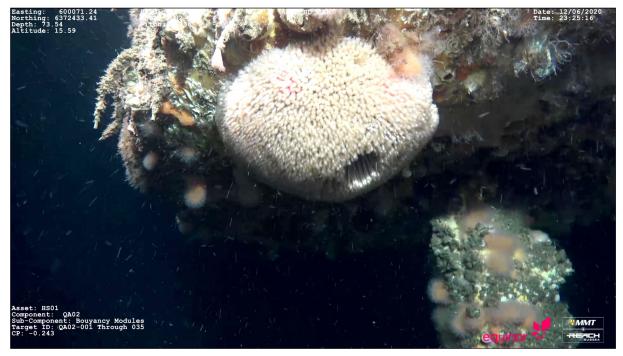
Figure 44 QA02 – HS01 Buoyancy Modules. Possible young colony of D. pertusum.
