ENVIRONMENTAL IMPACT ASSESSMENT
WAVE SWELL ENERGY TEST SITE
GRASSY HARBOUR, KING ISLAND, TASMANIA

prepared for
Wave Swell Energy
February 2023

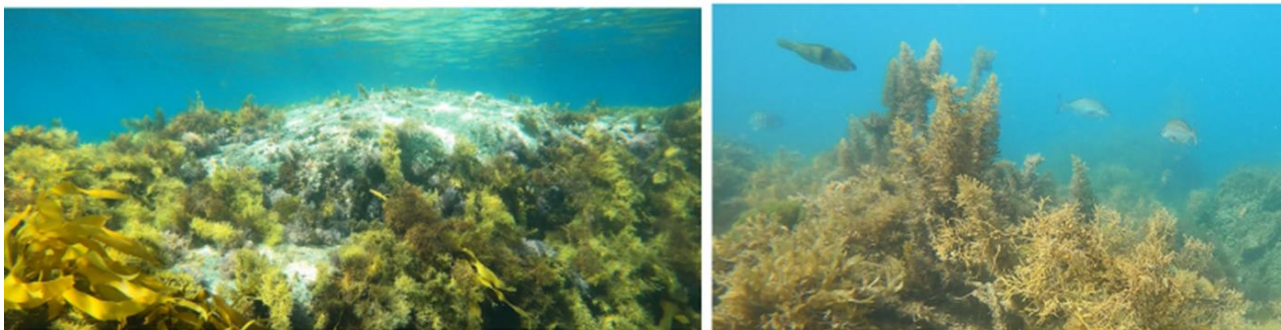
The area surrounding the marina control site consisted of a mixture of rocky reef and seagrass habitat (Figure 5). The reef was dominated with turf algae and had a higher fish abundance compared to the other two sites. Additionally, the sediment at the marina was visibly coarser and darker in colour.

Figure 5. Images from the underwater habitat survey at the marina control site.

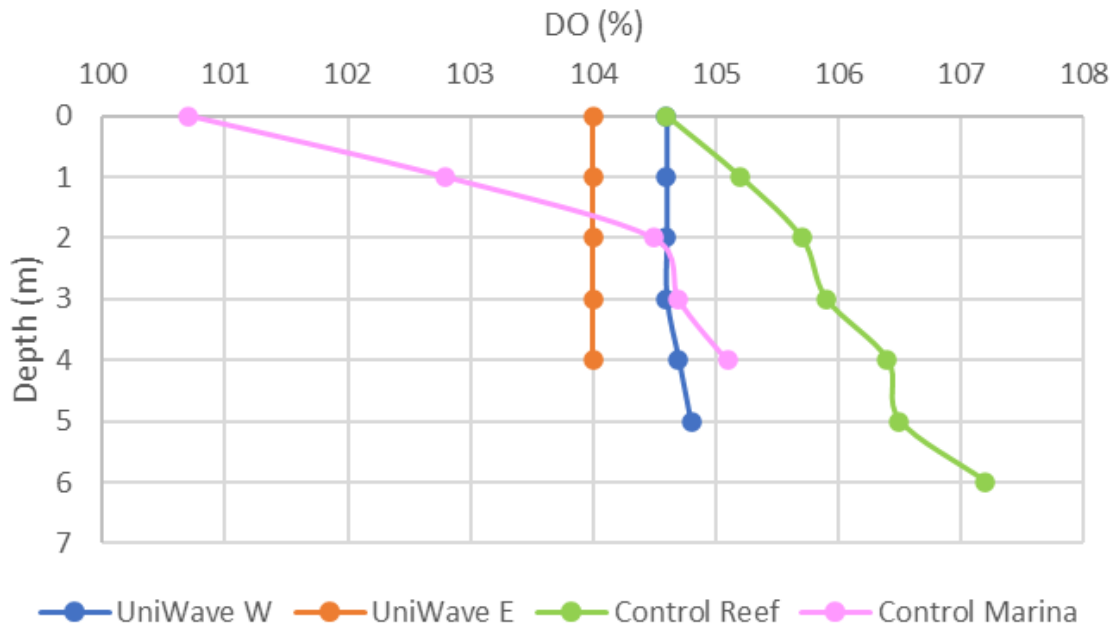
Dissolved oxygen levels were all just above 100% air saturation, with some slight variation through the water column across the different sites (Figure 6).

At the UniWave site, dissolved oxygen levels stayed relatively consistent throughout the shallower, wave-mixed water column with levels persisting around 104 %. In contrast, both the reef and marina sites had increasing dissolved oxygen from the surface to the seafloor, with a minimum 101 -103 % in the 0 -1 m depth range at the marina reference site and a maximum of 107% at 6m depth at the reef reference site. This sub-surface elevation of dissolved oxygen is common during early morning surveys where photosynthesis is occurring. The relatively high dissolved oxygen at the Control Reef site may correlate to increased photosynthetic activity in a localised area of higher plant biomass. All values are above 100% saturation.

Figure 6. Dissolved oxygen profiles for different sampling sites in Grassy Harbour.

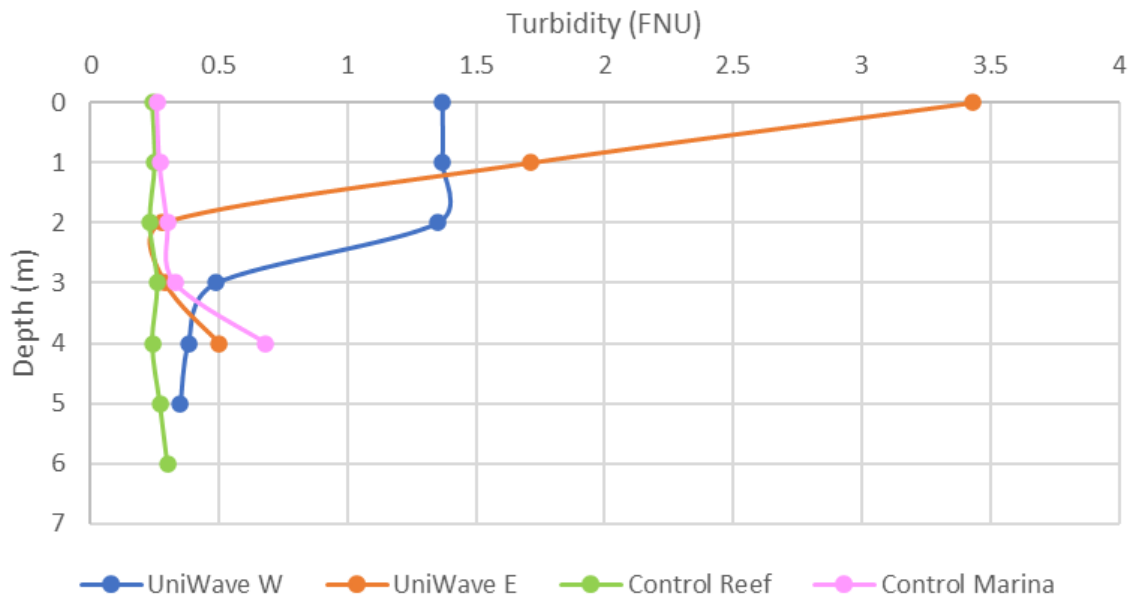
Potentially the most likely water quality parameter to be impacted by a moored installation, turbidity values ranged from 0.25 to 3.47 FNU at the time of sampling (Figure 7). These are relatively low values indicative of a benign environment. The highest turbidity levels were recorded in 0 - 1 m

depth at the UniWave and gradually decreased with increasing depth. Turbidity levels at the two reference sites showed little variation with increasing depth and consistently stayed below 1 FNU.

Although the recorded turbidity levels are considered low across all sites and depths, small variations in readings, for example in the case of the higher turbidity readings at the sea surface, may be from the interaction of the wind-driven waves at the time of sampling (10 knots from the NE), creating greater surface turbulence at WSE-East, relative to the other side of the installation at WSE-West.

Figure 7. Turbidity profiles across the different sampling sites in Grassy Harbour.
