**SAFE** STREAMLINING THE ASSESSMENT  
OF ENVIRONMENTAL EFFECTS  
OF WAVE ENERGY  
**WAVE**

**DELIVERABLE 2.4**  
**Monitoring of the seabed integrity**

### Deliverable 2.4 Monitoring of the seabed integrity

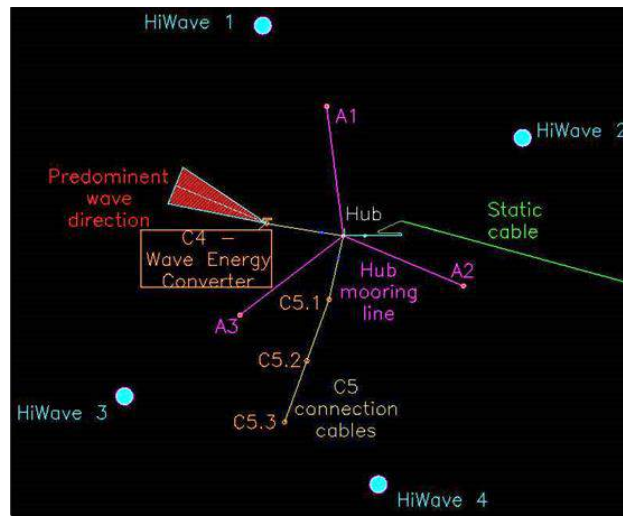
Figure 5. Layout of the HiWave Project (Source: CPO).

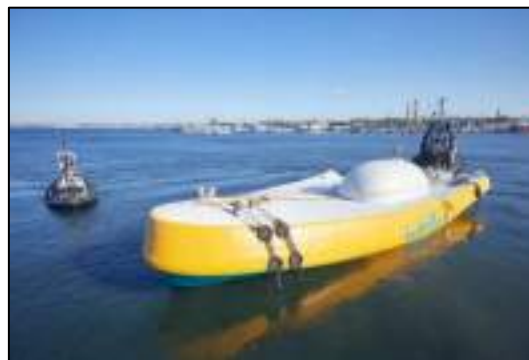
**Figure 6.** Wello Penguin II WEC (Source: Wello).

Penguin II is a direct drive wave energy converter. It is a vessel shaped attenuator device with 43.3 m length, 10.6 m depth, 6.8 m draught, 21.8 m beam and a weight of 2.2 t in its current commercially ready configuration, with a nominal power of 0.5-1 MW (Figure 6).

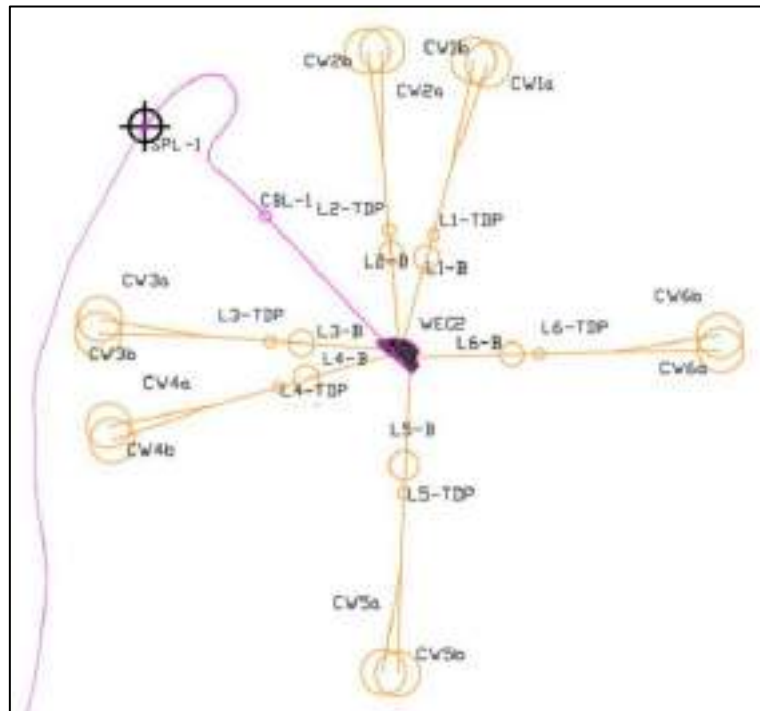
The mooring system was deployed at BiMEP in May 2021, following the scheme depicted in Figure 8 and with the clump anchors at the coordinates listed in Table 3. The Penguin II device was then deployed in June 2021. In December 2021, the device was decommissioned for maintenance.

**Figure 8.** Schematic view of positioning of the mooring system (Source: Wello).

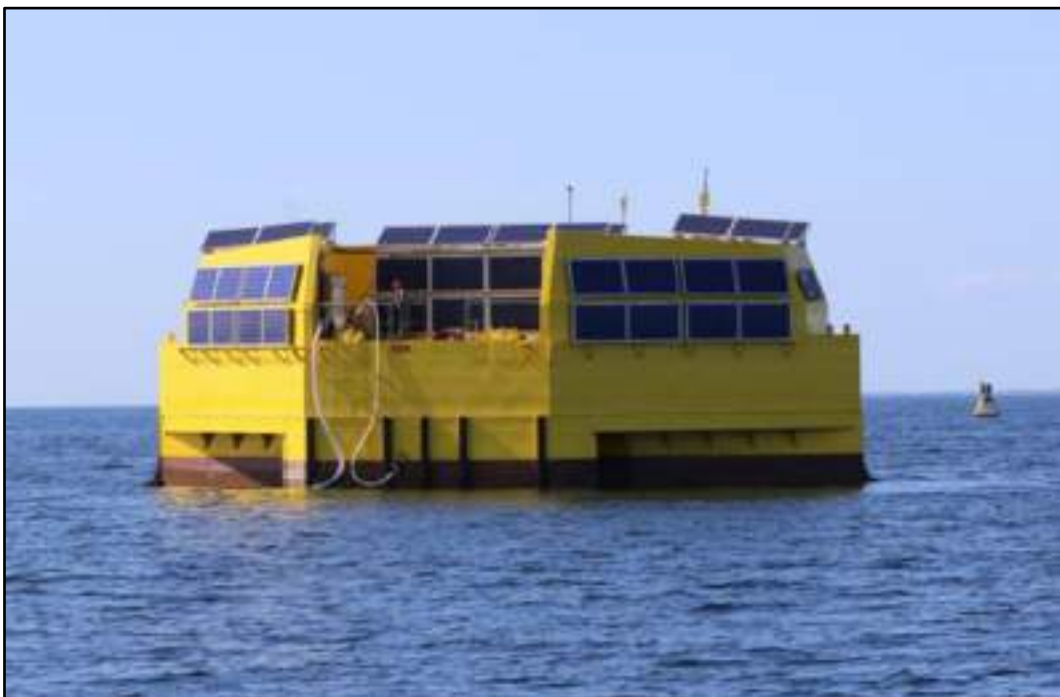
The WAVEGEM (Figure 10) is a hybrid autonomous energy recovery platform, developed by GEPS Techno, with a 150 kW power capacity. It is 21 m long and 14 m wide, with a height of 7 m. The device converts float motions into electric power through the circulation of seawater in closed loop, via a low-speed turbine.

Figure 10. GEPS Techno WAVEGEM (Source: GEPS Techno).

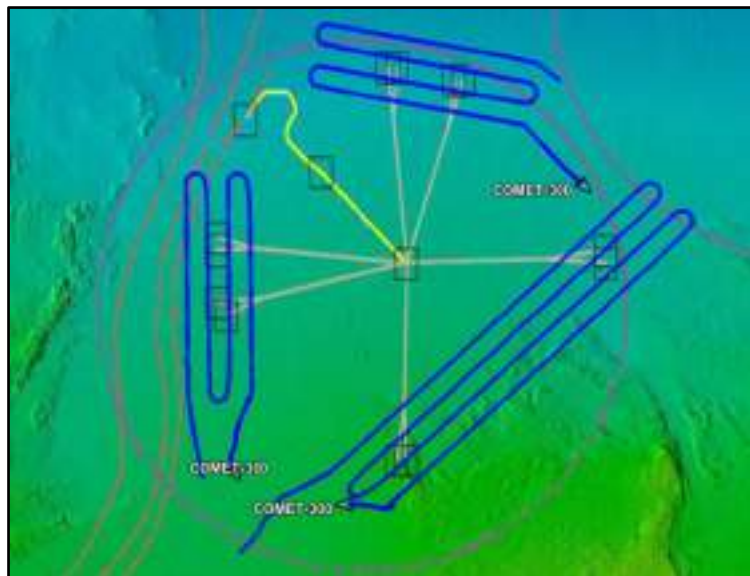
- 2 August: the AUV was programmed so that it carried out parallel transects that allowed the detailed inspection of each of the mooring lines (including lower catenary and anchors) (Figure 12). Three immersions were undertaken (one to cover mooring legs 1 and 2, another one for the mooring legs 3 and 4, and a

**Figure 12.** Navigation map of the COMET-300 in the first survey carried out on the 2nd of August 2022. The routes followed by the AUV are represented in blue.

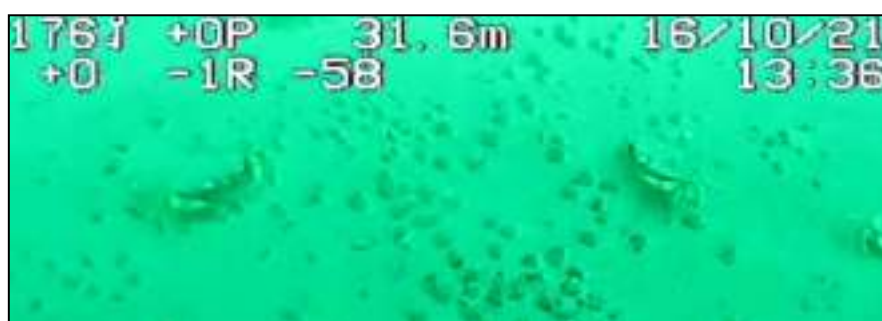
Figure 20. A few crabs feeding at -31.6 m depth, in the ROV survey of October 2021.

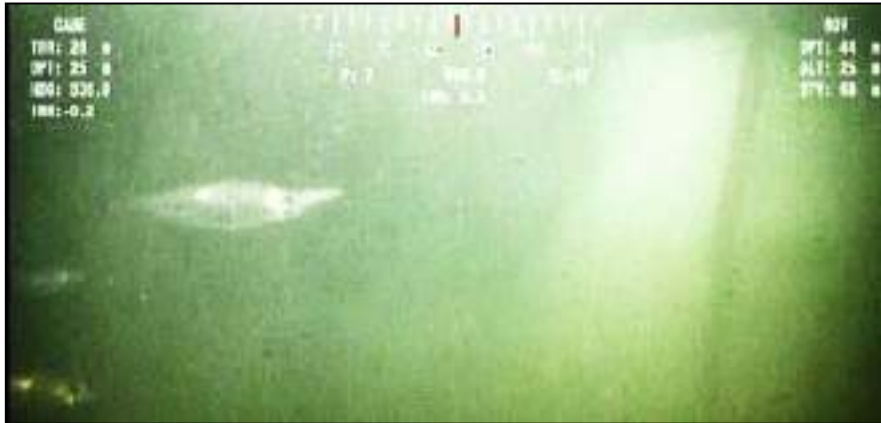
**Figure 24.** A group of squids (~15 individuals) at a sandbag near the sea bottom; at -44.0 m depth, in the ROV survey of January 2022.

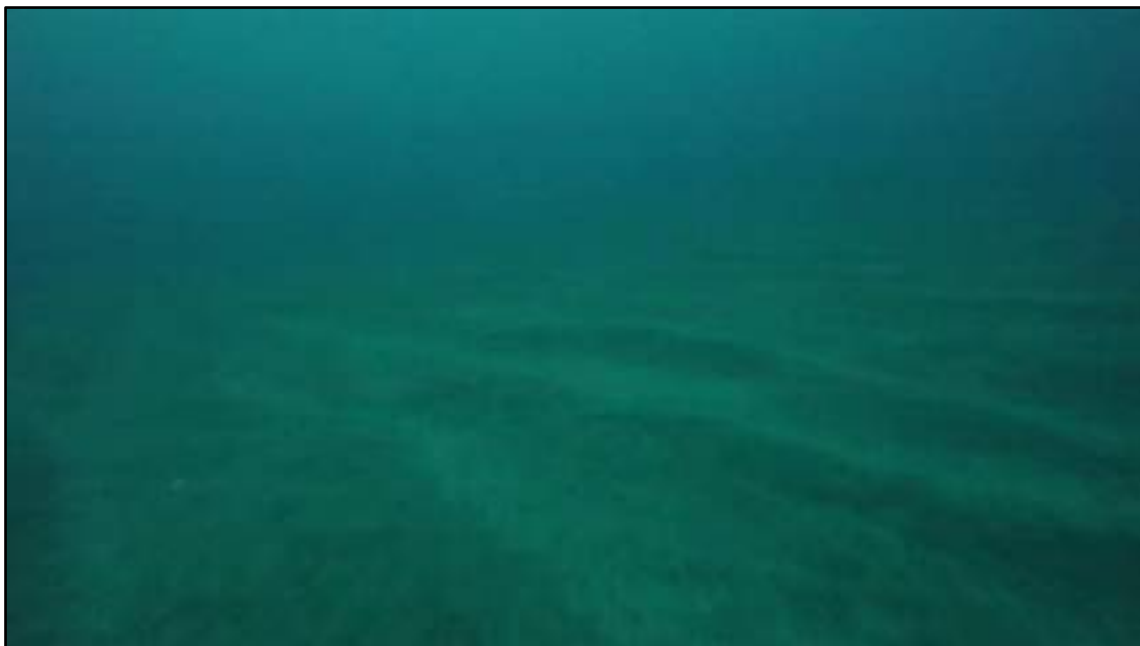
**Figure 26.** Ripple marks close to mooring leg 5.

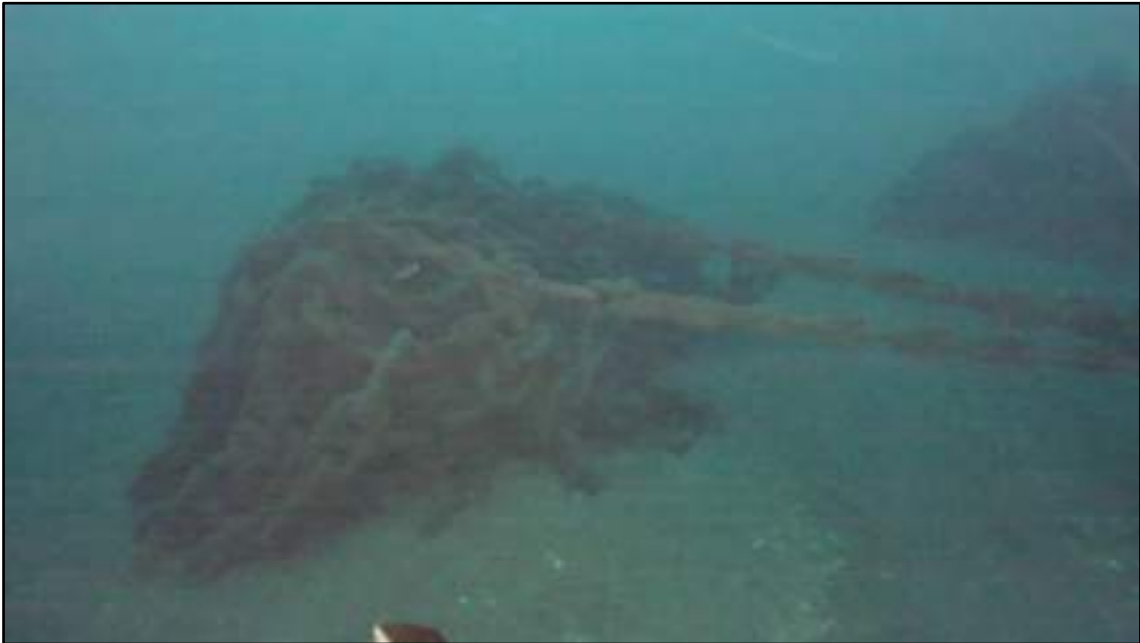
fishes, e.g.: an European conger (*Conger conger*) in the CW2b chain weight (Figure 27), and a female cuckoo wrasse (*Labrus mixtus*) and a shoal of poutings (*Trisopterus luscus*) close to the weights of mooring leg 1 (Figure 28 and Figure 29) were recorded.

**Figure 27.** European conger (*Conger conger*) protected in the CW2b chain weight.

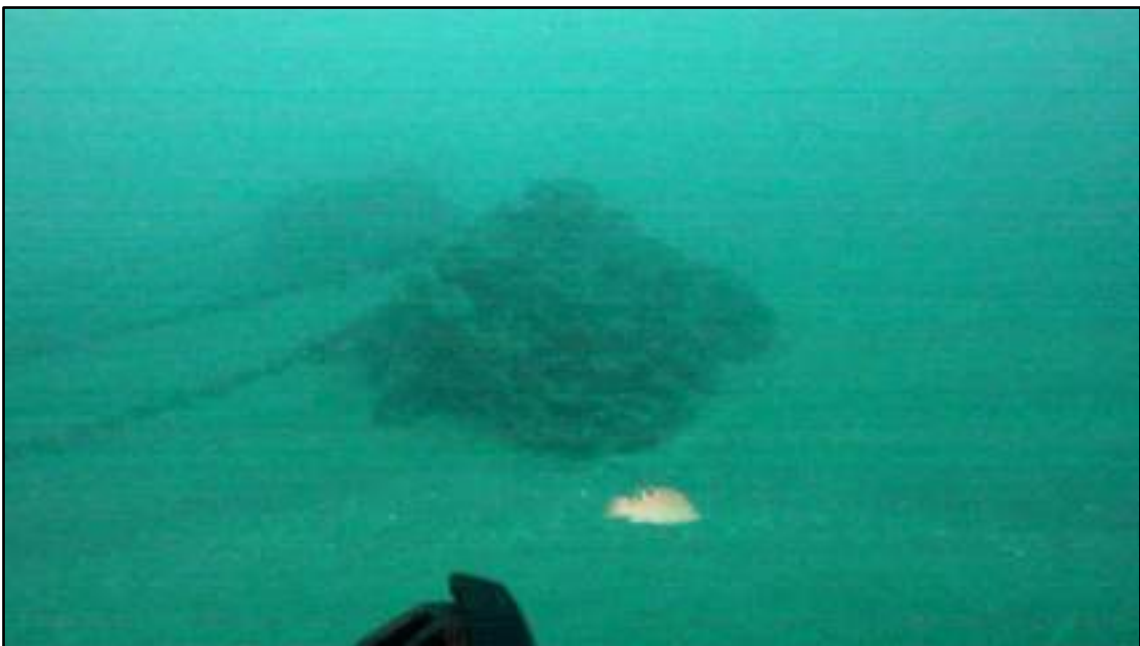
**Figure 28.** Female cuckoo wrasse (*Labrus mixtus*) near mooring leg 1 chain weights.

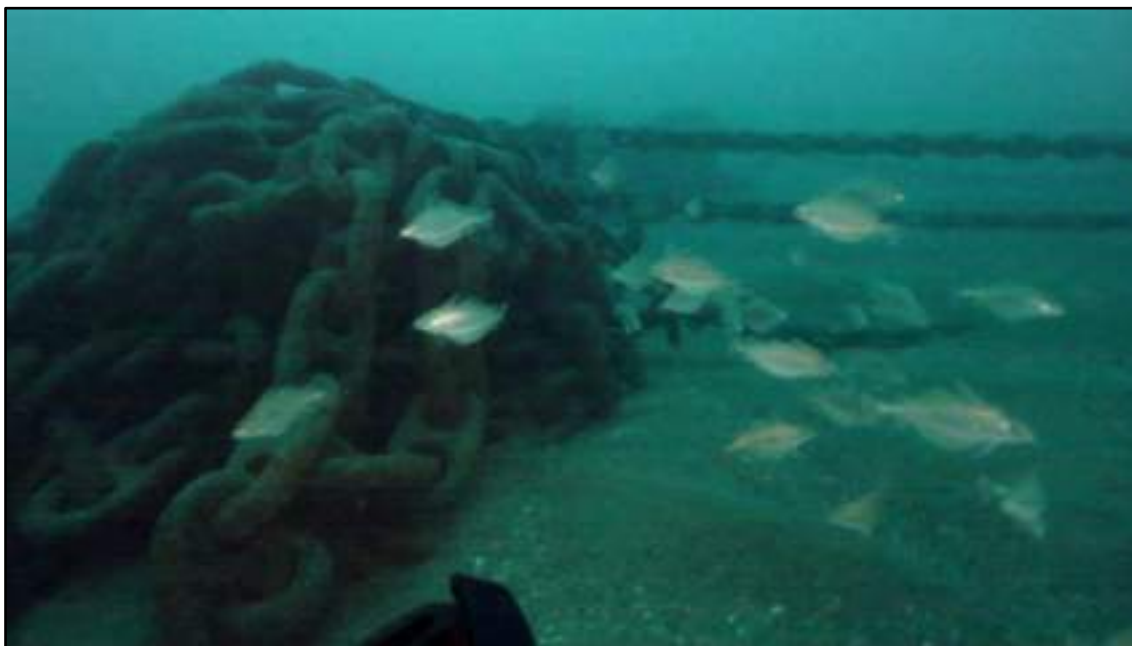
**Figure 29.** Shoal of poutings (*Trisopterus luscus*) swimming around one of the chain weights of mooring leg 1.

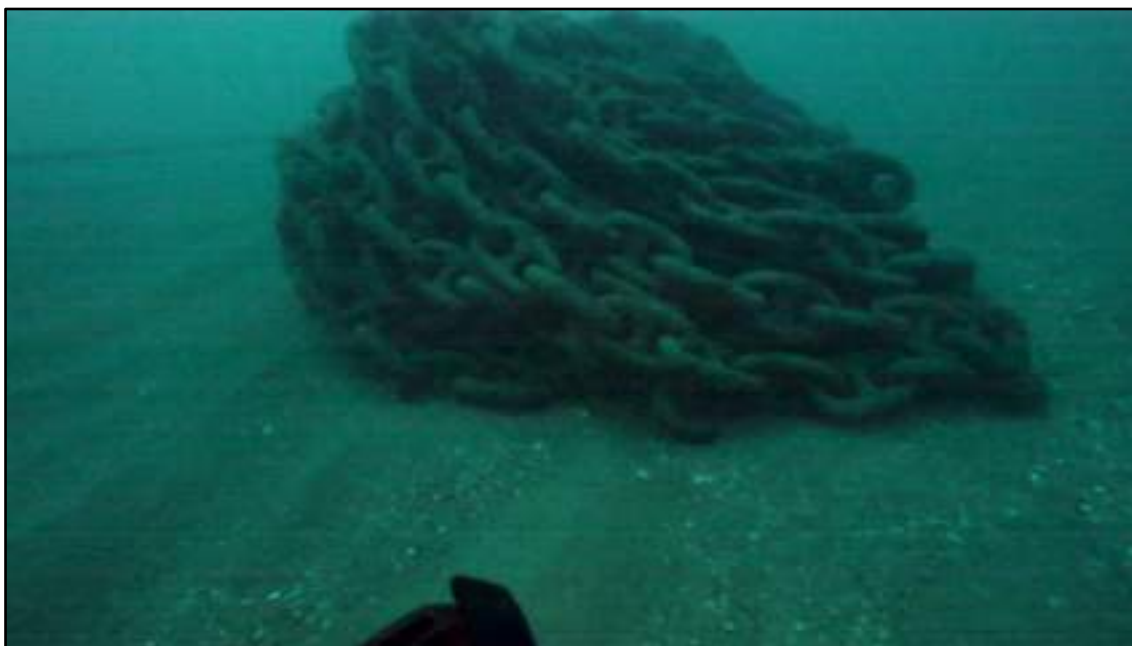
Regarding the seafloor, there is not any alteration beyond the presence of the chain weights as potentially colonizable hard substrata in a soft bottom environment. The ripple marks maintain their structure even next to the chains (Figure 30) and no physical alteration is observed.

**Figure 30.** Ripple marks close to one of the chain weights of mooring leg 1.

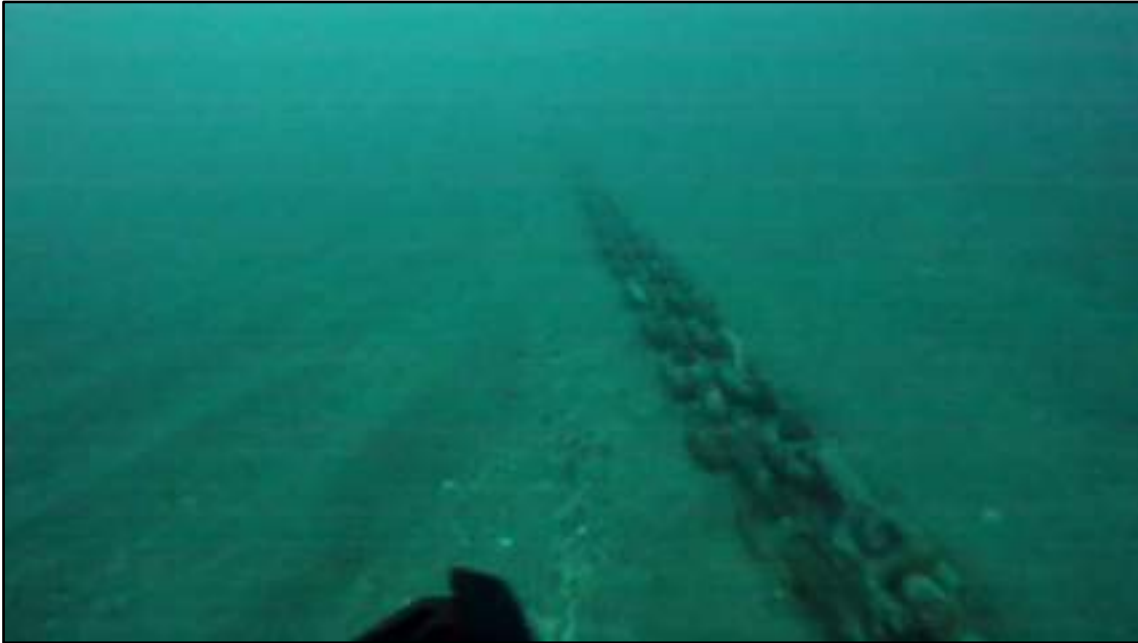
The lower catenary lies on the sediment (Figure 31), partially buried in some sections. No evidence of physical alteration of the substrate is observed apart from a slight accumulation of fine sediment at the sides of the chain. This accumulation is evidenced by the absence of coarse sediment fringes corresponding to the valleys of the ripple marks, but is limited to the first centimetres at both sides of the catenary.

**Figure 31.** The lower catenary of the mooring leg 1, lying on the bottom.

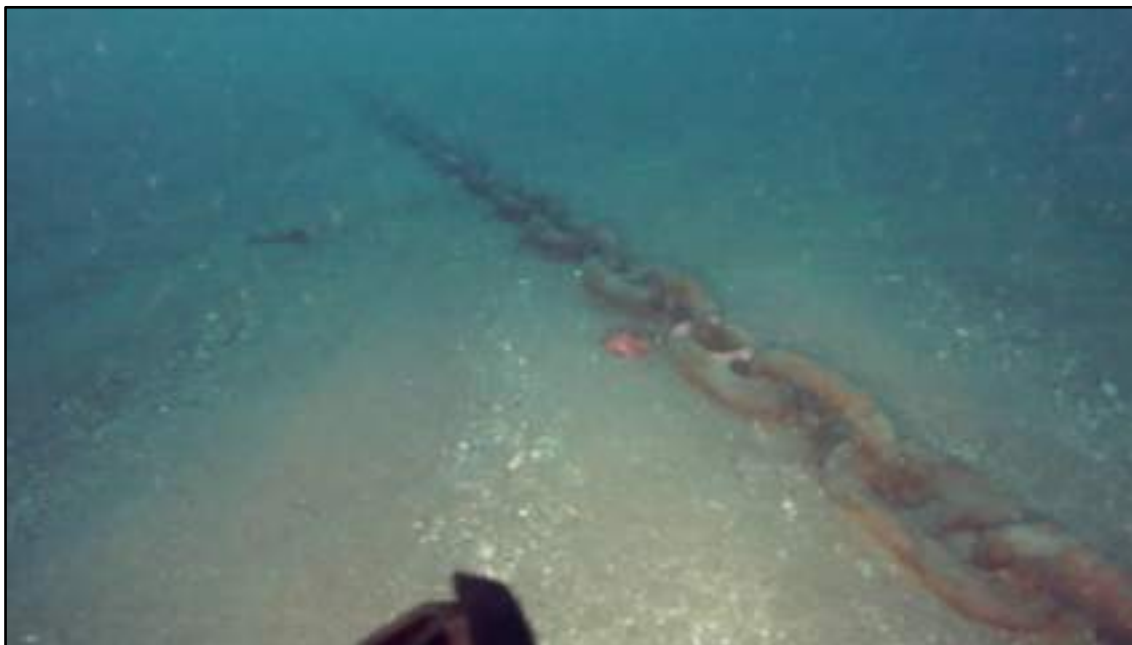
The catenaries act also as attractors of fauna. As an example, some red gurnards (*Chelidonichthys cuculus*; Figure 32) and a striped red mullet (*Mullus surmulletus*; Figure 33) were observed next to the lower catenary of the mooring leg 1.

**Figure 32.** Red gurnard (*Chelidonichthys cuculus*) next to the lower catenary of mooring leg 1.

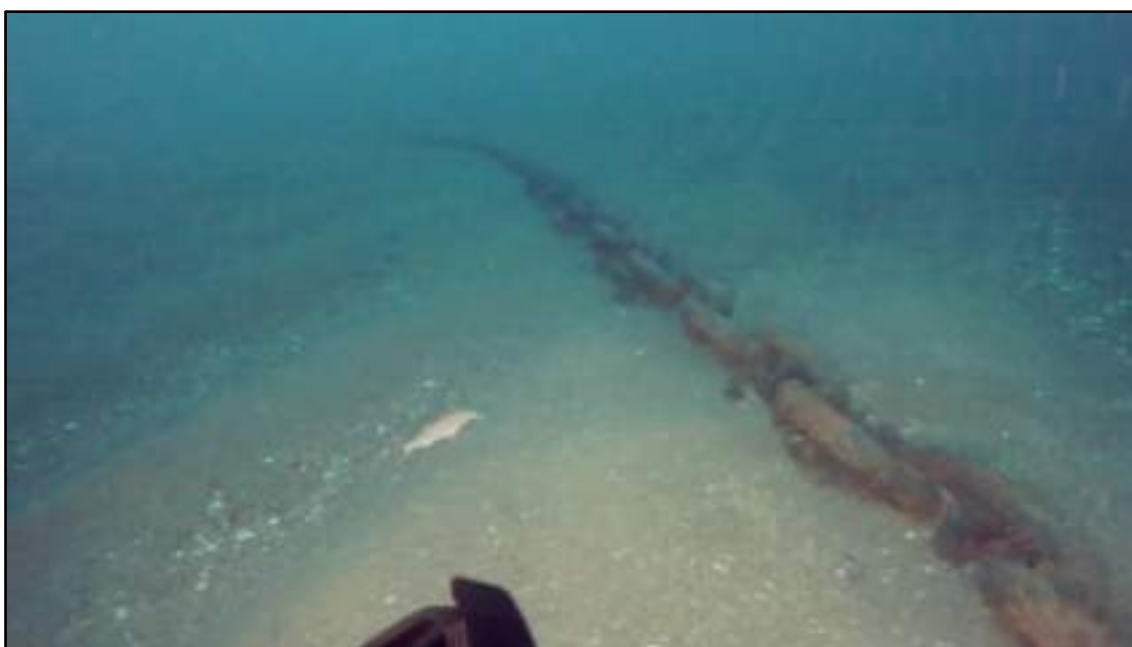
**Figure 33.** Striped red mullet (*Mullus surmuletus*) near the lower catenary of the mooring leg 1.

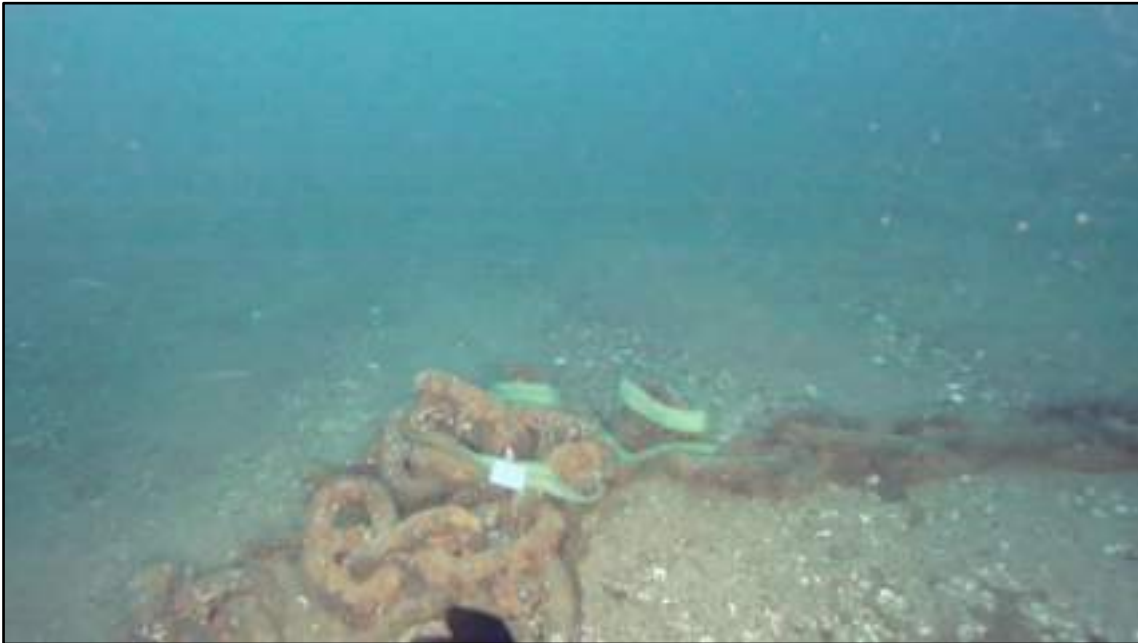
It should be noted that, when Penguin II was recovered for maintenance, the lower catenaries were abandoned in place and now lie on the bottom. In the case of the mooring leg 2 a girth, probably used for the recovery, was even recorded attached to the chain (Figure 34). There is no evidence of disturbance, different from the rest of the catenary, for this sections that were dropped when the device was removed.

**Figure 34.** A girth attached to the upper end of the lower catenary of the mooring leg 2.

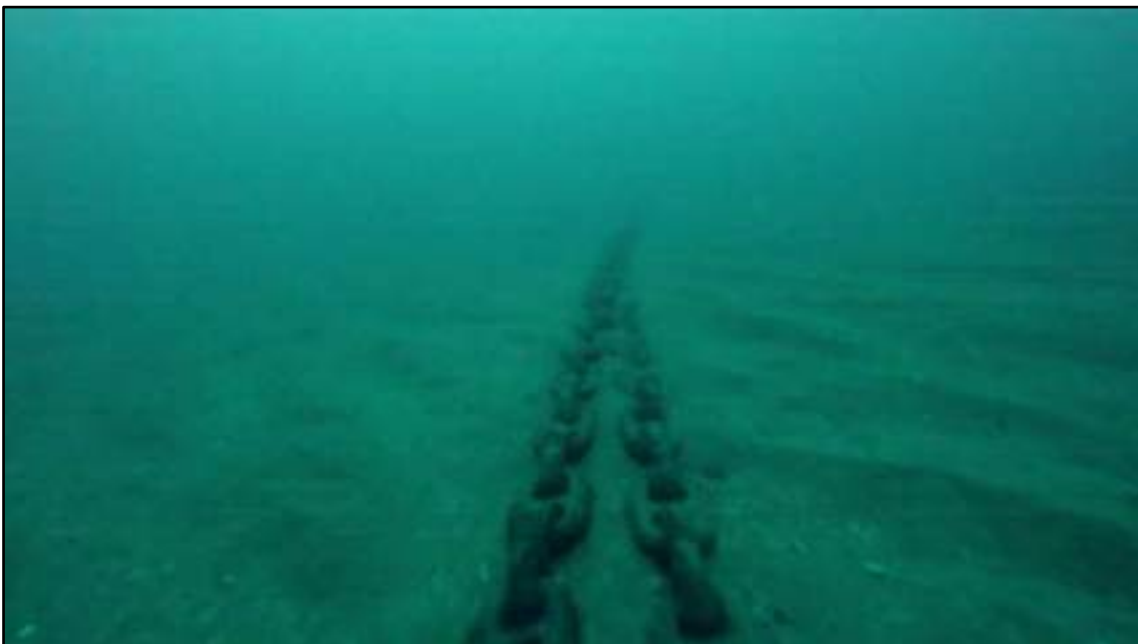
**Figure 36.** Lower catenary of the mooring leg 6.

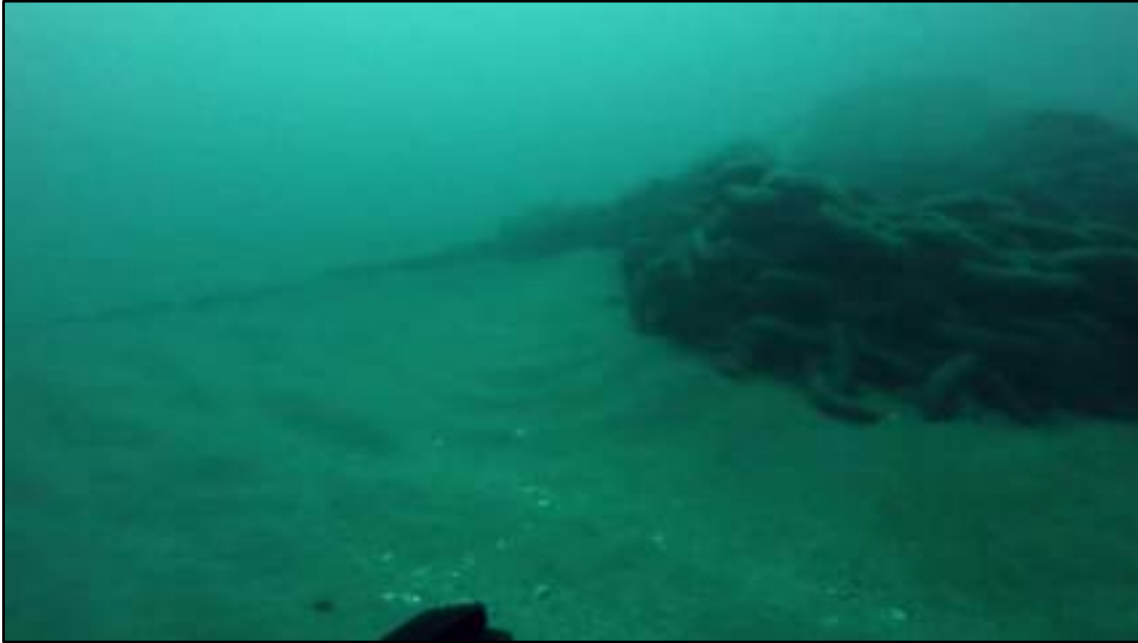
Finally, the mooring leg 5 is the one that is located shallowest, being the chain weights at 60 m water depth, approximately. A slight accumulation of fine sands is observed next to the chain weight CW5a, in its western side (Figure 37). Besides, the chain weight act also as attractors for fauna (Figure 38) Apart from that, no disturbance is appreciated on the seafloor.

**Figure 37.** Sand accumulation in the western side of the chain weight CW5a.

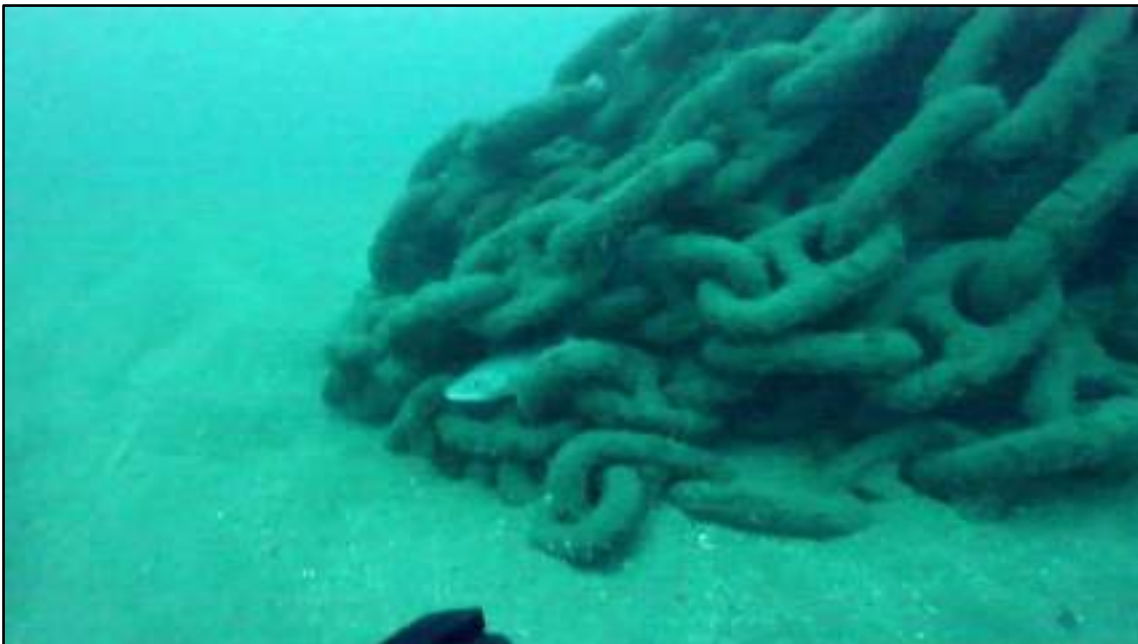
**Figure 38.** European conger (*Conger conger*) looking for protection between the chains of weight CW5b.

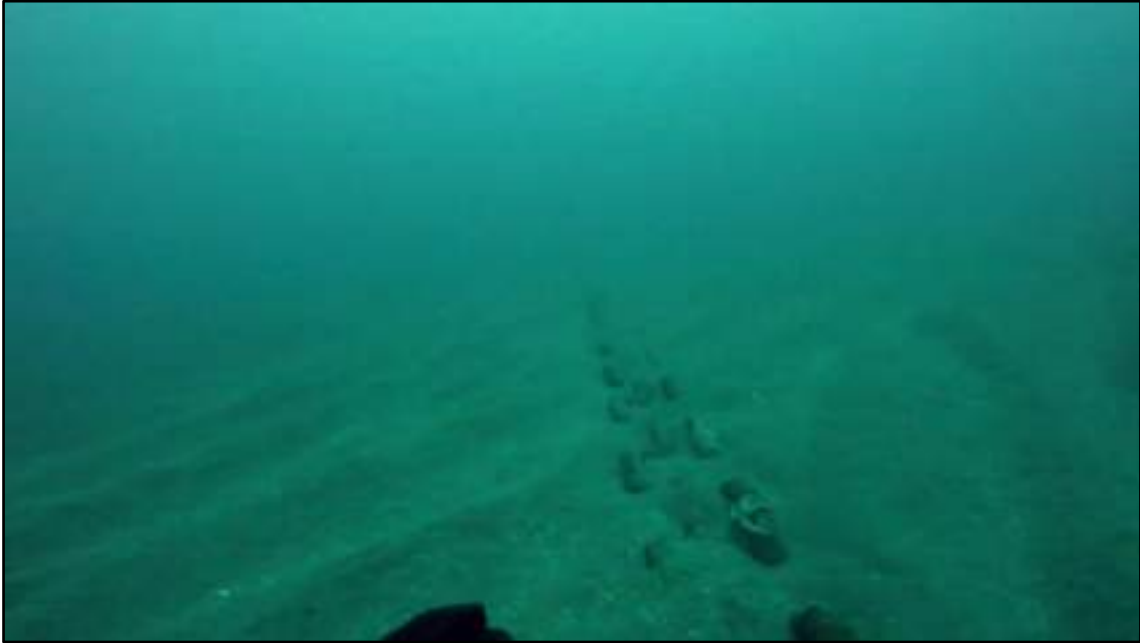
As indicated for the rest of the mooring legs, the lower catenary of the mooring leg 5 is also partially buried into the sediment along some sections (Figure 39). In the sections that it is over the sediment, some accumulation of sands is observed at the sides of the chain (Figure 40).

**Figure 39.** Unidentified starfish (Echinodermata, Asteroidea) on one of the links of the lower catenary of mooring leg 5, in a section that is partially buried into the sediment.

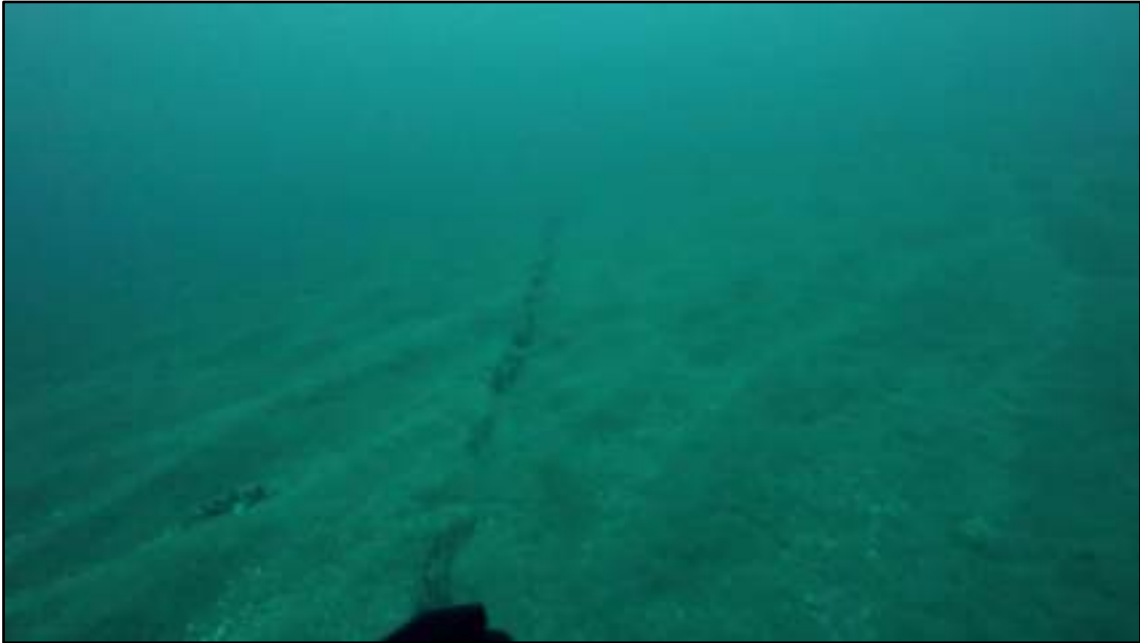
As for the rest, the lower catenary of the mooring leg 5 also works as attractor for fauna (Figure 39 and Figure 41). Besides, both the lower catenary and the chain weight, are covered by turfy fouling.

**Figure 41.** Red gurnard (*Chelidonichthys cuculus*) next to the lower catenary of mooring leg 5.

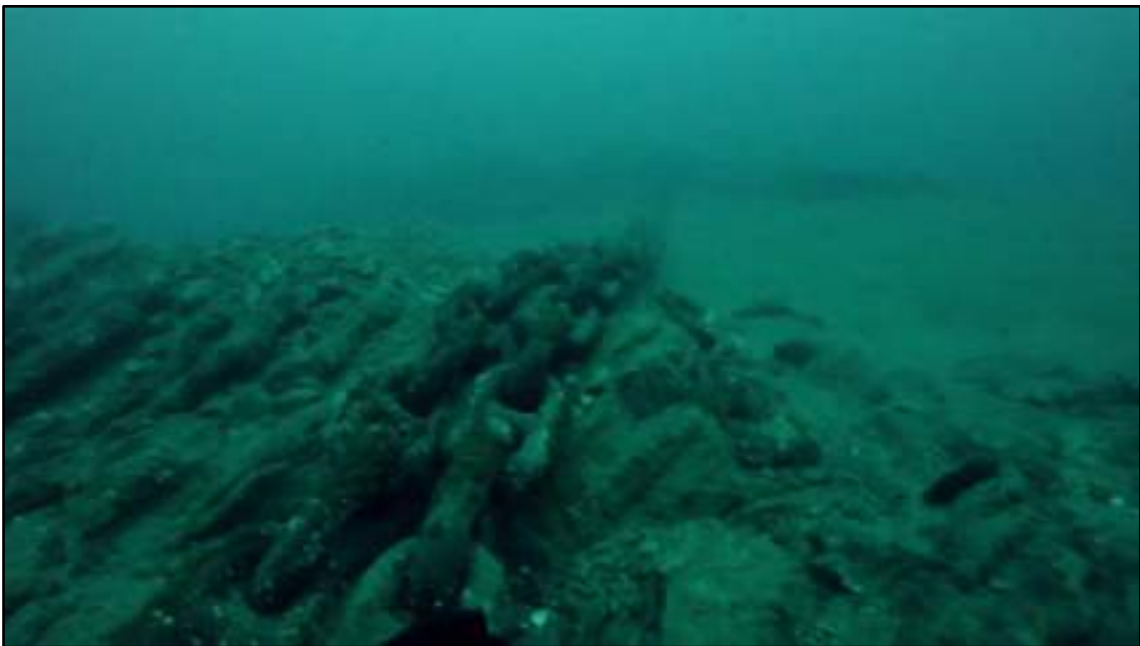
**Figure 42.** Section of the lower catenary corresponding to mooring leg 5 settled on outcrops.

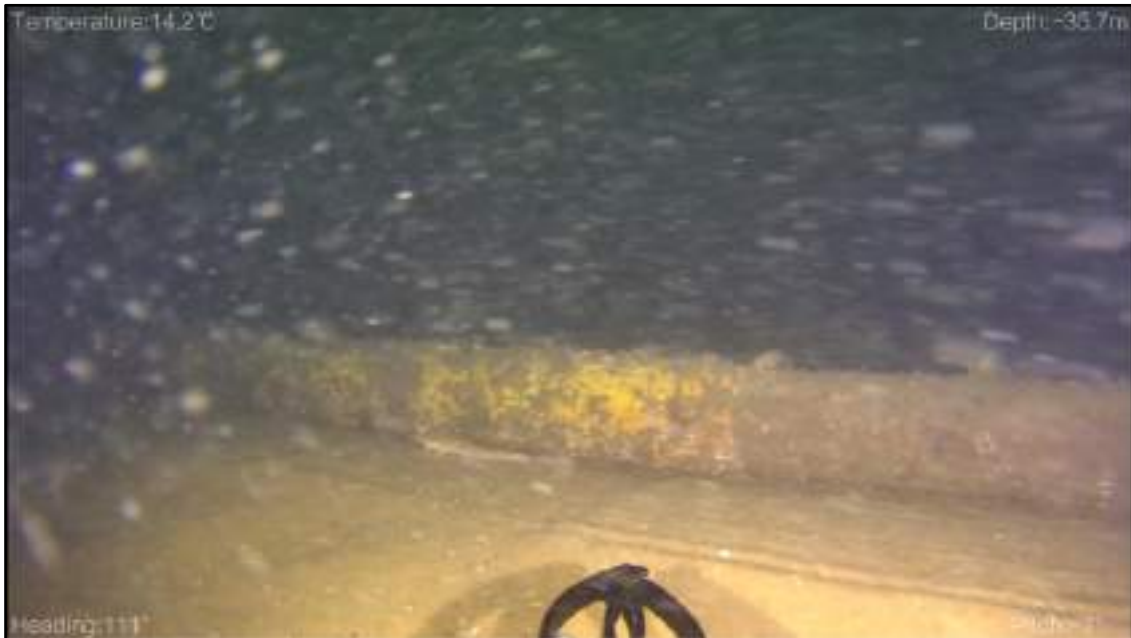
**Figure 46.** Scraping of the connexion piece between nylon and bottom chain on the seabed (mooring line #4 – 02/07/2021). A Gobiidae can be seen close to it.

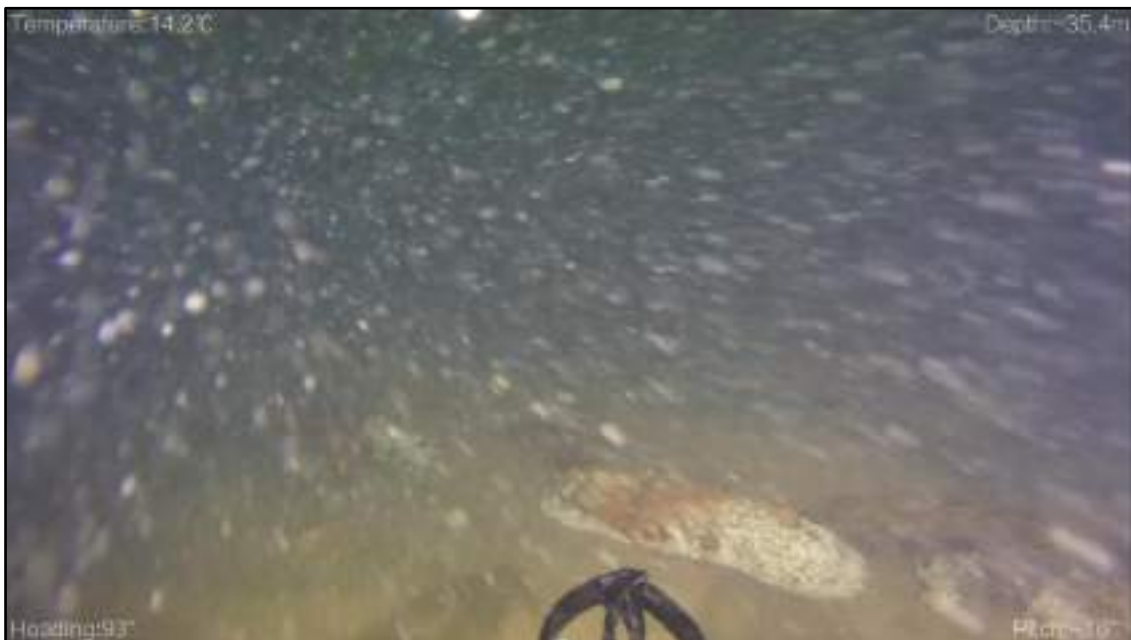
**Figure 47.** Bottom chain (#4) almost totally buried – only few chain links are visible (02/07/2021).

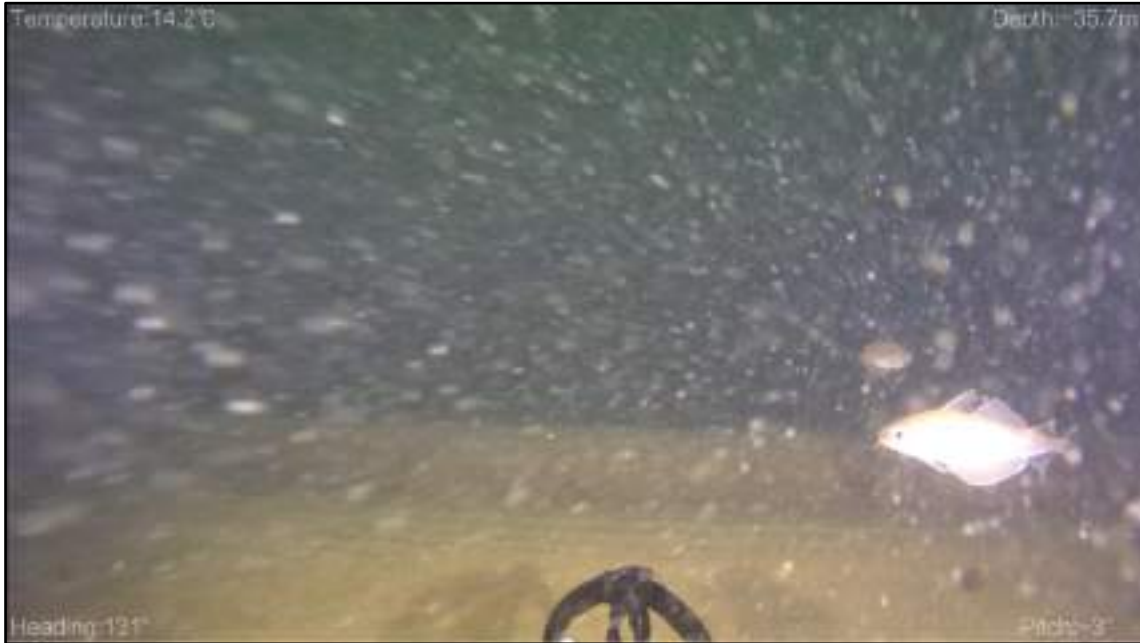
The mooring assets not totally buried attract fauna, especially in a soft bottom environment. Many Gadidae are observed (*Trisopterus* sp. and *Trisopterus luscus*) (Figure 48, Figure 49 and Figure 50). Close to the mooring line, Gobiidae are observed as well (Figure 46). Furthermore, a lobster finds shelter under a connection piece partially buried (Figure 51).

**Figure 48.** Pouting (*Trisopterus* sp.) close to the mooring line #4 (NE) (02/07/2021).

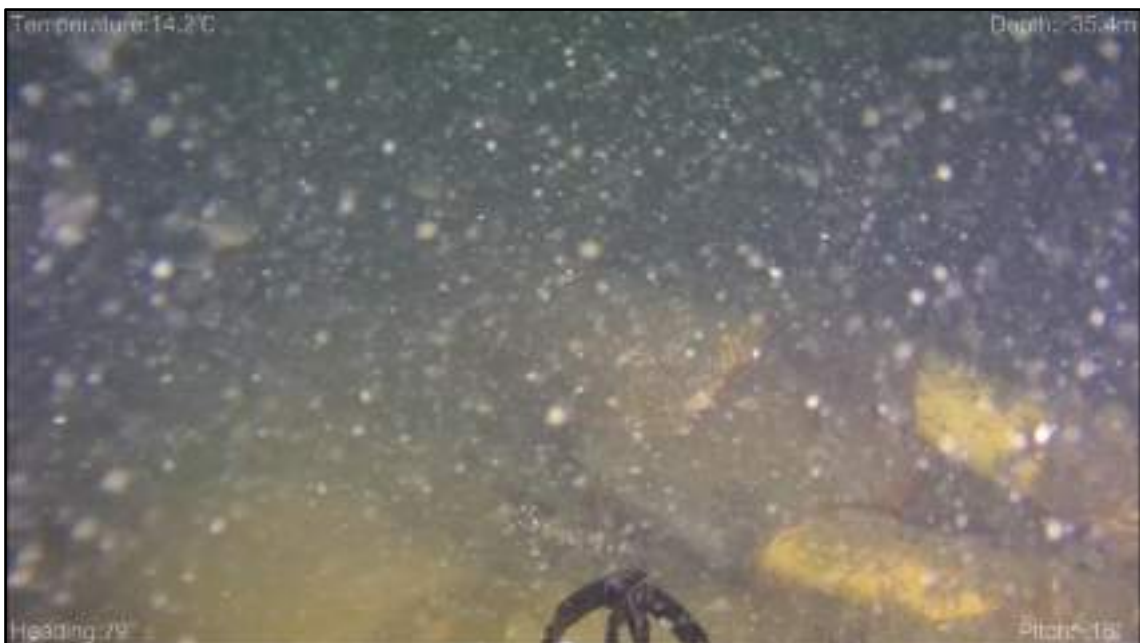
**Figure 51.** Lobster under a connection piece between the bottom chain and anchor #4 (NE) (02/07/2021).

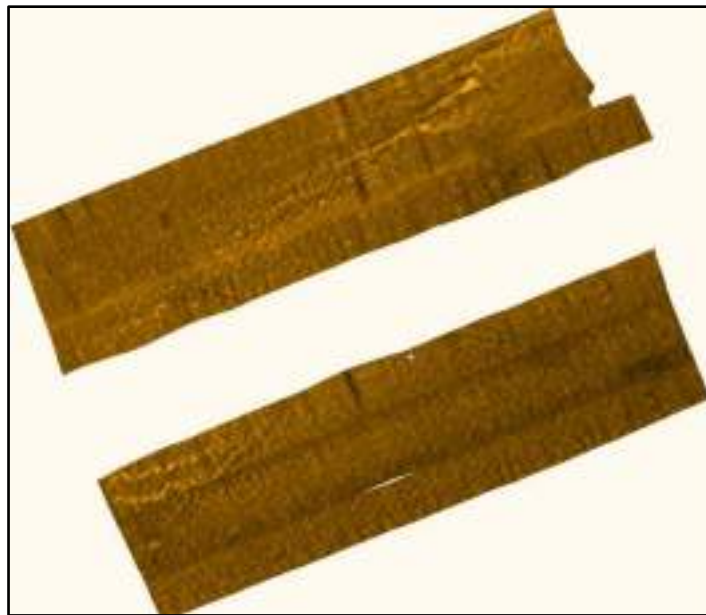
SSS results are shown in Figure 52 and Figure 53 (first navigation: AUV 10 m above seabed), and in Figure 54 and Figure 55 (second navigation: AUV 6 m above seabed).

**Figure 52.** SSS data of the entire area (nav#1 – 09/06/21).

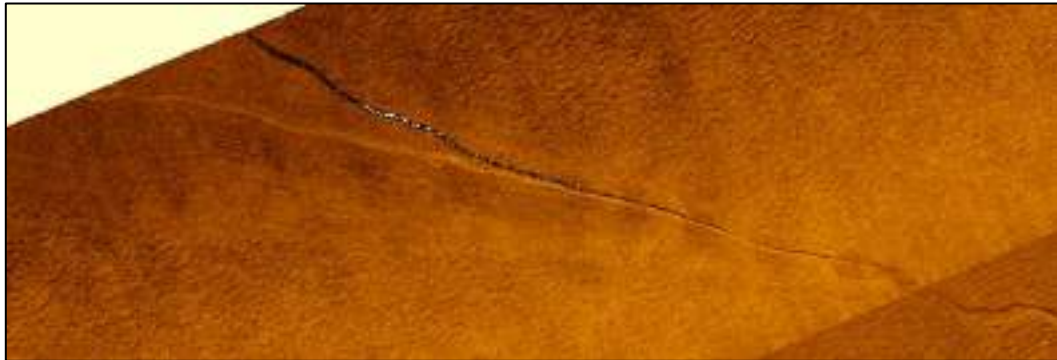
**Figure 56.** SSS data of mooring line #1 (SE) - zoom on footprint (09/06/21).

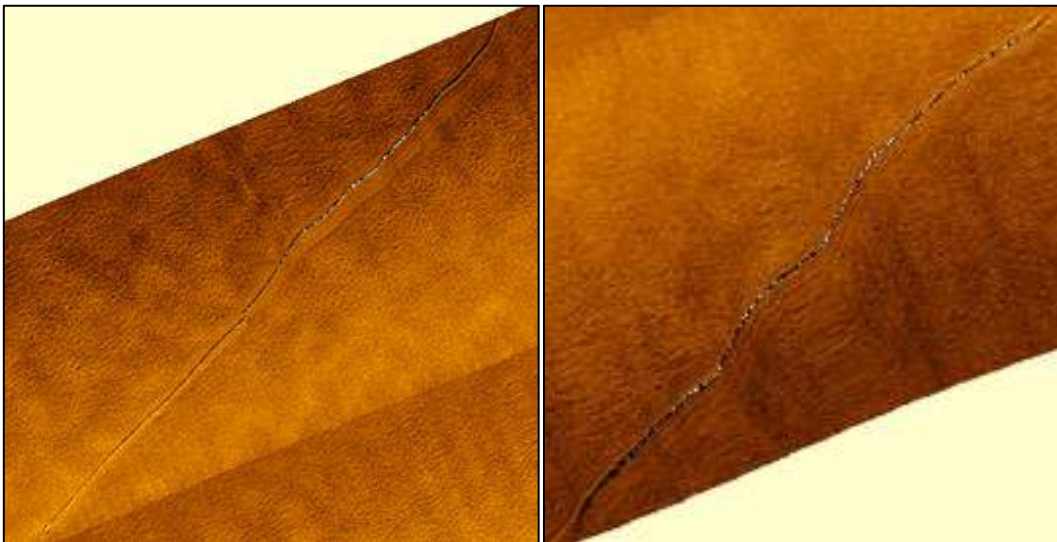
**Figure 57.** Zoom on footprint - SSS data of mooring line #2 (SW on the left) and mooring line #4 (NE on the right) (09/06/21).

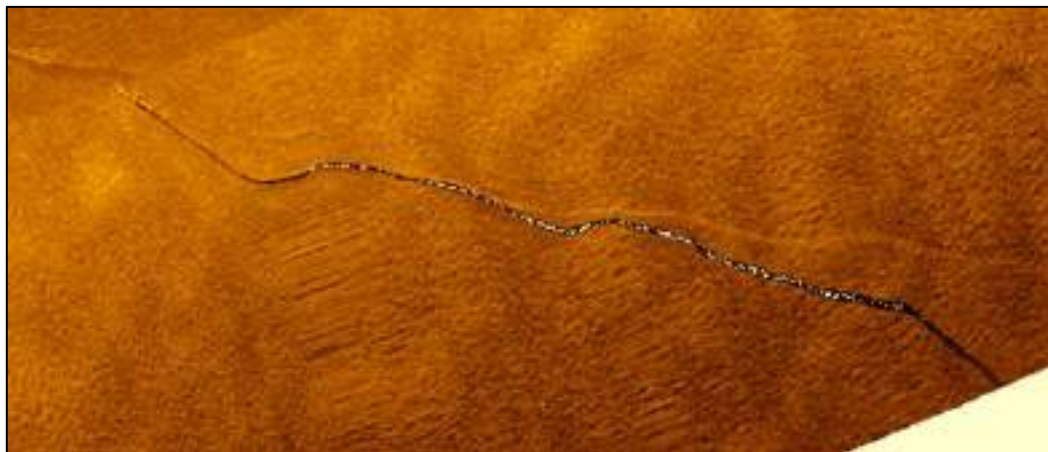
No footprint is measurable on the NW mooring line (Figure 58).

**Figure 58.** No measurable footprint - SSS data of mooring line #3 (NW) (09/06/21).
