Measurements of underwater noise during piling at the Red Funnel Terminal, Southampton, and observations of its effect on caged fish.

Report Reference: 558 R 0207

27 October 2003

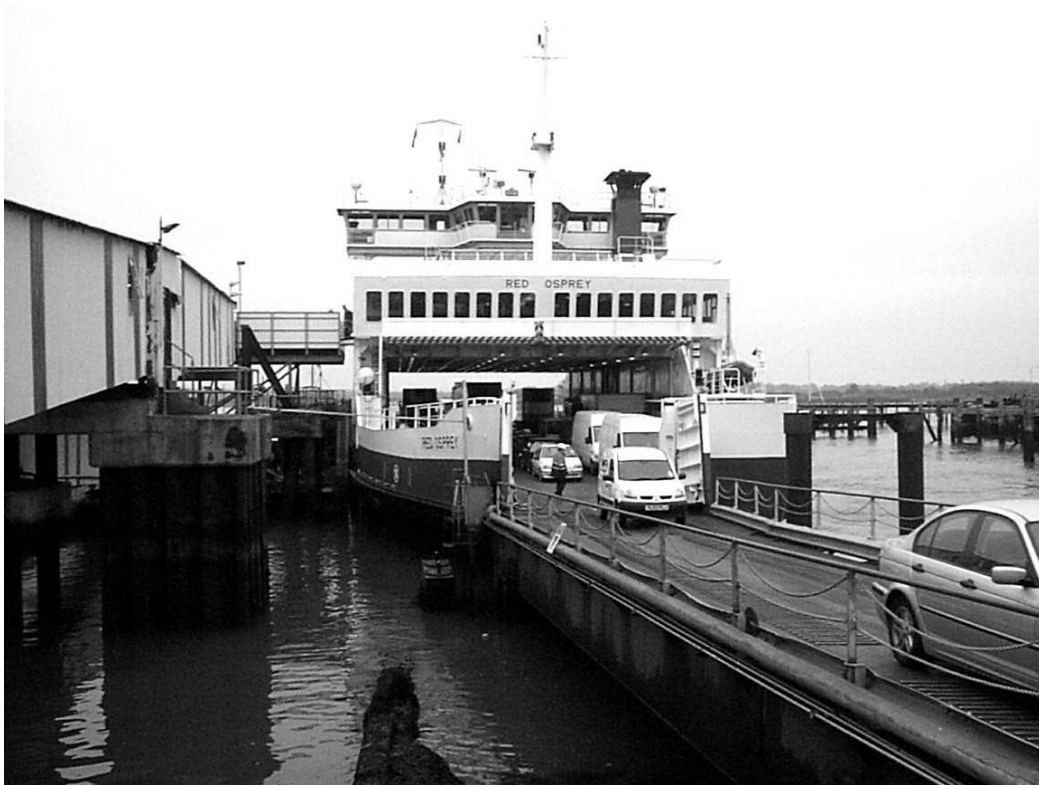
Fig. 1. Photograph taken from quayside with ferry docked at terminal, and vehicles disembarking along linkspan. Structure on left of photograph is covered walkway for pedestrian passengers, and the dolphin on which it rests can be seen.

The piling was required as part of a construction project for Red Funnel, installing improved loading facilities at their Southampton Terminal, illustrated in Fig. 1. The project was required to provide infrastructure for improved ferry services, and in particular to allow twin-deck access to ferries. As part of this project piling in the water adjacent to the dock wall was required to provide foundations for the new structure. Existing ferries were also modified during the period of construction to allow twin deck access; during this period a temporary ferry was provided.

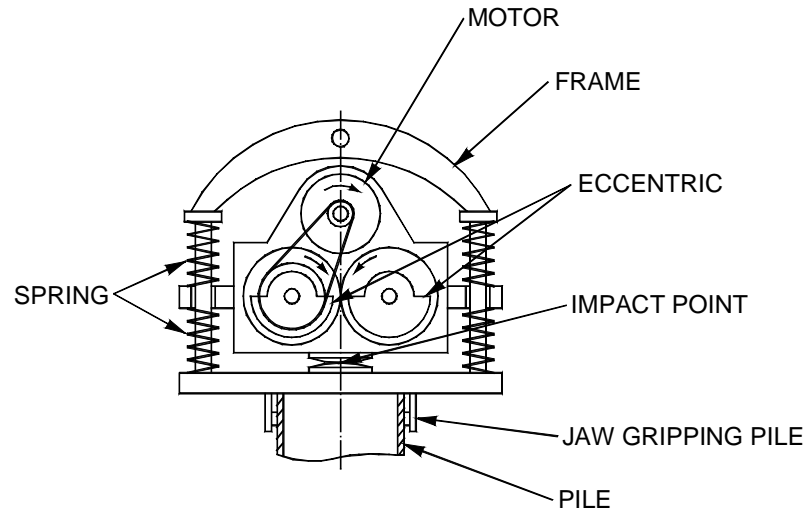
Fig. 2. Sketch to illustrate principle of vibro pile driving.

Vibratory pile drivers are machines that install piling into the ground by applying a rapidly alternating force to the pile. This is generally accomplished by rotating eccentric weights about shafts. Each rotating eccentric produces a force acting in a single plane and directed toward the centreline of the shaft. Fig. 2 shows the basic set-up for the rotating eccentric

weights used in most current vibratory pile driving/extracting equipment. The weights are set off-centre of the axis of rotation by the eccentric arm. If only one eccentric is used, in one revolution a force will be exerted in all directions, giving the system a good deal of lateral whip. To avoid this problem the eccentrics are paired so the lateral forces cancel each other, leaving only axial force for the pile. Machines can also have several pairs of smaller, identical eccentrics synchronised to obtain the same effect as one larger pair.

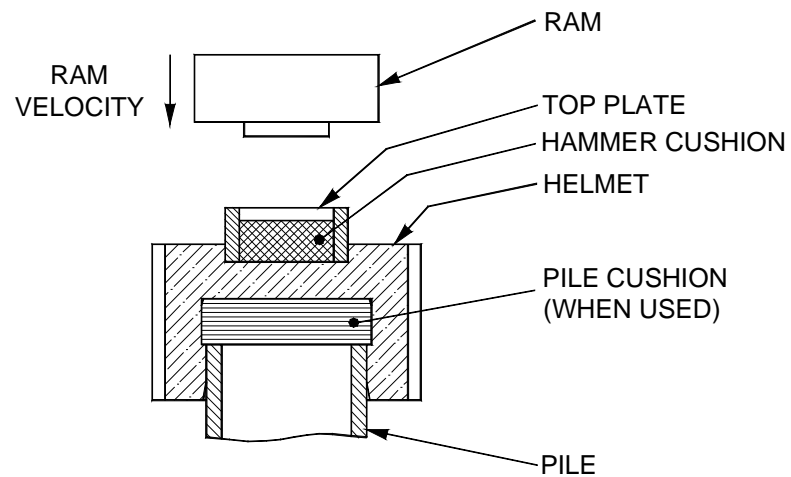
Fig. 3. Sketch to illustrate principle of impact piling.

Impact piling is performed using hammers which drive the pile by first inducing downward velocity in a metal ram, as shown in Fig. 3. Upon impact with the pile accessory, the ram creates a force far larger than its weight, which moves the pile an increment into the ground. Most impact hammers have some kind of cushion under the end of the ram which receives the striking energy of the hammer. This cushion is necessary to protect the striking parts from damage; it also modulates the force-time curve of the striking impulse and can be used to match the impedance of the hammer to the pile, increasing the efficiency of the blow.

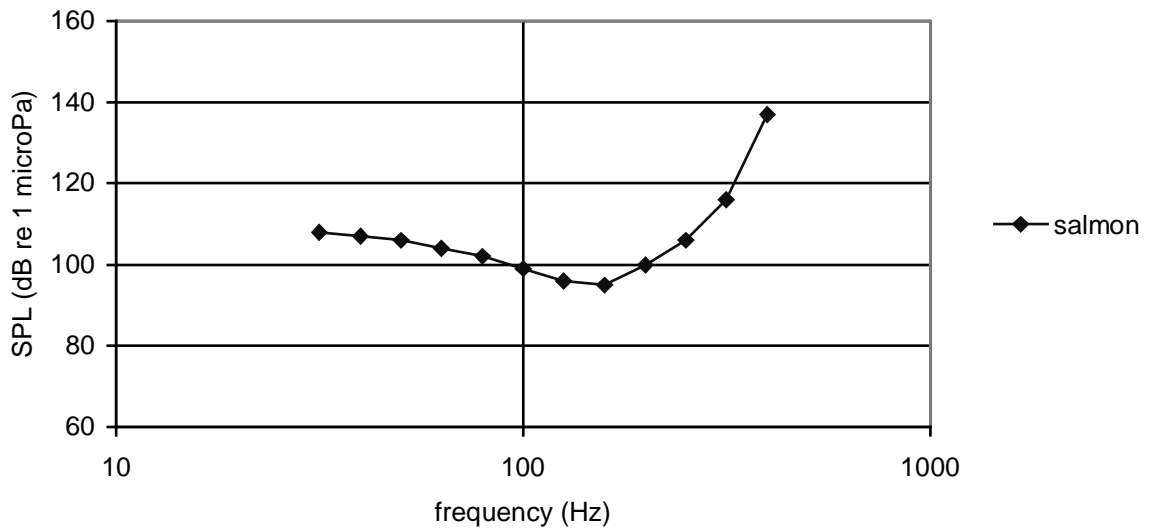
Fig. 4. An audiogramme of salmon hearing.

The salmon audiogramme used as the basis of the analysis herein is shown in Fig. 4.

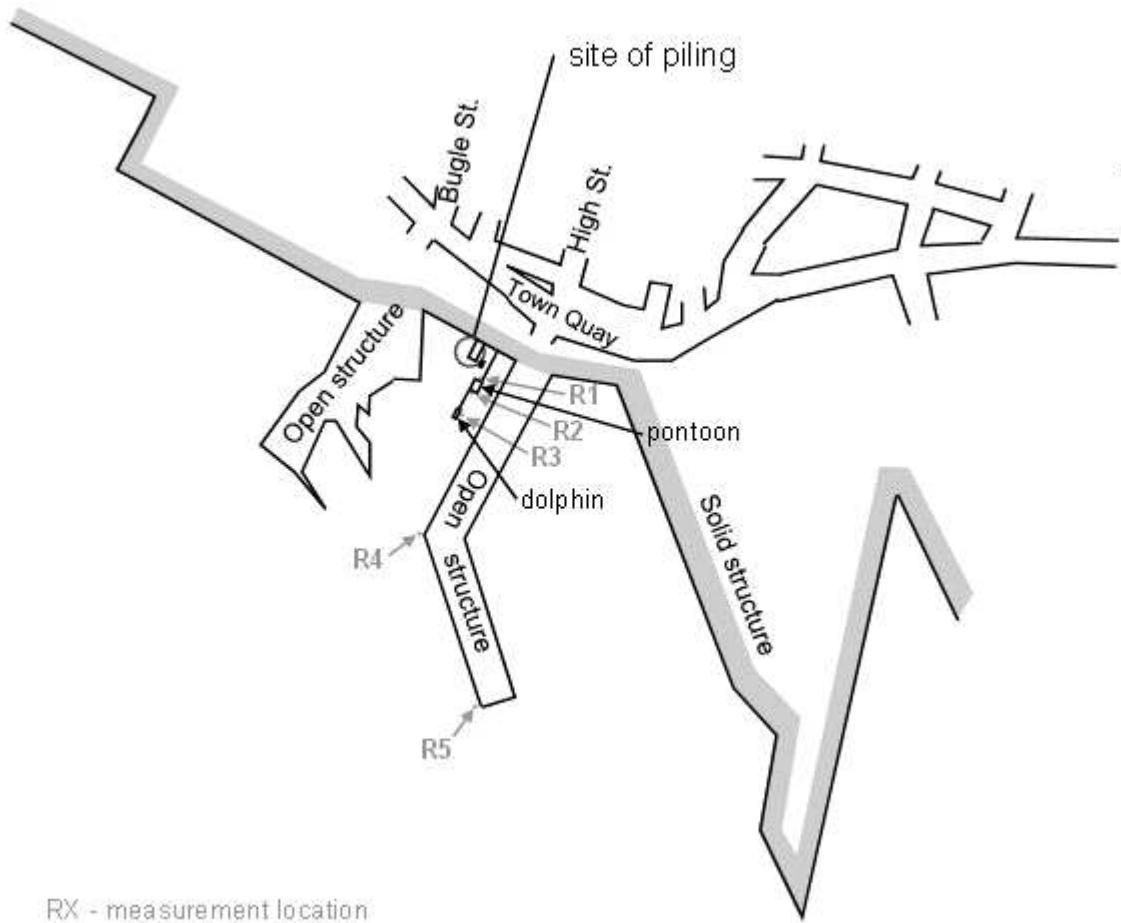
Fig. 6. Sketch map showing piling and measurement locations.

The piling was carried out at Red Funnel's terminal at Town Quay, at the southern end of Southampton High Street. The location of the site is illustrated in the sketch map in Fig 5. The monitoring measurements were taken at a number of locations, most of them at the far end of Town Quay, in Southampton Water, at the location labelled 'R5' in Fig. 6. In addition

to measurements at this location measurements were also taken at up to 4 other locations (labelled 'R1' to 'R4' in Fig. 6) for research purposes for the EA; the results obtained at these additional locations will be presented in a report in preparation for the EA.

Locations R1 and R2 were at each end of a pontoon which was used for maintenance work on Red Funnels vessels. R3 was from the side of a dolphin, access to which was via a ladder and walkway from the pontoon. R4 was at the 'knee' in Town Quay, and R5 was at the far end of the quay. While the area of the piling looks from the sketch to be relatively confined, in fact since both Town Quay and Royal Pier are open piled structures they did not influence the sound field and hence the propagation conditions approximated to open conditions.

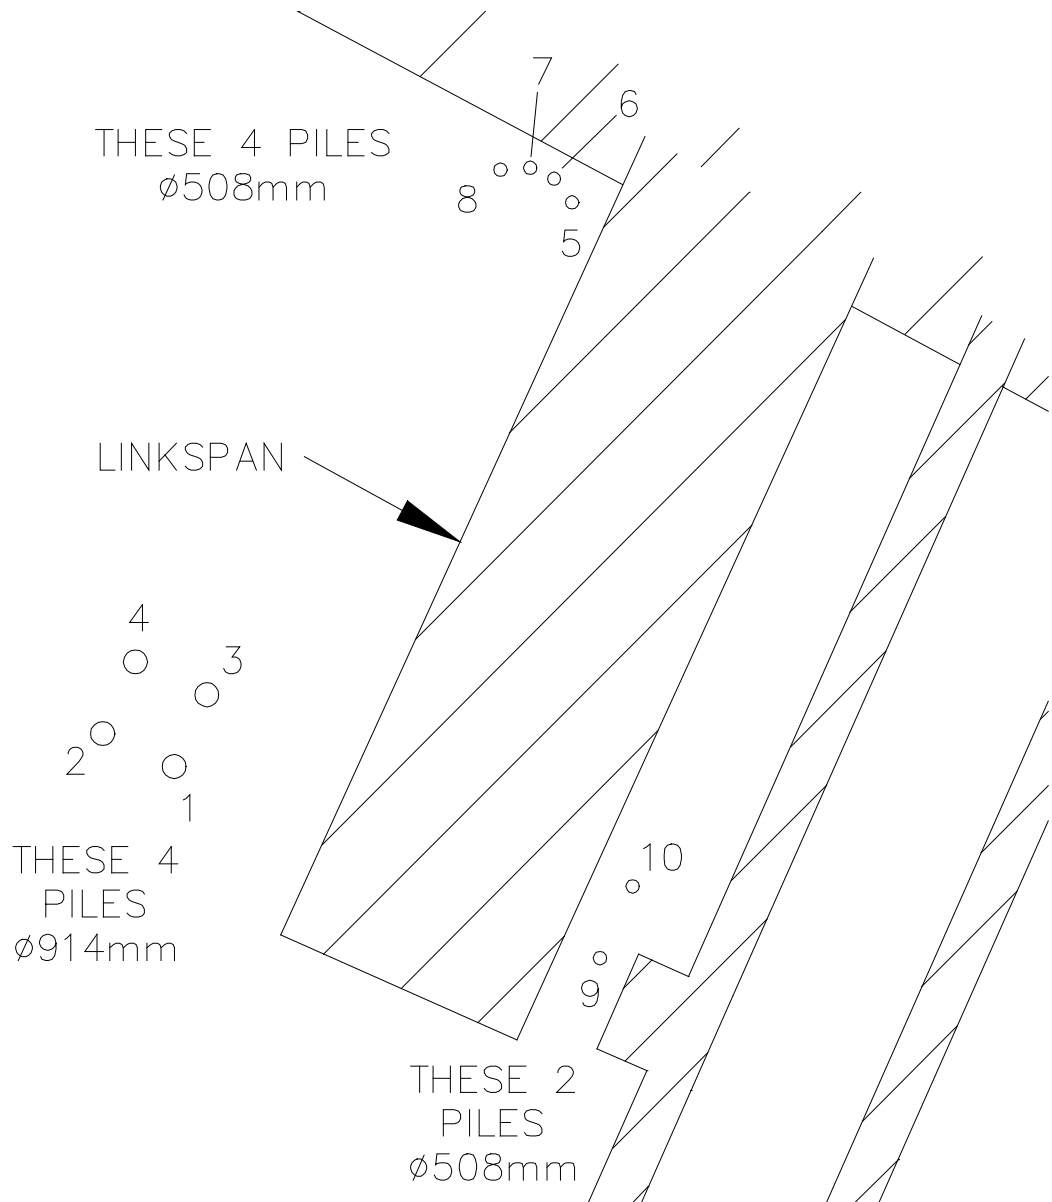
Fig. 7. Details of pile locations.

In total 10 piles were driven at the site. Fig. 7 is a sketch giving the locations of the individual piles on the site. It will be seen that two different diameter pile tubes were used, as indicated in the figure; a photograph of the piles is shown in Fig. 8. A general view of the site is given in the photograph of Fig 9.

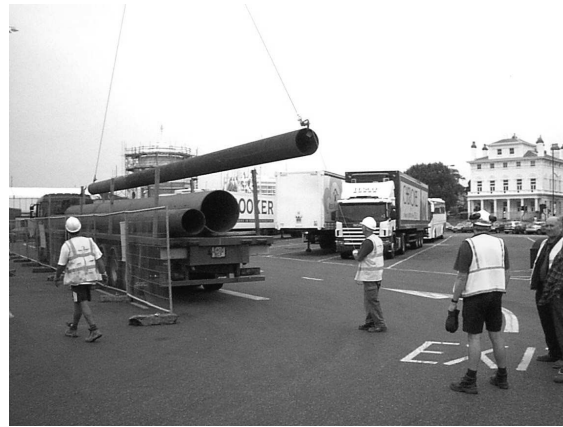
Fig. 8. Photograph of pile tubes being unloaded from lorry.

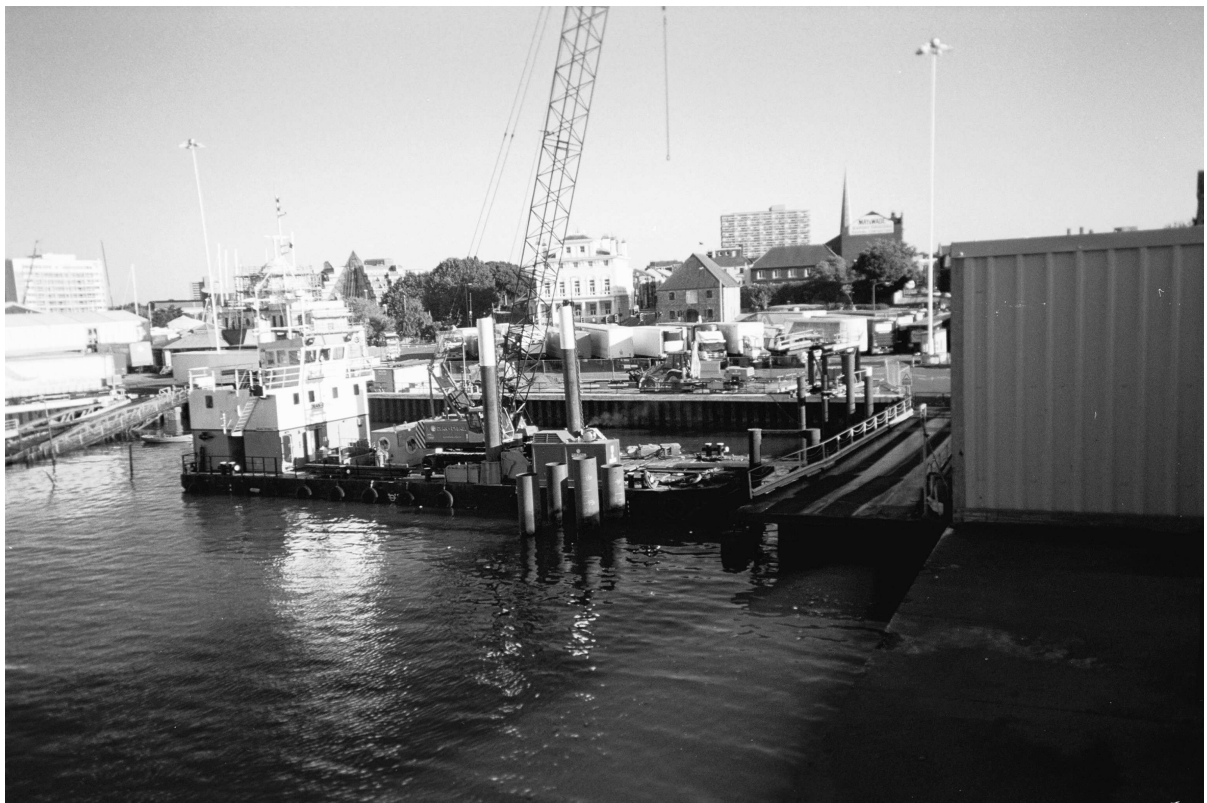
Fig. 9. Photograph of site during piling operations. The two groups of four piles to one side of the linkspan can be seen. The other two piles (numbers 9 and 10) are obscured by the structure (pedestrian walkway) on the right of the photograph. One pile in each of the groups was left standing proud, for later dynamic testing purposes using the impact driver.

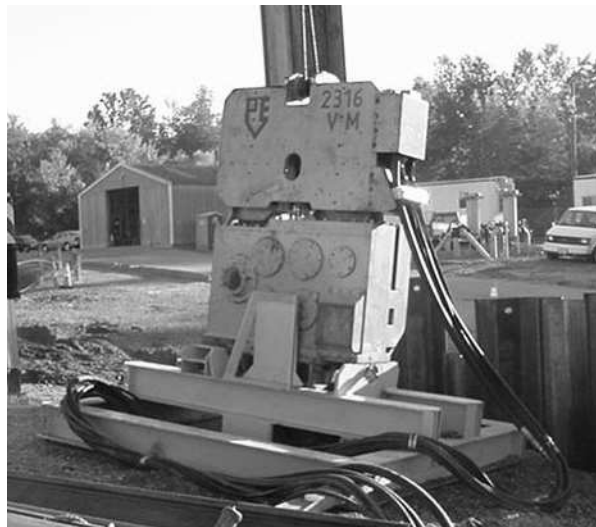
Fig. 10. A PVE 2316 VM vibropiling driver. It is shown resting in a cradle made of I-section beams.

The vibropiling was undertaken using a PVE 2316 VM driver; a picture of this driver is given in Fig 10. Impact piling was performed using a BSP357/9 hydraulic drop hammer; this is illustrated in Fig. 11.

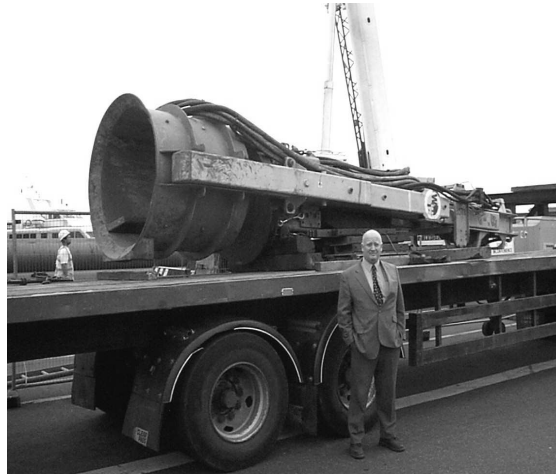
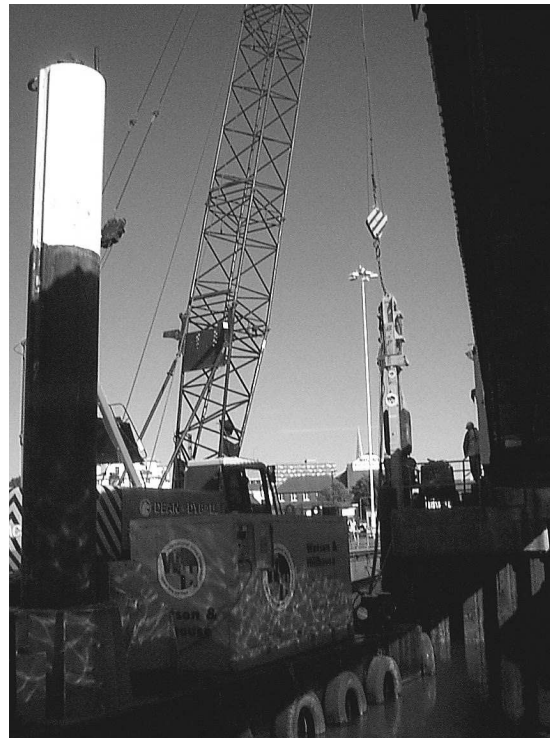
(a). A view of the lower end of the impact driver, while it was lying on a lorry.

(b). The impact driver being held on the top of a pile for driving purposes.

Fig. 11. The BSP 357/9 Hydraulic Drop Hammer used for impact driving.

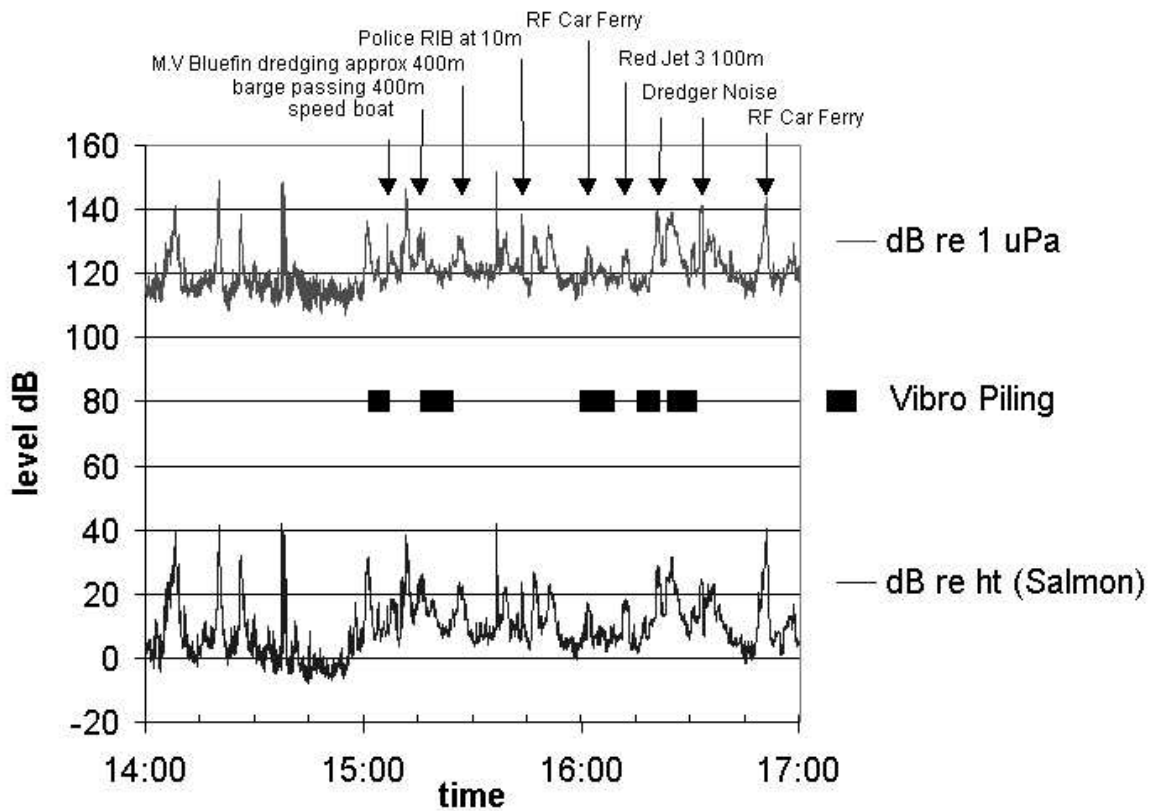
Fig. 13. A typical sound pressure level vs. time history obtained at the end of Town Quay (location R5) for a vibro-driving case.

Part of a typical sound pressure level *vs.* time history obtained at position R5 (at the end of Town Quay, at 417.4 m from the piling) on the 18th September 2003 for the vibro driven pile case is shown in Fig. 13. The figure illustrates the level of the sound in dB as a function of the time of day. The upper trace, in blue, indicates the unweighted sound level in dB re 1 μ Pa, and the lower trace the level in dB_{ht} (*Salmo salar*), i.e., as a frequency weighted level above the hearing threshold of salmon. Also marked on the figure are the periods during which vibropiling was undertaken.

First, looking at the unweighted sound pressure levels, it can be seen that there are periodic short but relatively large increases in level up to about 150 dB. These are associated with the passage of vessels along Southampton Water, which is a busy waterway, and the passage of ferries into the Red Funnel terminal. Most of these movements were noted at the time of the measurements, and have been noted on the figure. It is interesting to note that from about 15:00 hrs to the end of the recording at 17:00 hrs there is a significant and continuous increase in level over the earlier part of the recording from 14:00 hrs to 15:00 hrs. This is due to noise from the dredger *Bluefin*, which was removing silt from the waterway by suction dredging. The dredger was at a distance of about 200 m from the measurement position.

In respect of the vibropiling, it may be seen that there is no discernible increase of the signal when the driving is taking place compared to when it is not; in fact the vibropiling could not be discerned in the time history. It was noted when listening to the recordings that the background noise was completely dominated by other man-made noise, and in particular by the movement of vessels.

It is interesting to note that there is little difference in the shape of the time histories (i.e. in the level variations over time between the dB_{ht} (*Salmo salar*) values and the unweighted dB levels), other than the dB_{ht} (*Salmo salar*) values being of much lower level. The lower level results from salmon being relatively insensitive to sound, and to a lesser degree from their limited hearing bandwidth.

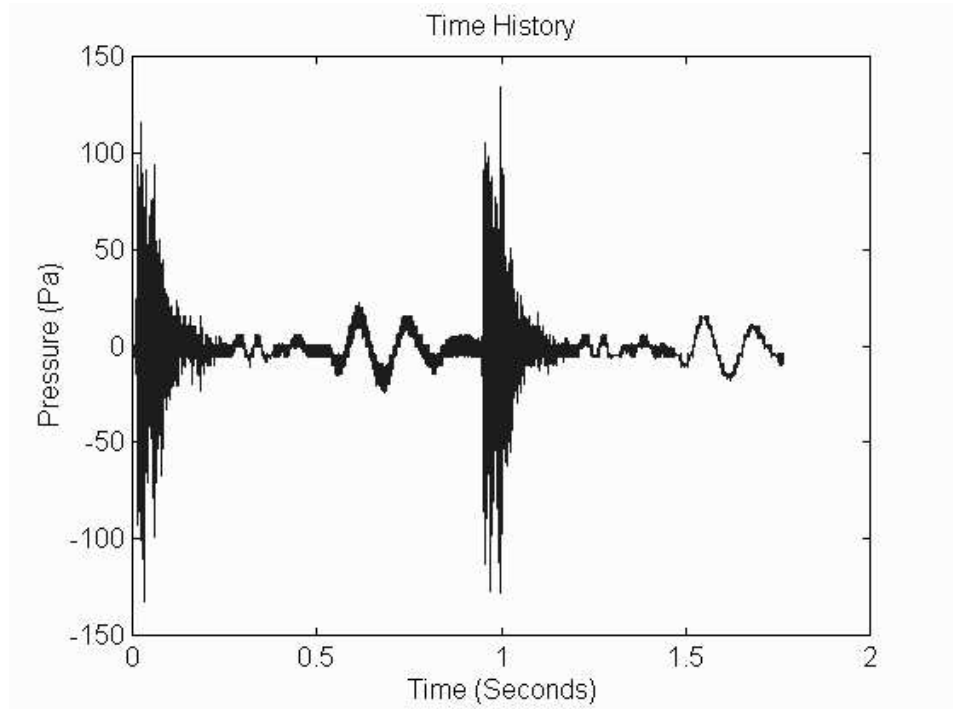
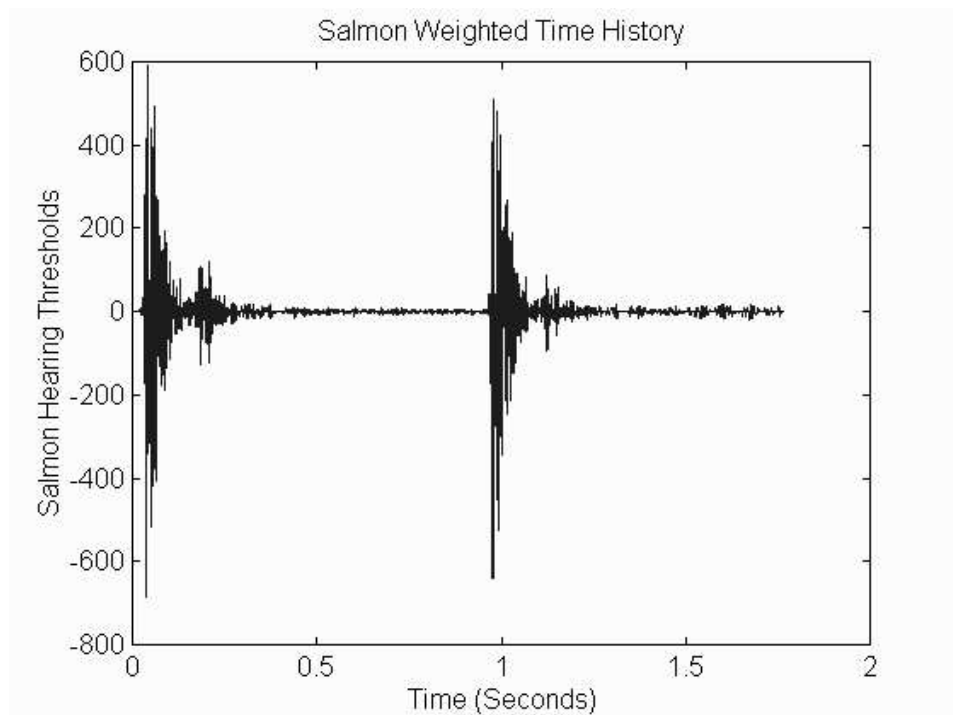
(a). An unweighted time history.

(b). Time history using the salmon weighting curve.

Fig. 14. A pressure vs. time history for impact driving, obtained from measurements at location R3.

Fig. 14 is a plot of a typical pressure time history recorded at location R3; a section of the recording having two pile driver strikes has been illustrated. Fig. 14 (a) illustrates the sound pressure in linear units, and Fig. 14 (b) illustrates the identical recording, but in units of salmon hearing thresholds. First, looking at the unweighted levels, it may be seen that there is a high level of impulsive sound as the pile is struck, having a peak-to-peak pressure of about 200 Pa and a roughly exponential decay, with a time constant of about 0.1 sec. There are two later arrivals, one small arrival occurring at about 0.2 sec after the main arrival, and a further large

arrival about 0.5 sec after the main arrival. These are thought to be seismic arrivals carried in the seabed.

The salmon hearing threshold weighted data of Fig. 14 (b) is generally similar in form to the unweighted data. It is interesting to note, however, that the seismic arrivals, which are at a frequency of about 10 Hz, have disappeared due to the relative insensitivity of salmon to these frequencies of sound.

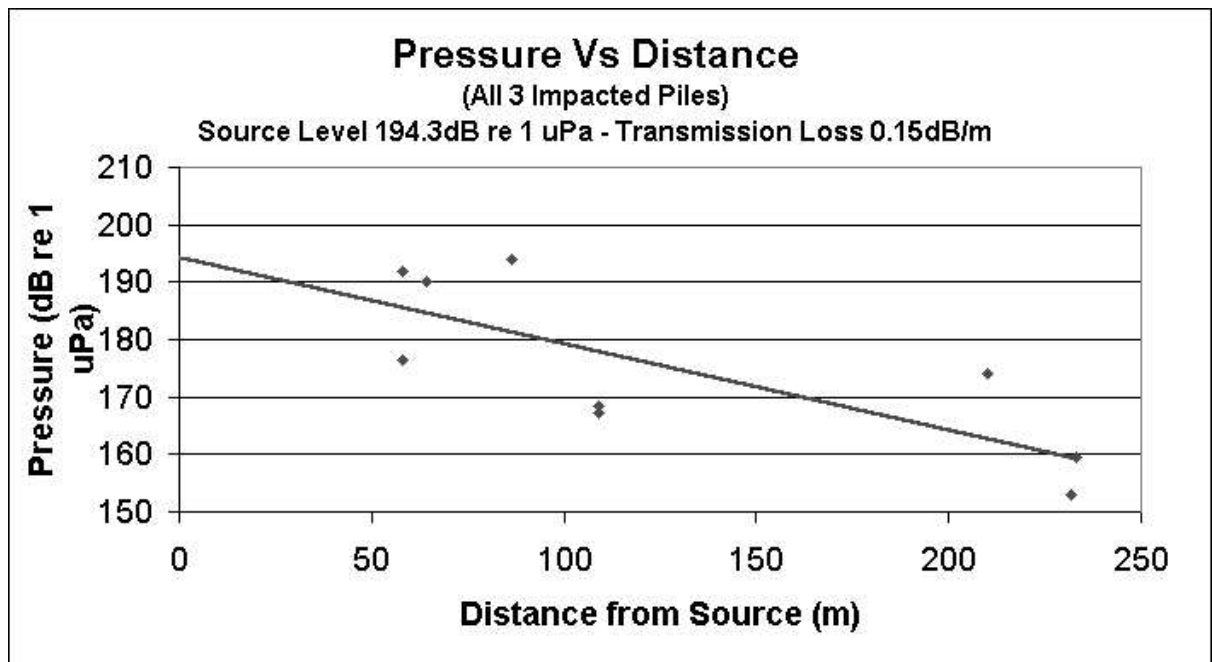
Fig. 15. Variation of peak-to-peak pressure with distance for impact driving.

Fig. 15 illustrates the peak-to-peak Sound Pressure Level of the impact piling as a function of the range from the piling, for all three piles driven. It may be seen that there is a significant scatter in the levels of noise recorded. It may be noted that although overall there was a general fall in noise level with range, there are some points where the noise was significantly higher or lower than the general trend. The reason for these is not known, but it is possible that it results from partial focussing or defocussing of noise during propagation through the water and sediments. There is also a significant variation in overall level between the three different piles driven.

However, for the measurements of impact piling at the Red Funnel terminal, the losses in level with range were thought to be mainly due to absorption; consequently a reasonable fit is given by the linear equation

where the Source Level is about 194 dB re 1 μPa , and the Transmission Loss rate N_a is about 0.15 dB per metre. At the range at which most of the monitoring was conducted (400 m) the average level from the impact piling would thus be 134 dB re 1 μPa

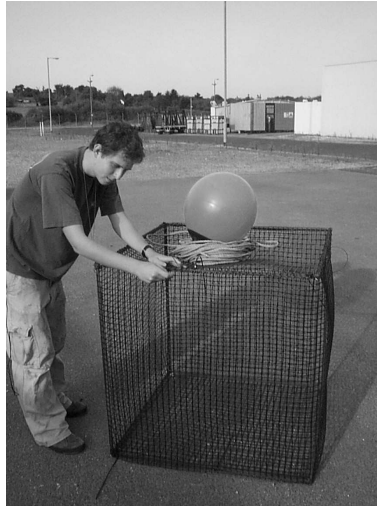
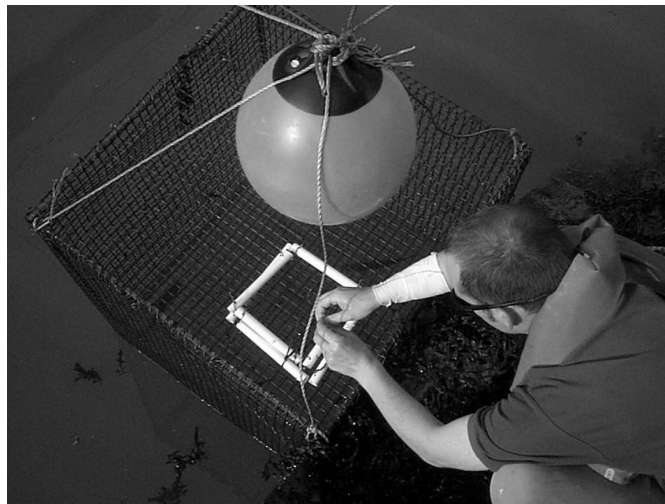
(a). A general view.

(b). View showing flap opening for introducing and removing the fish.

Fig. 16. A cage used for the fish monitoring.

Cages were purpose built for the project and were based on a nominal 1 m cube design. The frames were made from mild steel angle and spray-painted. Plastic mesh of about 25 mm square aperture was fixed to the outside of the frames using plastic-coated wire. A 20 cm-square flap opening was made in the top of the cage, the edges being reinforced with 25 mm plastic pipe attached to both the flap and the outer edges. These were used for introducing the fish and for removing them at the end of the trials. Cable-ties were used to close the openings during the tests. A photograph of a cage is given in Fig. 16.

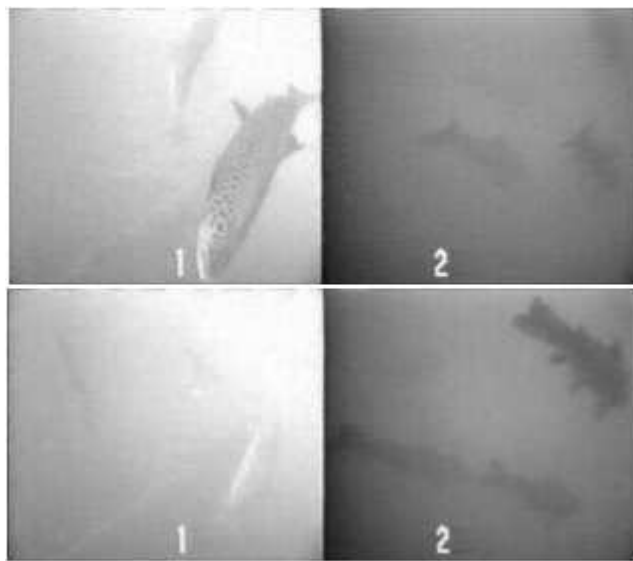
Fig. 17. A clip from the fish monitoring video.

Signals from the cameras were fed into multiplexers and thence into time lapse video cassette recorders (VCRs) and video monitors. The longest cable run was 180 m and a line amplifier was used to boost the signal and improve picture quality. The VCRs were run in 3-hour mode (i.e. non-time-lapse) and tapes were changed every 3 hours during the working day. This meant that a considerable number of hours of 'control' (background) records were made when there were numerous disturbances from boat traffic, including the regular arrivals and departures of the Red Funnel Isle of Wight ferries, small craft movements and the occasional ocean liner passing. A typical frame from the video recording is shown in Fig. 17.

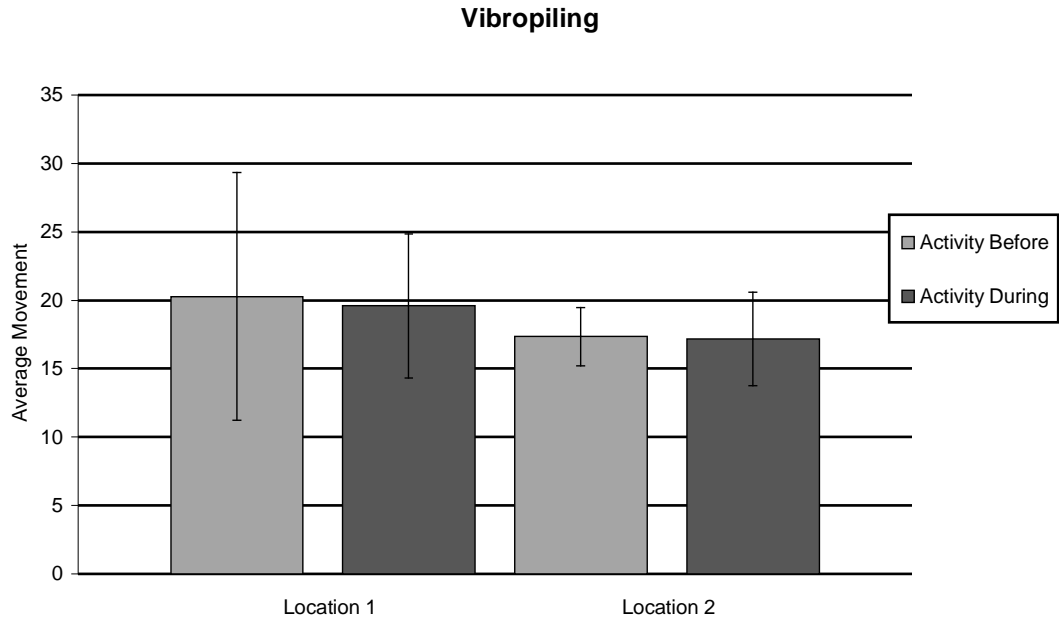
Fig. 18. Comparison of fish activity levels before and during vibropiling (all data collected between 15-23 September), based on observed fish movements over 2 minutes before the start of piling and for 2 minutes from the start of driving each pile (mean & 95% confidence interval).

Table 4.1 and Fig. 18 show the activity level observations (number of movements per 2-minute period) for the 2-minute period prior to piling and then for the first 2 minutes during vibropiling. Activity levels are seen to remain similar before and after the start of piling. The

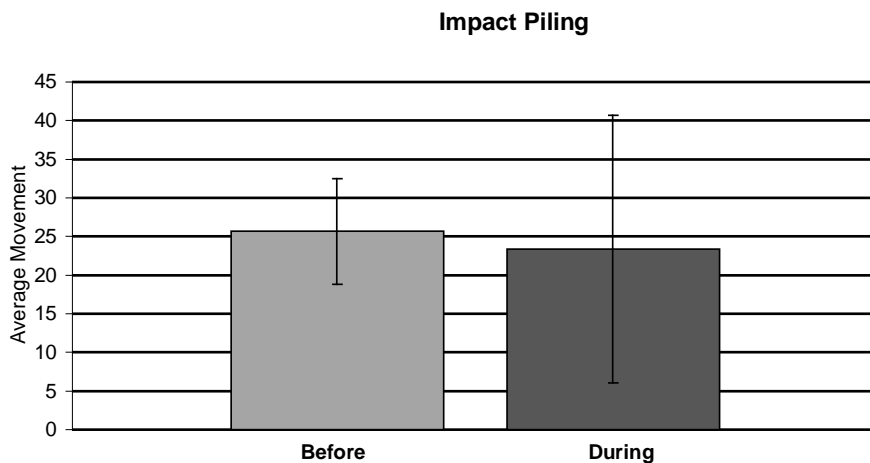
Fig. 19. Comparison of fish activity levels before and during impact piling (piling on 24th September), based on observed fish movements over 2 minutes before the start of piling and for 2 minutes from the start of driving each pile (mean & 95% confidence interval).
