Annual work report 2019

Offshore wind energy power plant

Nobelwind

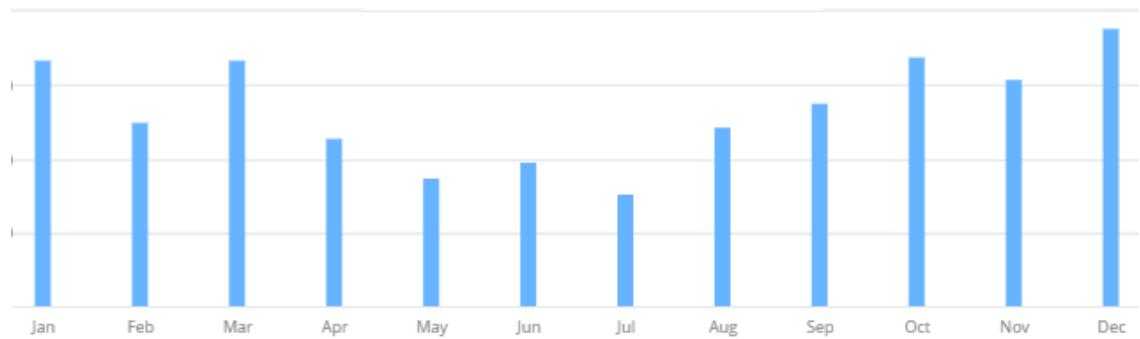
Monthly production V112 2019
