Annual work report 2021

Offshore wind energy power plant

Nobelwind

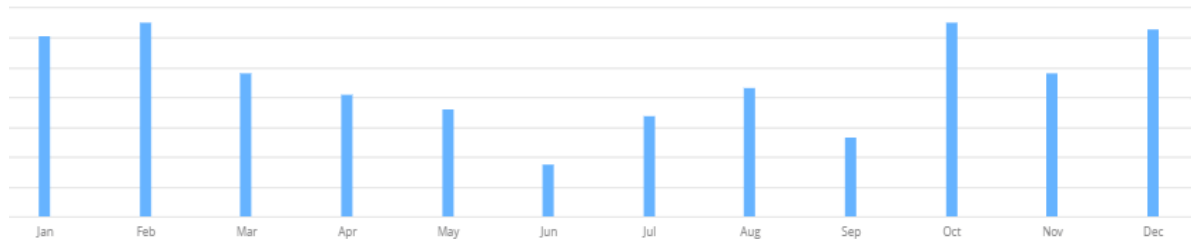
Monthly production V112 2021

Below figures cover the 50 MVOW V112 turbines.

On average, 2021 has been a low wind year and was below the expected (long term) wind resource.
