Seafloor Disturbance and Recovery Monitoring at the Block Island Wind Farm, Rhode Island - Summary Report (Year 6)

February 2022

CSA Ocean Sciences Inc.
8502 SW Kansas Ave
Stuart, Florida 34997

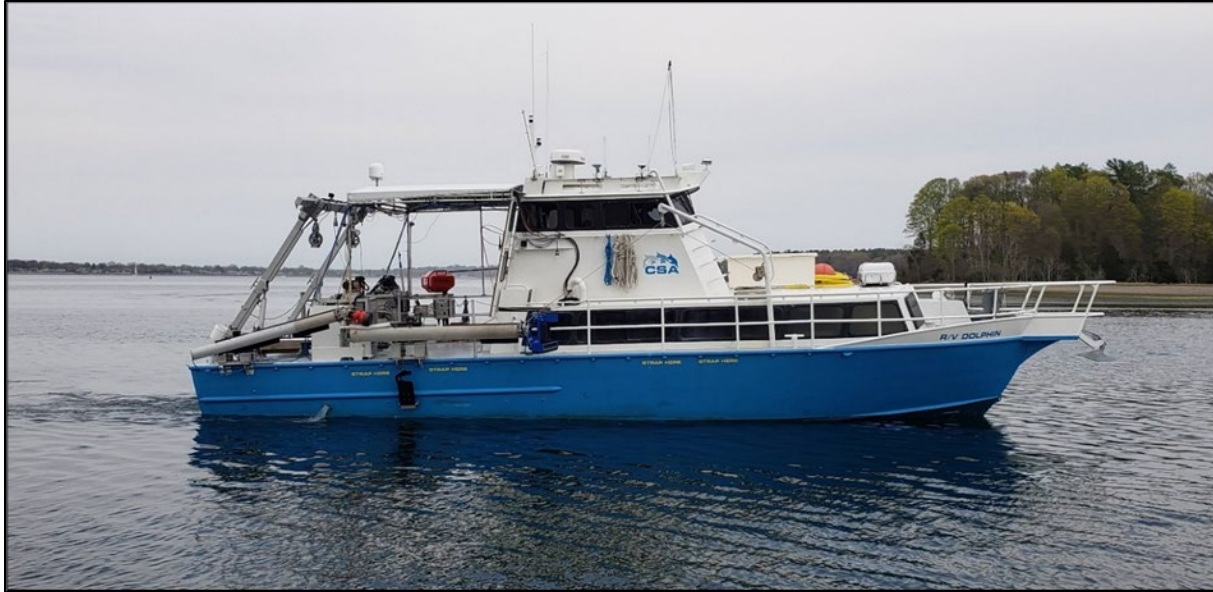
Figure 2. The 49 ft (15 m) R/V *Dolphin* utilized during the Block Island Wind Farm Geophysical Survey with starboard side pole mount
