Shetland Tidal Array Monitoring Report: Subsea video monitoring

EnFAIT-0364 Version 4.0

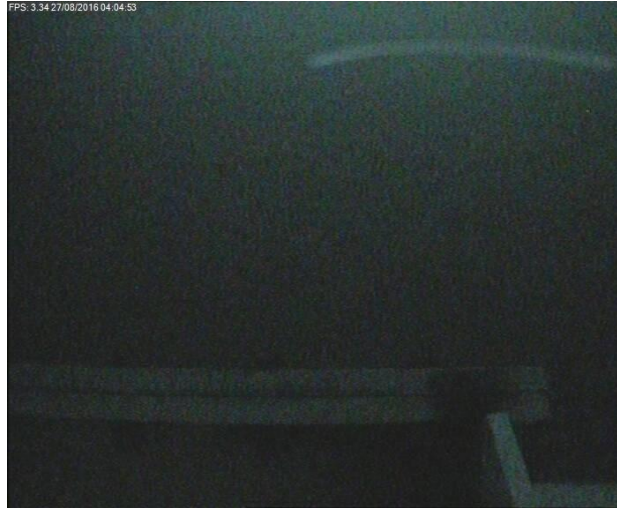
Figure 1 Flash of light recorded on T2 TOP on 2016-08-2 at 04:04 am

The camera also operates at night, when it can catch brief flashes of light as can be seen in Figure 1. Such images are presumed to be caused by passing bio-luminescent organisms.

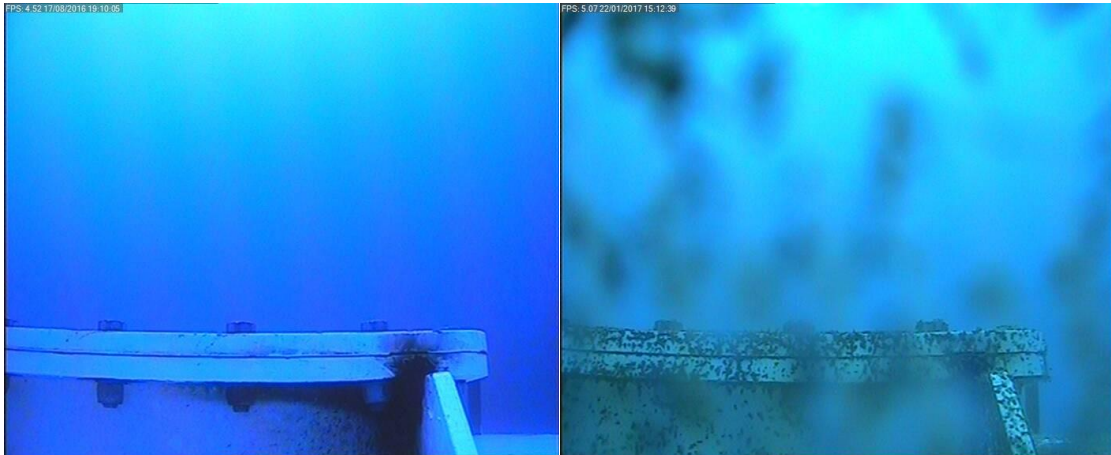
Figure 2 T2 TOP: Biofouling at the beginning (August, left) and the end (January, right) of the analysis period

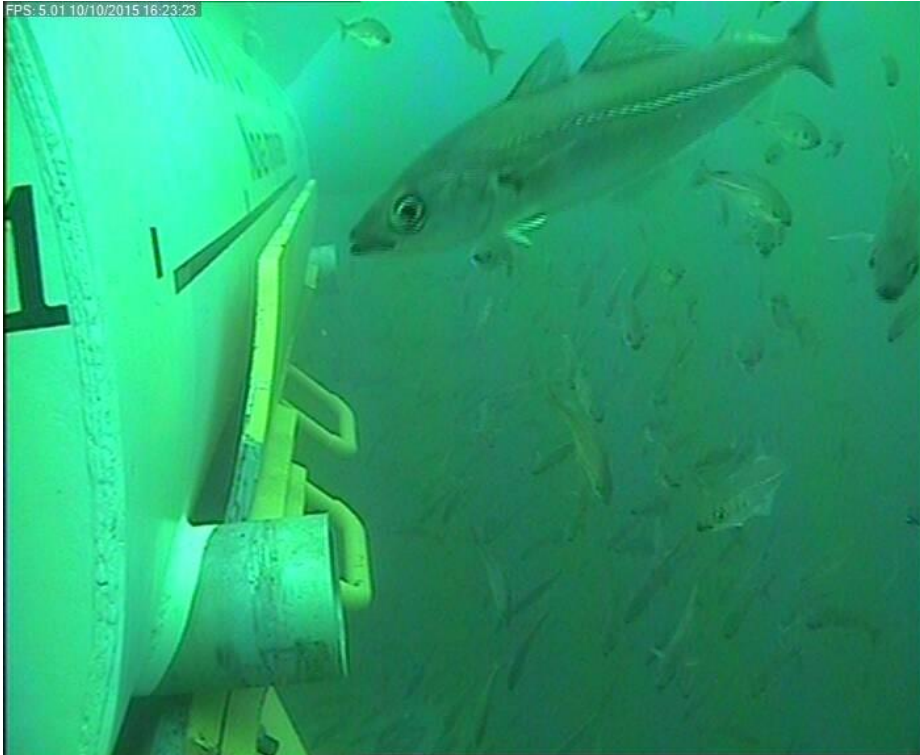
Figure 3 T1 SIDE: shoal of fish, 4_2015-10-10_16-23-10.mp4

Figure 3 and Figure 4 show shoals of fish, believed to be saithe, observed on 10th and 19th October 2015. These fish were observed frequently on all cameras; they are a reliable indicator of flow speed; they rise up from the seabed to the nacelle as the tide goes slack, and to sink back towards the seabed as tidal flow increases. Fish are rarely seen at the nacelle once flow speeds reach the cut-in speed of the turbine. The species in these images was provisionally identified as saithe using the following features: elongated body with white stripes on the side; pointed snout; protruding lower jaw; small barbel on the chin (occasionally visible); forked tail; three dorsal fins; and large eyes. With two exceptions noted below, this was the only species of fish observed in the video analysis.

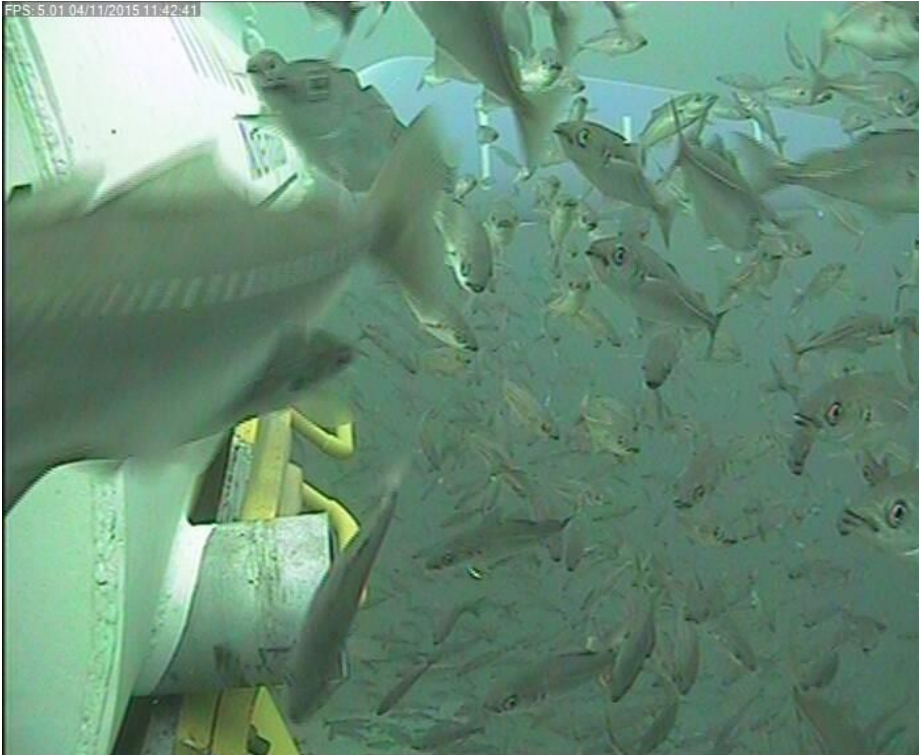
Figure 5 T1 SIDE: large shoal of fish, 4_2015-11-04_11-42-04.mp4

On 4th November, the large shoal of fish shown in Figure 5 attracted the predator shown in Figure 6, believed to be a European Shag. Birds were only observed during slack or slow tidal speeds, and were never observed when the turbine was in operation.

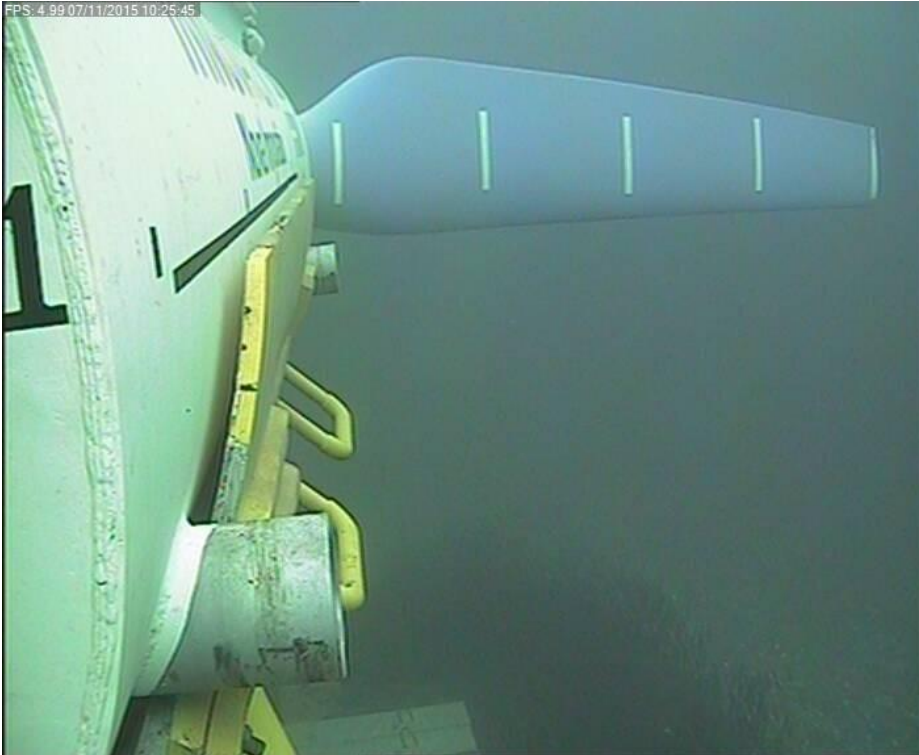
Figure 7 T1 SIDE: shoal of fish on the seabed, 4_2015-11-07_10-25-45.mp4

The behaviour of the fish during tidal flow is observed in Figure 7, where a large shoal forms a dark patch close to the seabed. The fish appeared to be sheltering in the lee of the turbine. This behaviour was also observed in the downward pointing cameras.

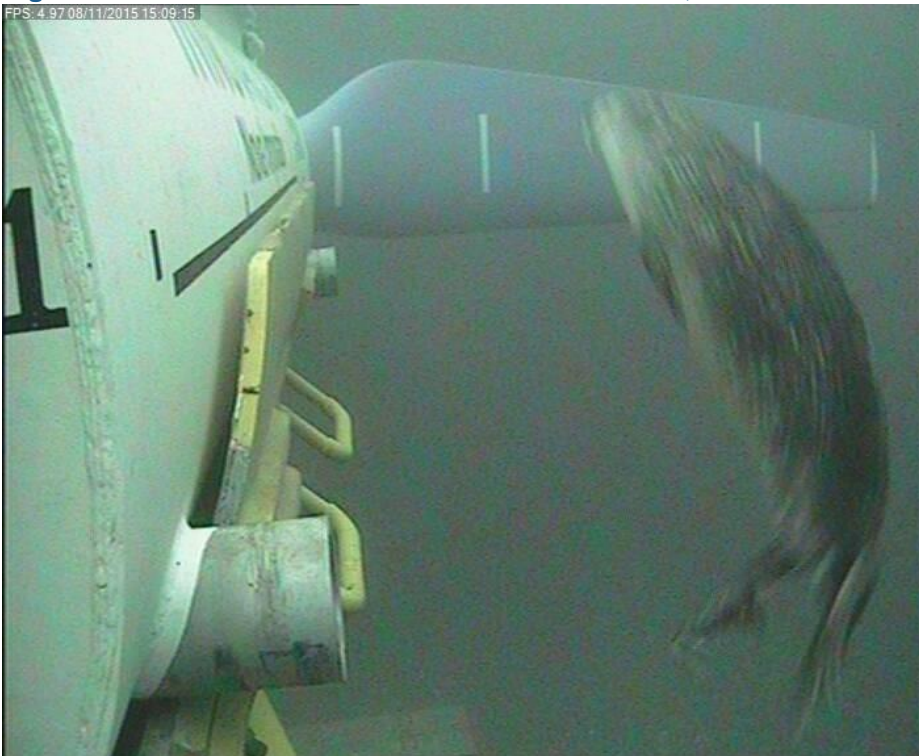
Figure 8 T1 SIDE: seal observed 8th November 2015, 4_2015-11-08_15-09-14.mp4

A seal was caught on camera on 8th November, as shown in Figure 8 and Figure 9. A similar looking seal was observed the following day, shown in Figure 10, and a week later, shown in Figure 11. As with birds, seals were observed rarely, and only during slack tide or low tidal speeds – never when the turbine was in operation. The mottled pattern and short snout suggest that this is a common seal (also known as a harbour seal).

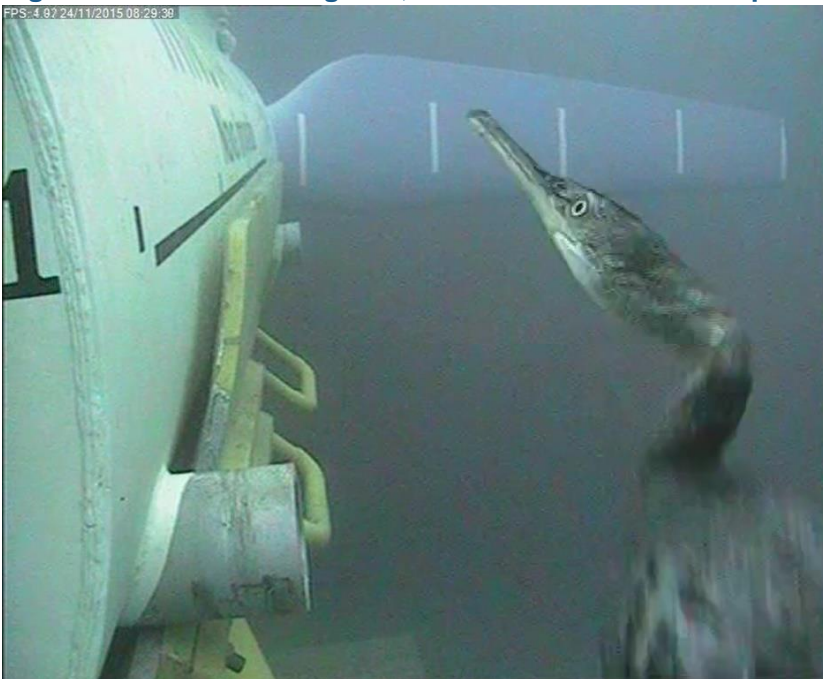
Figure 12 T1 SIDE: diving bird, 4_2015-11-24_08-29-39.mp4

Figure 12 shows a diving bird, believed to be a European Shag, observed on 24th November 2015.

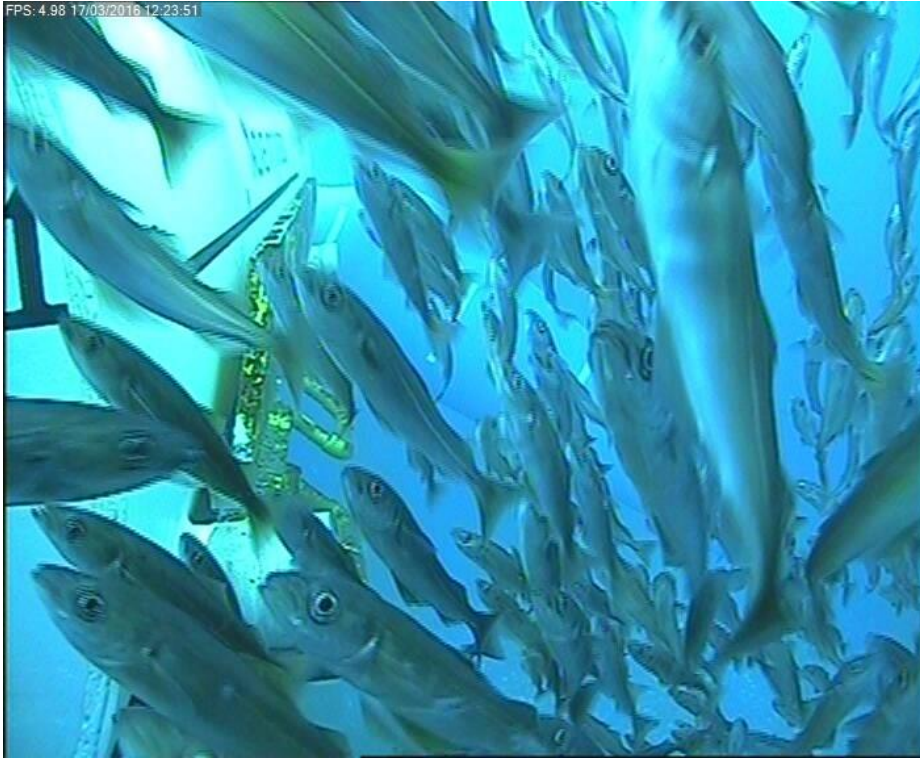
Figure 13 T1 SIDE: Schooling fish, 4_2016-03-17_12-23-34.mp4

The T1 nacelle was removed in December 2015 and redeployed in March 2016. Figure 13 and Figure 14 were captured just after redeployment. Schooling (i.e. coordinated motion of the shoal) was observed on occasion, and appears to be a response by the fish to a real or perceived threat. A few hours after the school was first observed, the threat was revealed in Figure 15 below. The diving bird in this case is believed to be a European shag.

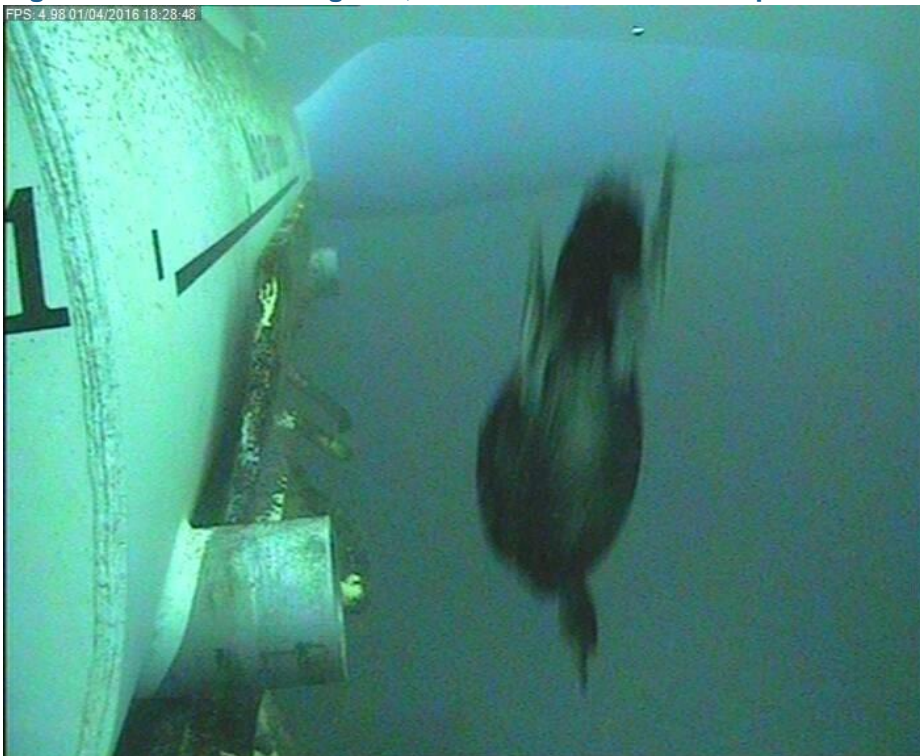
Figure 16 T1 SIDE: Diving bird, 4_2016-04-01_18-28-47.mp4

A diving bird was observed again a few weeks later, on the same camera; again, this is again thought to be a European shag.

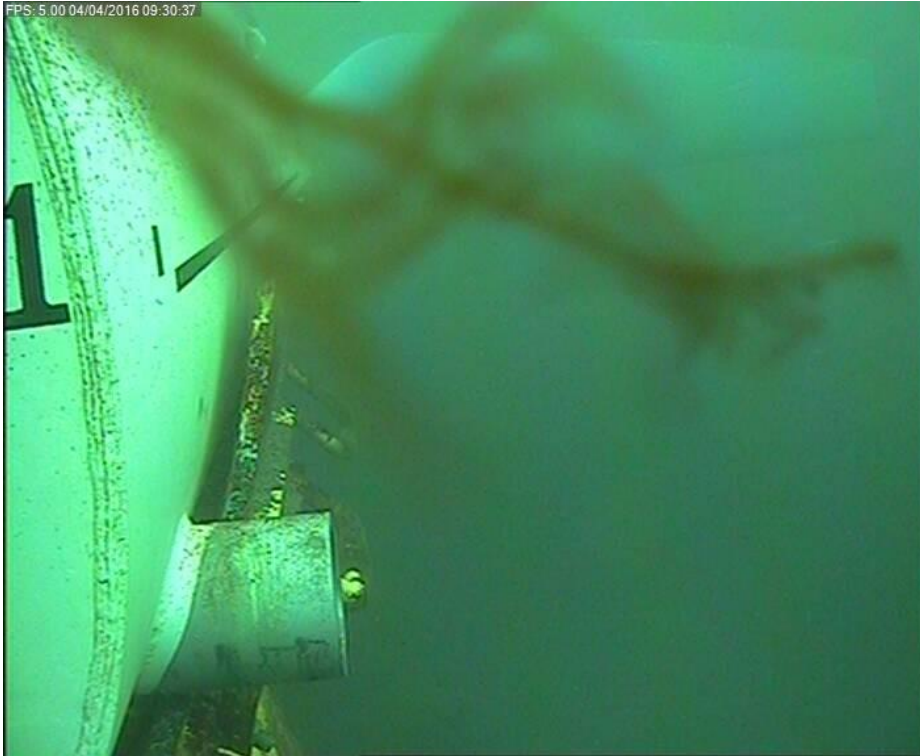
Figure 17 T1 SIDE: Seaweed caught next to the camera: 4_2016-04-04_09-30-37.mp4

Figure 17 shows a more typical video image. Seaweed has snagged next to the camera, and triggers a recording when it moves in the tide. This kind of event will be very difficult to filter out automatically, since the shape, colour and movement of the seaweed can change from event to event. The vast majority of recorded

The change in image clarity and colour from the previous events is due to a combination of water quality, sunlight conditions, biofouling on the camera window and the colour filter applied to the image. Water quality and sunlight have a strong impact on the clarity of the image.

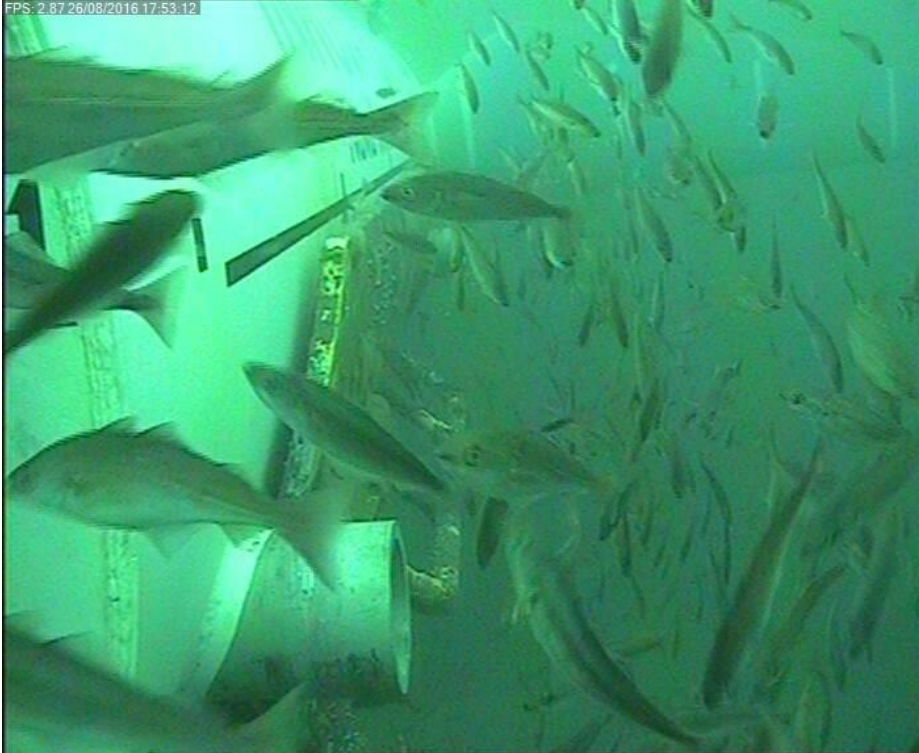
Figure 18 T1 SIDE: Fish observed during slack tide: 4_2016-08-26_17-47-56.mp4

Fish were not observed frequently on this camera until after the turbine redeployment in August, after which they became a regular feature at slack tide, as can be seen in Figure 18. This again creates an issue when filtering the data, since the camera triggers constantly in the presence of fish. The trigger event – a picture of which is used in the first level filter of the data – will not necessarily include a bird or a mammal, even if one were present.

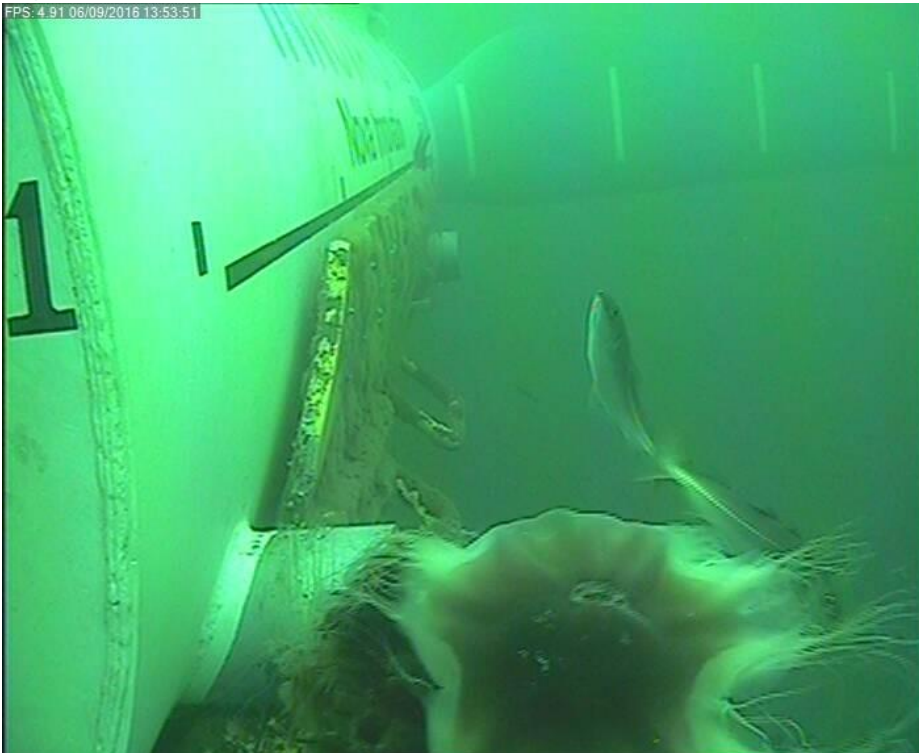
Figure 19 T1 SIDE: Jellyfish observed with fish: 4_2016-09-06_13-53-31.mp4

In addition to fish, other creatures were occasionally observed on camera. Figure 19 shows a jellyfish swimming with fish during slack tide. Jellyfish were also observed being carried past the camera by the flowing tide.

In addition, jellyfish such as Lion's mane jellyfish, *Cyanea capillata*, were occasionally recorded either actively swimming at slack tide or being carried passively past the turbines by the flowing tide (Figure 19, Annex A). On one occasion, a scorpion fish was observed attached to one of the camera lenses (Figure 36 & 37, Annex A)¹⁶.

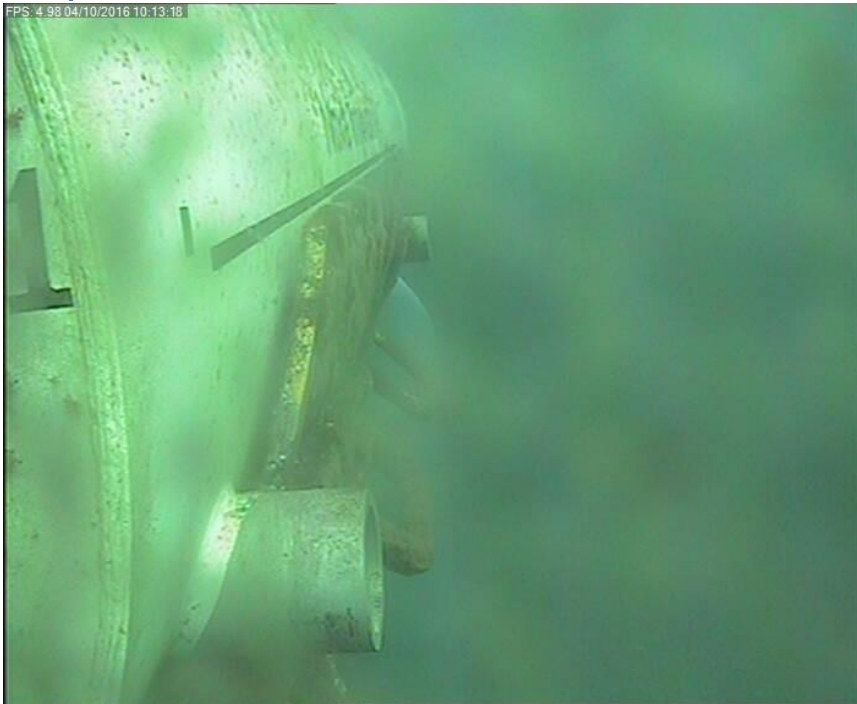
Figure 20 T1 SIDE: Biofouling begins to affect the camera view from October: 4_2016-10-04_10-05-32.mp4

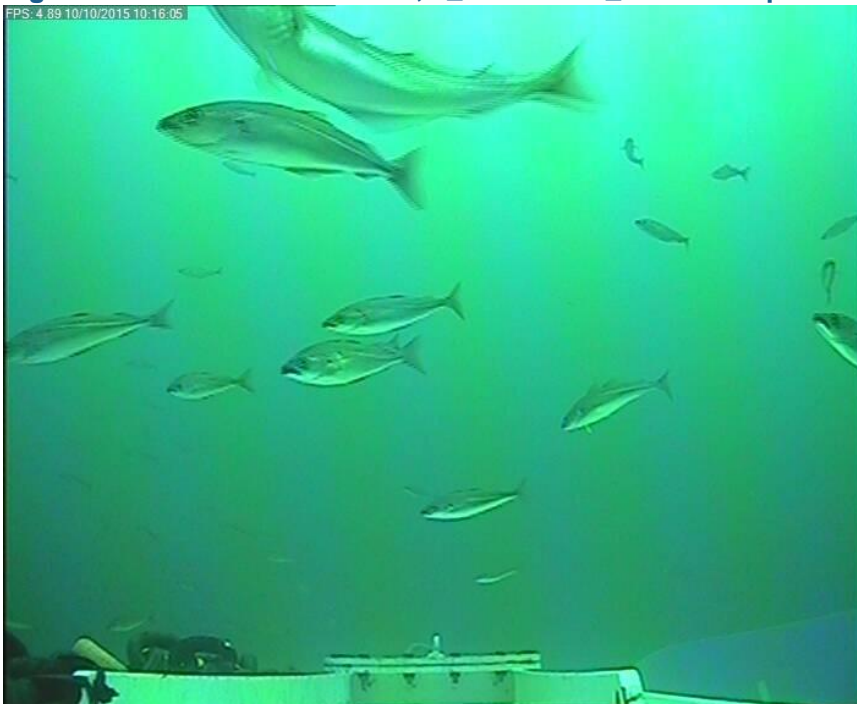
Figure 21 T1 TOP: shoal of fish, 3_2015-10-10_10-13-31.mp4

As with the T1 SIDE camera, fish were observed frequently on this camera, including the day after deployment as shown in Figure 21.

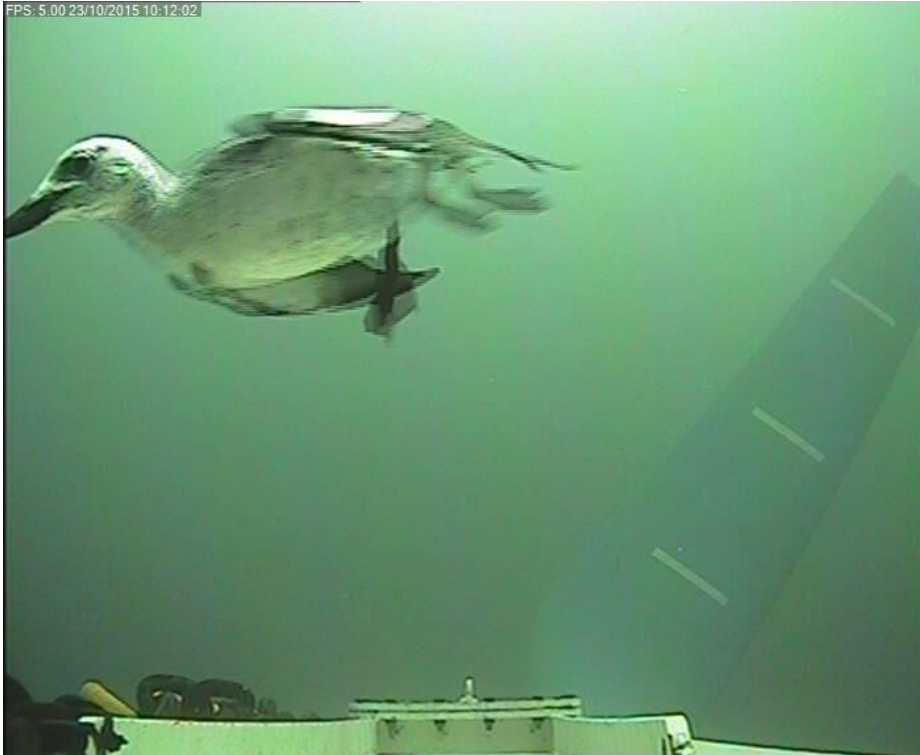
Figure 22 T1 TOP: diving bird, 3_2015-10-23_10-12-02.mp4

A diving bird was seen on 23rd October 2015, believed to be a Black Guillemot in its winter (non-breeding) plumage.

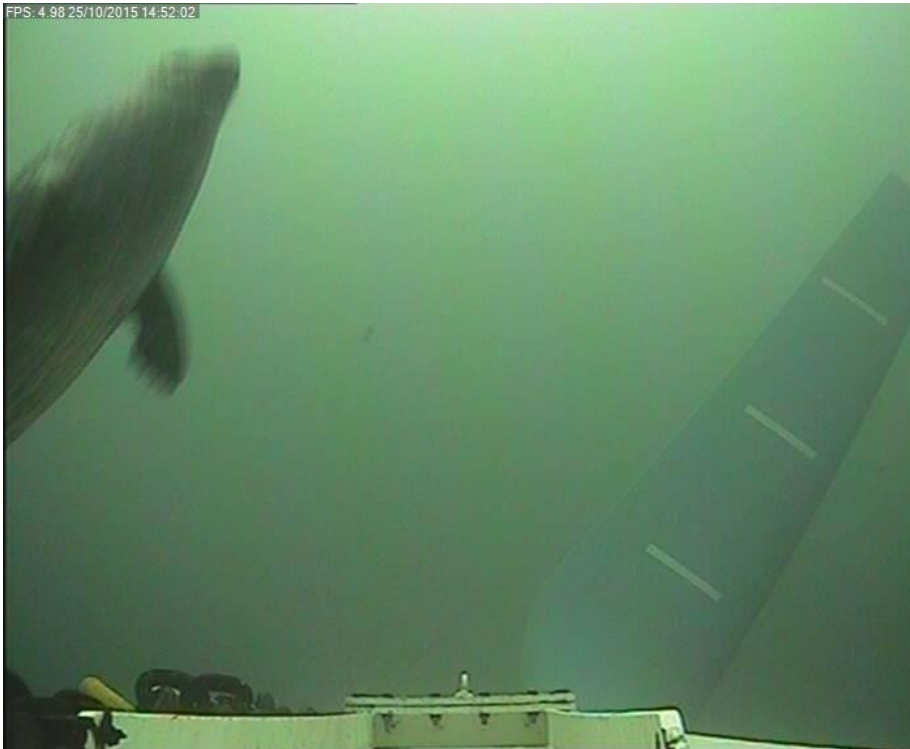
Figure 23 T1 TOP: seal observed 25th October 2015, 3_2015-10-25_14-52-02.mp4

Figure 23 shows a seal observed on 25th October; as with all other observations, this is believed to be a common seal, and it was observed during slack tide when the turbine was not rotating.

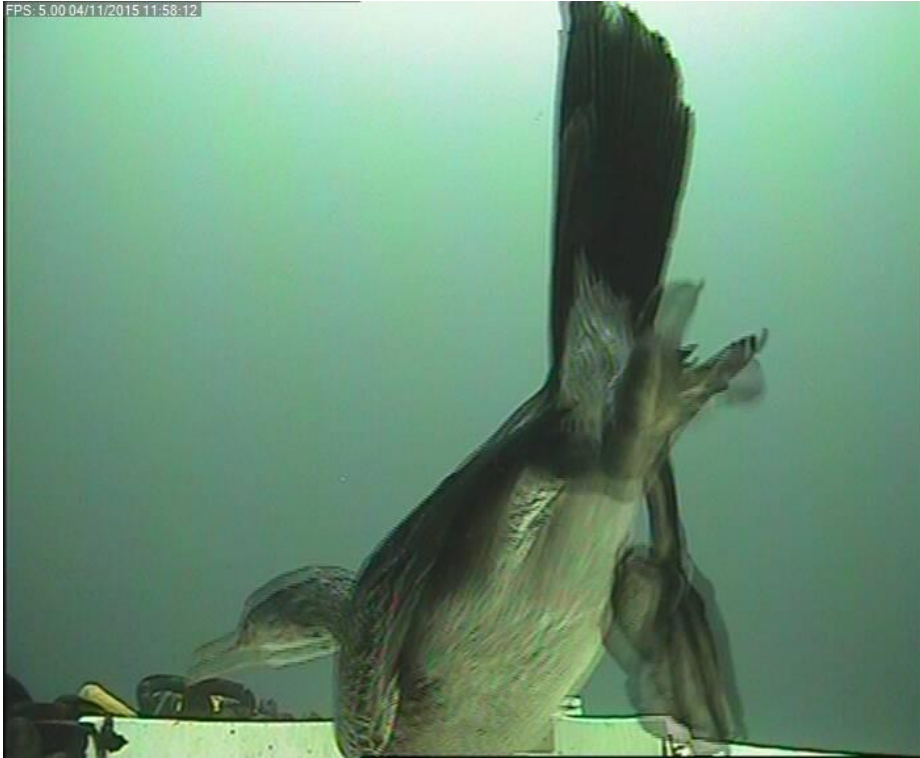
Figure 24 T1 TOP: diving bird, 3_2015-11-04_11-58-10.mp4

A diving bird, believed to be a European shag, was observed on 4th November (Figure 24). A seal, believed to be a common seal, was also observed on this date (Figure 25).

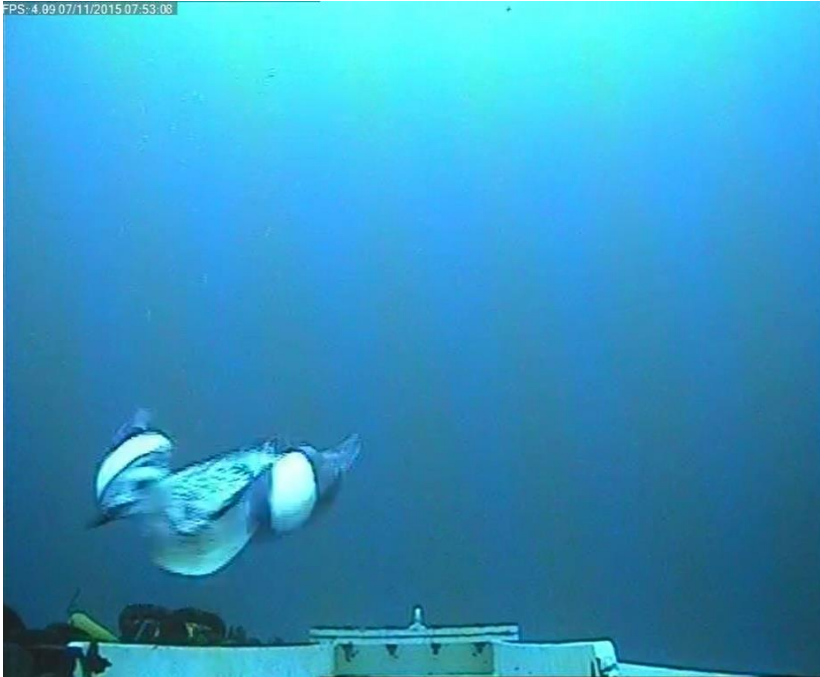
Figure 26 T1 TOP: diving bird, 3_2015-11-07_07-53-08.mp4

A diving bird, believed to be a black guillemot, was observed on 7th November 2015 (Figure 26).

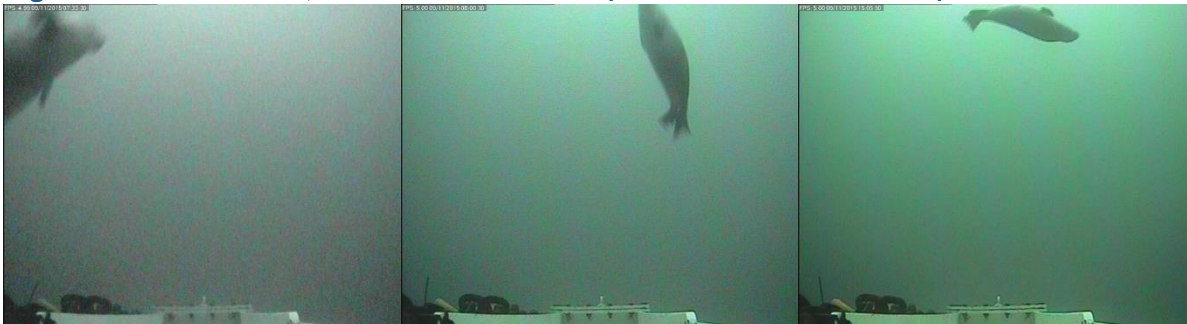
Figure 27 T1 TOP: seal, 3_2015-11-09_07-33-30.mp4, 3_2015-11-09_08-00-30.mp4, 3_2015-11-09_15-05-50.mp4

A seal, believed to be a common seal, was observed three times on 9th November 2015 (Figure 27). A seal was also observed on the side camera on this date (Figure 10).

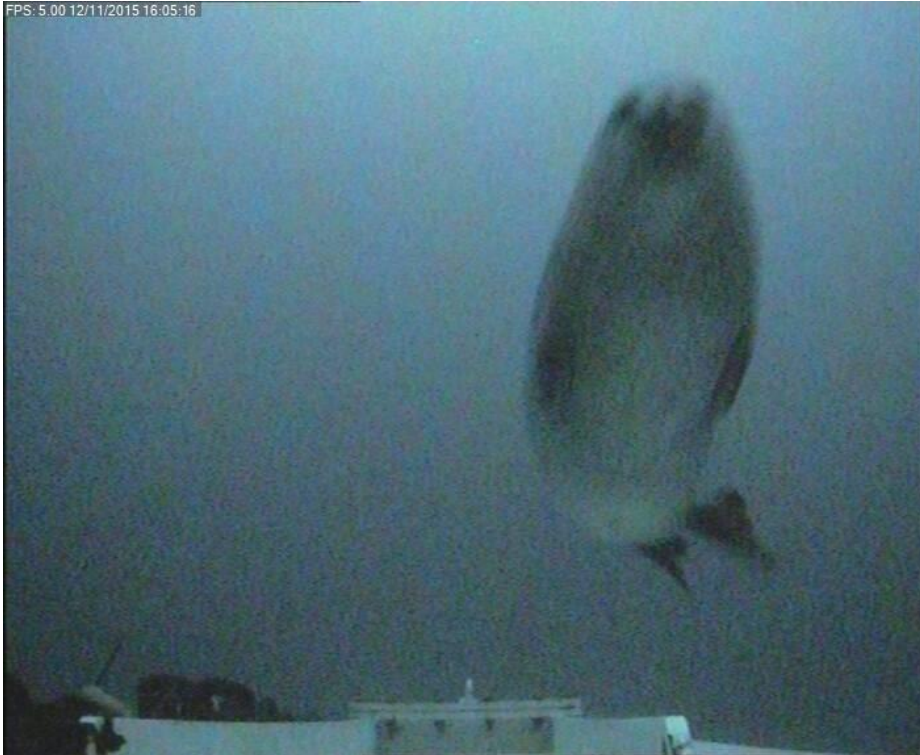
Figure 28 T1 TOP: seal, 3_2015-11-12_16-05-16.mp4

A seal, again believed to be a common seal, was observed on 12th November 2015 (Figure 28)

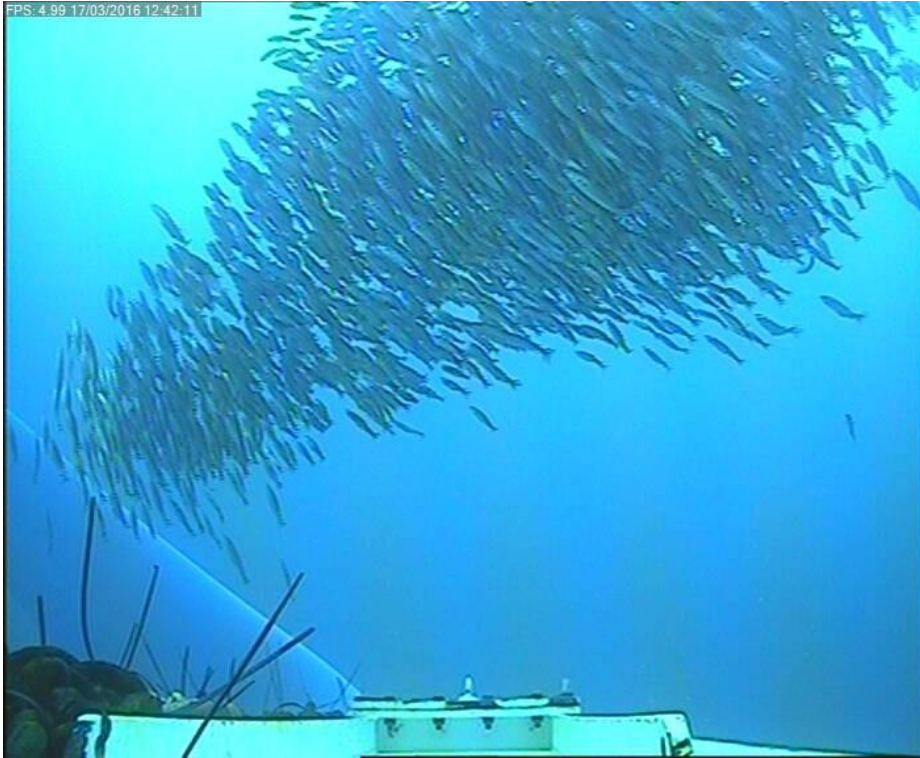
Figure 30 T1 TOP: School of fish: 3_2016-03-17_12-41-55.mp4

The turbine nacelle was removed in December 2015 and redeployed in March 2016. In Figure 30, the top camera on T1 captured the same school of fish seen on the side camera on 17th March (see Figure 13). A single bird was again observed on this footage, seen to the lower right of Figure 31, believed to be a European shag.

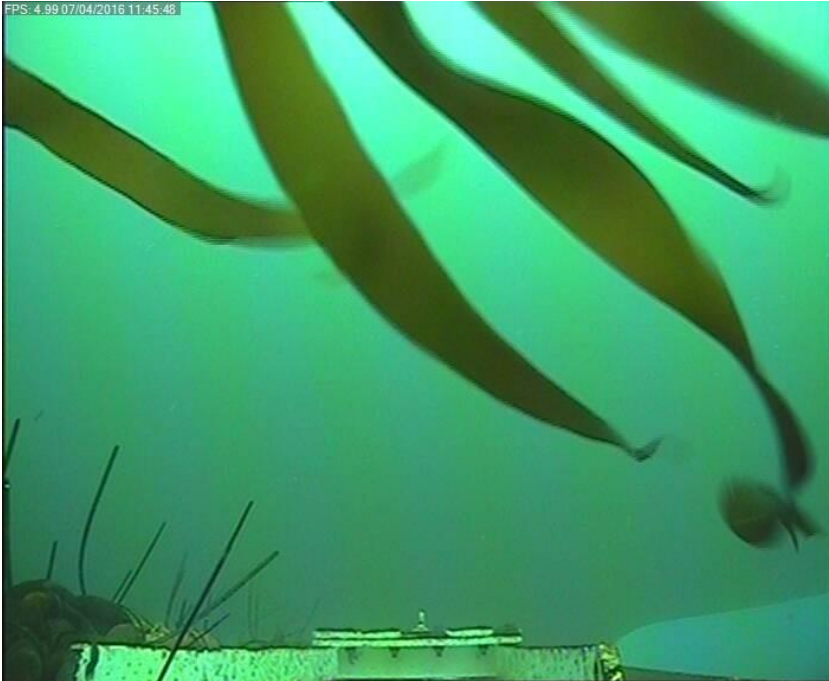
Figure 32 T1 TOP: Kelp snagged on camera: 3_2016-04-07_11-45-40.mp4

Soon after deployment some kelp was snagged next to the camera, leading to hundreds of triggered events and many hours of recorded data, typified by the picture below. As for the other cameras, this was a common occurrence which contributed significantly to “noise” in the data.

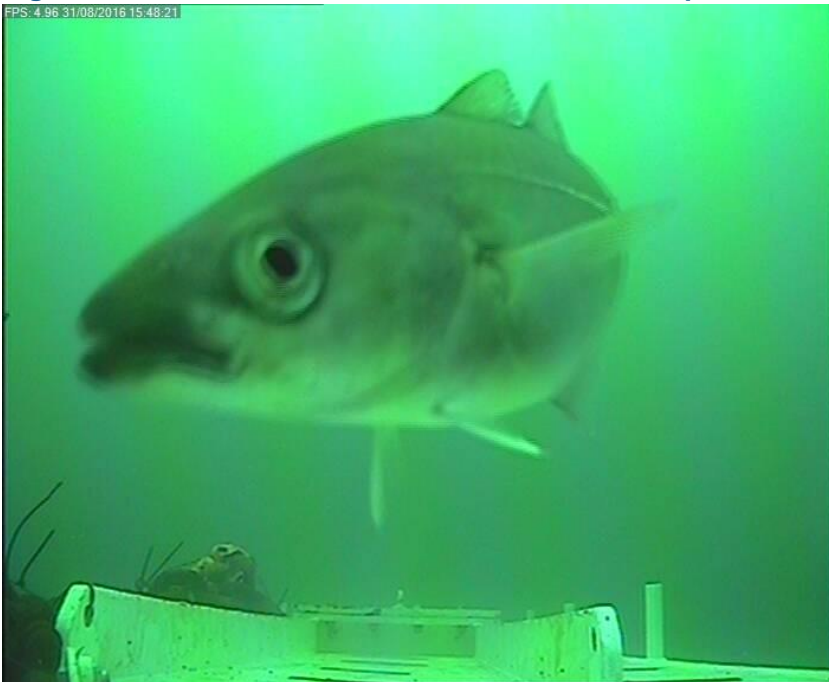
Figure 33 T1 TOP: Saithe, 3_2016-08-31_15-47-59.mp4

As with other cameras, the fish observed appeared to almost exclusively consist of the species shown in Figure 33, which is believed to be a saithe.

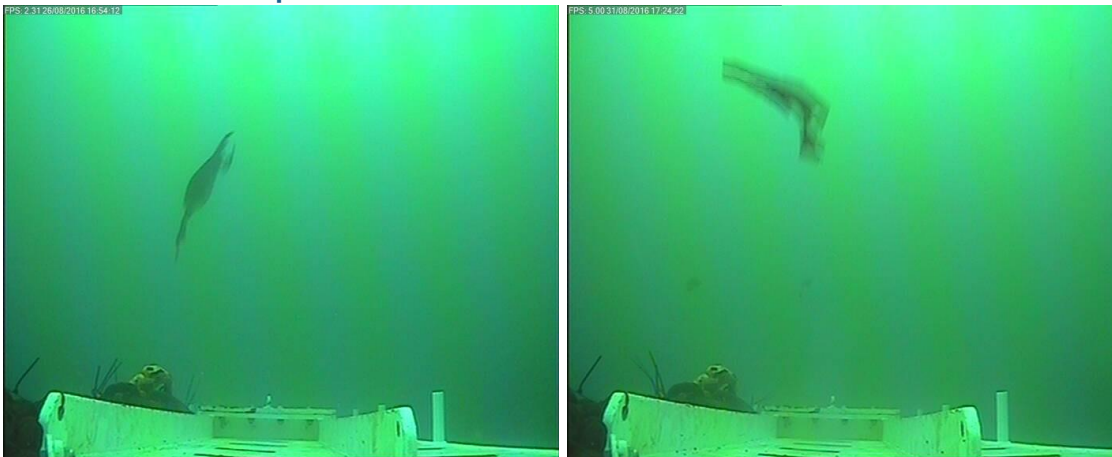
Figure 34 T1 TOP: (left) diving bird, 3_2016-08-25_14-42-00.mp4 (right) kelp, 3_2016-08-31_17-24-22.mp4

Figure 34 illustrates a difficulty in identifying diving birds in the video footage. The left image shows a diving bird (thought to be a European shag) which looks a bit like a piece of kelp, whilst the right image shows some kelp that looks a bit like a diving bird. The two can be easily distinguished in the associated video footage, which could be used to form the basis of a more sophisticated automatic filtering method: e.g. one that considers the speed and direction of passage of the object, and the flow and direction of the tide (birds were only observed during slack tide).

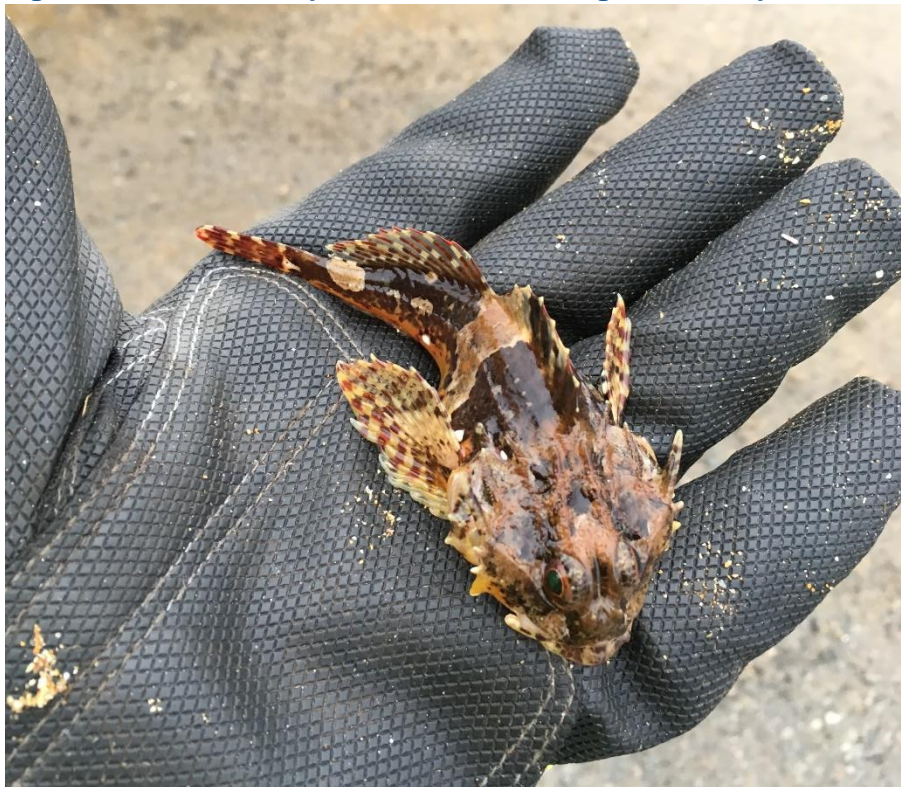
Figure 37 Possible lumpfish recovered during offshore operations

Whilst almost all of the observed fish appear to be of the same species, a different species of fish was observed on T1 in September, as shown in Figure 36. This is tentatively identified as a species of lumpfish; the video is not clear, but the image on the right could show the adhesive pelvic dish on the underside of the fish. The fish was observed to sit on the housing above the camera, which is consistent with the behaviour of a lumpfish. A similar fish was found during one of the recovery operations and is shown in Figure 37.

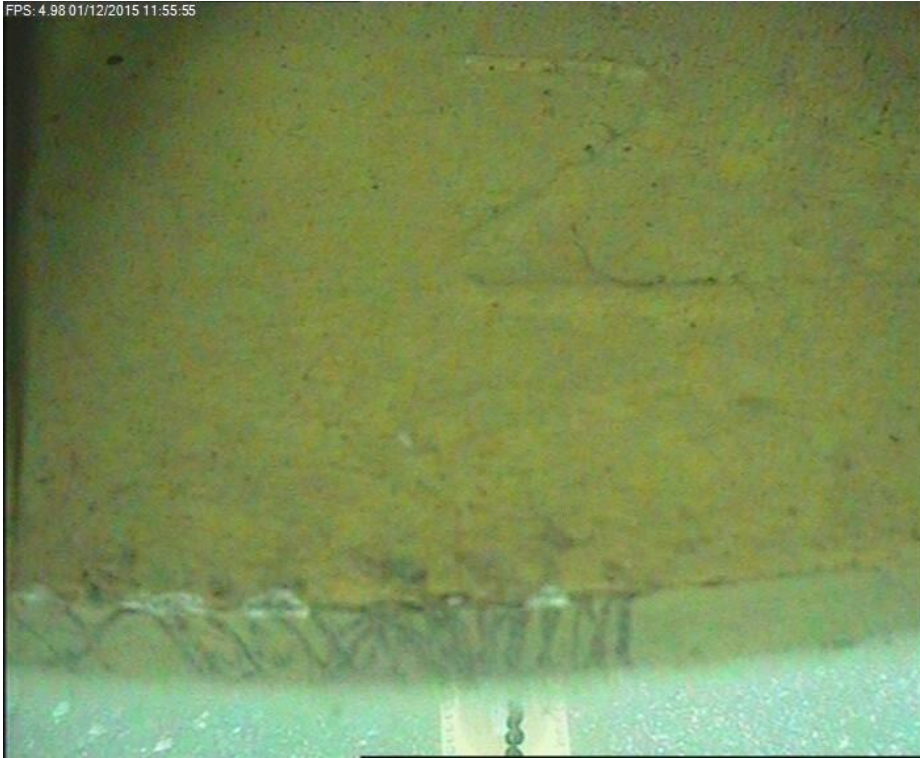
Figure 38 T1 DOWN: Obstructed view from camera Oct-Dec 2015, 5_2015-12-01_11-55-55.mp4

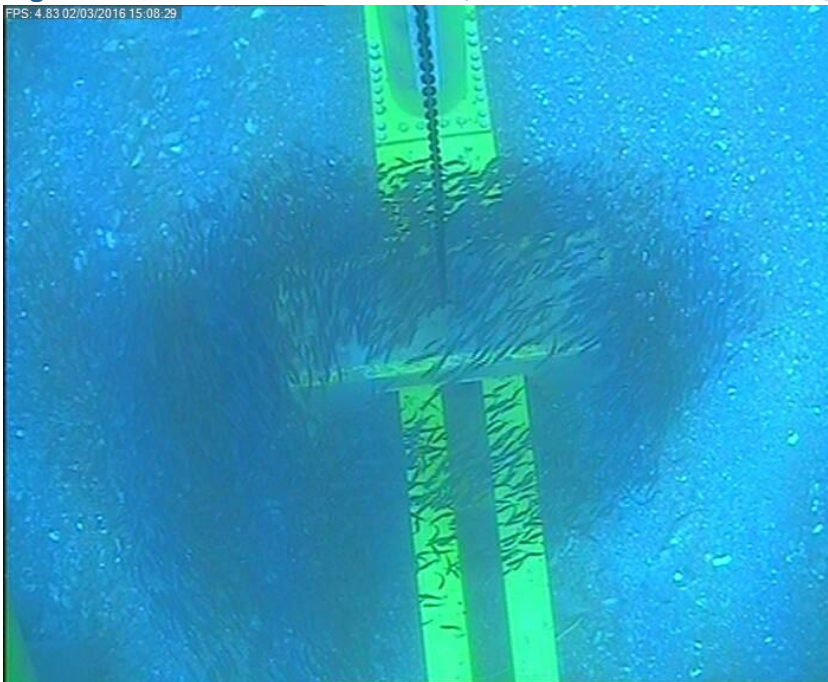
Figure 39 T1 DOWN: school of fish, as seen on other cameras, 5_2016-03-02_15-03-46.mp4

Figure 39 shows a school of fish circling beneath the turbine on 2nd March. The apparent cause of this behaviour is shown in Figure 40, and is thought to be a European Shag.

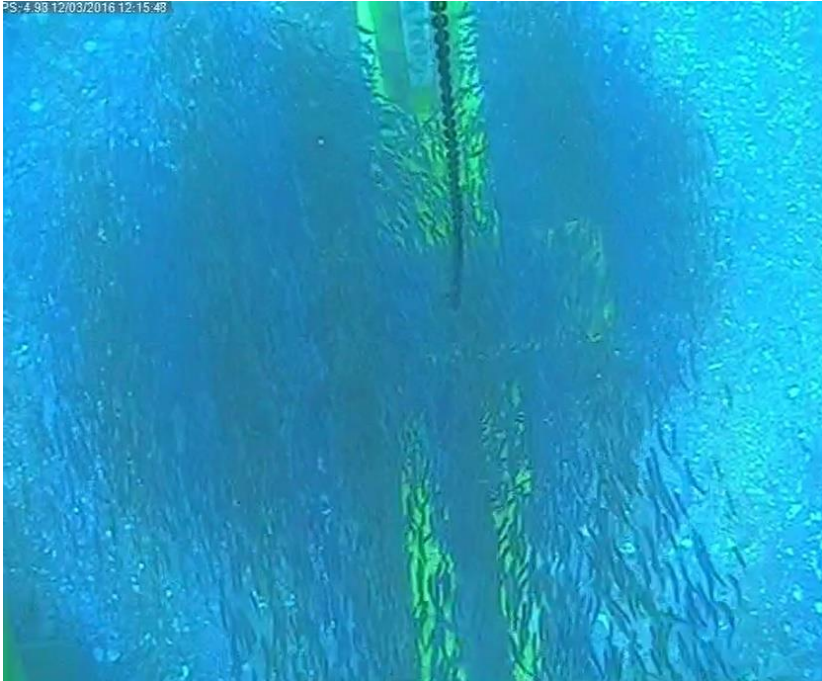
Figure 42 T1 DOWN: Large school of fish, 5_2016-03-12_12-15-46.mp4

Another large school was observed ten days later, as shown in Figure 42. On this occasion, no predators were seen on the video footage.

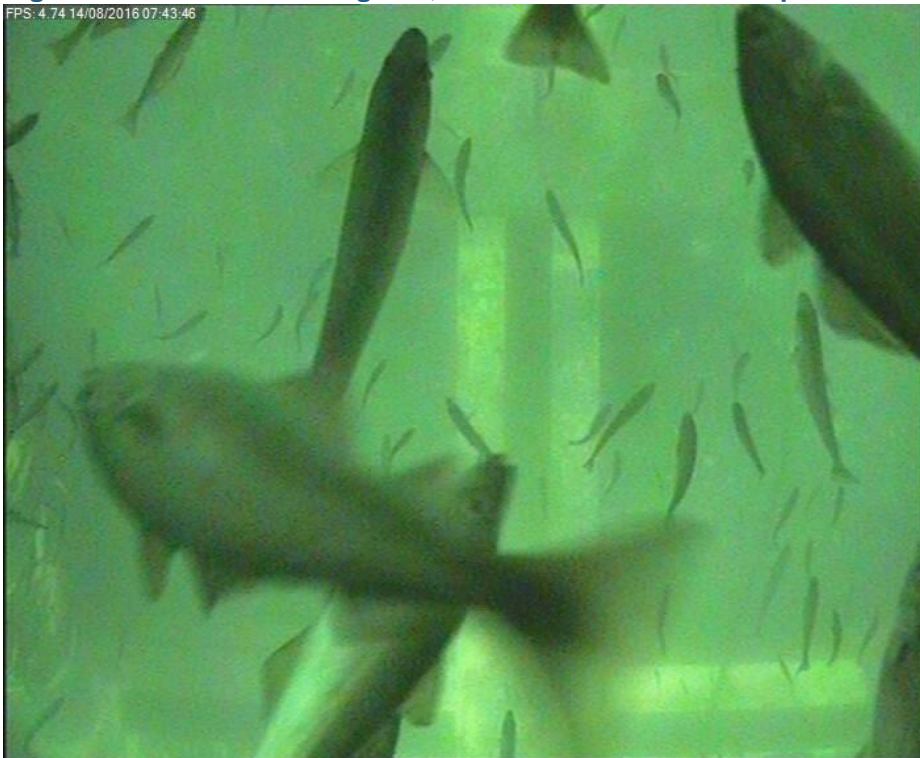
Figure 43 T1 DOWN: milling fish, 5_2016-08-14_07-43-35.mp4

A fault was encountered on this camera a few days after this picture was taken in March 2016, which put this camera out of action until after T1 redeployment in August 2016. Following that deployment, fish were frequently observed on this camera, as illustrated in Figure 43. Occasional schooling was observed, as shown in Figure 44, however no further predators were observed on this camera in this analysis.

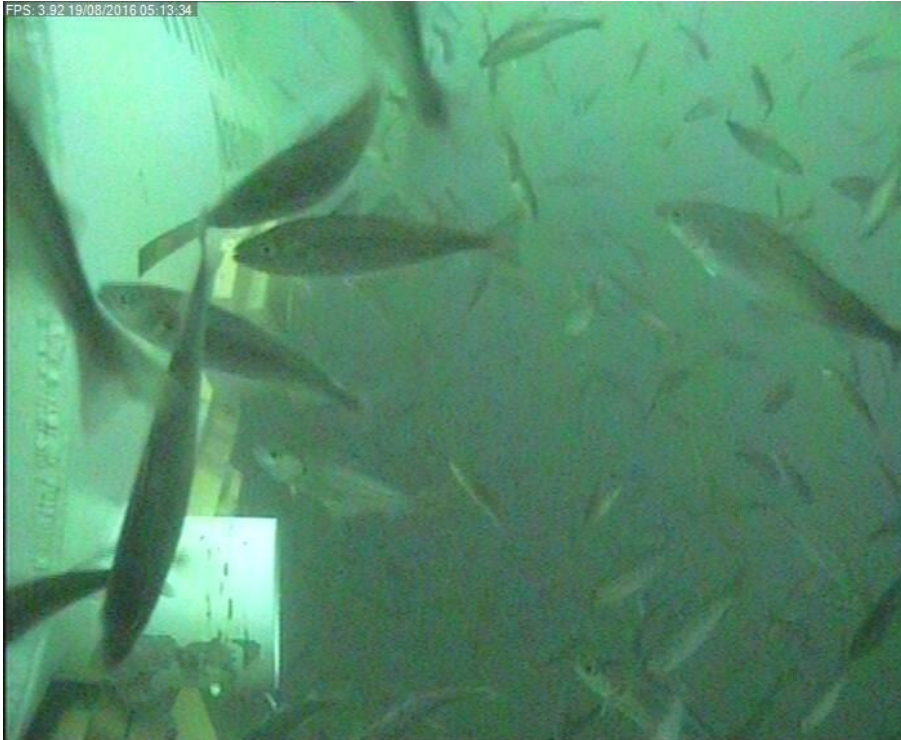
Figure 45 T2 SIDE: milling fish, 7_2016-08-19_05-13-35.mp4

Fish were frequently observed on this camera, as illustrated in Figure 45. An occasional jellyfish was also captured, as in Figure 46. However, the camera became affected by biofouling, and from mid-September 2016, biofouling on the camera window was causing the camera to trigger continuously during daylight. Whilst objects could still be seen in the water, the poor image quality made it impossible to pick out interesting events by filtering video images. No birds or mammals were observed on this camera.

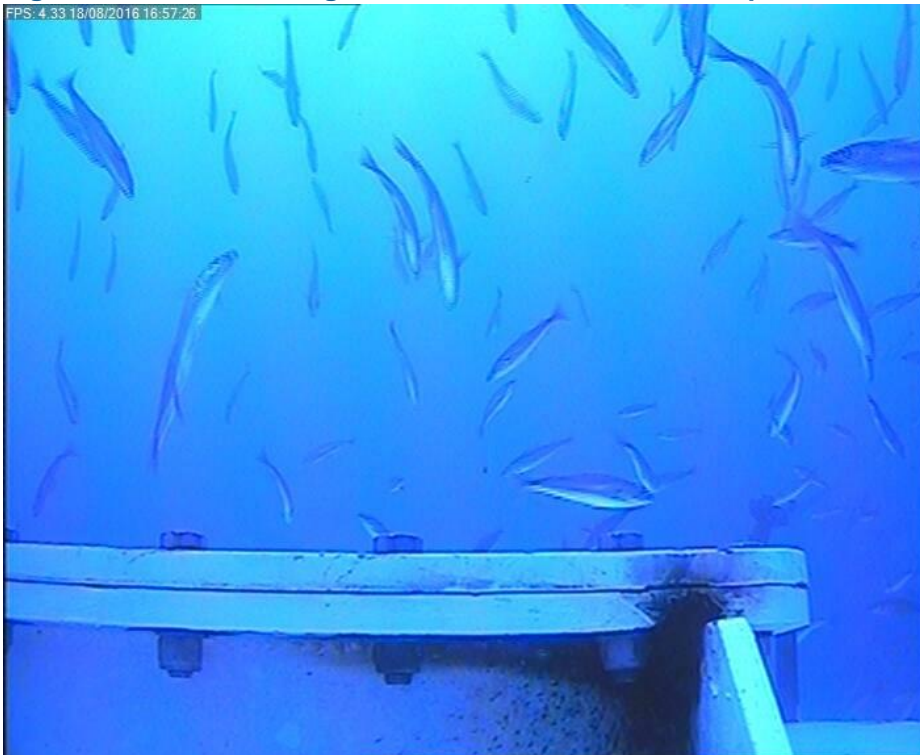
Figure 49 T2 TOP: Suspected lumpfish, 8_2016-10-03_06-15-03.mp4

Figure 48 shows a shoal of fish captured soon after deployment. As with the T1 turbine, a suspected lumpfish was also observed on the top of the T2 turbine, as shown in Figure 49 (pictured from below looking towards the head of the fish).
