Shetland Tidal Array Monitoring Report: Subsea video monitoring

EnFAIT-0364 Version 4.0

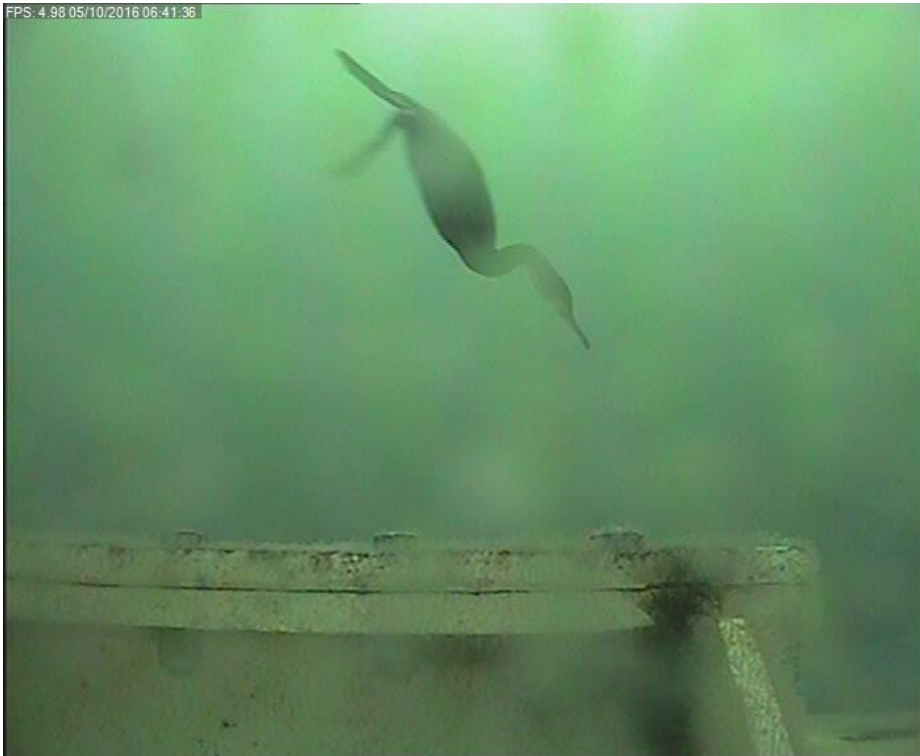
Figure 51 T2 TOP: Diving bird close-up, 8_2016-10-05_06-44-45.mp4

Three diving birds, believed to be European Shags, were observed on 5th October 2016, as shown in Figure 50, Figure 51 and Figure 52 ((a third bird not shown could be seen in video footage closer to the surface).

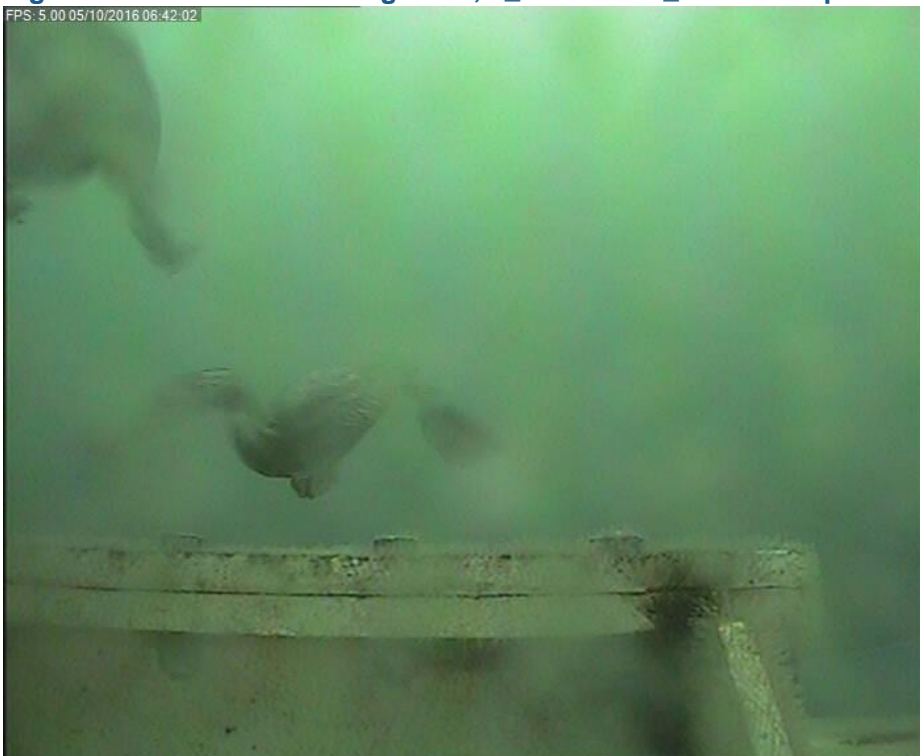
Figure 53 T2 TOP: seal passing during slack tide, 8_2016-10-14_15-34-54.mp4

As with the other cameras, image quality degraded through September. However, the uncluttered visual field for the TOP cameras makes it easier to continue to identify interesting events. Figure 53 shows a seal, thought to be a common seal, passing over the turbine during slack tide.

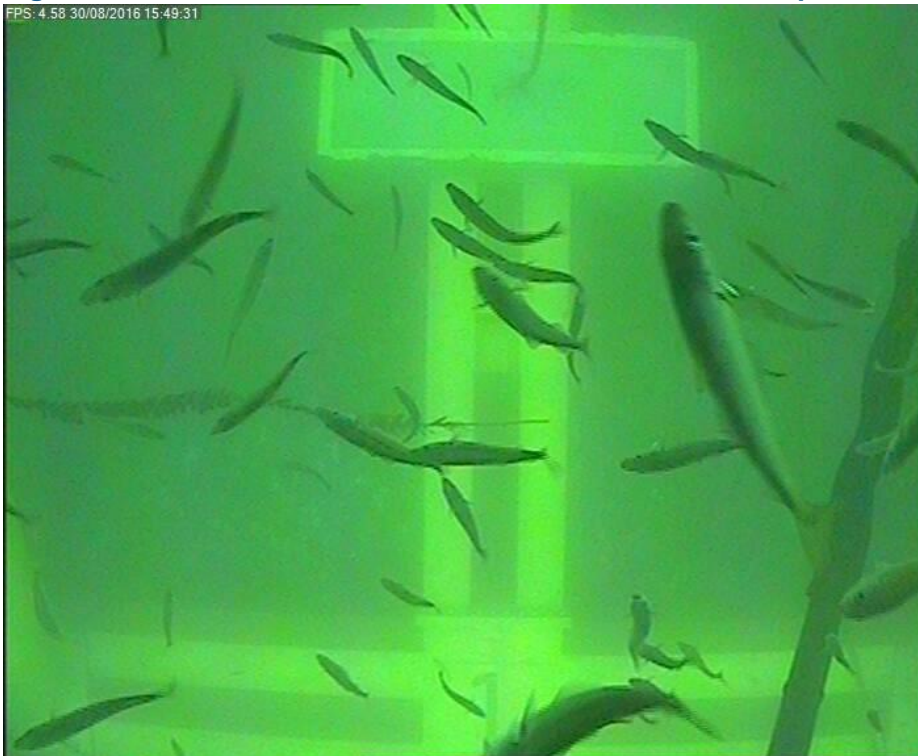
Figure 58 T2 DOWN: shoal of fish, 6_2016-08-30_15-48-37.mp4

Fish were also observed on this camera on numerous occasions, as shown in Figure 58.

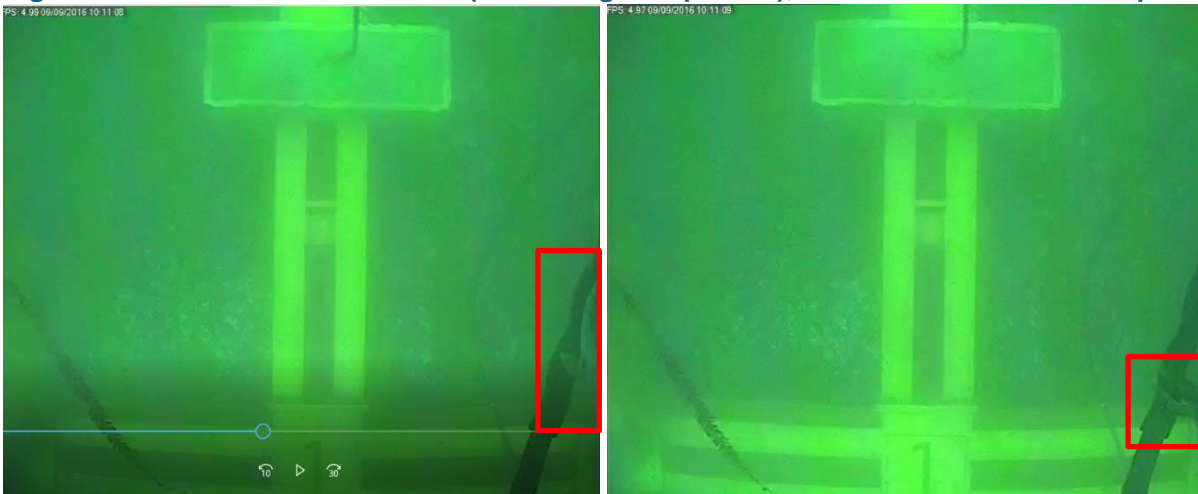
Figure 60 T2 DOWN: Possible seal (bottom right of picture), 6_2016-09-09_10-11-05.mp4

Interesting behaviour was observed on only one occasion on this camera, with a school of fish shown in Figure 59 (again during slack water). It was not possible to get a clear image of any predator from the video, but Figure 60 shows what appears to be a seal, visible on the lower right of the consecutive images. The images show one side flipper (left image), and two tail flippers (right image).

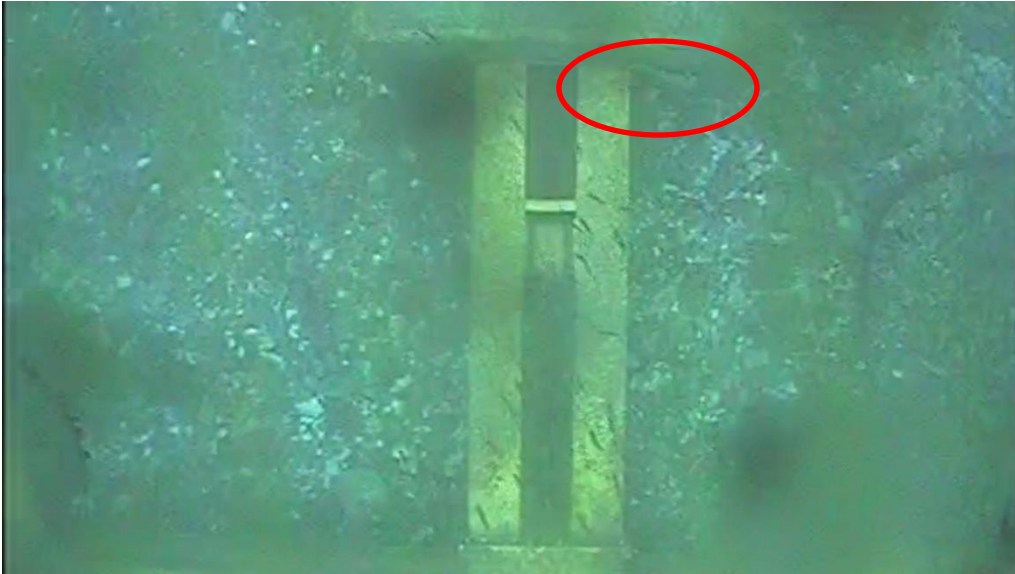
Figure 61 T2 DOWN: Unidentified fish, 6_2016-11-18_12-44-27.mp4

An unidentified species of fish was observed on 18th November. Whilst it is difficult to make out in the image below, the video reveals a fish with light colouration approximately 1m in length, possibly a dogfish, swimming close to the base of the turbine.
