## **New Creek Wind Project 2017 Post-construction Monitoring**

Results of April – November 2017  
Curtailement Evaluation, Acoustic Bat  
Monitoring, and Bird and Bat Carcass  
Surveys

January 31, 2018

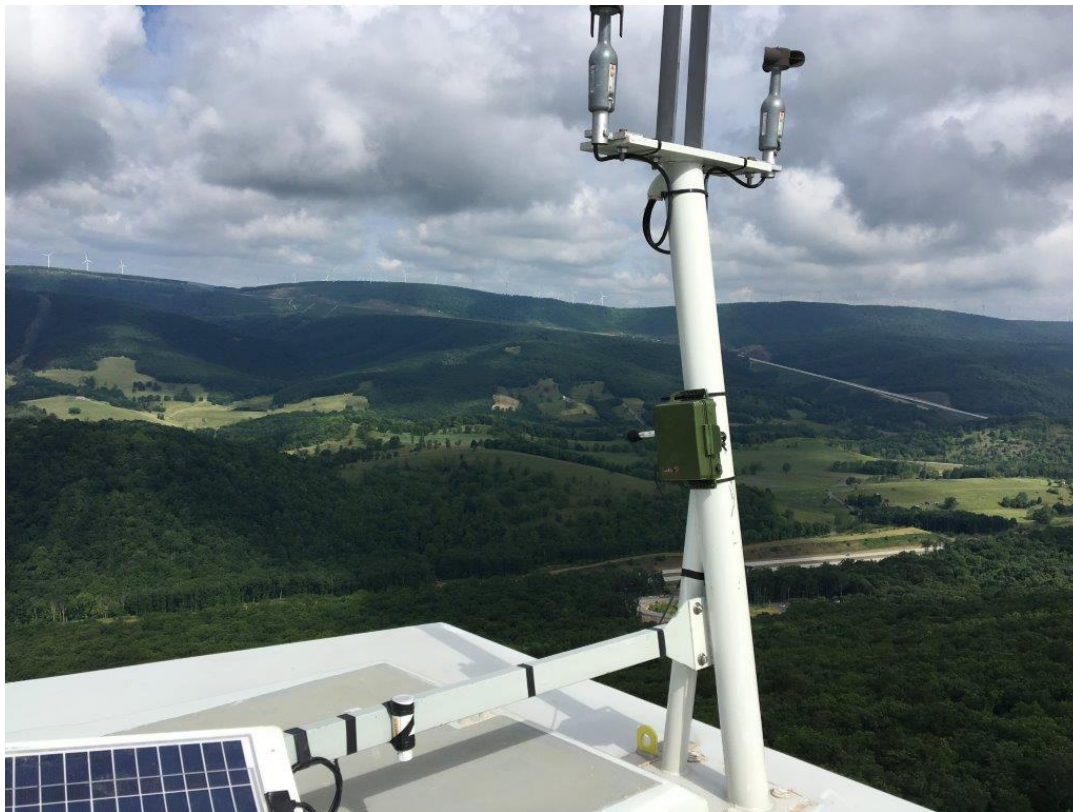
**Figure 2-1. Photo of acoustic bat detector (in green box) mounted on the nacelle of Turbine 1 at the New Creek Wind Project, 2017**

Enbridge deployed acoustic bat detectors on the nacelles of 9 wind turbines (evenly distributed among the 49 total turbines) to document bat activity in the turbine rotor zone, characterize relationships between bat activity and weather conditions, and determine the amount of bat activity exposed to turbine operation versus protected by the curtailment treatments. Full-spectrum (Wildlife Acoustics SM4) echolocation detectors were fixed to nacelle-mounted anemometer masts and were oriented facing away from the rotor (Figure 2-1). Detectors were programmed to operate continuously from 30 minutes before sunset to 30 minutes after sunrise and were powered by 12-volt battery systems charged by small solar panels. Enbridge or Gamesa staff inspected detectors when possible during the survey period to offload data and check that detectors were operating properly.

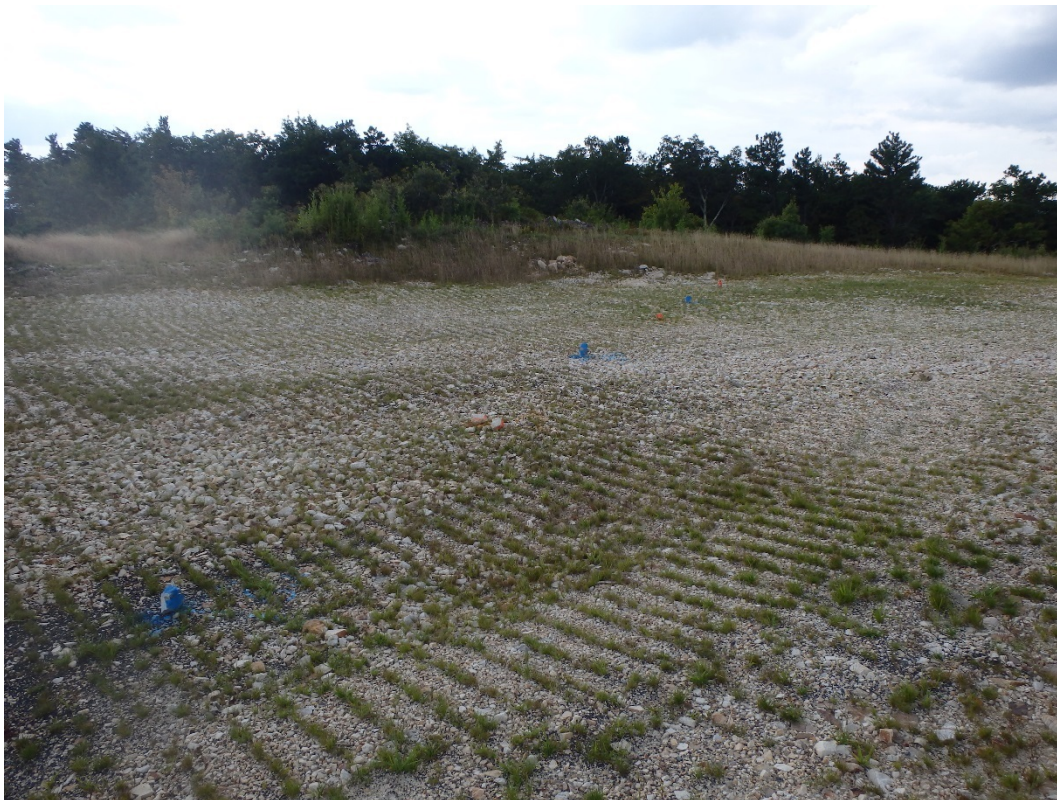
**Figure 2-2. Photo of ground conditions and transect markings (orange and blue cairns) at a typical turbine at the New Creek Wind Project, 3 August 2017**

Parallel search transects spaced at 4 m (13 ft) intervals were oriented north-to-south (magnetic) within searchable areas (see Section 2.3.1 Search Area Mapping and Management) at each turbine. Transects were marked using temporary flagging and fluorescent marking paint. Searchers visually scanned the ground on either side of the transects, walking at an approximate speed of 30 to 50 m per minute, resulting in approximate search times per full plot turbine between 25 and 60 minutes depending on the size of searchable area and survey conditions. Surveyors temporarily marked the location of any bird or bat carcasses found during the search using flagging tape.

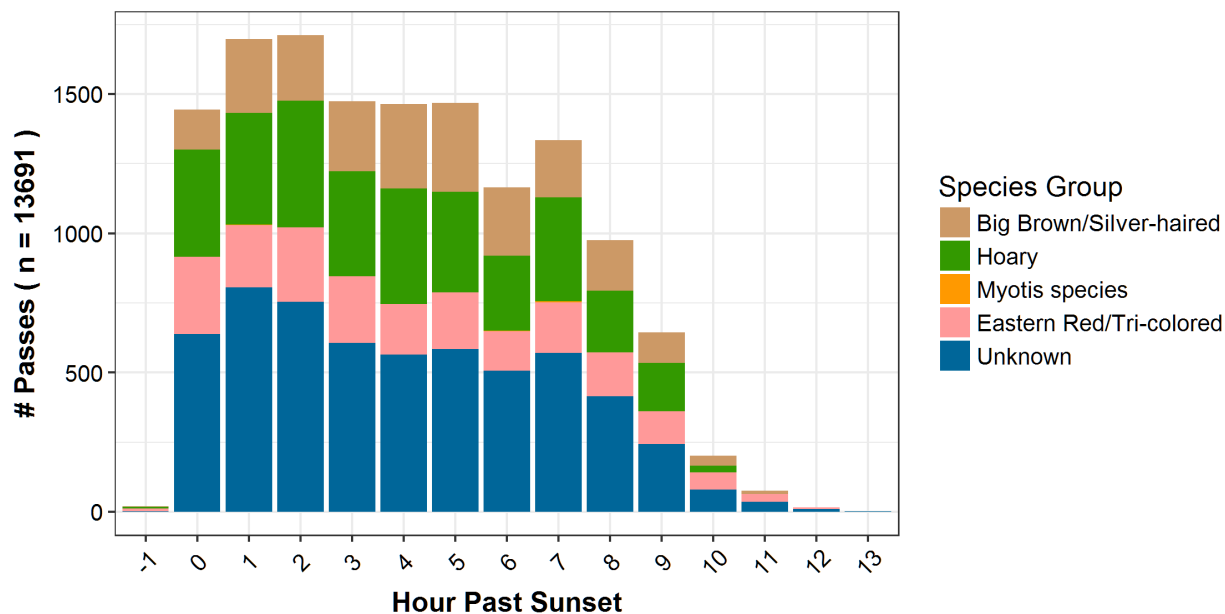
Figure 3-4. Overall timing of bat activity recorded at turbine nacelles, New Creek Wind Project, 2017

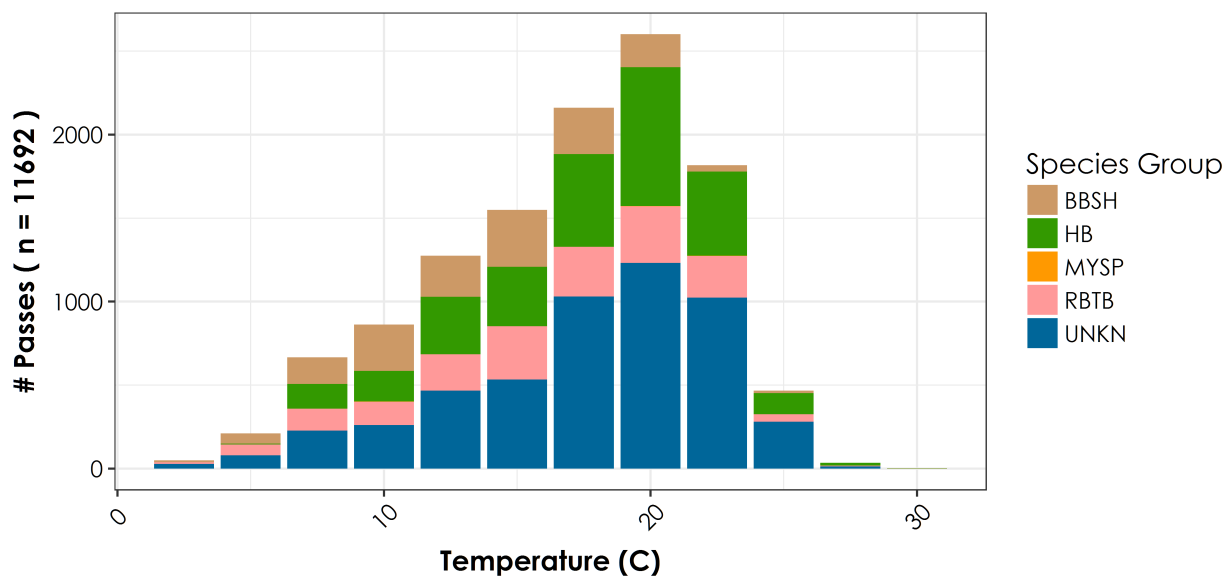
Figure 3-5. Bat activity by temperature bin (2.5 degrees C) recorded at turbine nacelles, New Creek Wind Project, 2017

Bat activity showed clear relationships with temperature and wind speed measured at corresponding turbine nacelles, with 92% of passes for which weather data were available (n = 11,692) occurring when temperature was greater than 10° C and 54% of passes occurring at wind speeds less than 4.5 m/s (Figure 3-5, Figure 3-6). Considering temperature and wind speed together, bat activity occurred disproportionately during calm, warm conditions, and few bat passes were recorded during times with higher wind speeds or cooler temperatures (Figure 3-7). Also, Figure 3-7 suggests an apparent interaction between the effects of temperature and wind speed on bat activity, with activity during windy conditions occurring primarily at warmer temperatures.

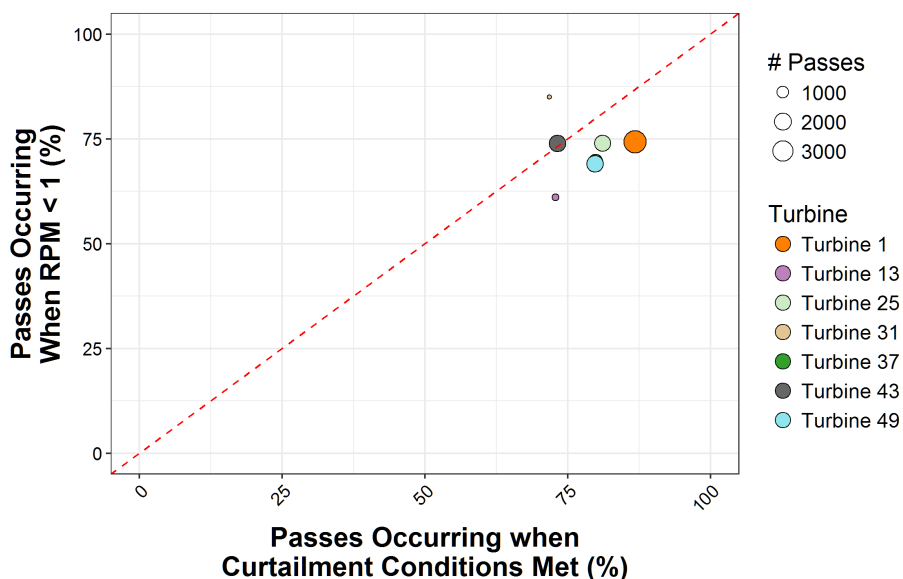
**Figure 3-8. Predicted avoidance (passes recorded when curtailment conditions were met) versus actual avoidance (passes recorded when RPM < 1) of bat activity at nacelle height, New Creek Wind Project, 2017**

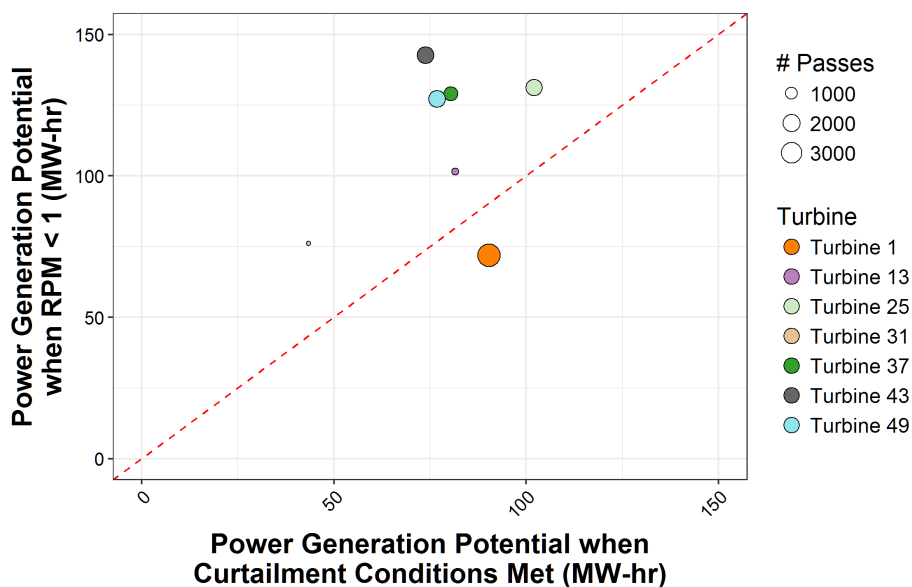
Figure 3-9. Predicted energy loss (energy production potential during periods when curtailment conditions were met) versus actual energy loss (energy production potential during periods when RPM < 1) measured at 7 turbines with acoustic bat detectors, New Creek Wind Project, 2017

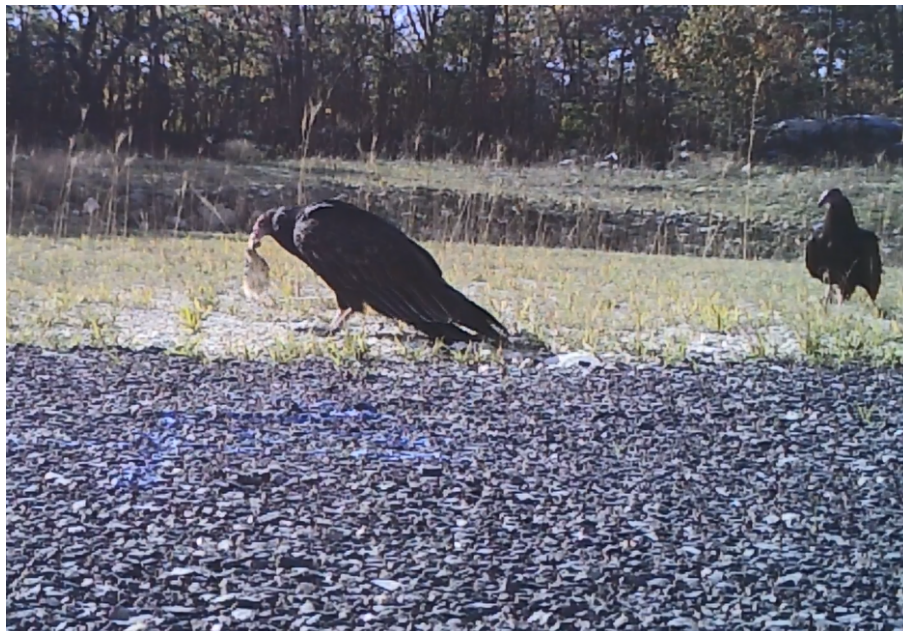
Stantec deployed automatic game cameras at selected trials occasionally during the 2017 monitoring period and recorded videos of American crows (*Corvus brachyrhynchos*), common ravens (*Corvus corax*), and turkey vultures removing carcasses (Figure 3-14). Cameras also documented activity of other potential scavengers including black bears and bobcats, although none were observed removing carcasses.

**Figure 3-14. Turkey vulture removing a trial carcass (quail) from Turbine 18 on 20 October 2017**

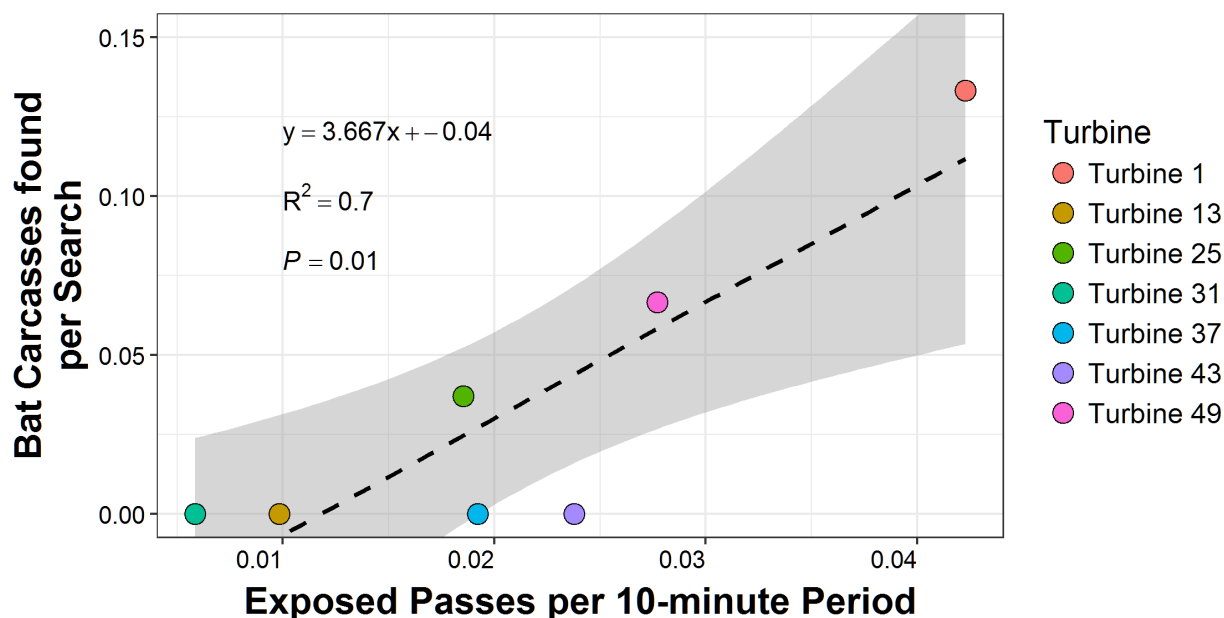
**Figure 3-15. Relationship between bat activity (passes per 10-minute period) and fatality (carcasses found per search) for the 7 turbines with operating acoustic detectors, New Creek Wind Project, 2017**

Stantec found 7 bat carcasses at the 7 turbines with acoustic datasets. Based on these turbines, the total number of bat carcasses found per turbine search was significantly higher at turbines with higher levels of acoustic data (Figure 3-15). Because all turbines were curtailed throughout the monitoring period, an insufficient sample size of bat carcasses was available for more detailed analyses of bat activity versus fatality (e.g., nightly analyses).

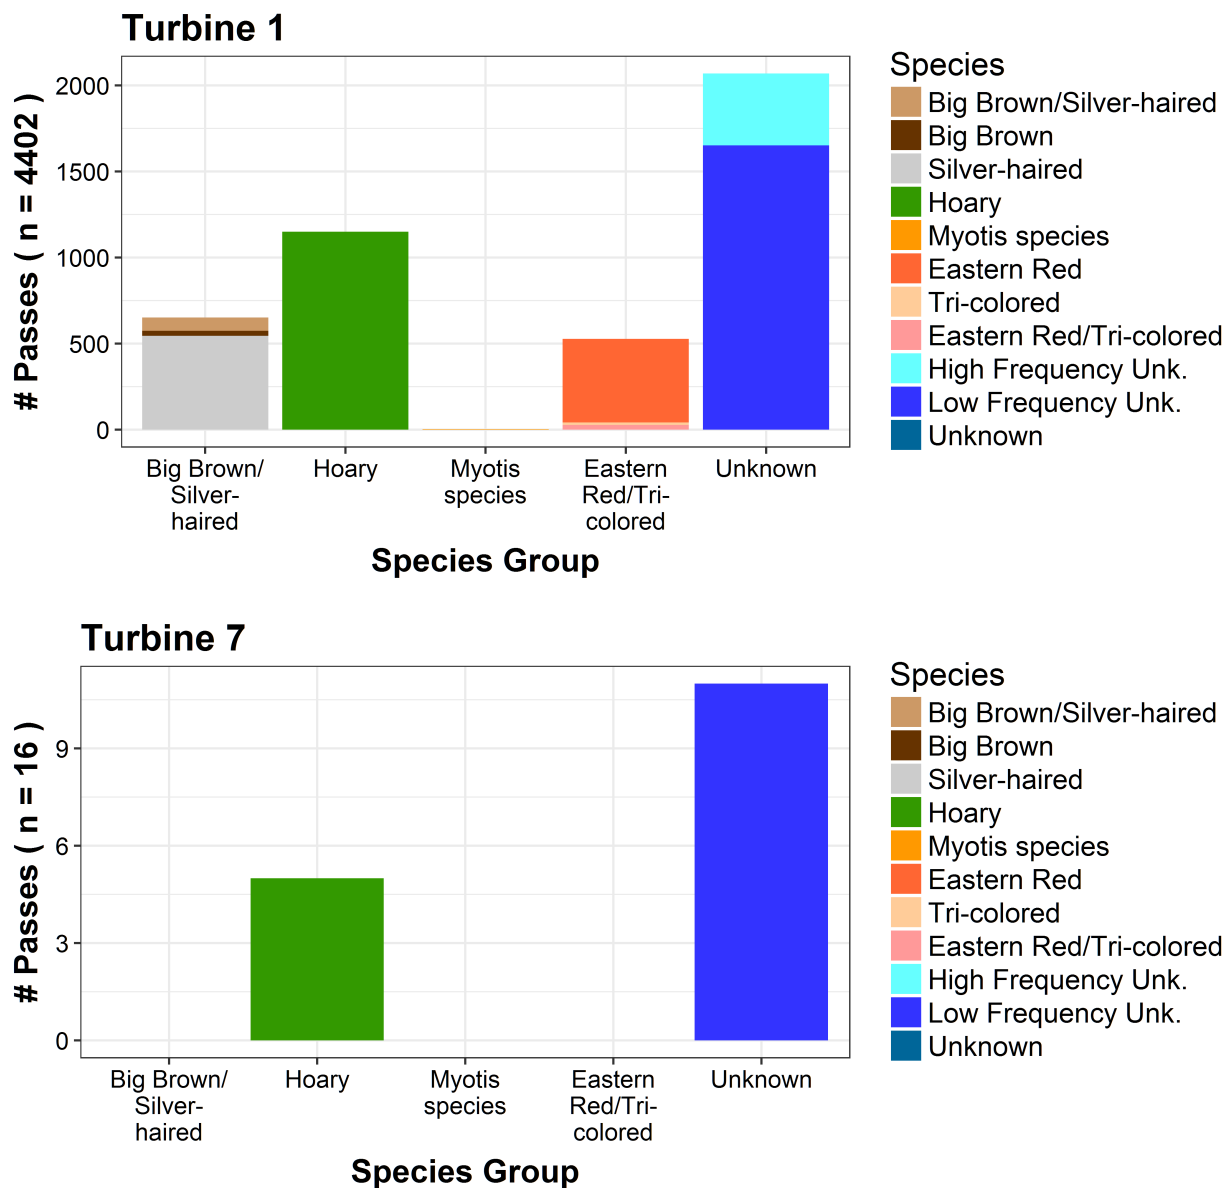
Appendix B Figure 1. Species composition of bat activity detected by turbine, New Creek Wind Project, 2017
