## **New Creek Wind Project 2018 Post-construction Monitoring**

Results of April – November 2018  
Curtailed Evaluation, Acoustic Bat  
Monitoring, and Bird and Bat Carcass  
Surveys

January 31, 2019

Stantec Consulting Services Inc.  
30 Park Drive  
Topsham, ME 04086

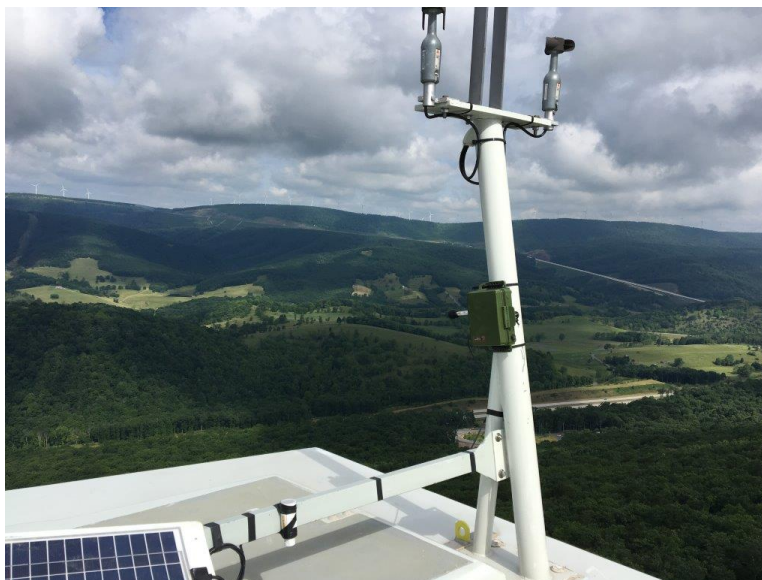
**Figure 2-1. Photo of acoustic bat detector (in green box) mounted on the nacelle of Turbine 1 at the New Creek Wind Project (photo from 2017).**

Enbridge deployed acoustic bat detectors on the nacelles of 10 wind turbines (evenly distributed among the two treatment groups) to document bat activity in the turbine rotor zone, characterize relationships between bat activity and weather conditions, and determine the amount of bat activity exposed to turbine operation versus protected by the curtailment treatments. Full-spectrum (Wildlife Acoustics SM4) echolocation detectors were fixed to nacelle-mounted anemometer masts and were oriented facing away from the rotor (Figure 2-1). Detectors were programmed to operate continuously from 30 minutes before sunset to 30 minutes after sunrise and were powered by 12-volt battery systems charged by small solar panels. Enbridge or Gamesa staff inspected detectors when possible during the survey period to offload data and check that detectors were operating properly.

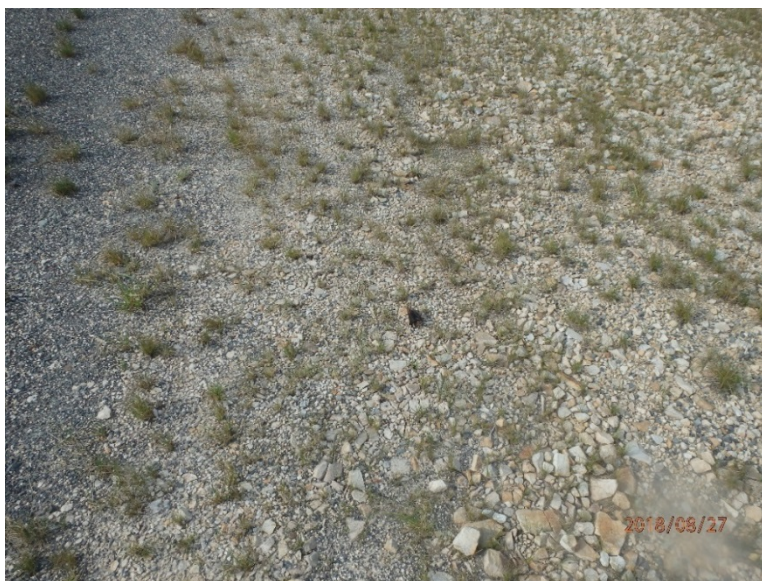
**Figure 2-2. Photo of ground conditions and hoary bat carcass (centered in photo) at Turbine 11 at the New Creek Wind Project, 27 August 2018.**

Typically, mowing or other similar vegetation management is conducted periodically to improve visibility of the ground and maximize searcher efficiency, which in turn improves the precision of mortality estimates (Sonnenburg and Erickson 2010). However, vegetation remained sparse throughout the 2018 monitoring period, such that mowing was not required (Figure 2-2).

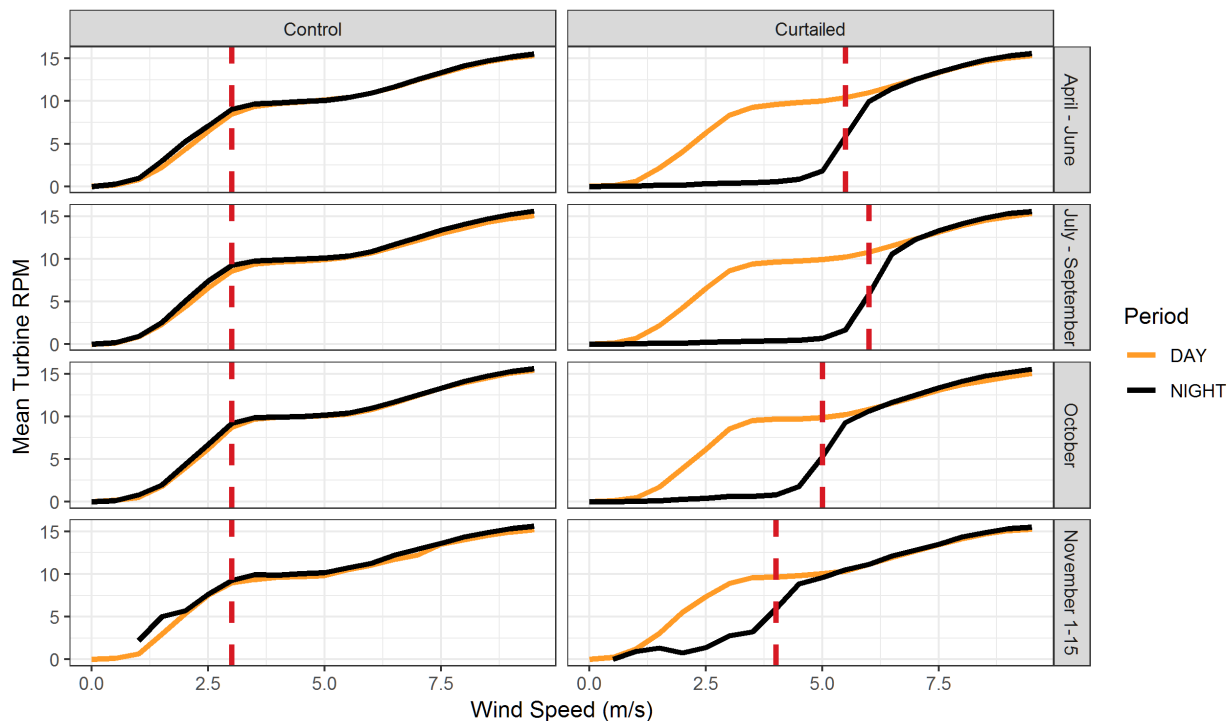
Figure 3-1. Mean turbine RPM by operational treatment, time period, and time of year and associated cut-in speed (vertical red line) for the New Creek Wind Project, 2018.

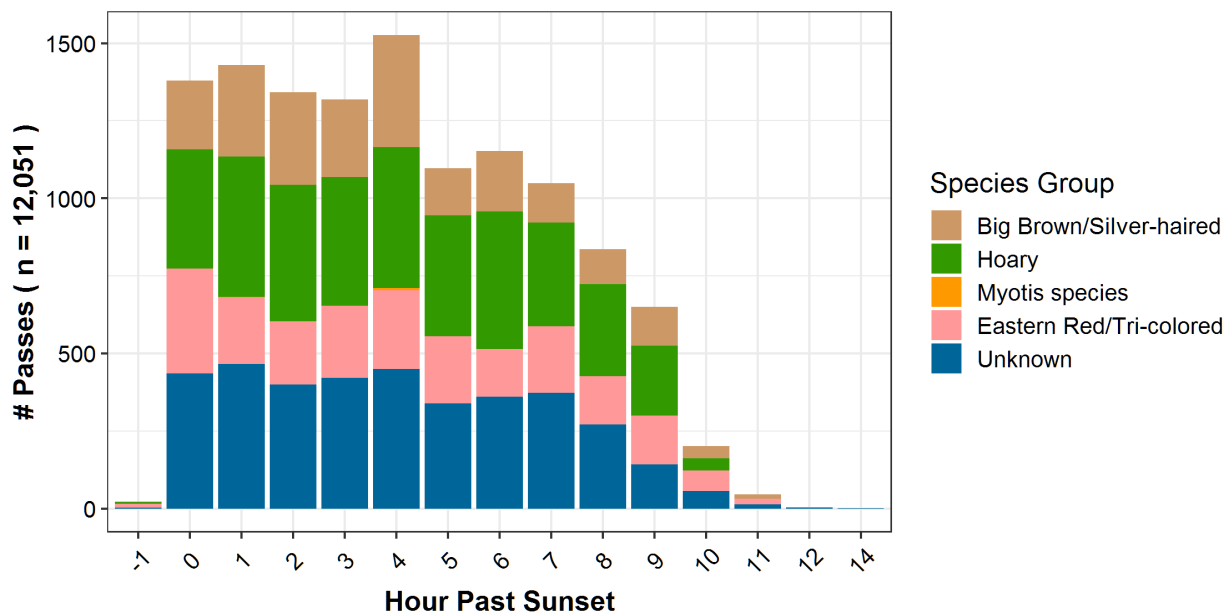
Figure 3-4. Overall timing of bat activity recorded at turbine nacelles, New Creek Wind Project, 2018

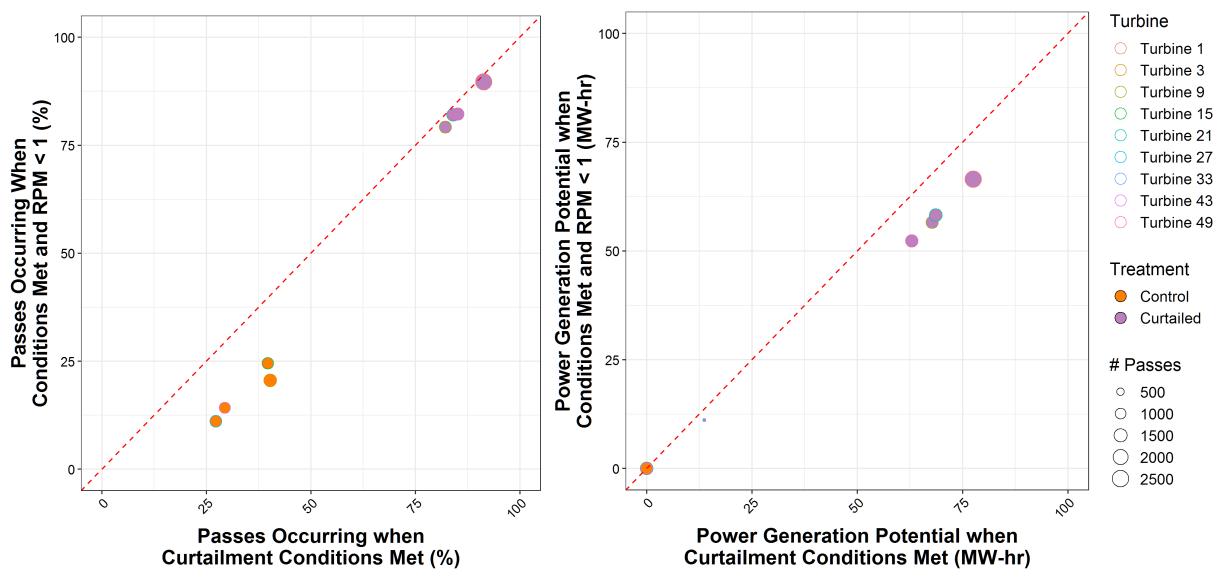
Figure 3-8. Simulated (conditions met) and actual (conditions met and RPM < 1) avoidance of bat activity (left) and power loss (right), New Creek Wind Project, 2018

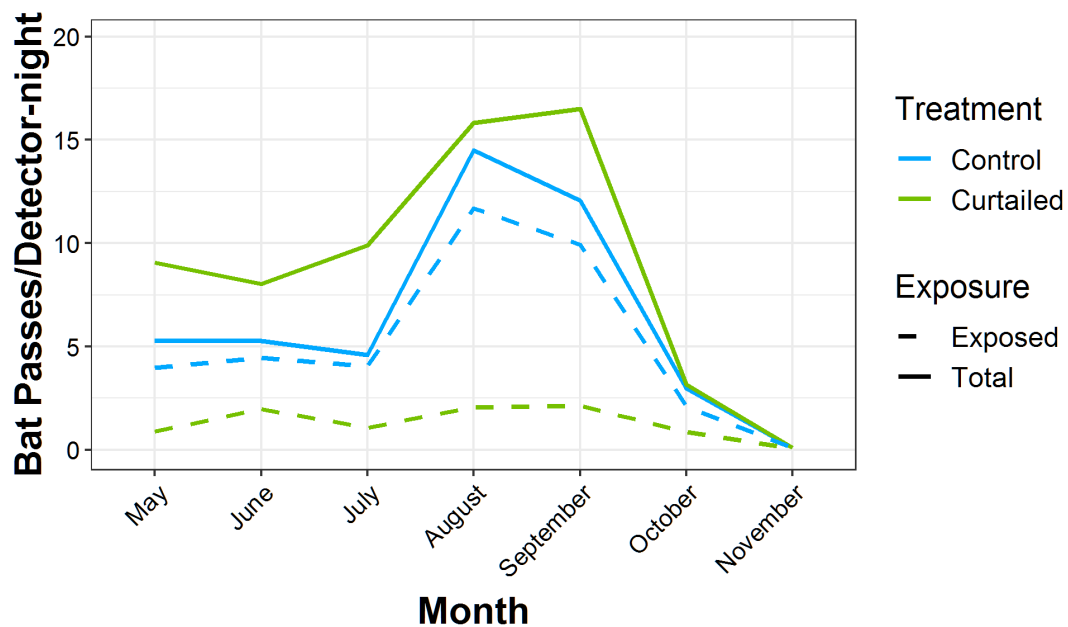
Figure 3-9. Total and exposed (occurring when turbine RPM > 1) bat activity by month and treatment, adjusted for survey effort based on 9 nacelle-mounted acoustic detectors at the New Creek Wind Project during 2018

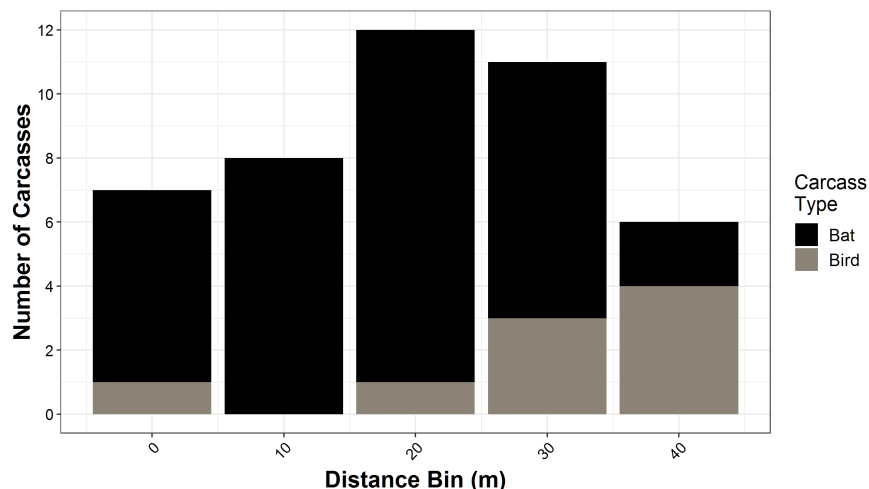
**Figure 3-12. Bat and bird carcasses found within survey plots according to distance from turbine (including incidentals) at the New Creek Wind Project from 4 May to 14 November 2018**

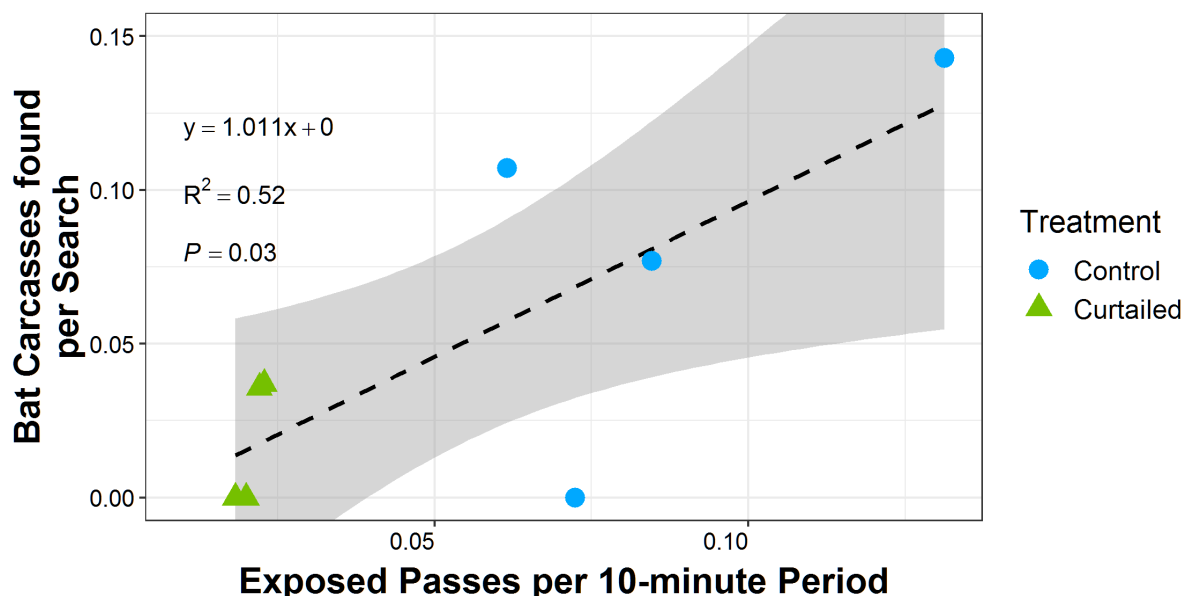
**Figure 3-13. Relationship between bat activity (passes per 10-minute period) and fatality (carcasses found per search) for the 8 turbines with operating acoustic detectors, New Creek Wind Project, 2018**

Stantec found 11 bat carcasses at the 8 turbines with acoustic datasets representing most of the monitoring period. Based on these turbines, the total number of bat carcasses found per turbine search was significantly higher at turbines with higher levels of acoustic data (Figure 3-13). An insufficient sample size of bat carcasses was available for more detailed analyses of bat activity versus fatality (e.g., nightly analyses).

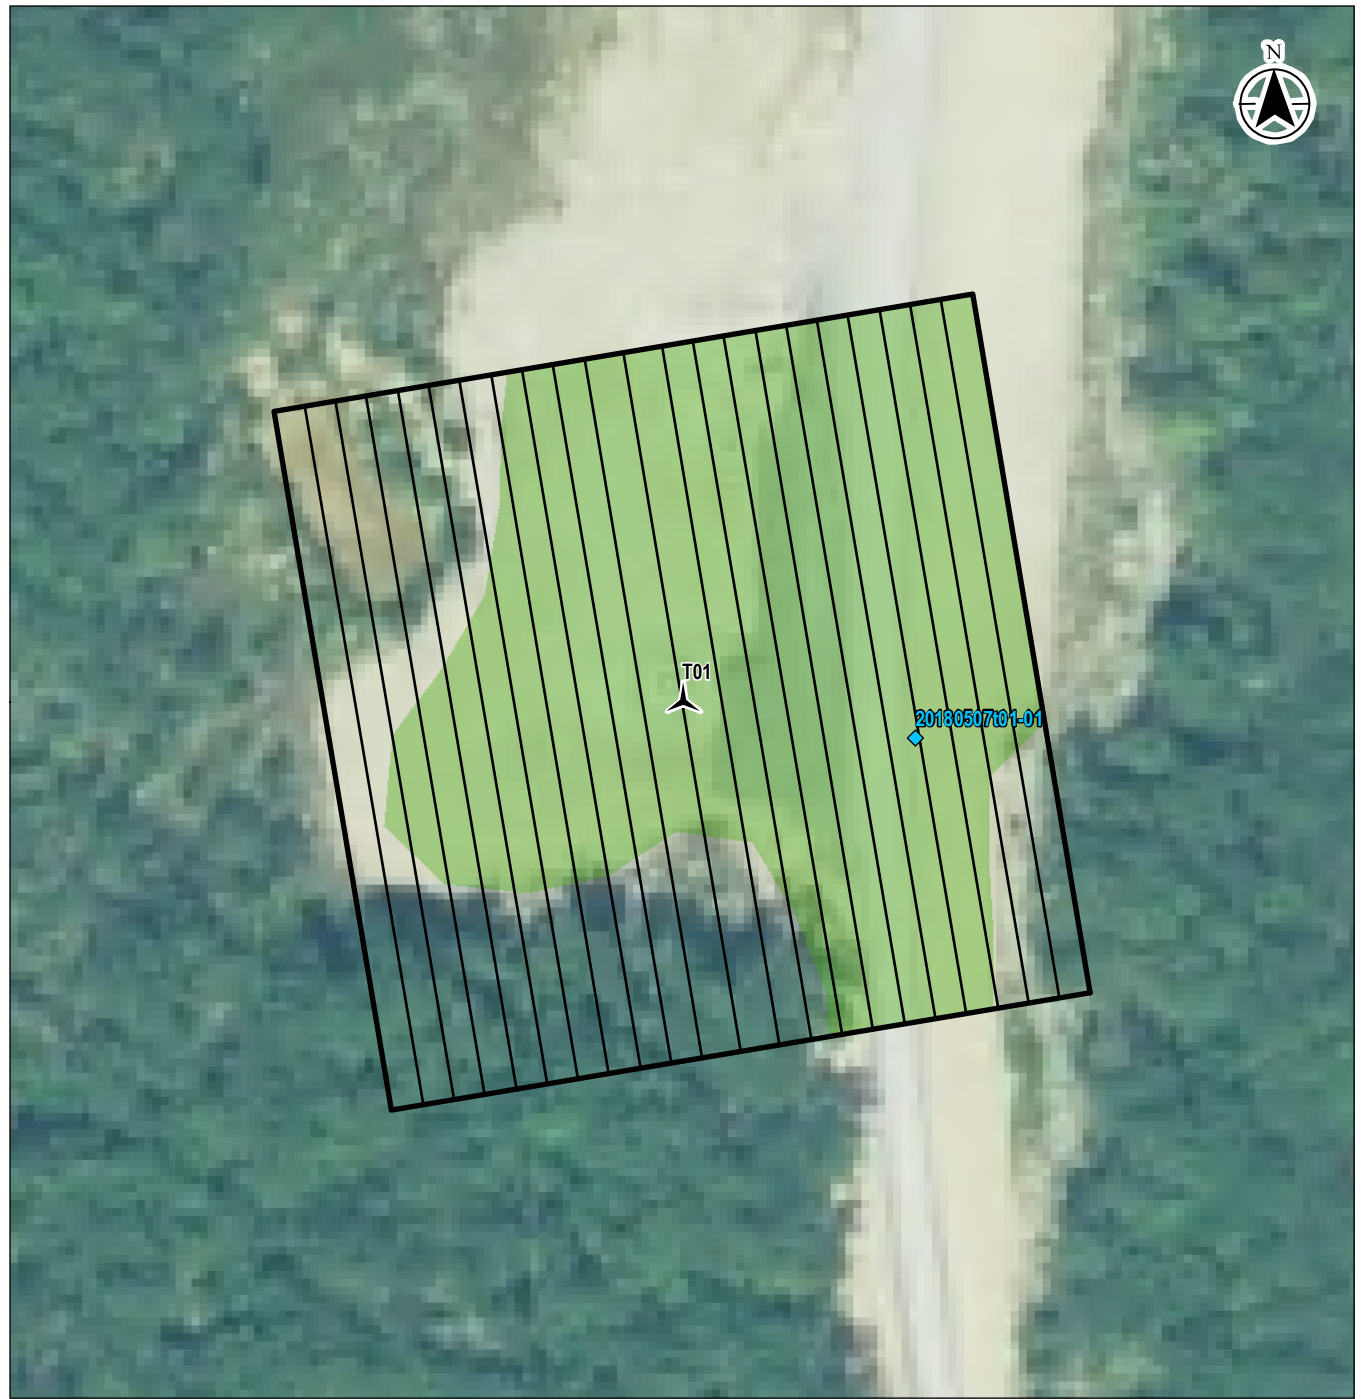
Figure No. 1

- Legend**
- ◆ Bat Carcass Location
  - ▲ Turbine Location
  - Survey Transect
  - Survey Grid Area
  - Search Area

1. Coordinate System: NAD 1983 UTM Zone 17N
2. Orthoimagery: NAIP 2016
3. Survey grid area and carcass azimuths measured from magnetic north (approximate declination 9.603°).

No more than 1 bat carcass was found per turbine during an individual search, except on 31 August when 2 hoary bats were found at Turbine 19. No more than 1 bird carcass was found per turbine search. Bat carcasses were found between 4 and 48 m from turbines, and bird carcasses were found between 2 and 48 m from turbines (Figure 3-12). There were also 3 incidental bird carcasses found outside the search area beyond 60 m. Appendix D includes a map of each turbine showing the extent of searchable area and location of all bird and bat carcasses.
