**NATURAL RESOURCES IMPACT
ASSESSMENT UNDER
30 V.S.A 248(B)(5)
GEORGIA MOUNTAIN
COMMUNITY WIND PROJECT**

March 17, 2009

Georgia Mountain Community Wind, LLC

ARROWWOOD ENVIRONMENTAL

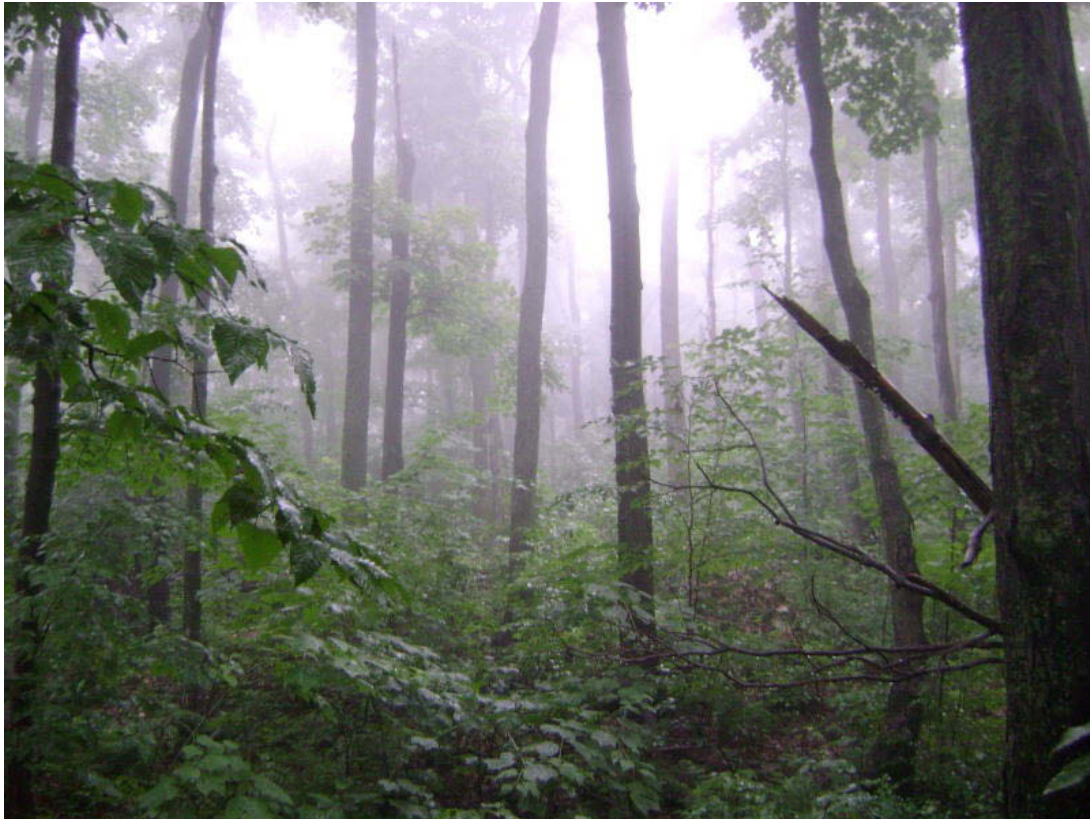
Figure 2. Northern Hardwood Forest in the Northern Part of the Study Area

This forest is fairly variable in terms of moisture and nutrient availability. Some steeper areas are drier while the bases of slopes tend to be moister and richer. Surficial rocks are common in some areas. Soils are loams and fine sandy loams with depth varying from 10-20 inches over un-weathered bedrock.

The presence of this community in the northern part of the Project study area corresponds with the northern facing slopes of Georgia Mountain. As is discussed below, the forests with a more dominant oak component are relegated mainly to the slopes with a southern aspect. But on these northern and eastern slopes, the Northern Hardwood Forest community predominates. This occurrence appears to be sandwiched in between the drier Mesic Red Oak-Northern Hardwood Forests to the south and the more enriched Rich Northern Hardwood Forest on the lower slopes to the north. The canopy in this forest is dominated by sugar maple (*Acer saccharum*), black cherry (*Prunus serotina*), American ash (*Fraxinus americana*), and yellow birch (*Betula alleghaniensis*). Northern red oak (*Quercus rubra*) is found occasionally in this community, but in isolated dry pockets, not typically as a canopy co-dominant. Due to recent logging in this forest, the canopy is fairly open, ranging from 50-80%. This open canopy has resulted in a lot of shrub growth. Red raspberry (*Rubus idaeus*), striped maple (*Acer pensylvanicum*) and various canopy species are common in this layer. Common herbs include wild sarsaparilla (*Aralia nudicaulis*), acuminate aster (*Aster acuminatus*), and Evergreen Woodfern (*Dryopteris intermedia*). There are localized areas of enriched conditions with herbs such as blue cohosh (*Caulophyllum thalictroides*) and herb robert (*Geranium robertianum*). These enriched areas may be more common in areas lower on the mountain slope.

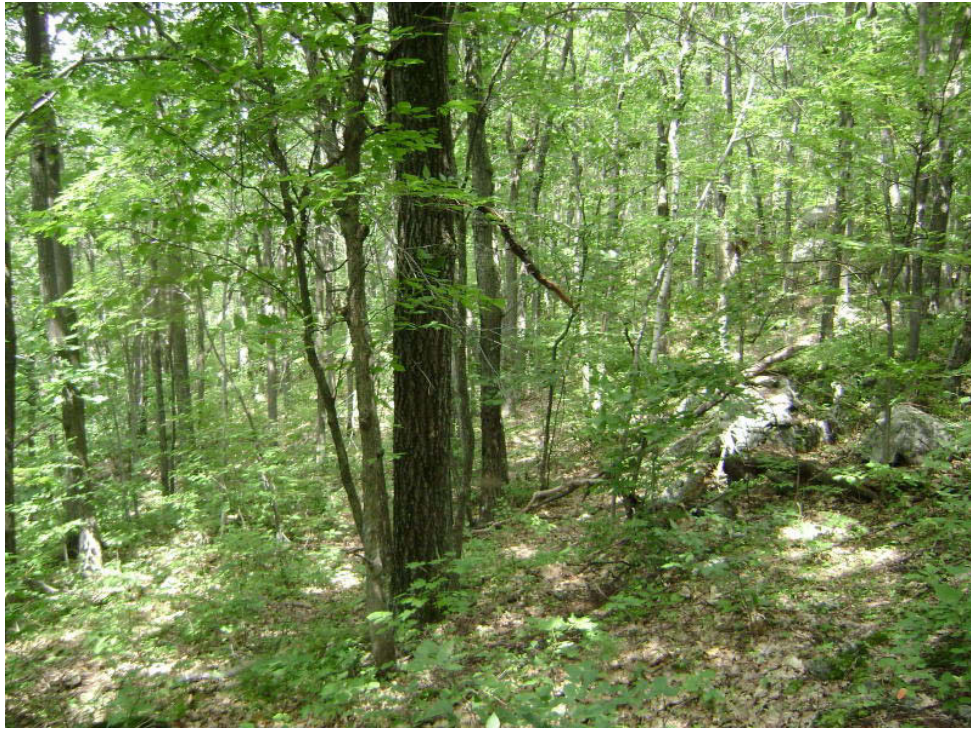
Figure 3. Mesic Red Oak-Northern Hardwood Forest

The canopy of the Mesic Red Oak-Northern Hardwood Forest is dominated by a mixture of northern red oak (*Quercus rubra*), sugar maple (*Acer saccharum*), and American beech (*Fagus grandifolia*). More Mesic sites also have black cherry (*Prunus serotina*) and American ash (*Fraxinus americana*), whereas hop hornbeam (*Ostrya virginiana*) is more common in the drier sites. Hobblebush (*Viburnum lantanoides*) is a common short shrub in these forests, sometimes becoming very dense. The herbaceous layer is fairly variable depending on the site but throughout seems to be rather sparse. Common herbs include wild sarsaparilla (*Aralia nudicaulis*), Canada mayflower (*Maianthemum canadense*), and evergreen woodfern (*Dryopteris intermedia*). On the slightly drier sites, Pennsylvania sedge (*Carex pensylvanica*) is also common.

Soils in this community are loams and silt loams with depth varying depending on the local site conditions. These variations in soil depth often drive the variation seen in the vegetation as described above. In more mesic areas, soils can reach 20 inches deep, whereas in the drier areas, typical depth is around 8-10 inches. This forest has seen a fair amount of active management in recent years. A 24 acre clearcut from 1996 is present in the south end of the study area. Selective logging has also occurred in other areas throughout the study area. In addition, ATV traffic on various ATV trails and old logging roads is fairly common in this and the other natural communities on Georgia Mountain.

The current condition of this forest has been given a sub-rank of B. This B-rank is the result of the management history. As mentioned above, this forest has seen a fairly active management regime in recent years. Even though these impacts are temporary, they have affected the condition rank. In addition, the numerous ATV trails, snowmobile trails, logging roads and cell tower access road that criss-cross this community have also affected the condition rank.

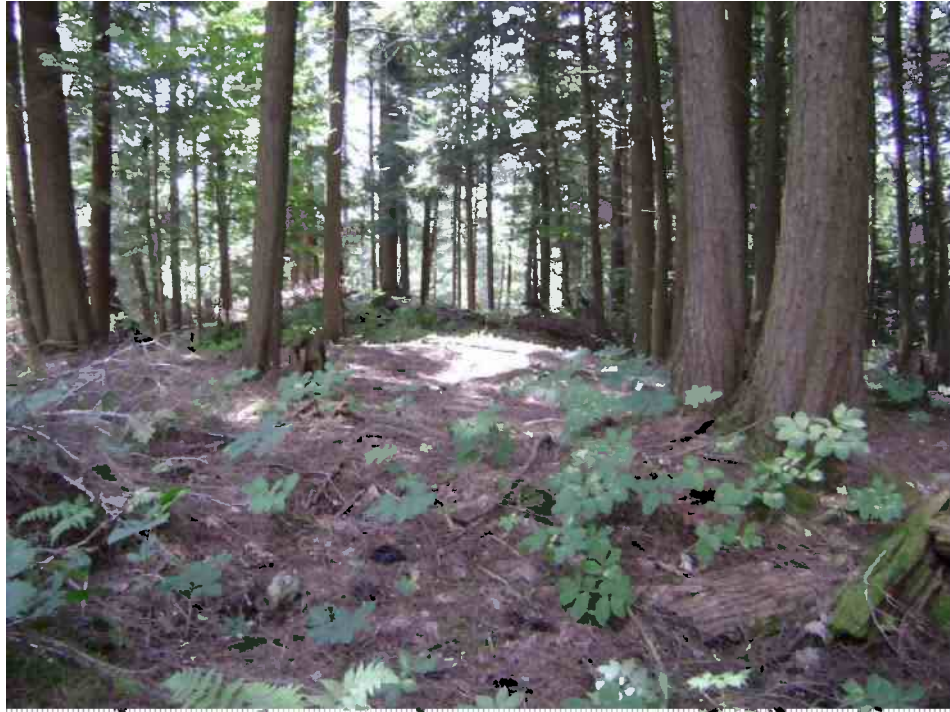
Figure 4. Hemlock Forest

The Hemlock Forest community can be found in many parts of the state on steep ravines, lower mountain slopes and on the summits of lower elevation knolls. There are two occurrences of this conifer dominated community within the study area, together comprising about 40 acres. The occurrence in the southeastern part of the study area is a narrow band of hemlock on a very steep west-facing slope. The western occurrence sits on gentler, south facing slopes. Both are dominated by a canopy of hemlock (*Tsuga canadensis*) trees. Yellow birch (*Betula alleghaniensis*) and red maple (*Acer rubrum*) are also found in the canopy but don't become dominant. White pine (*Pinus strobus*), on the other hand, becomes co-dominant in some areas, especially the southern part of the western occurrence. Canopy cover is typically dense, ranging from 70-100% and tree height is approximately 50-60 feet. The shrub and herbaceous layers are rather sparse. Occasional hobblebush (*Viburnum lantanooides*) and yellow birch shrubs are found, while the herbaceous layer is composed of scattered marginal wood fern (*Dryopteris marginalis*), common wood-sorrel (*Oxalis acetosella*) and goldthread (*Coptis trifolia*). Surficial rocks as well as bedrock outcrops are common and the loamy soils are fairly shallow. The example in the southeastern part of the study area also has small cliff and ledge faces scattered throughout this community.

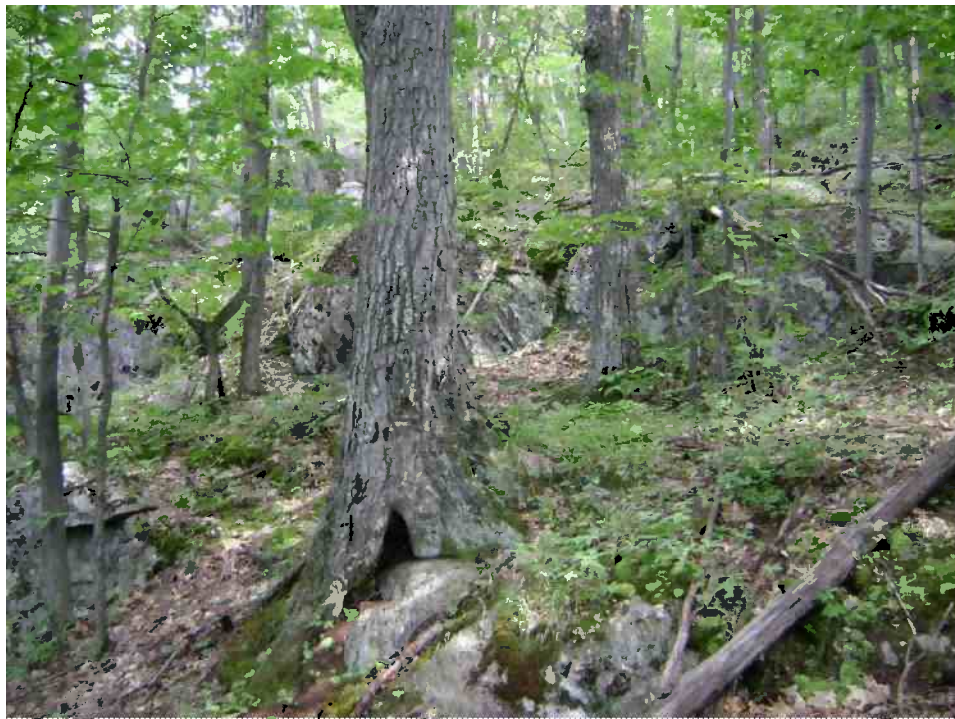
Figure 5. Dry Oak Hickory Hophornbeam Forest

There are two different varieties of this community shown on the attached map: the standard Dry Oak-Hickory-Hophornbeam Forest and a slightly richer variant called a Sugar Maple-Hophornbeam Forest. The standard Dry Oak-Hickory-Hophornbeam Forest is dominated by northern red oak (*Quercus rubra*), red maple (*Acer rubrum*) and American beech (*Fagus grandifolia*). Canopy cover ranges from 50-90% and tree height from 30-60 feet. In areas that are drier and have more bedrock outcrops, both canopy cover and tree height are at the lower ends of those ranges. There is a moderate sub-canopy cover composed of musciewood (*Carpinus caroliniana*), hop hornbeam (*Ostrya virginiana*) and the various canopy species. The shrub layers are dominated by canopy and sub-canopy species as well as maple-leaved viburnum (*Viburnum acerifolium*), lower lowbush blueberry (*Vaccinium angustifolium*), striped maple (*Acer pensylvanicum*), and shadbush (*Amelanchier sp.*). The herbaceous layer is sparse to moderate with cover values ranging from 20-60%. As with the canopy layer, the herbaceous layer tends to be sparser in areas dominated by bedrock outcrops. Common species include acuminate aster (*Aster acuminatus*), Canada mayflower (*Maianthemum canadense*), Pennsylvania sedge (*Carex pensylvanica*) and common bellwort (*Uvularia sessilifolia*).

Three small occurrences of Sugar Maple Hophornbeam Forests are mapped in the study area. These are sites surrounded by the Mesic Red Oak-Northern Hardwood Forest but occur on knolls and areas of shallow soil resulting in drier conditions. These sites resemble the Dry Oak-Hickory-Hophornbeam Forests described above but tend to be a little more mesic (moist) and slightly calcareous. This results in the oaks being replaced by species such as Sugar Maple (*Acer saccharum*) and American Beech (*Fagus grandifolia*). In some areas, these sites are richer and more diverse, resembling the Mesic Maple-Ash-Hickory-Oak Forest.

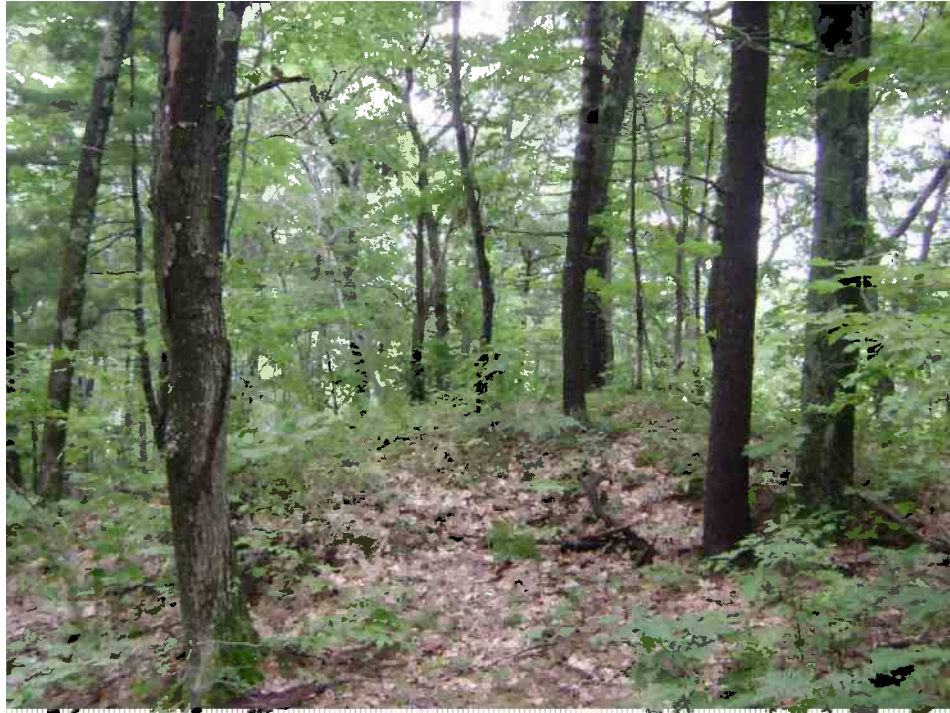
Figure 6. White Pine-Red Oak-Black Oak Forest

There are two occurrences of this community which have been mapped within the Project study area. The largest occurrence sits on the southern slope of the Georgia Mountain summit. There is also a small, 1 acre stand of this community in the southeastern corner of the study area. Both of these occurrences are fairly similar to the Dry Oak-Hickory-Hophornbeam Forest described above but occupy the drier areas with shallower soils and more frequent bedrock outcrops. Floristically, they can be distinguished by the presence of occasional white pine (*Pinus strobus*) and red pine (*Pinus resinosa*) in the canopy of the White Pine-Red Oak-Black Oak Forest. The presence of these species potentially suggests a historic fire regime in this forest. Lower lowbush blueberry (*Vaccinium angustifolium*) shrubs are more common in this community than in the Dry Oak-Hickory-Hophornbeam Forest. The herbaceous layer is also similar, but bracken (*Pteridium aquilinum*), common hairgrass (*Deschampsia flexuosa*) and common oatgrass (*Danthonia spicata*) are more common. In some areas (especially on the summit) where pine is less abundant these forests resemble the Dry Oak Forest community. The occurrence of hardwoods such as red maple and beech along with the white pine component, however, warrant their classification as White Pine-Red Oak-Black Oak Forest.

Like the Dry Oak-Hickory-Hophornbeam Forest, the soils in this community are shallow loams, rarely reaching depths greater than 10 inches. Bedrock outcrops are frequent, however, resulting in many areas where 3”-7” of soil is the norm. These sites are excessively to somewhat excessively drained and can be droughty during the summer months. As mentioned above, it is likely that fire historically played a role in the development of this community.

The White Pine-Red Oak-Black Oak Forest community is an S3 ranked community in Vermont. Using NNHP ranking guidelines, these two occurrences are considered a single “element” and receive the same EO rank. The NNHP has ranked these sites as B-ranked communities and as such the site is considered by NNHP as a significant natural community. However, one factor that has affected the condition rank of the largest example of this community is the presence of the cell tower and cell tower access road. This development cuts through the center of the community and fragments the stand to some degree. This community should not, in our opinion, be considered a rare or irreplaceable natural area.

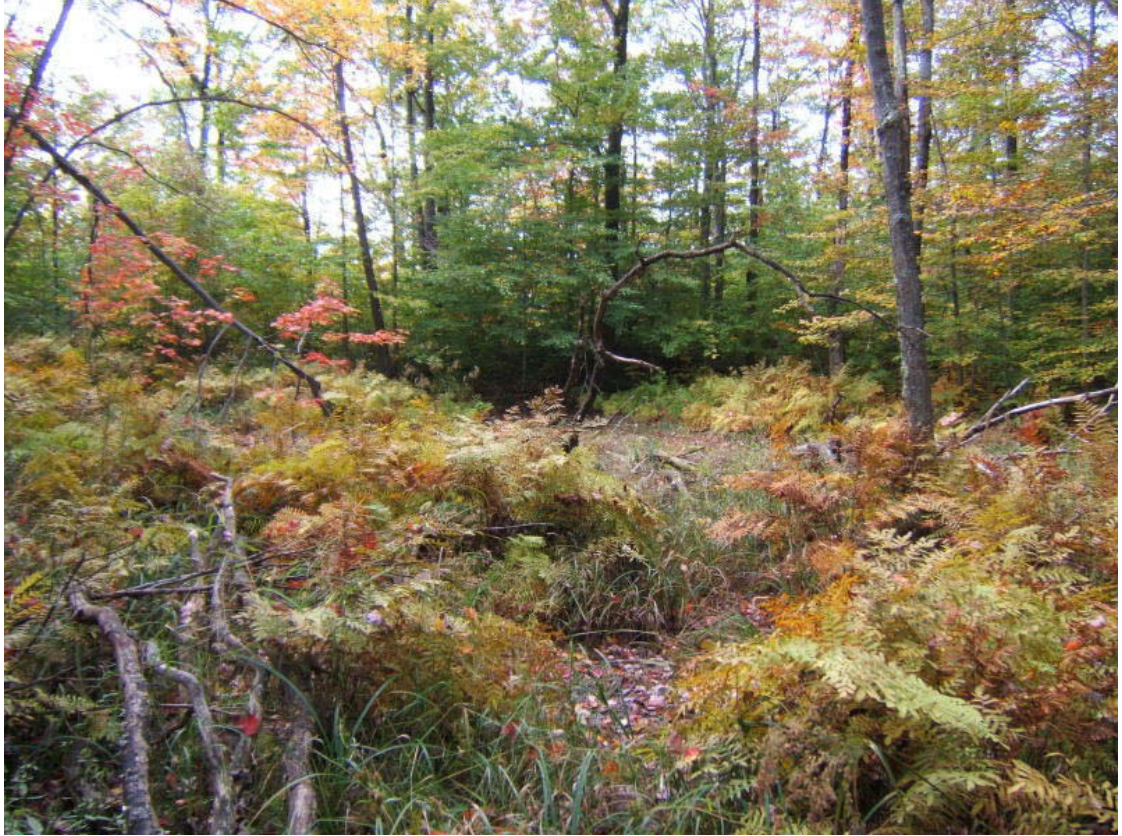
Figure 7. Wetland #31: Vernal pool habitat. (10/6/08)

Wetland #31 is a Class III vernal pool and is located along the ridgeline, south of the proposed turbine locations. The vegetation in this wetland consists of tussocks of sedges (*Carex spp.*) and manna grass (*Glyceria canadensis*) as well as a small area colonized by sphagnum moss. Green frogs, wood frogs and spotted salamanders have been found in this pool. Because of its size and deep pools of standing water, Wetland #31 likely supports successful reproduction of these vernal pool species. There is an old ATV trail that runs through the eastern end of this pool.

This wetland is important for the wildlife habitat that it provides. Wood frogs (*Rana sylvatica*) and Spotted salamanders (*Ambystoma maculatum*) are dependent on these habitats for reproduction. Though most of their lives are spent in the forest habitats surrounding these ephemeral wetlands, they migrate to these vernal pools to breed. For this reason, the condition of the forest around the vernal pool is also important for these species and ultimately the functioning of the vernal pool itself.

Recognizing the importance of these habitats, Arrowwood Environmental worked with Project designers to minimize impacts to this vernal pool and the surrounding forest. As shown in Table 4, the proposed clearing area is 77' away from the boundary of this wetland at its closest point. For this reason, it is our opinion that the development as proposed will not have an undue adverse impact on this vernal pool.

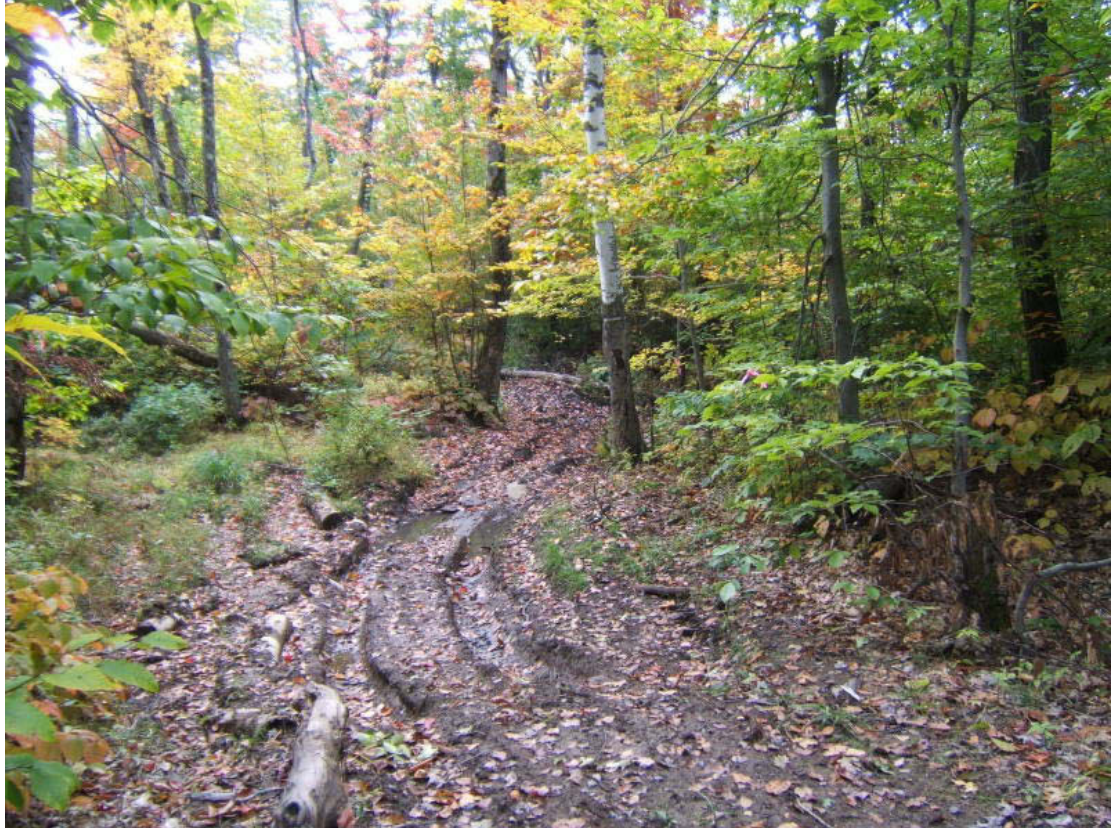
Figure 8. ATV trail along boundary of Wetland #31 (10/6/08)

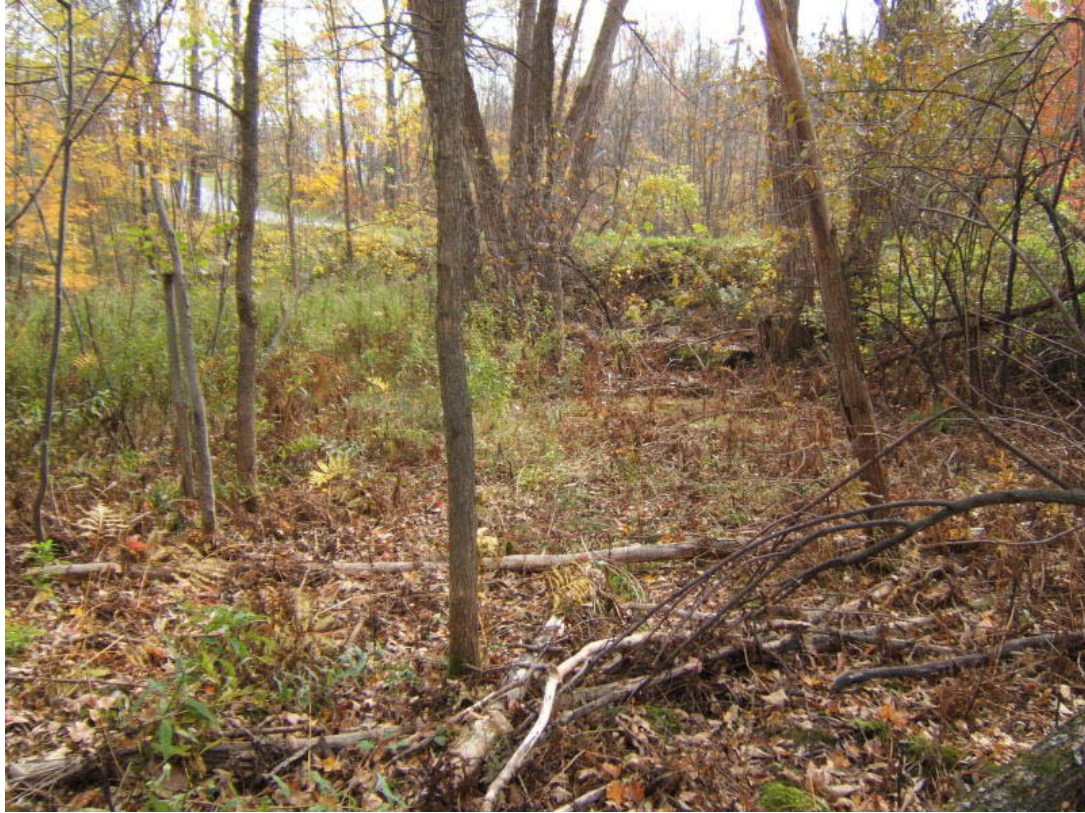
Figure 9. Wetland #22: Wetland at base of Ted Road. (10/15/08)

The Project requires the widening of this road intersection to accommodate construction vehicles with wide turning radii. The road widening involves permanent wetland impacts related to clearing and site grading. The square footage of wetland impact is 3 sq.ft. The area of proposed impact is directly adjacent to the existing roadway, at a culvert outfall. The proposed impact will not have an adverse impact on the long term capacity of the wetland to provide the functions of water storage, water protection and erosion control. Appropriate erosion control measures employed during construction will ensure that short term impacts do not have an adverse impact on wetland function and value as well.

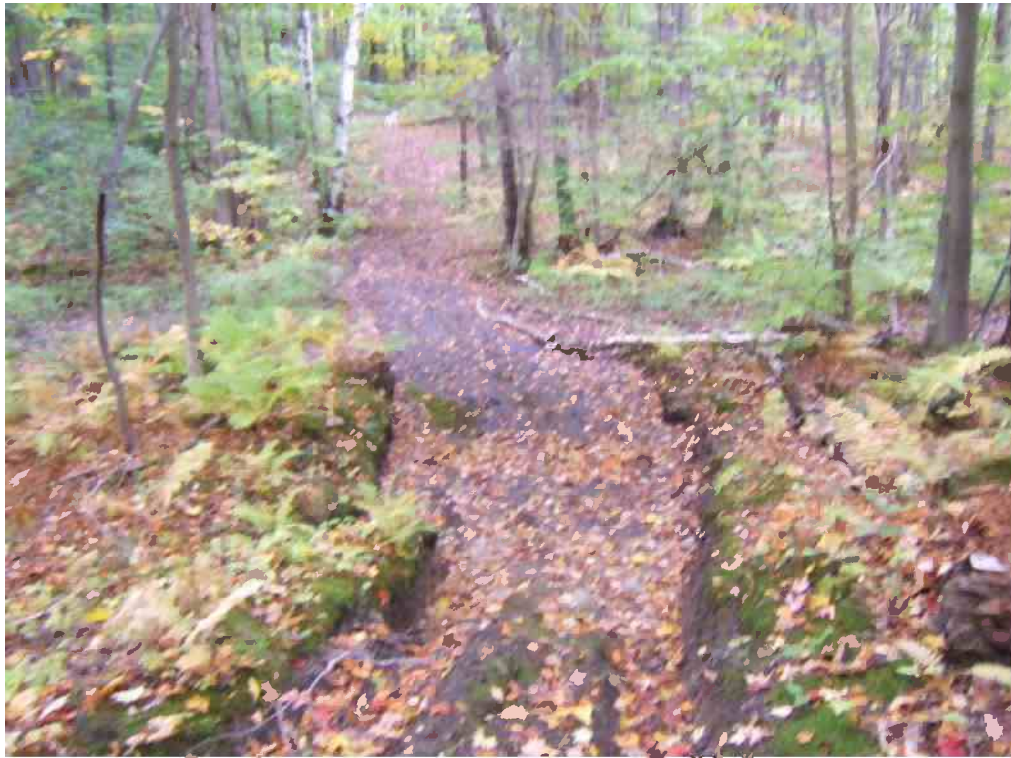
Figure 10. Wetland #15: Existing ATV trail to be utilized for proposed transmission corridor. (10/6/08)

existing ATV trail crossing (see attached map). This wetland will be spanned by the overhead electric collection line poles. Impacts to this wetland from the transmission line corridor will therefore be limited to minimum clearing of trees in the upland buffer of the wetland.

It is our opinion that the transmission line crossing will not present undue or adverse impacts to this wetland. In addition we do not believe that this crossing will negatively affect the functions and values that this wetland performs.

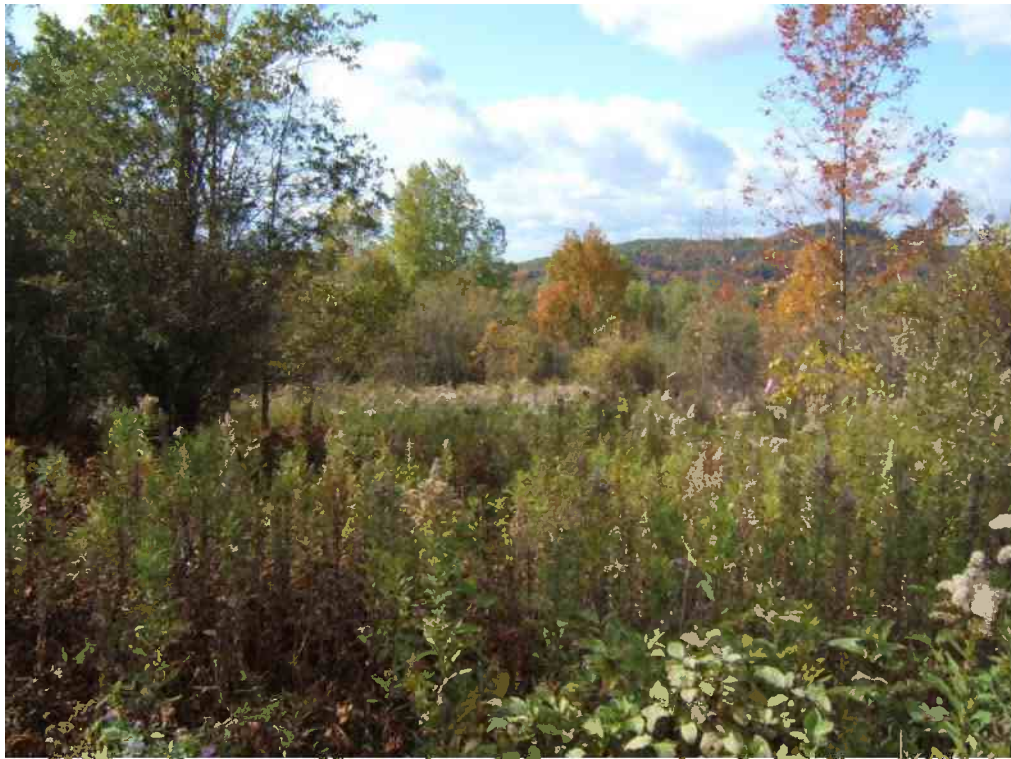
Figure 11. Wetland #34: Old field wetland. Transmission line to follow existing ATV trail through meadow. (10/6/08)

The Project proposes to locate the overhead transmission line through this wetland. The 25 ft wide corridor will be centered along an existing ATV trail on the north side of the wetland. The line will likely result in the installation of a single pole within the wetland.

In order to minimize impacts to this wetland, during construction swamp mats should be placed to access poles located at this site. The mats should be timber mats, fabricated from square timbers running parallel in the long direction, each mat section being approximately 16ft wide by 4ft long, placed sequentially beginning at the edge of the wetland, quantity as required to create a 16' access drive way to allow construction vehicles to achieve the required proximity to each pole location. Swamp mats should generally be in place for approximately 1 week. Any soil disturbance from the mats should be mulched with weed free straw immediately upon their removal. Large tire, all terrain style vehicles should be used during construction in order to minimize disturbance. Soils displaced by pole holes should be removed for disposal outside of wetland areas. Adherence to these construction specifications can result in avoidance of adverse impacts to this wetland resource.
