**Biological Fouling**  
**OWEZ\_R\_112\_T1\_20100114\_biofouling**

**Survey of marine fouling on turbine  
support structures of the Offshore  
Windfarm Egmond aan Zee**

Author M.C.M. Bruijs  
KEMA Technical & Operational Services

Prepared for Noordzeewind

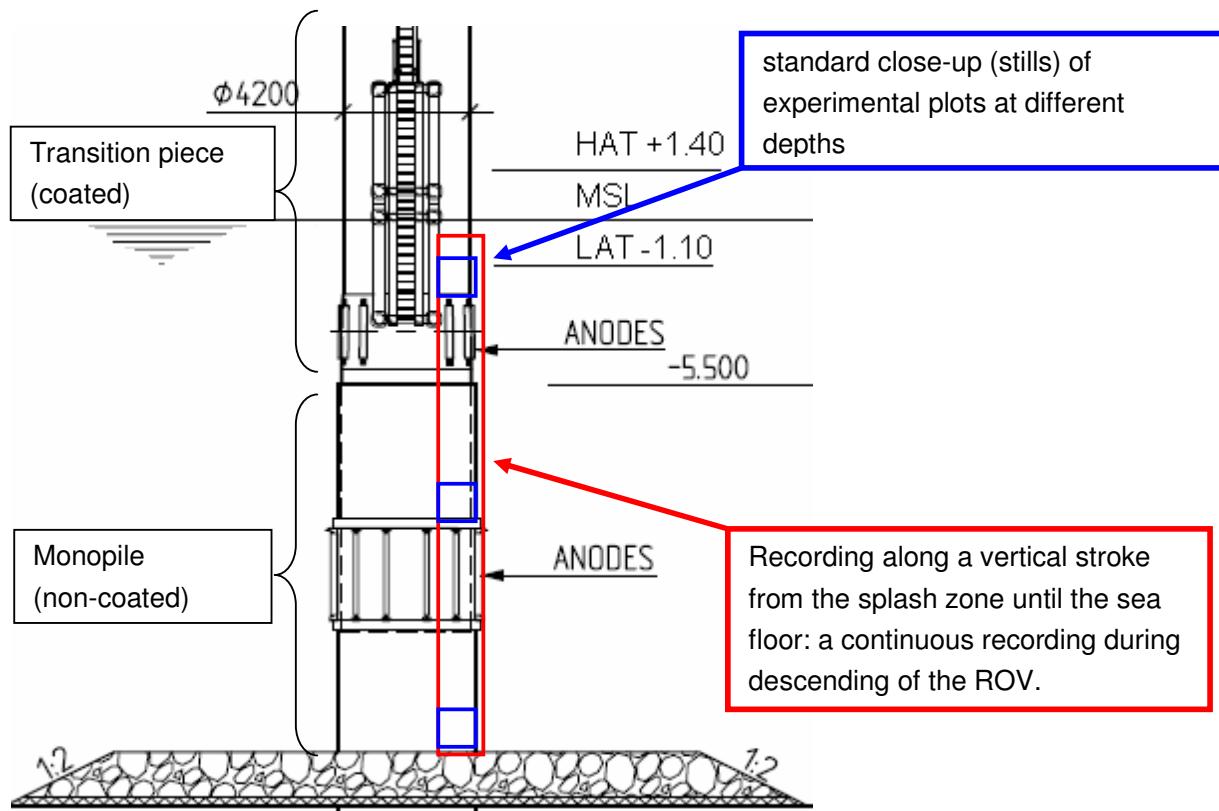
Figure 1. Schematic view on the submerged part of the monopile and OWEZ foundation. The surface to be recorded for the monitoring of biofouling, i.e. a single narrow vertical stroke that is perpendicular to the monopile axis is marked in red. The experimental plot surfaces for making close-ups / stills are marked in blue.

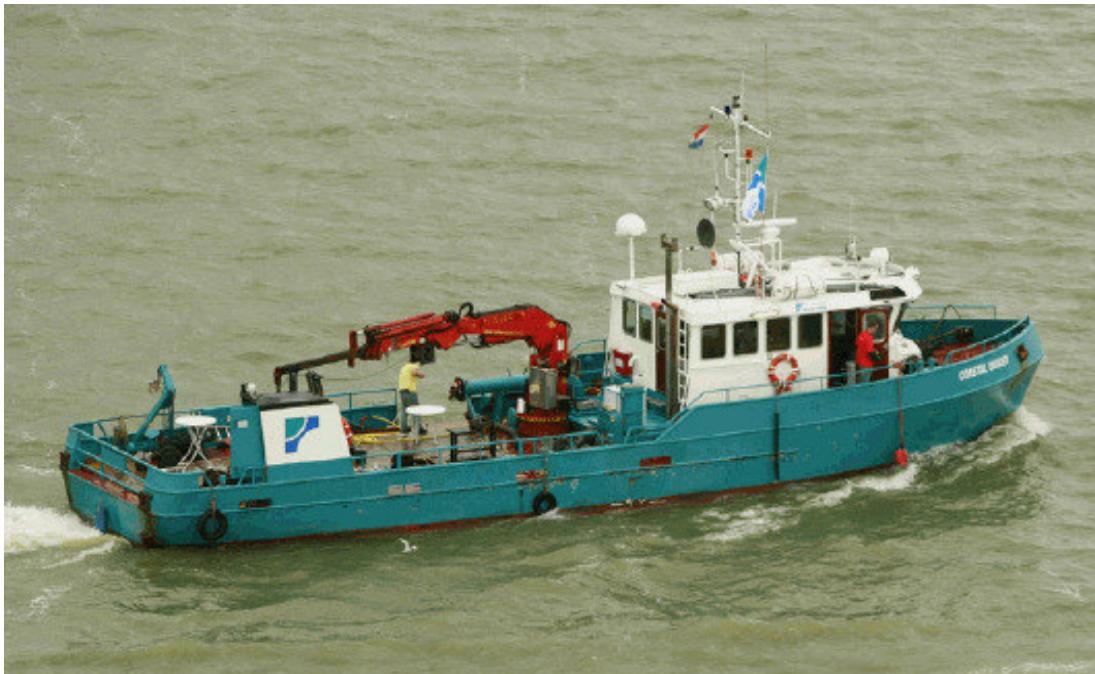
Figure 2. The 'Coastal Digger'.

The ROV inspections have been carried out from the support vessel 'Coastal Digger'. The support vessel has been equipped with the appropriate surface positioning system for precise positioning of the anchors (anchor handling survey equipment). This positioning system comprises a DGPS receiver and 17" monitor for visualization.

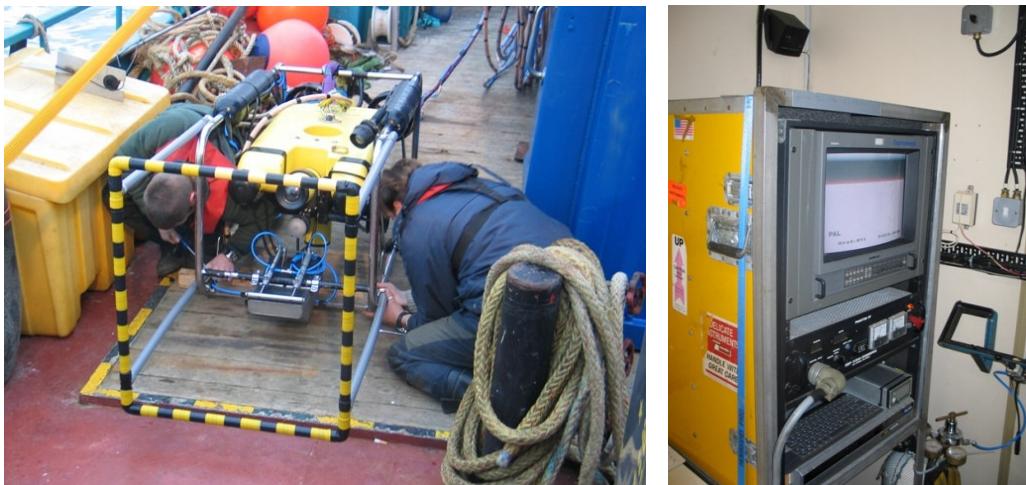
The ROV system has been fitted with a PVC elongate to keep a set distance from the masts surface and to have a steady view on the fouling (figure 3). A grab sampler was also attached to the ROV to take samples of the fouling (figure 3).

Figure 3. The ROV with the attached PVC device (left) and the ROV control unit on board (right).

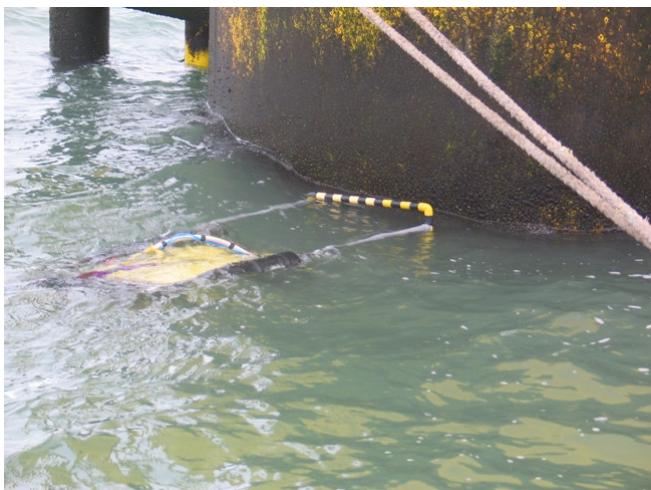
Figure 4. The ROV approaching the WTG-07. At this moment the PVC elongates were still at full length, but needed to be shortened in order to obtain a proper view of the fouling.

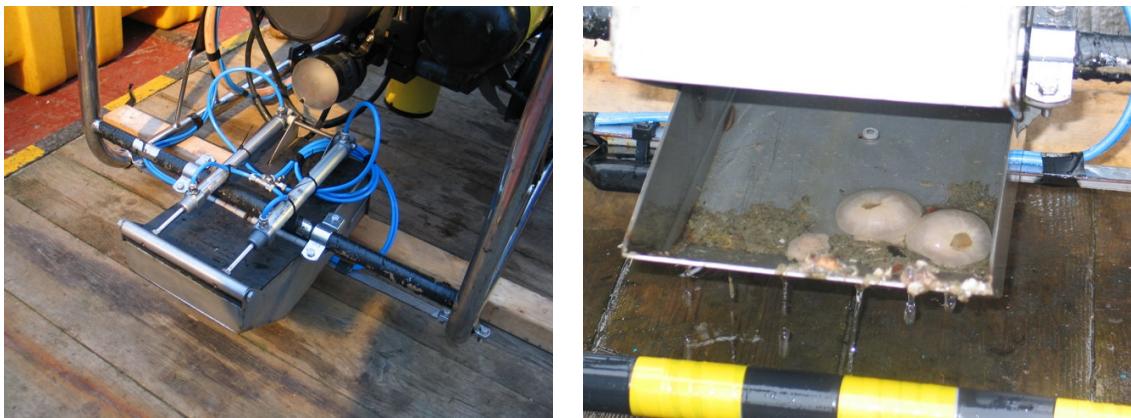
By means of an automated grab-sampler (figure 5), a few samples of fouling were taken from the surface at several depths. These samples have been analysed by Bureau Waardenburg. The species that have been identified are:

Figure 5. The grab sampler mounted on the ROV (left) and the fouling grabbed from the surface of WTG-07 (right).

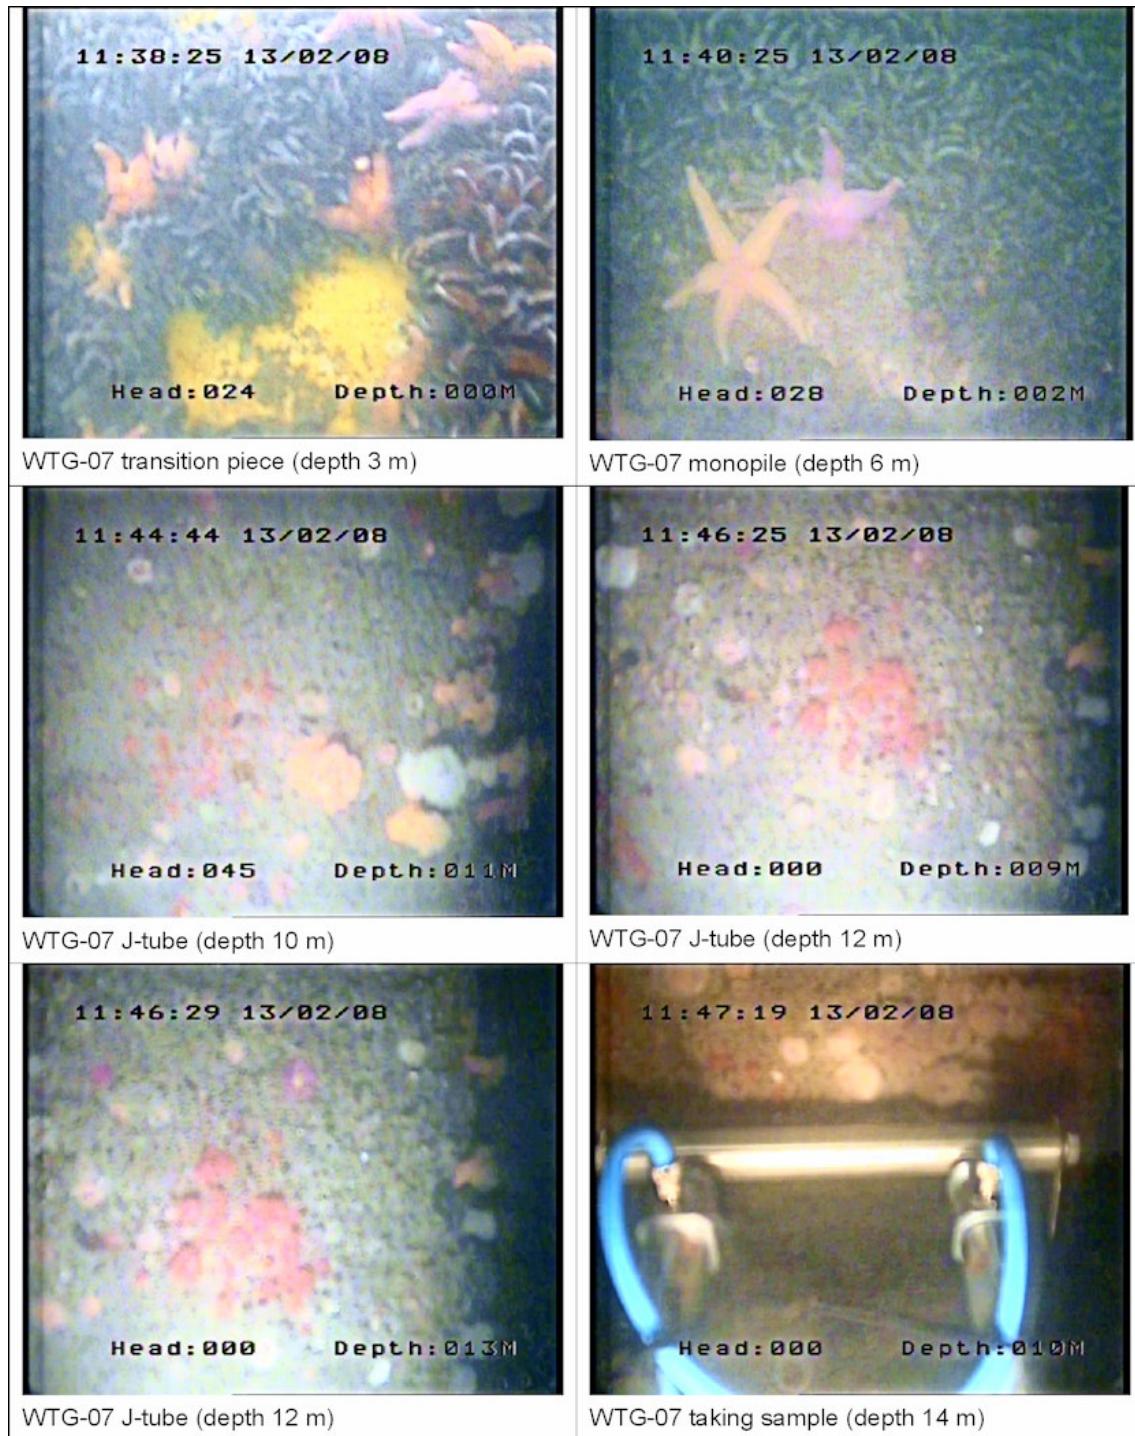
After alteration the ROV was lowered into the water to start the monitoring. In the range from the water line along the J-tube to a depth of 7 metres, the surface was estimated to be covered with mussels for ~90% (figure 6). The mussel species were *Mytilus edulis* and *Mytilus galloprovincialis* and formed a layer of about 5 – 15 cm in thickness with a roughness of 10 cm. Yellow patches of the coating of the transition piece were visible where clumps of mussels have fallen off the monopile surface. On the mussels, common starfish (*Asterias rubens*) were foraging on the mussels. The ROV was then lowered to a depth of 9 m to the upper ridge of the second anode ring. Between 7 – 9 metres, more fouling species were

observed including plumose and other anemones (small clusters and individuals randomly spread over the surface), bryozoans, barnacles, hydroids, tube worms and some oysters (specifically the Japanese oyster, *Crassostrea gigas*). However, less mussels were present here with only small clusters scattered over the surface. It was however not possible to distinguish between the two mussel species based on the video images as the images did not allow observation of the specific features of each species. In principle the total surface was covered by this fouling community (with the tube worms and hydroids as the main species) and no fouling-free surfaces were observed. The thickness was estimated between 1 and 5 cm, depending on the species (roughness is very limited).

In the area below 12 – 13 metres, (the lower ridge of the anode ring) the same fouling community as at a depth of 7 – 9 m was observed, covering the monopile surface 100% (roughness is very limited). At lower depth the water was very turbid and the view on the fouling community was not optimal. The total depth was 15 metres down to the scour protection stones.

Figure 6 below shows the stills at WTG-07 at different depths (recorded as the water column above the ROV during inspection) with specific fouling communities as described above. A summary of the observations at WTG-07 is provided in figure 7. The red line indicates the transition between hard and soft fouling communities as observed at all monopiles and mentioned in the last paragraph. The coverage percentage and layer thickness correspond to the depth layer as indicated by the brackets. This also holds for the figures 9 – 10 (MetMast) and 13 – 14 (WTG-08) in the following paragraphs.

Figure 6. Pictures of the fouling by means of the ROV recording at WTG-07.

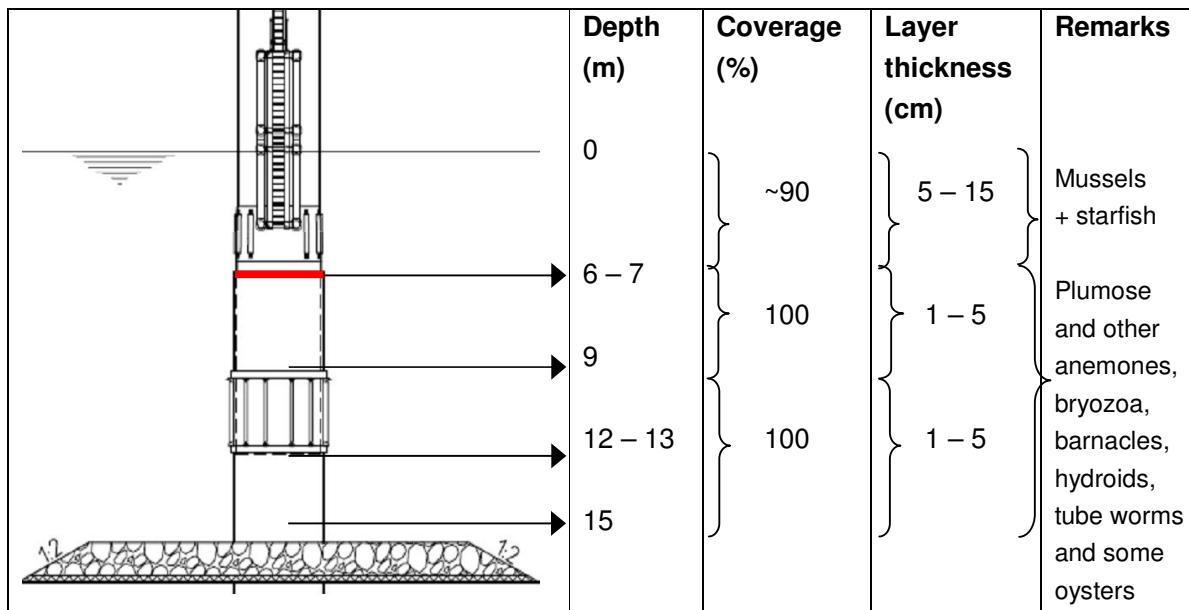
Figure 7. Summary marine growth at the WTG-07.

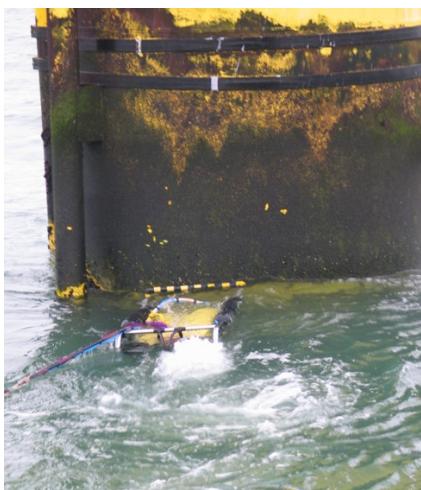
Figure 8. The ROV approaching the MetMast.

At low tide the ROV was lowered into the water and the recording of the MetMast began. At the transition piece, the fouling mainly consisted of young mussels, covering the yellow coated surface for about 40 - 70% at the surface layer and up to 90% in deeper layers (figure 9). It was noted that the transition piece at the surface depth had previously partially been cleaned, so this is the reason that mainly young mussels were present. This cleaning took place because of J tube maintenance. Many starfish were found foraging here and also sea urchins were observed. The thickness of the mussel fouling was estimated between 5 – 10 cm.

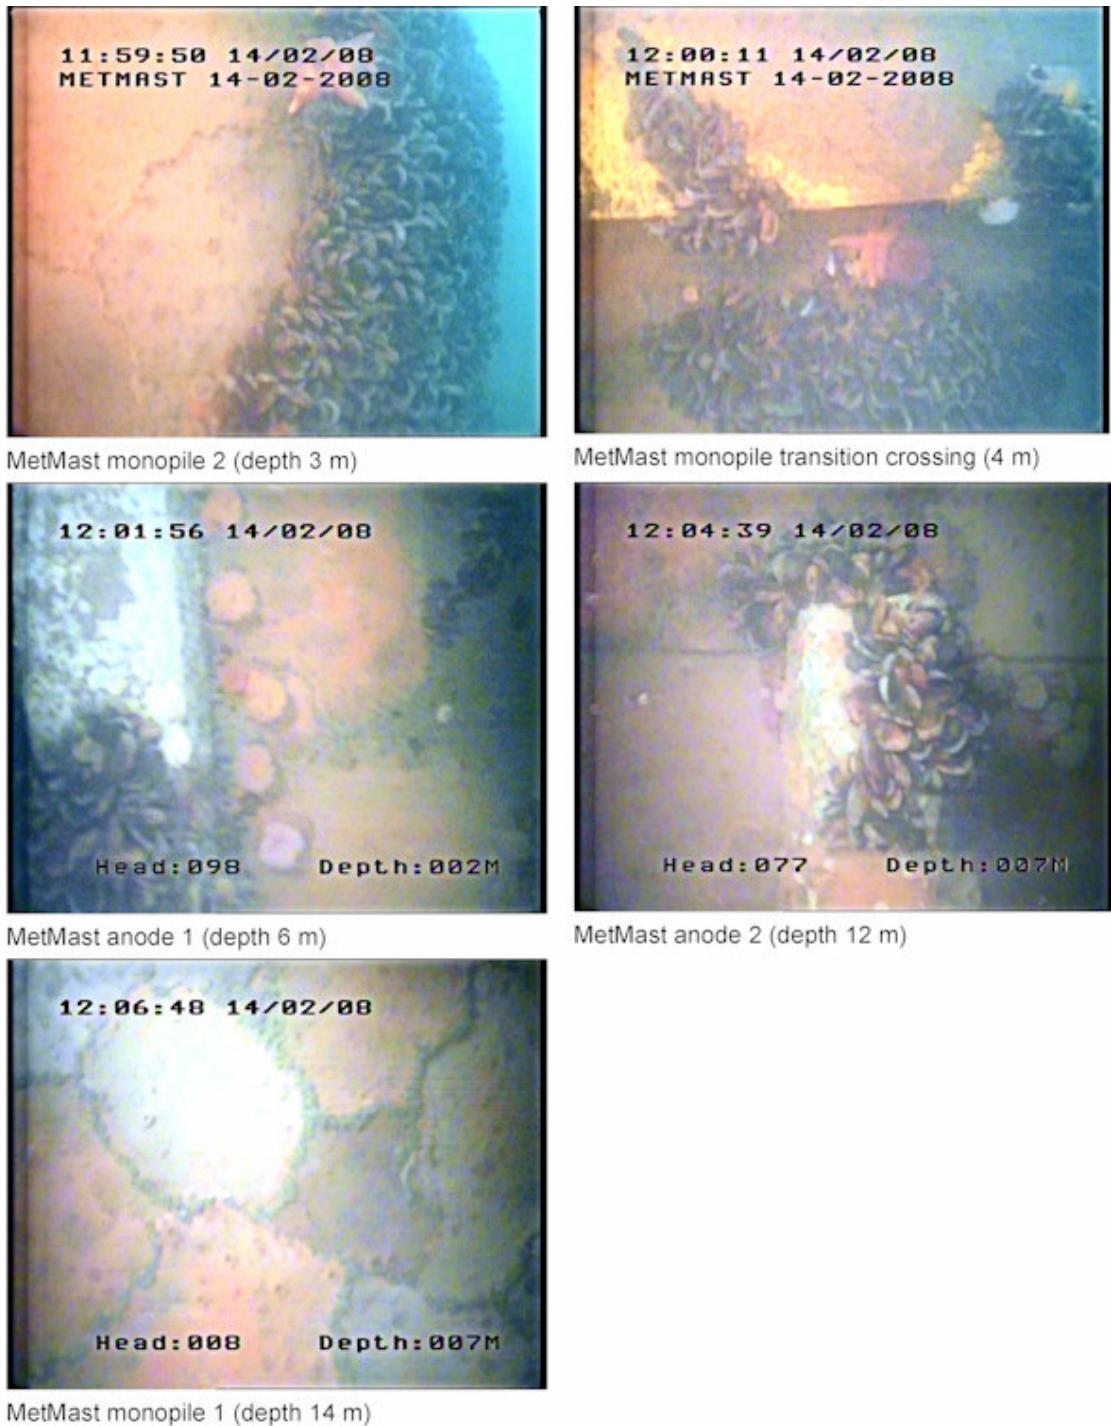
When reaching the ridge between the transition piece and the monopile (down to 4 m), it was found that the growth significantly changed. The fouling formed thick patches of mussel clusters and in between the surface of the coated transition piece was visible (60 – 80% coverage of the surface), with some growth of barnacles. At the location of the anodes, the fouling species mussels, anemones, barnacles and also sea urchins were observed. The thickness of the mussel fouling was estimated between 5 – 10 cm.

Below the anode ring (6 – 12 m), the surface of the monopile was very clean (welding ridges were visible), showing very little marine growth (10 – 20%), only small clusters of mussels and some anemones. A rather strange pattern of some kind of 'ridges' (figure 9) on the surface was also observed. The thickness of the mussel fouling was estimated between 1 – 5 cm. In the area below (12 – 18 metres, lower ridge of the anode ring) the same fouling community was observed, covering the monopile surface ~10 – 20%. The total depth was 21.5 metres onto the scour protection stones.

Figure 9. Pictures of the fouling by means of the ROV recording at different depths.

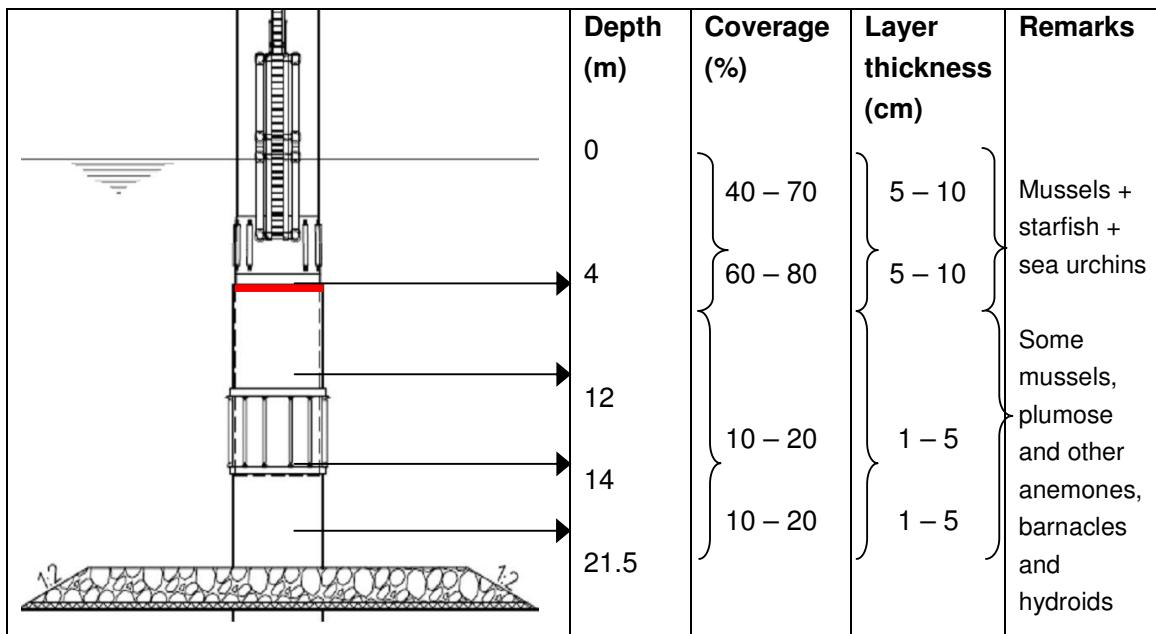
Figure 10. Summary marine growth at the MetMast.

The marine growth on the MetMast differs from WTG-07 and WTG-08. Because of J tube maintenance requiring cleaning, the MetMast had partially been cleaned and the mussels are smaller (younger specimens). Probably these are the result of a second spat-fall during September 2007, possible because of higher water temperatures at the end of the summer. At lower depths, on the monopile, it was observed that the metal surface was largely 'clean', free from extensive marine growth and the bare material of the monopile was visible. The images do not indicate that this could be caused by physical stress on the fouling community by for example sandblasts during 'sand storms' during storms at sea. Such sandblast may remove specimens from the surface of the lower parts of the monopiles. However, the visual impact of such effects should be visible at the other monopiles as well. As the MetMast was installed during 2003, and therefore has a longer fouling history, it was expected that the marine growth would be more extensive than at WTG-07 and WTG-08. It was mentioned by Nuon (personal communication Martin Dekker, 2008) that during construction it was found more difficult to weld the material of the MetMast, which is an indication that there can be significant differences in surface characteristics or the material. As some growth is present and a specific pattern has formed (presumably unaffected by sand scour), it is hypothesised that the difference in fouling can be explained by potential differences between the monopiles with respect to the material used, or different treatment of the raw material of which the monopile is made.

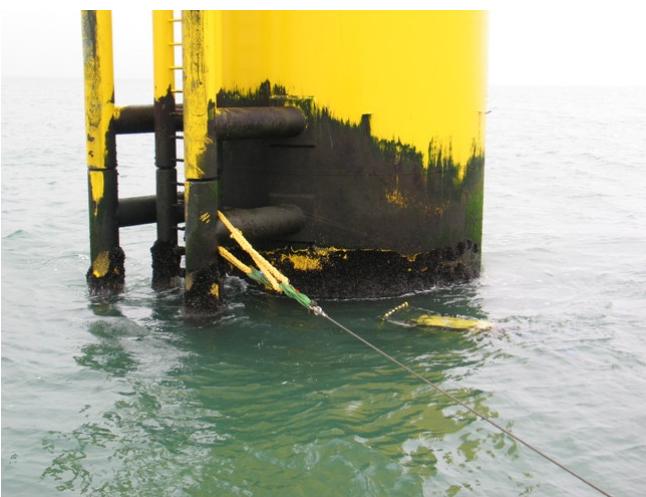
Figure 11. The ROV approaching WTG-08.

The marine growth at WTG-08 was found to be nearly similar to the marine growth at WTG-07, both in species observed and in the growth pattern.

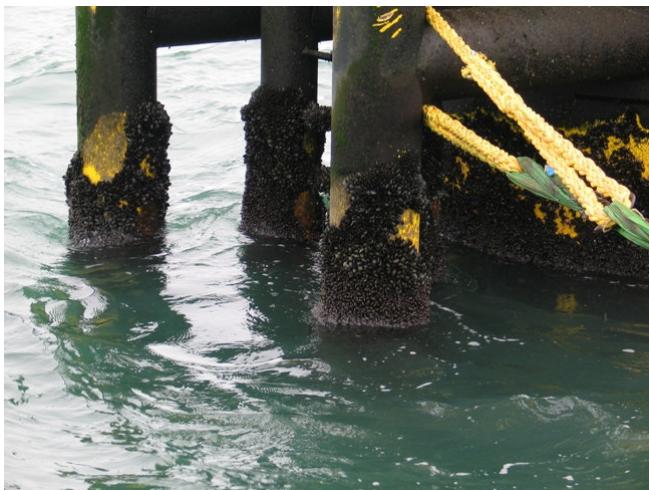
To a depth of 7 metres the fouling was mainly adult mussels and foraging starfish. In this range the surface was estimated to be covered with mussels for ~90% (figure 12). The mussel species form a layer of about 5 – 15 cm. Yellow patches of the coating of the transition piece were visible. Common starfish (*Asterias rubens*) were foraging on the mussels.

Figure 12. Detail of the fouling near the splash zone of WTG-08.

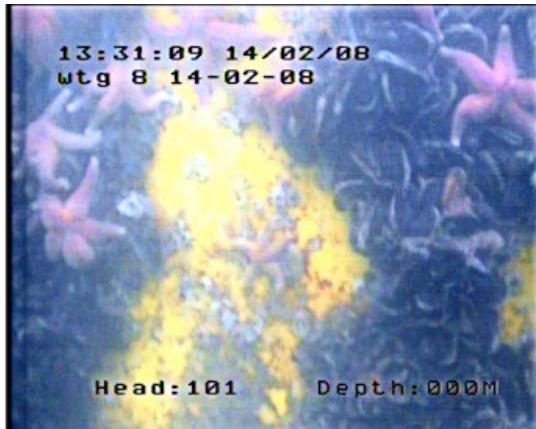
WTG-08 transition piece (depth 2 m)

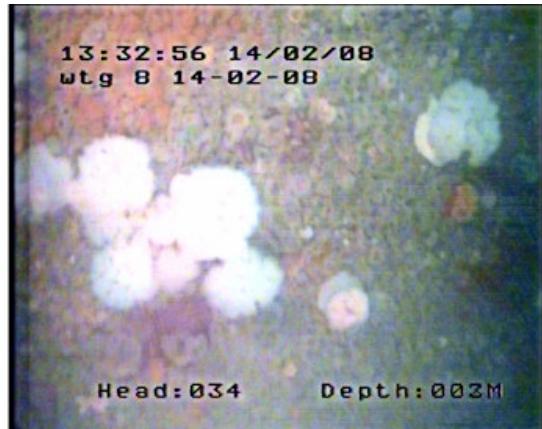
WTG-08 monopile (depth 6 m)

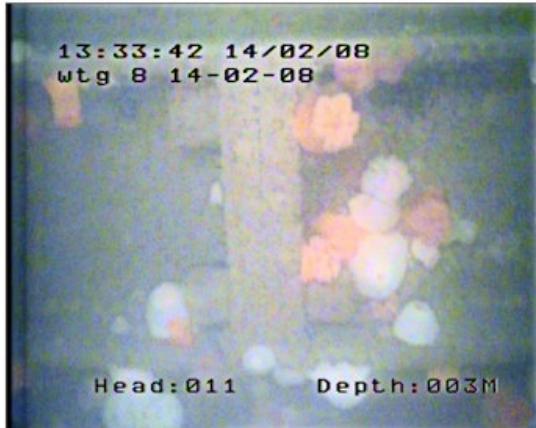
The ROV was then lowered to a depth of 9 m (upper ridge of the anode ring) along the surface of the monopile. Between 7 – 9 metres, more fouling species were observed, among others plumose and other anemones, bryozoa, barnacles, hydroids, tube worms and mussels. It was however not possible to determine the species. The total surface was covered by this fouling community and no clean surface areas were found. The thickness of the mussel fouling was estimated between 1 – 5 cm.

WTG-08 bolt section anode ring (7 m)

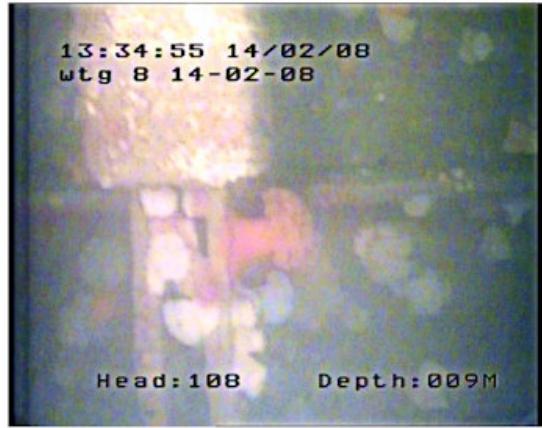
In the area below (12 – 15 metres, lower ridge of the anode ring to the bottom) the same fouling community was observed, covering the monopile surface 100%. The total depth was 16 metres onto the scour protection stones.

WTG-08 anode (depth 14 m)

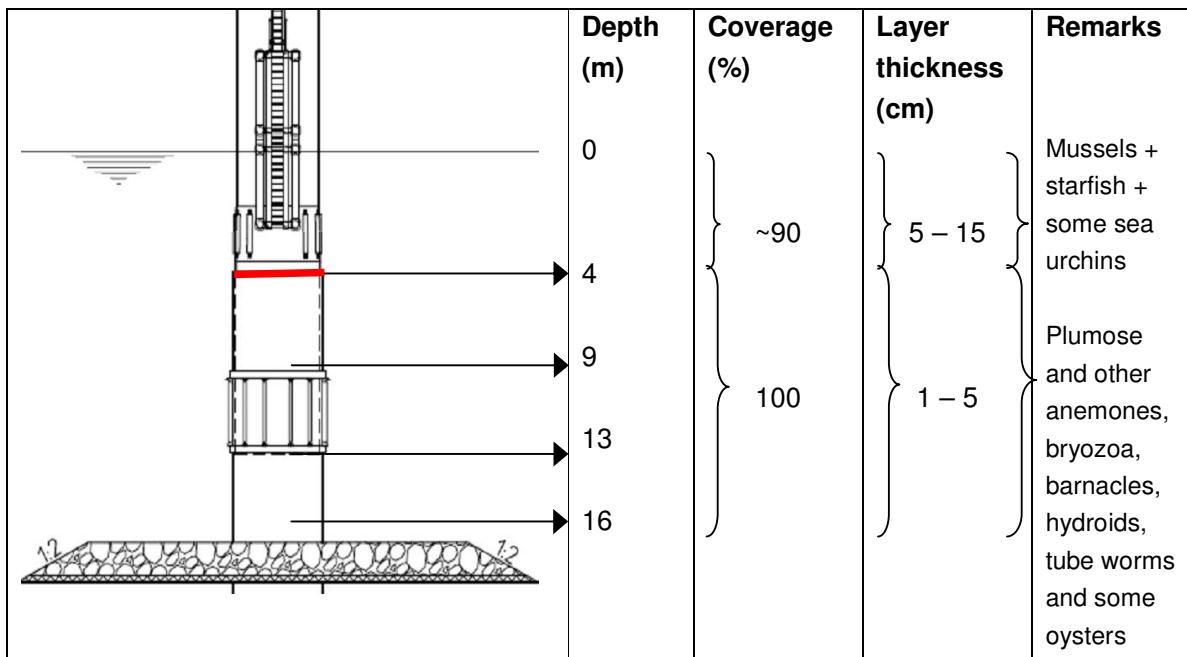
Figure 14. Summary marine growth at the WTG-08.
