Biological Fouling
OWEZ_R_112_T1_20100211

**Survey of marine fouling on turbine
support structures of the Offshore
Windfarm Egmond aan Zee, July 2008**

Arnhem, February 11 2010

Author M.C.M. Bruijs
KEMA Technical & Operational Services

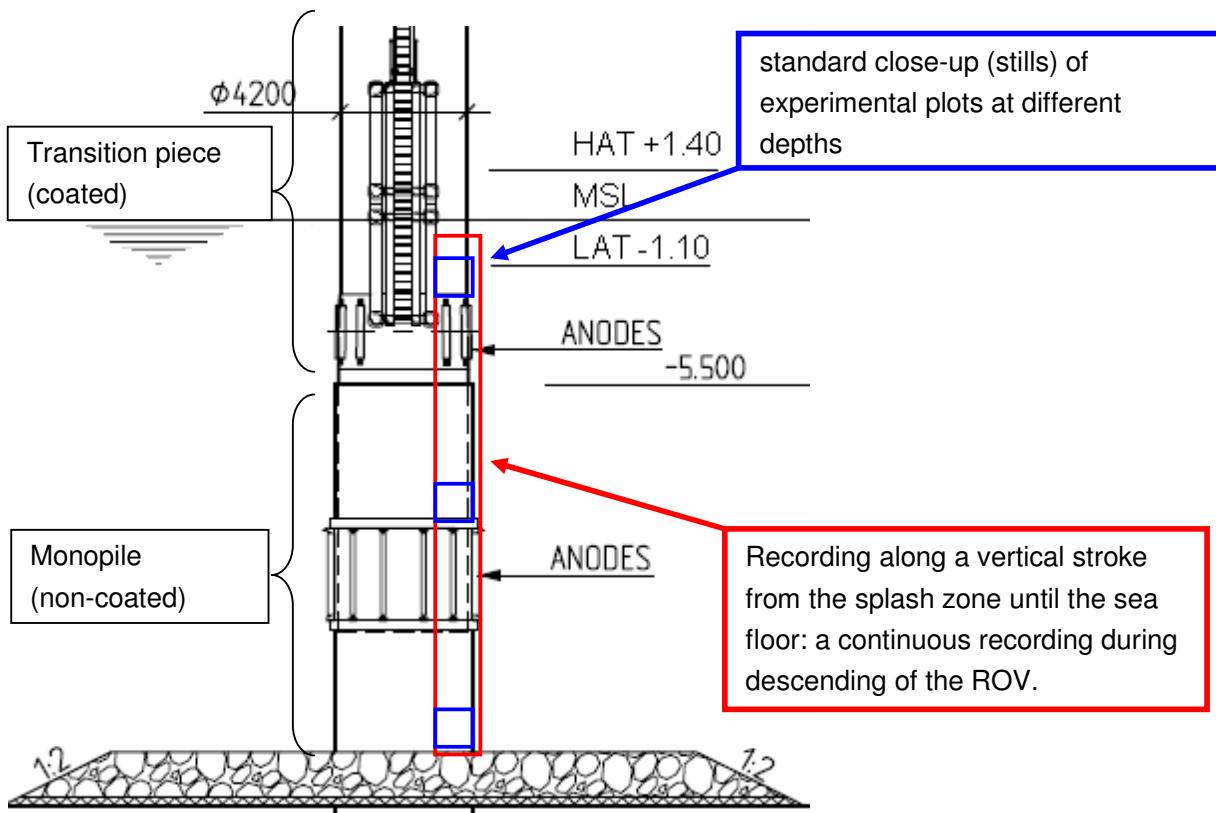
Figure 1. Schematic view on the submerged part of the monopile and OWEZ foundation. The surface to be recorded for the monitoring of biofouling, i.e. a single narrow vertical stroke that is perpendicular to the monopile axis is marked in red. The experimental plot surfaces for making close-ups / stills are marked in blue.

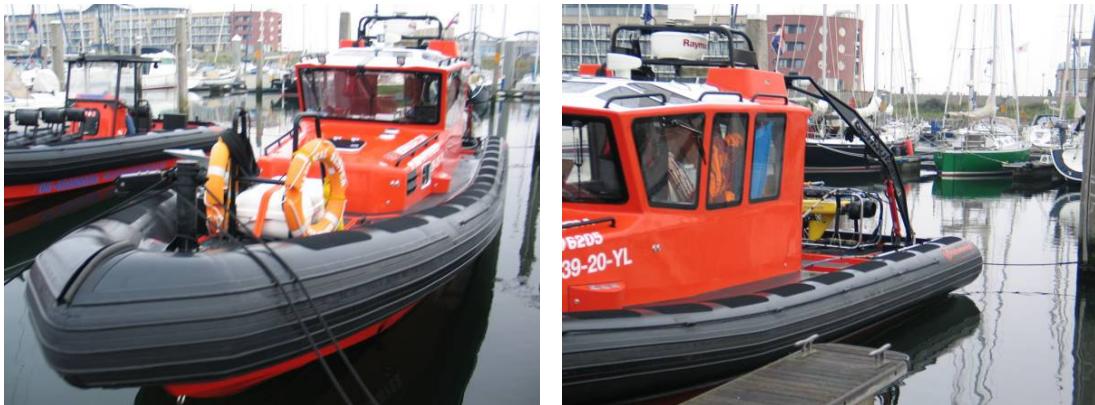
Figure 2. The 'Nautical Server'.

The deployment of the ROV (Annex D) was done by means of the A-frame at the quarterdeck (figure 2, right picture). When the ROV was in the water, it was disconnected from the frame. The ROV pilot started the inspection sequence and based on his experience he decided which route of inspection will be followed taking current and waves and weather predictions in consideration. After the inspection the ROV was returned to the surface and connected to the A-frame to easily recover the ROV.

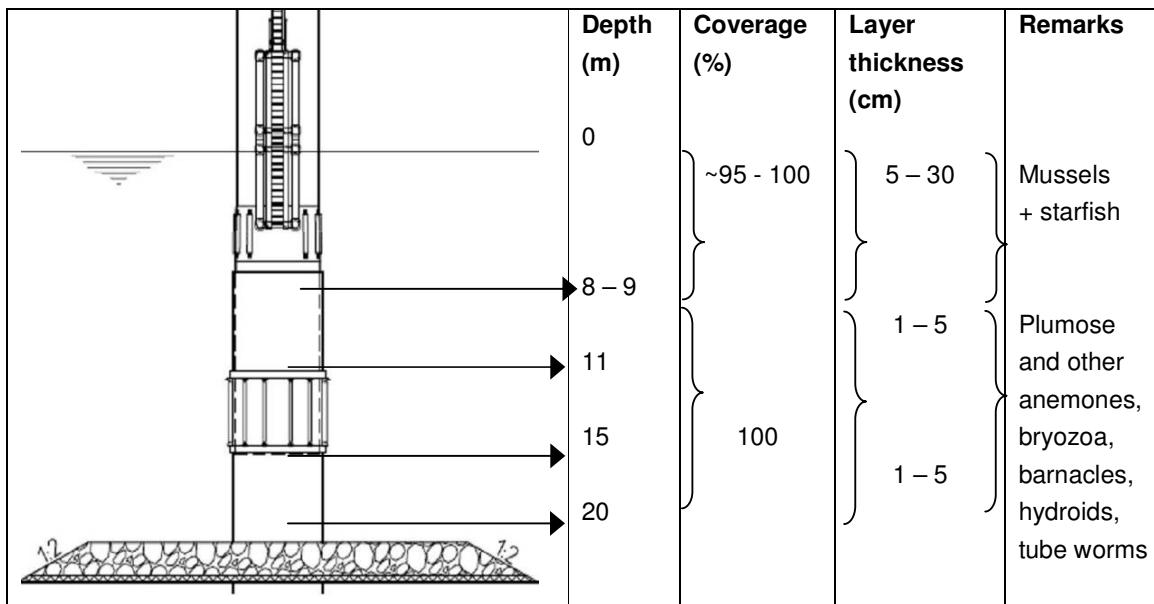
The upper layer, splash zone, was clearly covered with algae and barnacles. In the range from the water line to a depth of 5 metres, the surface was estimated to be covered with mussels for ~95 – 100 % (figure 3), some patches of yellow colour of the coating were visible. The mussel species were *Mytilus edulis* and likely *Mytilus galloprovincialis*, however, it was not possible to distinguish between the two mussel species based on the video images as the images do not allow to observe the specific features of each species. The mussels form a layer of a few centimetres up to 25 – 30 cm in thickness, with a roughness of 10 cm. Yellow patches of the coating of the transition piece were visible, probably due to small clusters of mussels that have fallen off the monopile surface. Many of the mussels seemed to be relatively small (young) as observed by their relative length, *i.e.* these likely settled during the second spat fall period during September 2007. On the mussels, common starfish (*Asterias rubens*) were foraging and anemones were observed as well. The ROV was then lowered to a depth of 8 m, the upper ridge of the second anode ring. During ascending, more fouling species were observed, such as plumose and other anemones (small clusters and individuals randomly spread over the surface). At depths below 8 – 9 m, only small numbers of mussels were present. Below 9 m, the relatively thin fouling layer existed in anemones, bryozoans, barnacles, hydroids and tube worms. In principle the total surface was covered by this fouling community (with the tube worms and hydroids as the main species) no fouling-free surfaces were observed. The thickness was estimated between 1 and 5 cm, depending on the species.

In the area below 14 – 15 metres, (lower ridge of the anode ring) the same fouling community as at a depth of 8 – 9 m was observed, covering the monopile surface 90 - 100% as some of the yellow coating was sometimes visible. The total depth was 20 metres onto the scour protection stones.

Figure 4. Summary marine growth at the WTG-07 (depth is water column above ROV).

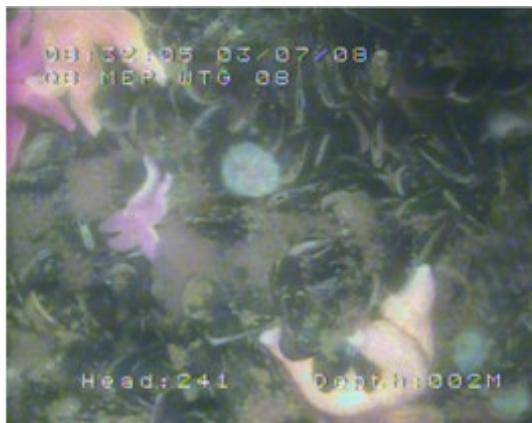
08:32:05 Transition piece

Figure 5. Pictures of the fouling by means of the ROV recording at WTG-08, July 3 2008.

On Friday July 3, the ROV monitoring of the turbine mast WTG-08 took place during the same tide as the monitoring of WTG-7. The marine growth at WTG-08 was found to be nearly similar to the marine growth at WTG-07, both in species observed as well as in the growth pattern and zonation. To a depth of 6 - 7 metres the fouling mainly existed in young mussels and foraging starfish. In this range the surface was estimated to be covered with mussels for ~90 – 95%. The mussel species formed a layer of a few centimetres up to 20 – 25 cm. At WTG-8, more yellow surface of the coating of the transition piece was visible in the first 6 metres. On the mussels, common starfish (*Asterias rubens*) were foraging and other species as plumose anemones were present as well. The ROV was then lowered to a depth of 12 m (upper ridge of the anode ring) along the surface of the monopile. Between 6 – 9 metres, many soft fouling species were present, among others plumose and other anemones, bryozoa, barnacles, hydroids, tube worms and also mussels. From 9 - 10 m and below, the abundance of mussels decreased instantly. It was not possible to exactly determine the species. The total surface was covered by this fouling community (100%), no clean surface areas were found. The thickness of the soft fouling was estimated between 1 – 5 cm. In the area below (15 – 20 metres, lower ridge of the anode ring to the bottom) the same fouling community was observed, covering the monopile surface 100%. Some larger clusters of *Metridium* were observed. The total depth onto the scour protection stones was 20 metres.

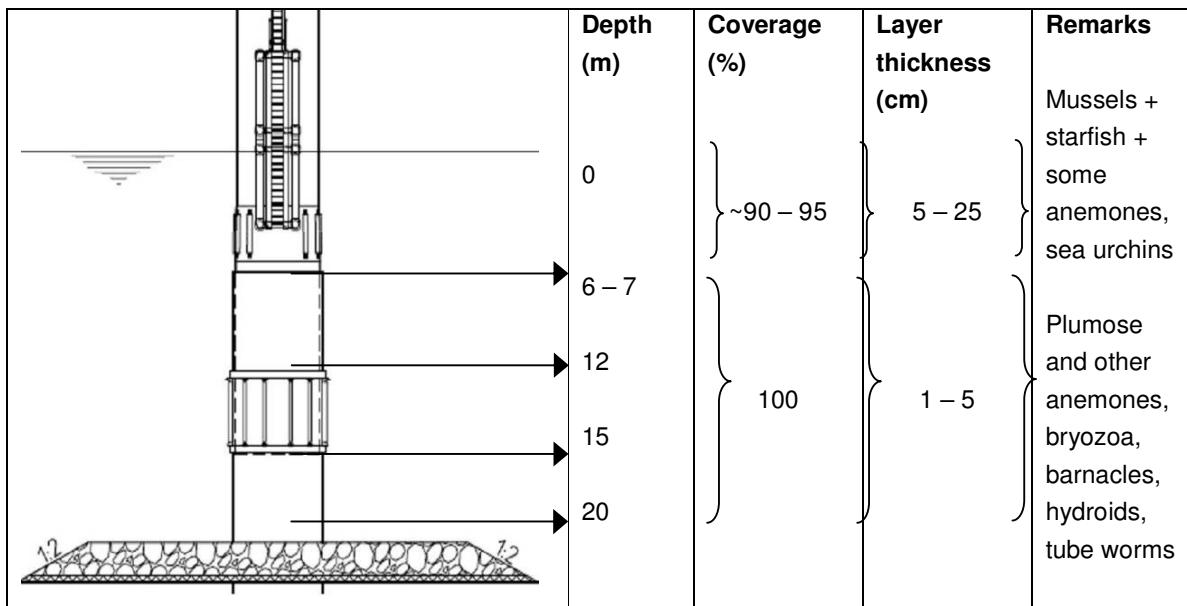
Figure 6. Summary marine growth at the WTG-08.

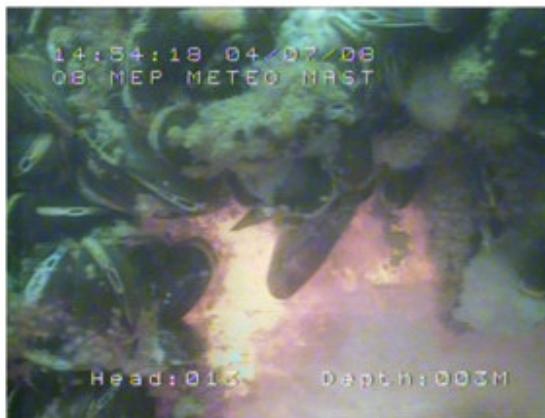
14:54:18 Transition piece

The ROV monitoring of the MetMast was performed on July 4th. At the transition piece, the fouling mainly existed in young mussels, covering the yellow coated surface for about 70 - 90% at the surface layer and up to 90% in deeper layers (figure 7). The thickness of the mussel fouling was estimated between 5 – 20 cm.

Figure 7. Pictures of the fouling by means of the ROV recording at different depths.

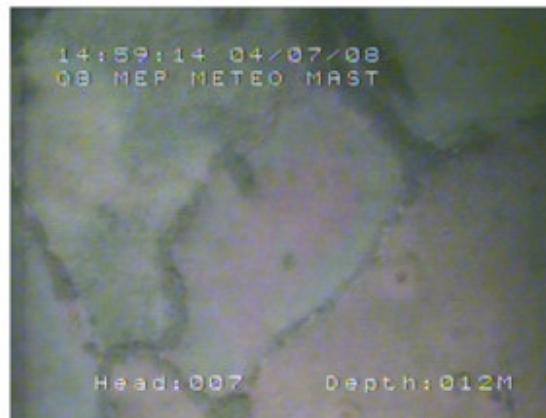
14:59:14 Monopile

Below the anode ring (6 – 12 m), the surface of the monopile was very clean (welding ridges were visible), showing very little marine growth (10 – 20%), only small clusters of mussels and some anemones and sea urchins. Similar to the monitoring of 2007, a rather strange pattern of some kind of 'ridges' (figure 7) on the surface was observed as well, on which *Jassia* colonies seem to grow. Also light coloured and dark (black) coloured areas were

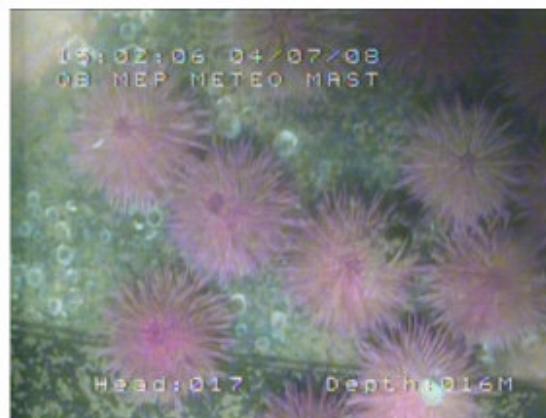
15:02:05 Monopile near anode ring

observed. On the darker areas more fouling was present, basically a thin layer of *Jassia* colonies and colonies of barnacles. Groups of sea urchins seemed to scavenge solely on these darker areas, as well as on the ridges. Anemones also grew on the darker areas. On the light areas, basically no fouling occurred at all. The thickness of the fouling (very small clusters) was estimated between 1 – 5 cm. In the area below (12 – 18 metres, lower ridge of the anode ring) the same very thin fouling community was observed, covering the monopile surface ~10 – 20%. In the lowest 4 m, the larger numbers of *Metridium* and plumose anemones were observed. The total depth was 25,5 metres onto the scour protection stones.

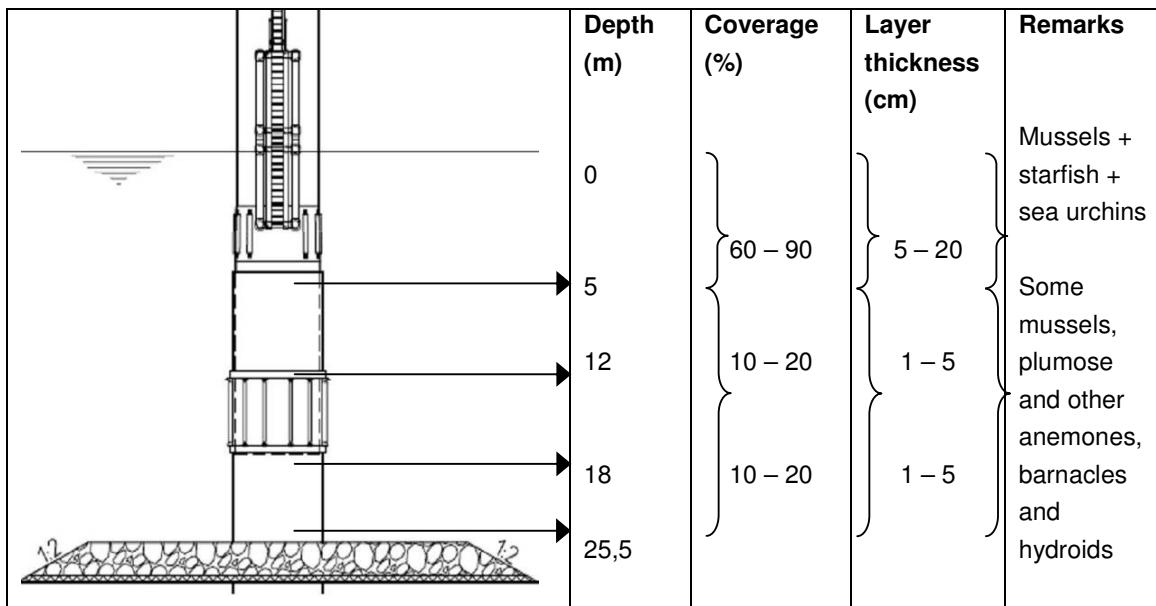
When reaching the ridge between the transition piece and the monopile (depth 4 m), the fouling significantly changed. The fouling existed in mussel clusters and in between the surface of the coated transition piece was visible (70 – 90% coverage of the surface), with some growth of barnacles. At the location of the anodes, mainly anemones, but also mussels, barnacles and sea urchins were observed. The thickness of the mussel fouling was estimated between 5 – 20 cm. At 5 m depth, there was almost no fouling present any more and the bare surface of the monopile was clearly visible. Also soft fouling was not present in high quantity, only a very thin layer is observed.

Figure 8. Summary marine growth at the MetMast.

Similar to 2007, the marine growth on the MetMast still clearly differs from WTG-07 and WTG-08. A similar pattern of growth has been observed compared to the year before. The upper part showed an increase in mussel growth compared to 2007. However, below 4 m, the monopile was still largely 'clean', free from extensive marine growth and the bare material of the monopile was visible. The images do not indicate that physical stress (e.g. sandblasts during 'sand storms' during storms at sea) could explain this. There is still a strong indication that significant differences in surface characteristics or the material used cause the differences between the MetMast and WTG-07 and wTG-08.

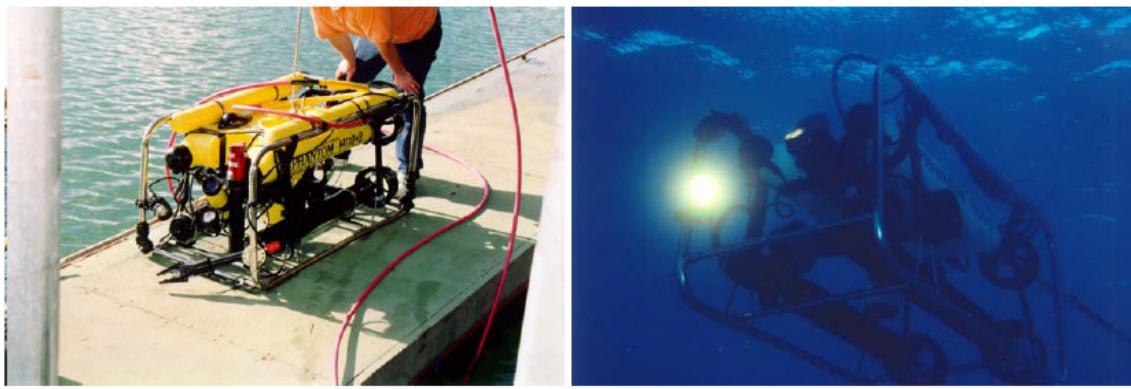
***Phantom® HD2+2***

- Dependable ROV for offshore inspection and light work tasks
- For use in moderate to strong currents to depths of 300m (1,000 ft.)
- Accommodates cameras, sonar, tracking, manipulators and custom tooling

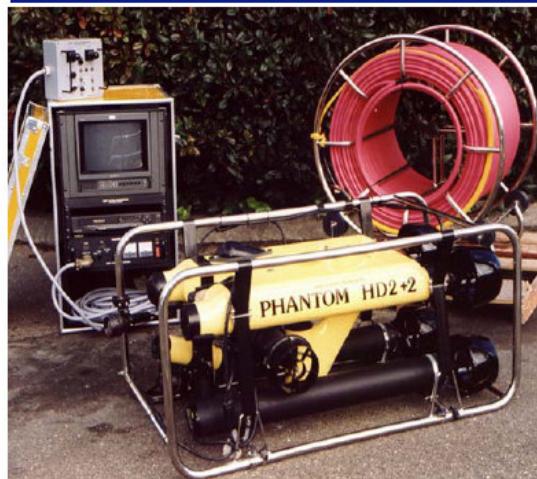
- Superb video quality, $\pm 90^\circ$ camera tilt
- Hardwired Phantom control system — easy to troubleshoot and add accessories
- Shock-mounted full perimeter stainless steel crash frame for rugged protection and durability
- Interchangeable components with DOE Phantom Spectrum vehicles
- Enhanced vehicle stability with low center of gravity and torque-balanced horizontal thrusters.

Weight:	120kg	265 lb
Operating depth:	305m	1,000ft
Overall length:	1400mm	55"
Overall width:	686mm	27"
Maximum height:	673mm	26.5"
