Churchill Barriers – Wave Overtopping and Tidal Flow Energy Capture

Screening Request

January 2015

**Orkney Islands Council
School Place
Kirkwall
ORKNEY
KW15 1NY**

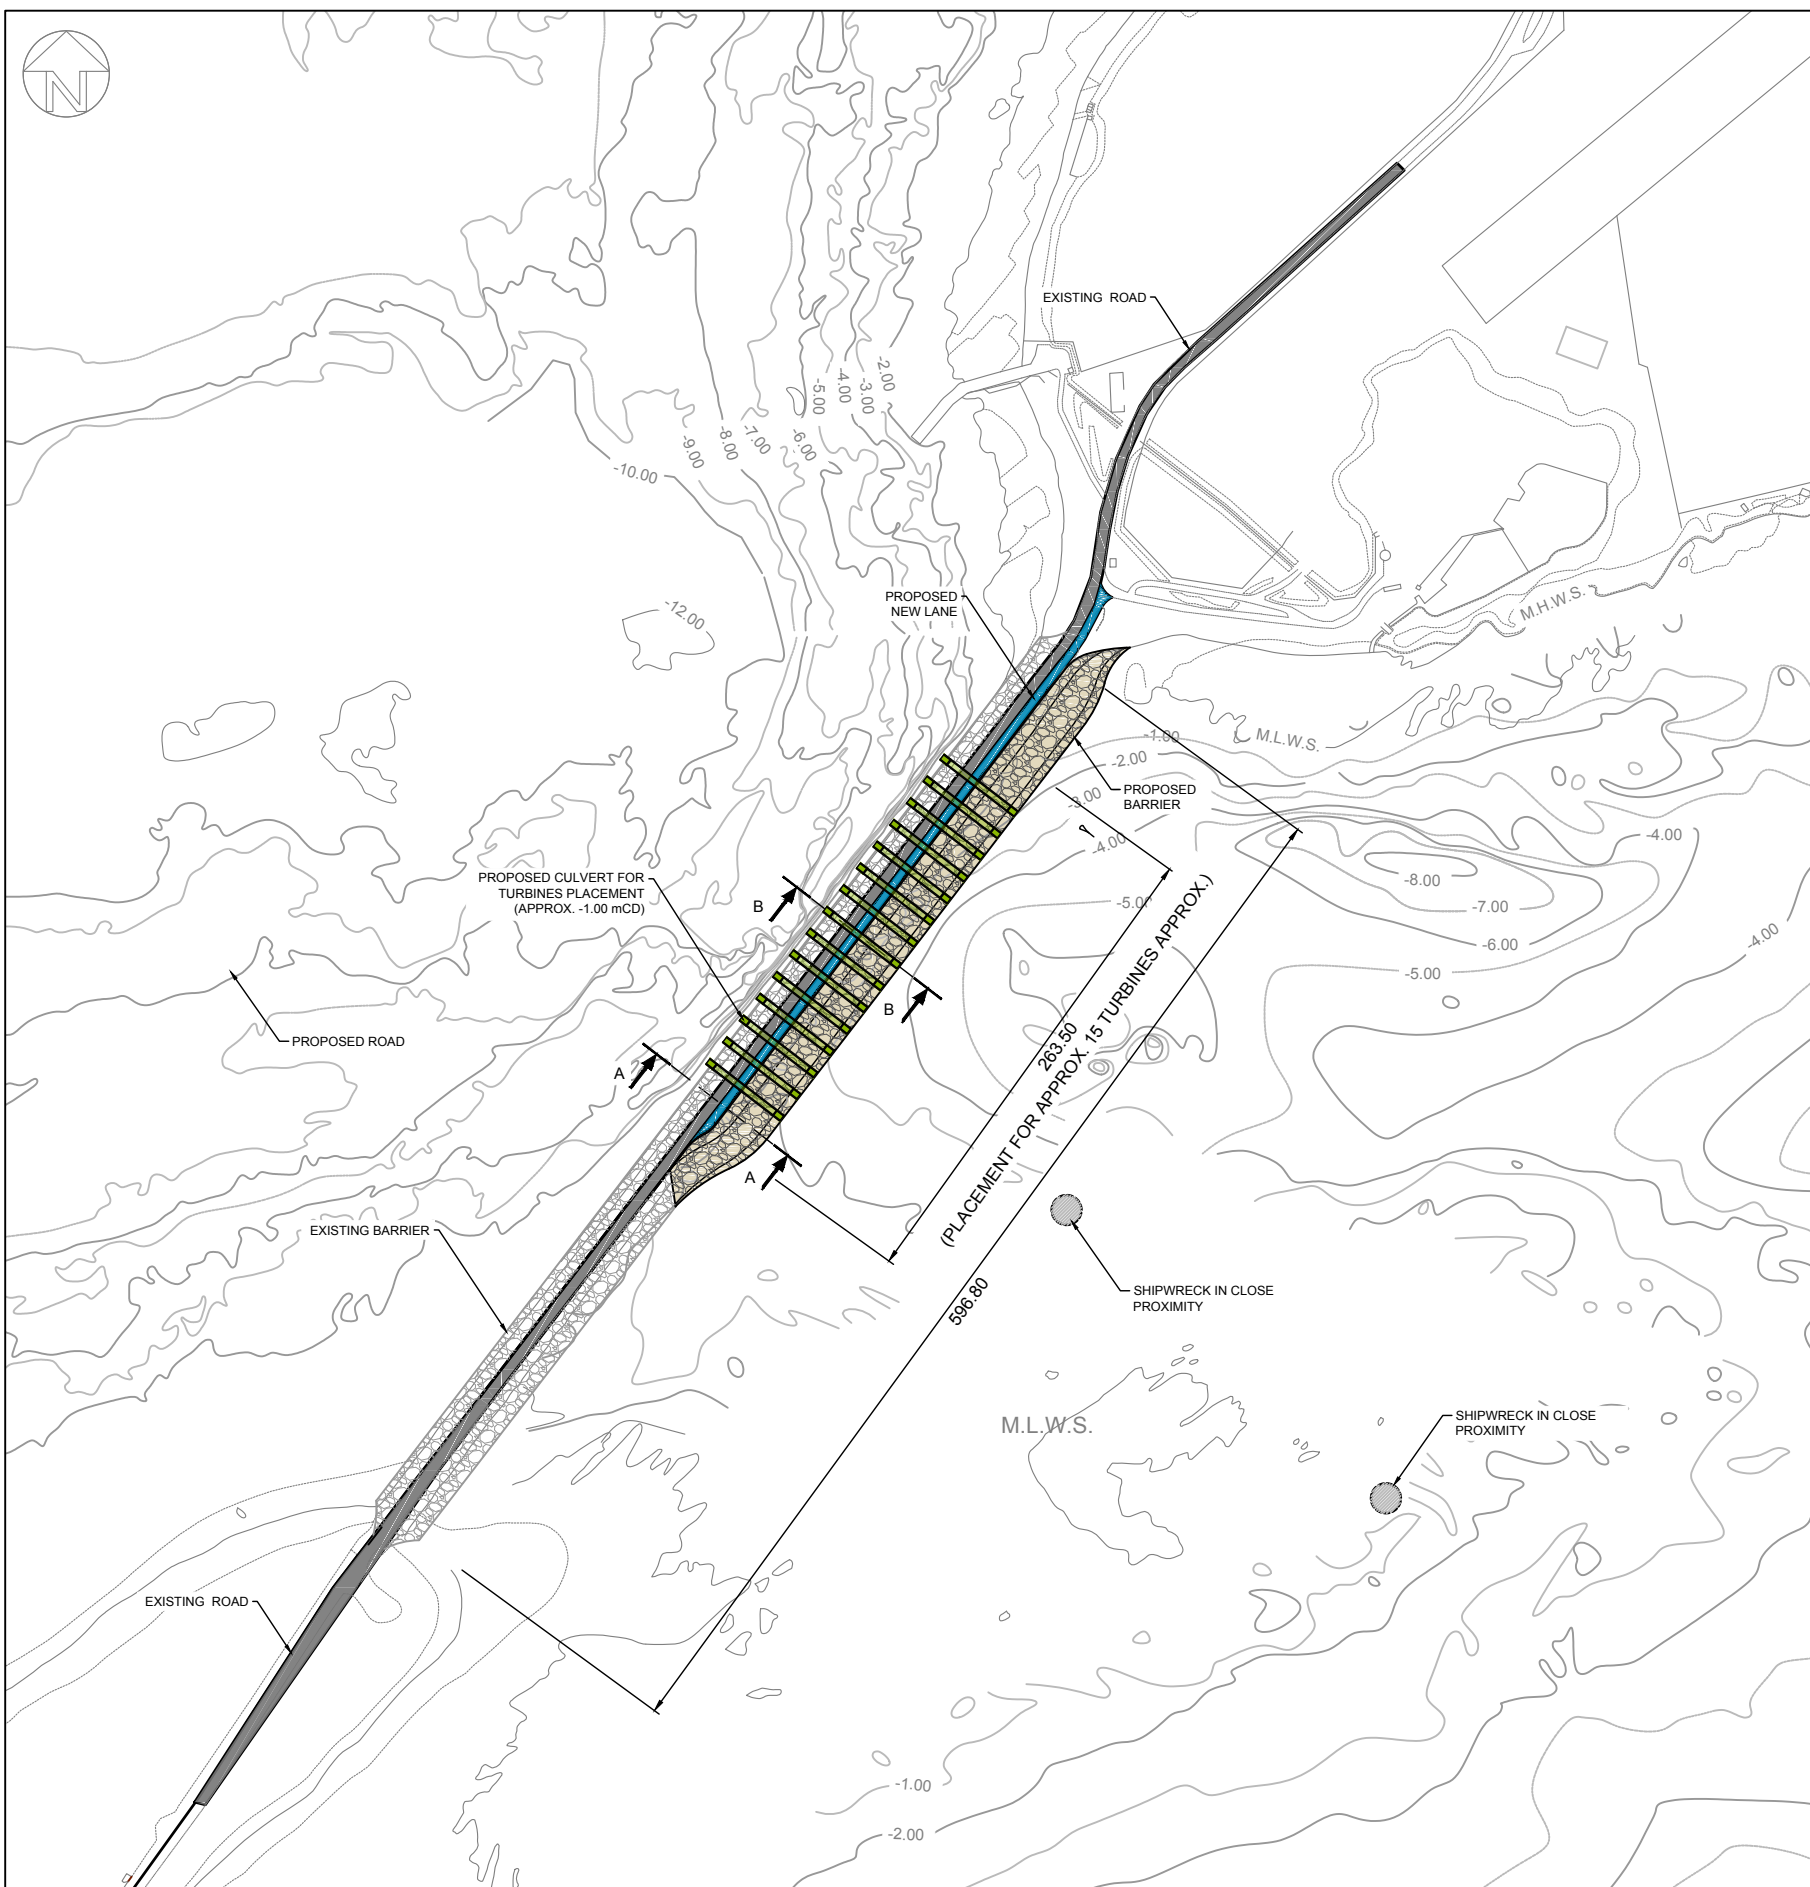
PLAN
SCALE 1:2000

D Energy Capture at 2 (Culverts)
