# Lynn and Inner Dowsing Hydrographic Monitoring Survey

Issue Date: 14<sup>th</sup> December 2009

Report No: 09/□1/02/1495/0925

| <b>Title: Lynn and Inner Dowsing Hydrographic Monitoring Survey</b> | | | |
|---|---|---|---|
| Client Name | : Centrica Renewable Energy Limited | | |

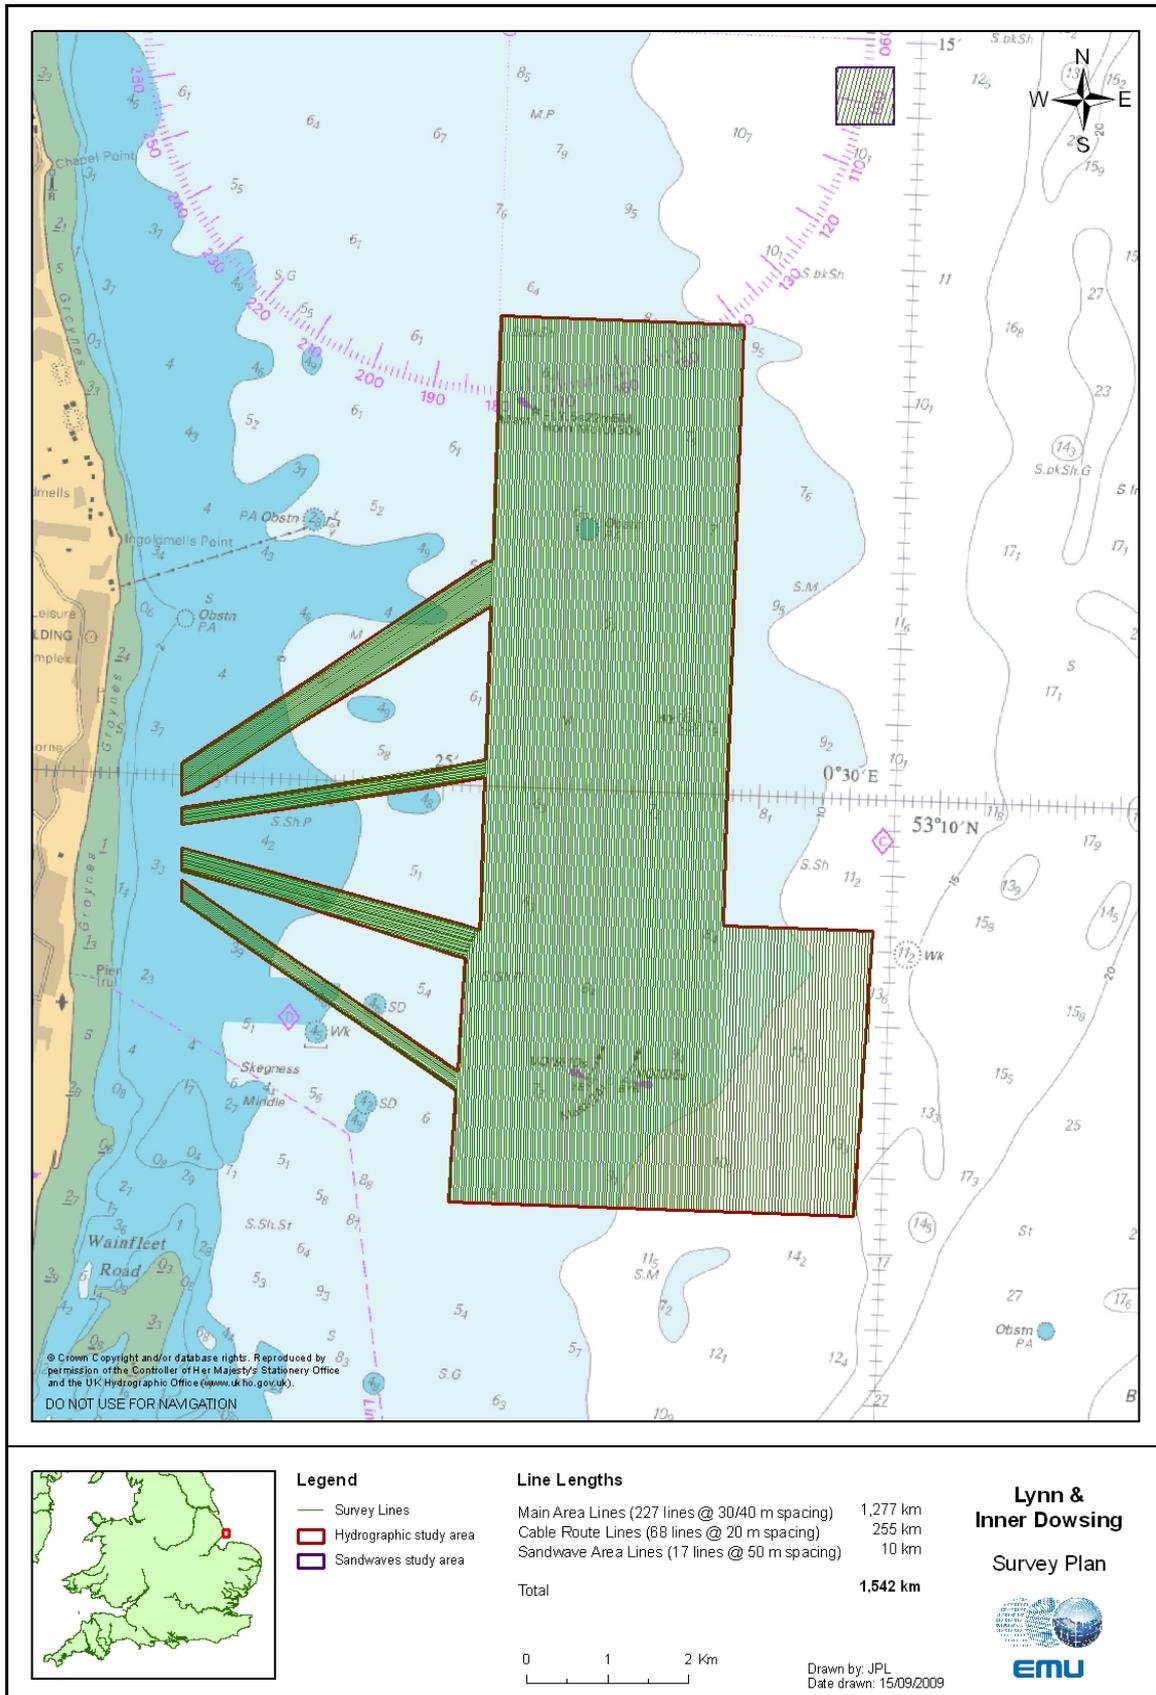
Figure 1.4.1 Site Location Diagram and Line Plan

In addition, bathymetry coverage could be observed real-time in the QINSy navigation software. Any areas that may not have had adequate coverage were infilled. Refer to Figure 1.4.1 for an overview of the main site and line plan.

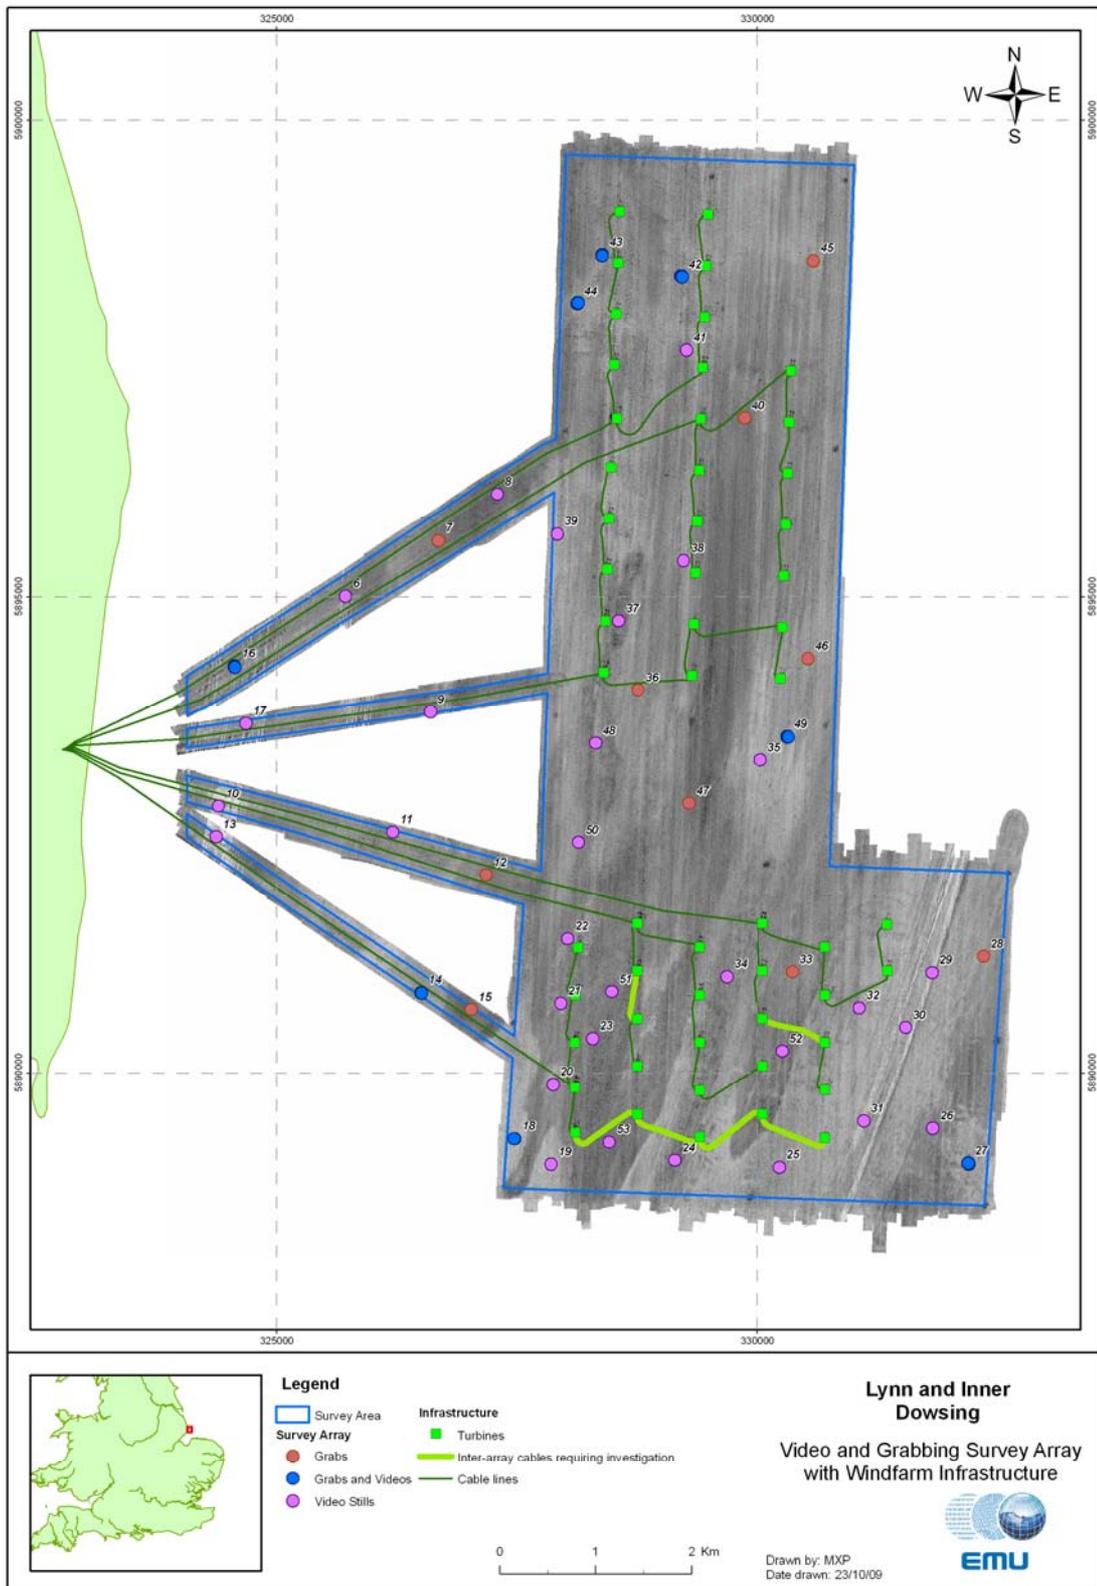
Figure 1.4.2 Video and Grabbing Survey Array within Lynn and Inner Dowsing OWF Area

The drop down video and grabbing surveys was conducted from the *Arie Dirk* between the 9<sup>th</sup> and the 12<sup>th</sup> September 2009. Daily progress logs can be found in Appendix B.

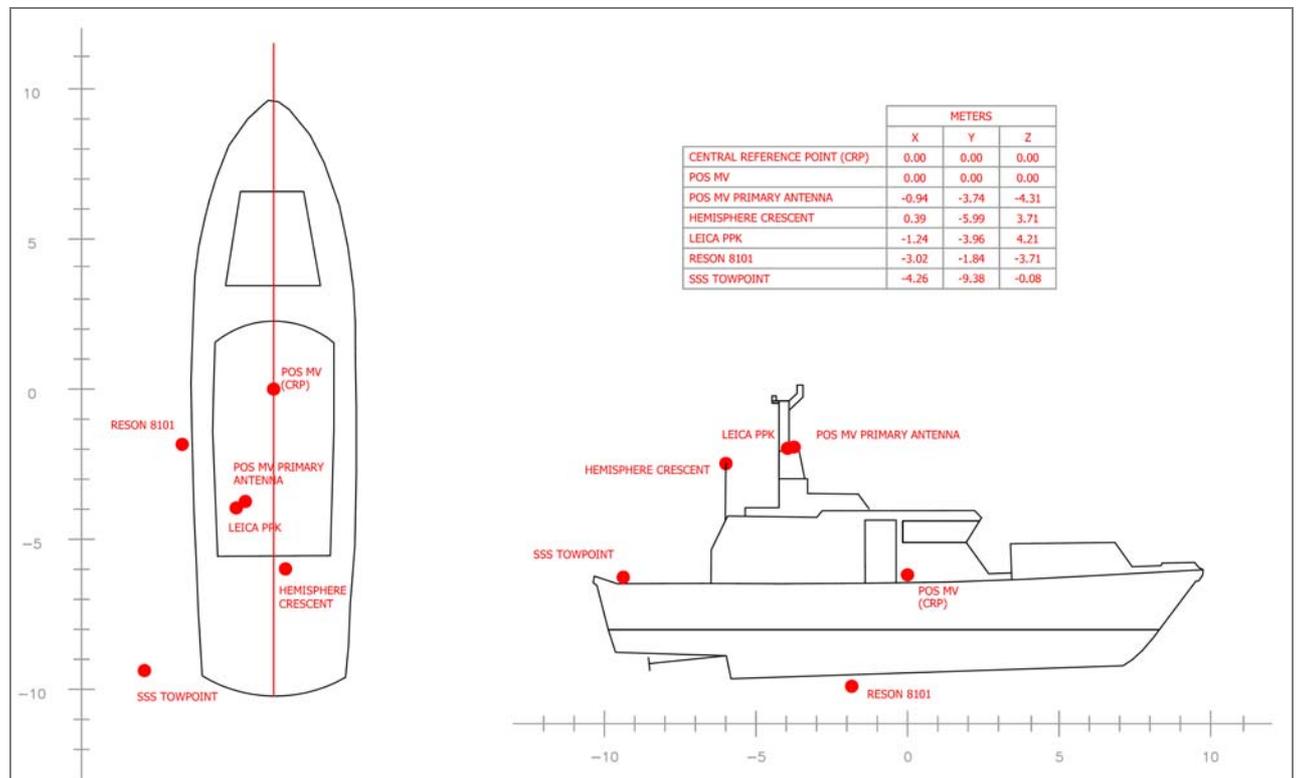
**Figure 2.1.1 FPV Morven Vessel Offset Diagram.**

Vessel offsets of the *FPV Morven* were based on a dimensional control survey performed by Oceanfix International Limited in June 2009. These measurements were confirmed before the survey commenced and entered into QINSy 8 software. The offsets are presented below:

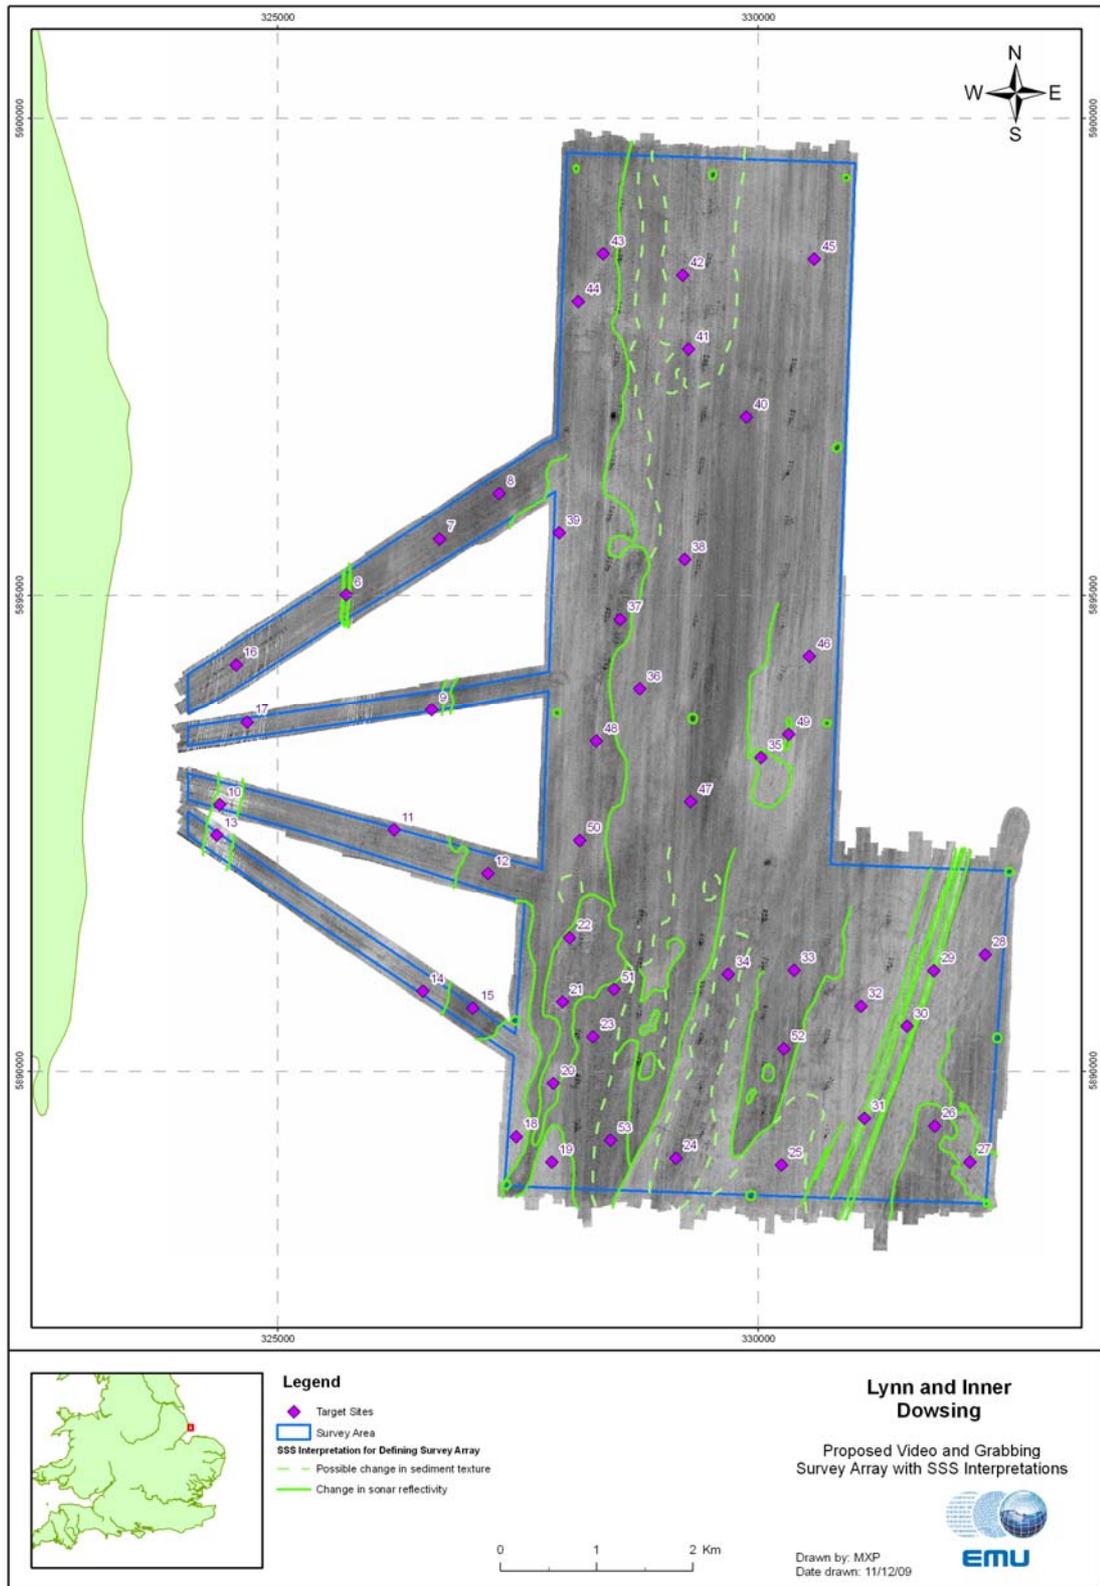
Figure 2.5.1 Proposed video and grabbing survey array with initial SSS interpretations

Table 2.5.1 contains a list of the sites selected for ground truthing and the specific feature observed in the sidescan sonar interpretation that prompted further investigation. Figure 2.5.1 illustrates the areas delineated on the initial sidescan interpretation and the location of the proposed ground truth sites.

From the hydrographic survey interpretation 38 sites were identified to be ground truthed with the drop down video system and/or the mini-Hamon grab. An additional 10 sites were selected to ground truth sediment classifications from acoustic methods with the mini-Hamon grab. Included within these 48 sites were 5 stations (24, 25, 51, 52 and 53) that were also selected to illustrate the distribution of *Sabellaria* reefs and/or agglomerations along the inter-array cable runs.

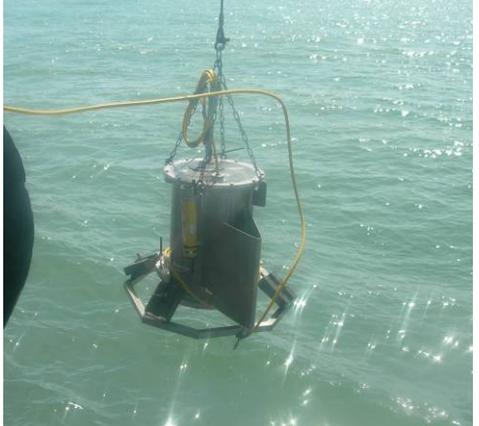
| Drop Down Video Specifications | |
|---|--|
| | <ul style="list-style-type: none"> <li>• Kongsberg OE14-208 new generation digital stills colour camera. Stills images are framed using real time video.</li> <li>• ELViS (Extreme Low Visibility System) – video camera was housed within a low visibility clear water box system due to potentially poor underwater visibility in the area. This system permits seabed footage to be collected in turbid waters as it provides a clear column of water between the camera lens and the seabed. The base of the box was positioned approximately 3.5cm above the seabed.</li> <li>• Subsea camera telemetry cable system (200m)</li> <li>• Bespoke topside control unit (comprising a 400GB Hard Disk Drive (HDD) incorporating a DVD recorder for use as the primary video recording system, 15” LCD monitor, with GPS Overlay using a Hemisphere Crescent V100 series DGPS system)</li> <li>• Mini-DV player and full screen colour monitor for simultaneous backup.</li> <li>• Horizontal positioning was provided using a Differential Global Positioning System accurate to ±5m in conjunction with the navigation software package Trimble HYDROPro.</li> </ul> |
| <p><b>Deployment of drop down video system housed within ELViS</b></p> | |

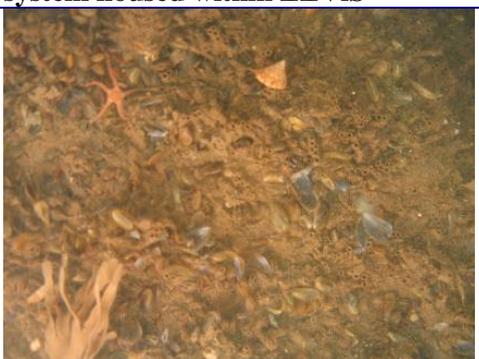
| Drop Down Video Specifications | |
|---|--|
| <p><b>Example stills image of seed mussel and <i>Sabellaria</i> reef.</b></p> | |

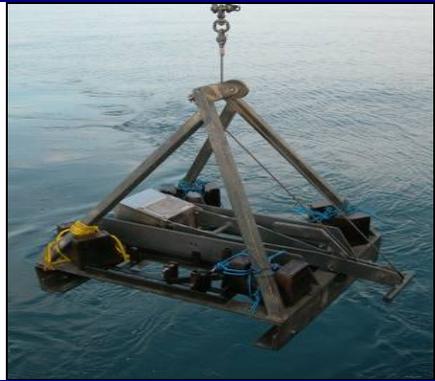
| Grab Sampling Equipment Specifications | |
|---|---|
| | <ul style="list-style-type: none"> <li>• 0.1m<sup>2</sup> mini-Hamon grab</li> <li>• 1mm sieves</li> <li>• Nikon Coolpix 7900 digital camera and housing for deck photography</li> <li>• Differential GPS accurate to ±5m.</li> </ul> |
| <p><b>Close up of Mini-Hamon Grab Sampler</b></p> | |

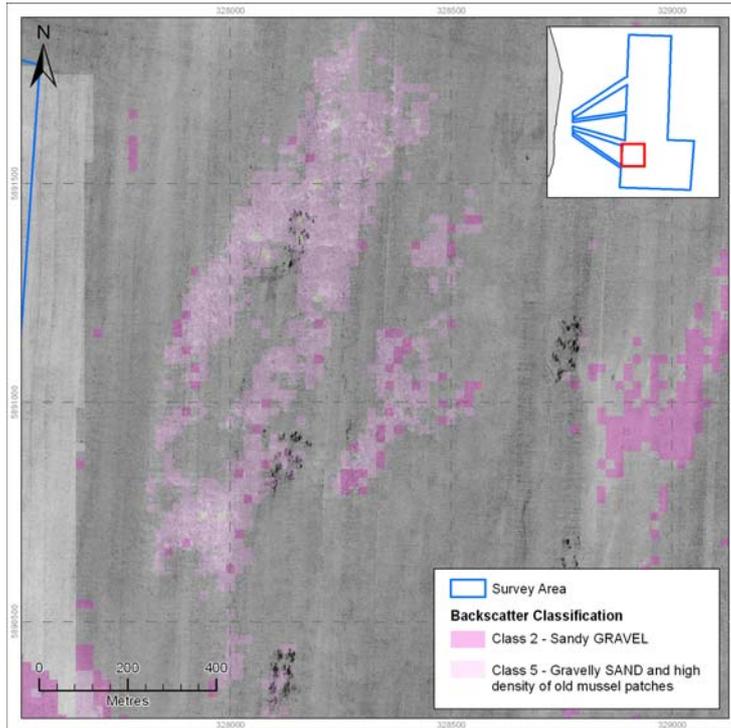
**Figure 3.4.1. Multibeam acoustic backscatter data highlighting a dense area of old mussel patches**

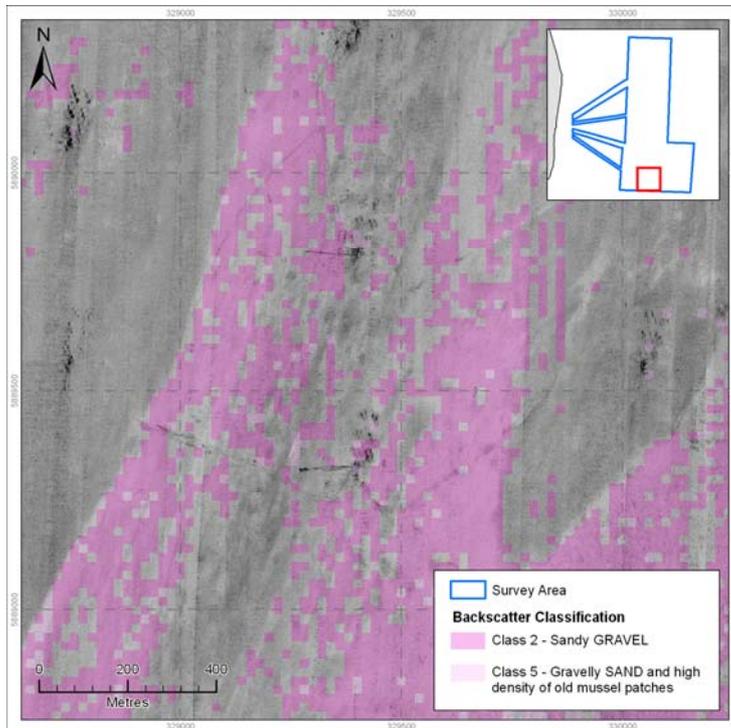
**Figure 3.4.2. Multibeam acoustic backscatter highlighting a boundary between different sediment types**

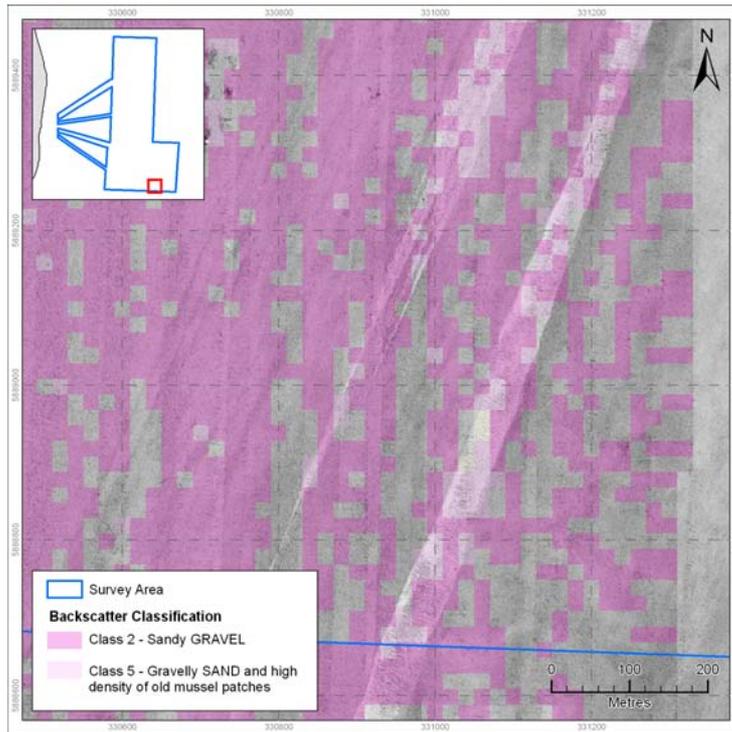
**Figure 3.4.3. Multibeam acoustic backscatter highlighting a sand wave area**

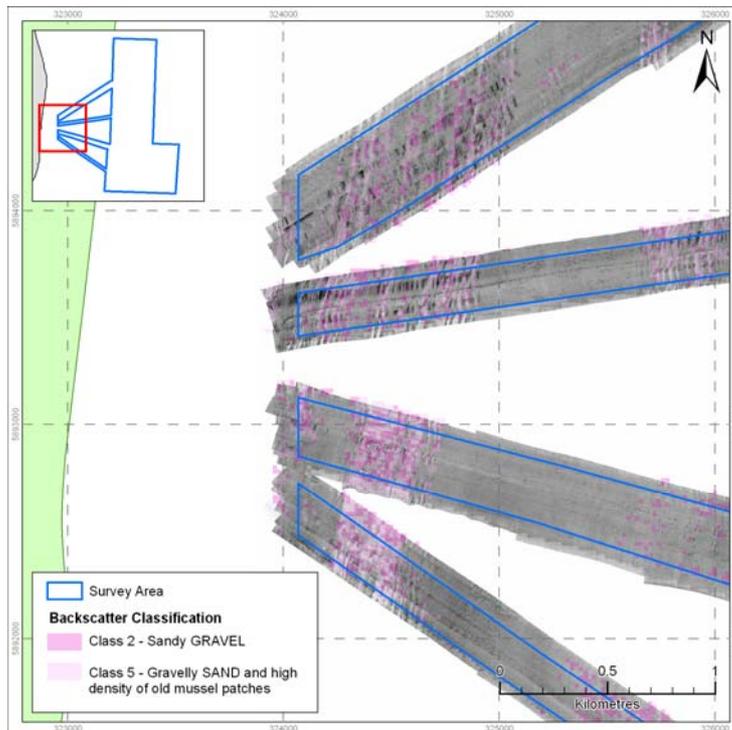
**Figure 3.4.4. Multibeam acoustic backscatter highlighting the sand wave areas on the cable routes**

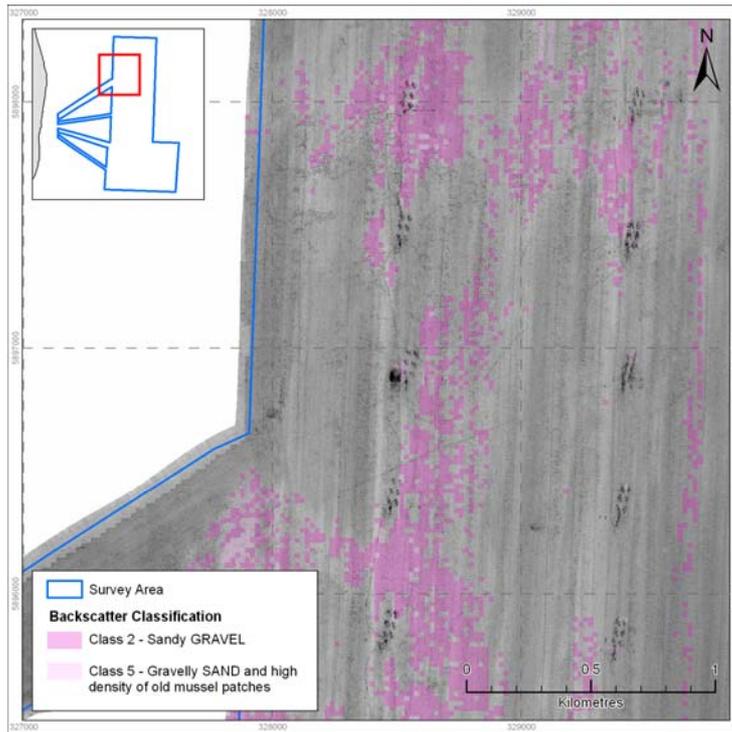
**Figure 3.4.5. Multibeam acoustic backscatter highlighting different sediments and a possible area of low lying *sabellaria* reef**

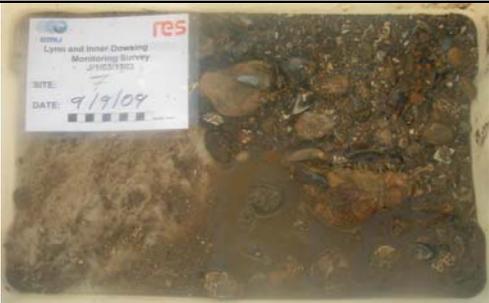
| Site No. | Location (lat/long) | Water Depth (m) | Image |
|---|---|---|--|
| 7 | 53.181335 N<br>0.406337 E | 7.1 | |

**Table 3.5.1. Grab site locations, water depths & deck photos**

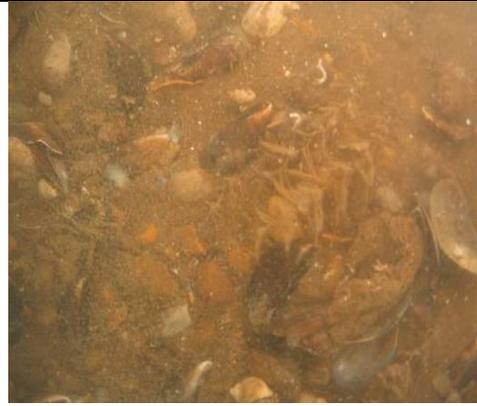
| Site | Sediment and <i>Mytilus edulis</i> / <i>Ampelisca diadema</i> aggregation description | Stage 2 analysis | | | | | Image | Stage 3 analysis | |
|---|--|--|---|---|---|---|--|--|---|
| 6 | Slightly gravelly shelly silty sand with occasional pebbles.<br><br>Old mussel patch - lots of dead <i>Mytilus edulis</i> shells.<br>4% absolute percentage of live individuals. | Moribund loose tubes and small amount of Crusts on shells and sediment (2% cover).<br><br>No reef. | * | * | * | Hydrozoan / Bryozoan turf, <i>Pomatoceros</i> sp., <i>Flustra foliacea</i> , Anthozoan sp., Bryozoan crust, <i>Hydrallmania falcata</i> . | | NOT SABELLARIA REEF | NOT SABELLARIA REEF |

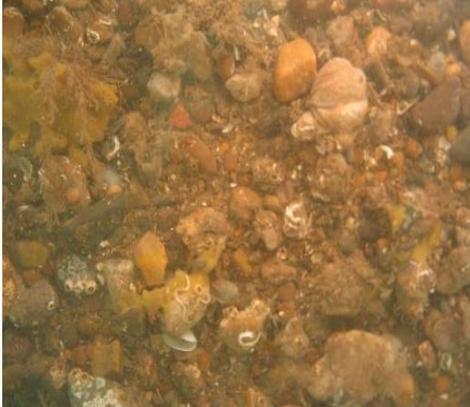
| Site | Sediment and <i>Mytilus edulis</i> / <i>Ampelisca diadema</i> aggregation description | Sabellaria characteristics | | | | | Image | Sabellaria reef definition based on Elevation | Sabellaria reef definition based on Patchiness |
|---|--|---|---|---|---|---|--|---|--|
| 8 | Slightly silty sandy gravel with pebbles and some cobbles. | Moribund loose tubes (10% cover).<br>No reef. | x | x | x | <i>Frustra foliacea</i> , Hydrozoan / Bryozoan turf, <i>Pomatoceros</i> sp., <i>Macropodia</i> sp., <i>Asterias rubens</i> , Decapod sp., <i>Crepidula</i> sp., <i>Porifera</i> sp., <i>Sabella</i> tubes | | NOT SABELLARIA REEF | NOT SABELLARIA REEF |

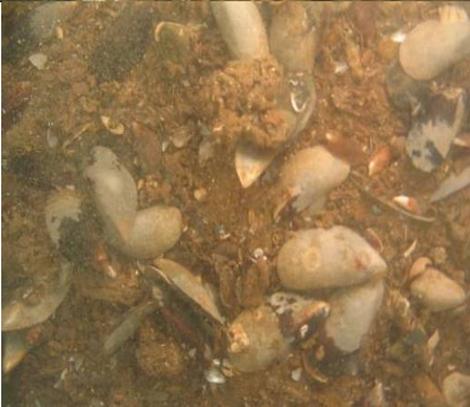
| Site | Sediment and <i>Mytilus edulis</i> / <i>Ampelisca diadema</i> aggregation description | Sabellaria characteristics | | | | | Image | Sabellaria reef definition based on Elevation | Sabellaria reef definition based on Patchiness |
|---|--|---|---|---|---|---|--|---|--|
| 9 | Shelly silty sandy gravel. Old mussel patch with dense patches of dead mussel shells. 10% - absolute percentage of live individuals. | Moribund loose tubes and Crusts (6% cover).<br>No reef. | x | x | x | Hydrozoan / Bryozoan turf <i>Pomatoceros</i> sp., Bryozoan crust., <i>Crossaster papposus</i> , Decapod sp. | | NOT SABELLARIA REEF | NOT SABELLARIA REEF |

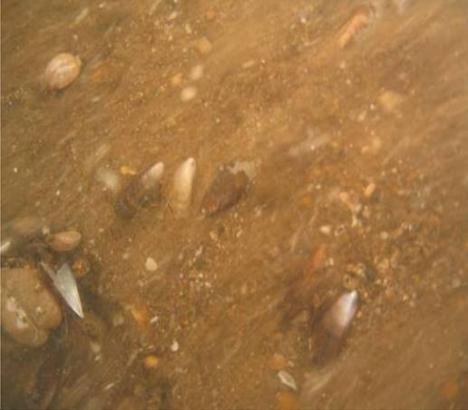
| Site | Sediment and <i>Mytilus edulis</i> / <i>Ampelisca diadema</i> aggregation description | Sabellaria characteristics | | | | | Image | Sabellaria reef definition based on Elevation | Sabellaria reef definition based on Patchiness |
|---|--|---|---|---|---|---|--|---|--|
| 10 | <p>Slightly gravelly shelly mobile sand. Sand, waves/ripples present.</p> <p>Scattered mussel shells with few possibly live individuals. Some possibly alive (absolute percentage 1%).</p> | <p>Moribund loose tubes and Crusts on shells and sediment (1% cover).</p> <p>No reef.</p> | x | x | x | None | | NOT SABELLARIA REEF | NOT SABELLARIA REEF |

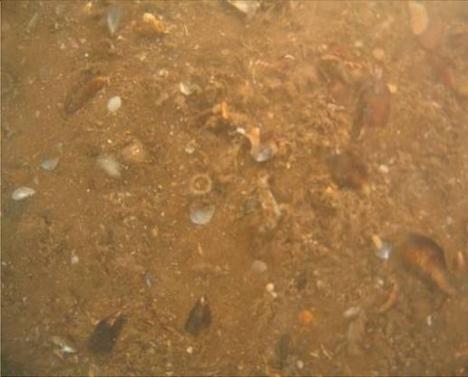
| Site | Sediment and <i>Mytilus edulis</i> / <i>Ampelisca diadema</i> aggregation description | Sabellaria characteristics | | | | | Image | Sabellaria reef definition based on Elevation | Sabellaria reef definition based on Patchiness |
|---|--|---|---|---|---|---|--|---|--|
| 11 | <p>Shelly slightly silty sand with some gravel patches.</p> <p>Old mussel patch with scattered dead mussel shells. Absolute percentage of live individuals 3%).</p> | <p>Moribund loose tubes and Crusts (2% cover).</p> <p>No reef.</p> | x | x | x | <p>Antho<sup>o</sup>oa sp.<br/>Pomatoceros sp.<br/>Hydro<sup>o</sup>oan / Bryo<sup>o</sup>oan turf, <i>Crepidula fornicata</i>.</p> | | NOT SABELLARIA REEF | NOT SABELLARIA REEF |

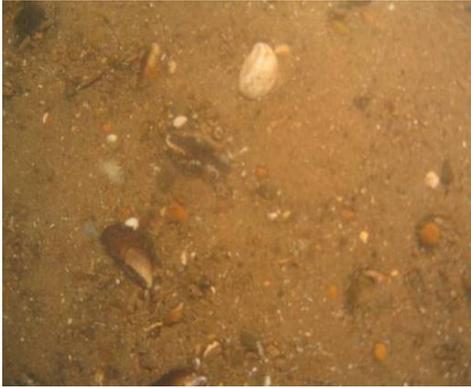
| Site | Sediment and <i>Mytilus edulis</i> / <i>Ampelisca diadema</i> aggregation description | Sabellaria characteristics | | | | | Image | Sabellaria reef definition based on Elevation | Sabellaria reef definition based on Patchiness |
|---|---|---|---|---|---|---|--|---|--|
| 13 | <p>Slightly shelly gravelly mobile sand. Sand ripples present.</p> <p>Scattered mussel shells with few possibly live individuals. Absolute percentage of live individuals (2%).</p> | <p>Moribund loose tubes (2% cover).</p> <p>No reef.</p> | * | * | * | <i>Anseropoda placenta</i> | | NOT SABELLARIA REEF | NOT SABELLARIA REEF |

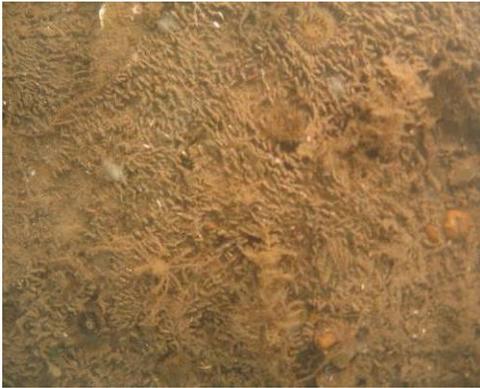
| Site | Sediment and <i>Mytilus edulis</i> / <i>Ampelisca diadema</i> aggregation description | Sabellaria characteristics | | | | | Image | Sabellaria reef definition based on Elevation | Sabellaria reef definition based on Patchiness |
|---|---|---|---|---|---|---|--|---|--|
| 14 | <p>Gravelly silty sand.</p> <p>Ampelisca reef. Med-high density and abundance. 3.5cm proud. Absolute percentage 87%.</p> <p>Grab results for <i>Ampelisca</i> 1.5cm high, 5% percentage cover within grab bite.</p> | Absent | * | * | * | <p><i>Ampelisca diadema</i>,<br/><i>Ophiura albida</i>,<br/><i>Pomatoceros</i> sp.,<br/><i>Anthozoa</i> spp.,<br/><i>Macropodia</i> sp.,<br/>Hydrozoan / Bryozoan turf, <i>Sabella</i> sp., <i>Ophiura</i> sp.,</p> | | NOT SABELLARIA REEF | NOT SABELLARIA REEF |

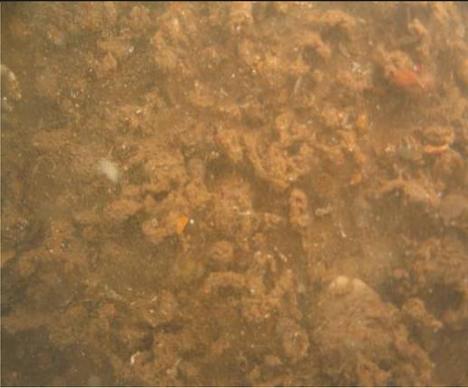
| Site | Sediment and <i>Mytilus edulis</i> / <i>Ampelisca diadema</i> aggregation description | Sabellaria characteristics | | | | | Image | Sabellaria reef definition based on Elevation | Sabellaria reef definition based on Patchiness |
|---|--|---|--|---|--|--|--|---|--|
| 16 | Slightly shelly sand with some pebbles. Sand ripples/waves present. | Crusts and Clumps (4% cover).<br>Potential reef (not a continuous feature) (12% cover). | ±3.5cm<br><i>Sabellaria</i> in grab 4cm high. 2 clumps, each 4cm across. Percentage cover within grab bite ±5% | 12% | Clumps and crusts of <i>Sabellaria</i> and low lying reef. Low-med consolidation, abundance and density. | <i>Cirripedia</i> sp., <i>Antho</i> oa sp., <i>Urticina</i> sp.<br>Hydrozoan / Bryozoan turf | | LOW | LOW |

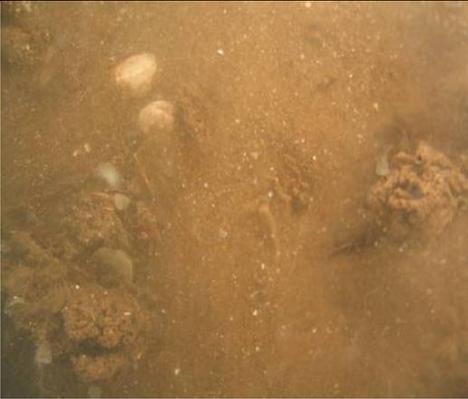
| Site | Sediment and <i>Mytilus edulis</i> / <i>Ampelisca diadema</i> aggregation description | Sabellaria characteristics | | | | | Image | Sabellaria reef definition based on Elevation | Sabellaria reef definition based on Patchiness |
|---|--|---|--|---|--|--|--|---|--|
| 17 | Slightly shelly mobile sand. Sand waves/ripples present.<br>Scattered <i>Mytilus edulis</i> (±2% cover). | Moribund loose tubes, Crusts and Clumps - little consolidation (3% cover).<br>Not reef. | x | x | x | <i>Liocarcinus</i> sp.,<br>Hydrozoan / Bryozoan turf, Bryozoan crust, <i>Pomatoceros</i> sp. | | NOT SABELLARIA REEF | NOT SABELLARIA REEF |

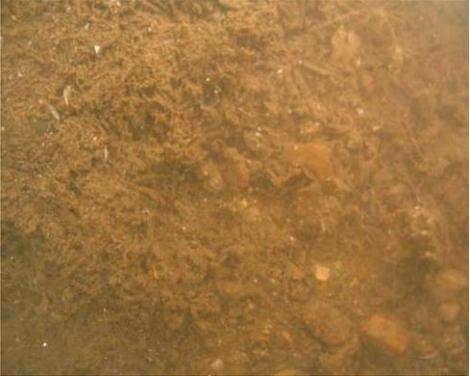
| Site | Sediment and <i>Mytilus edulis</i> / <i>Ampelisca diadema</i> aggregation description | Sabellaria characteristics | | | | | Image | Sabellaria reef definition based on Elevation | Sabellaria reef definition based on Patchiness |
|---|---|---|---|---|---|---|--|---|--|
| 18 | Gravelly silty sand.<br>Ampelisca clumps and patchy reef. □3.5cm proud. Med density and abundance. Absolute percentage 10□. | Absent | * | * | * | <i>Ampelisca diadema</i> ,<br><i>Sabella</i> tubes, <i>Ophiura albida</i> , Hydrozoan / Bryozoan turf, <i>Flustra foliacea</i> , <i>Pomatoceros</i> sp., <i>Asterias rubens</i> , <i>Anthozoa</i> sp. | | NOT SABELLARIA REEF | NOT SABELLARIA REEF |

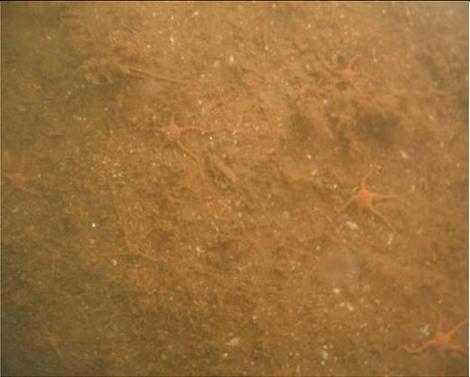
| Site | Sediment and <i>Mytilus edulis</i> / <i>Ampelisca diadema</i> aggregation description | Sabellaria characteristics | | | | | Image | Sabellaria reef definition based on Elevation | Sabellaria reef definition based on Patchiness |
|---|---|---|---|---|---|---|--|---|--|
| 19 | Gravelly silty sand | Absent | * | * | * | <i>Asterias rubens</i> ,<br>Hydrozoan / Bryozoan turf, <i>Ophiura albida</i> , <i>Sabella</i> tube, <i>Ophiura</i> sp., | | NOT SABELLARIA REEF | NOT SABELLARIA REEF |

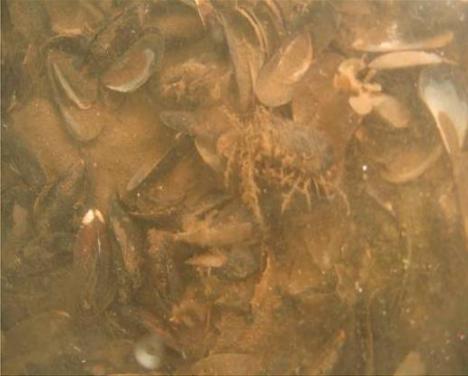
| Site | Sediment and <i>Mytilus edilus</i> / <i>Ampelisca diadema</i> aggregation description | Sabellaria characteristics | | | | | Image | Sabellaria reef definition based on Elevation | Sabellaria reef definition based on Patchiness |
|---|---|---|---|---|---|---|--|---|--|
| 20 | Shelly muddy sand.<br>Patches of old, large mussels, appear to be mainly dead (absolute percentage 7%). | Absent | * | * | * | Bryozoan crust, <i>Pomatoceros</i> sp., Hydrozoan / Bryozoan turf, <i>Flustra foliacea</i> | | NOT SABELLARIA REEF | NOT SABELLARIA REEF |

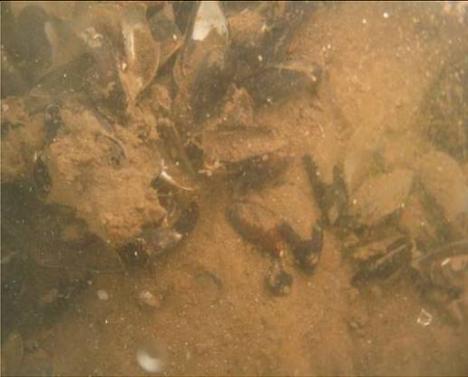
| Site | Sediment and <i>Mytilus edilus</i> / <i>Ampelisca diadema</i> aggregation description | Sabellaria characteristics | | | | | Image | Sabellaria reef definition based on Elevation | Sabellaria reef definition based on Patchiness |
|---|---|---|---|---|---|---|--|---|--|
| 21 | Muddy sand with some shell.<br>Old mussel patch (absolute percentage 28%). | Absent | * | * | * | <i>Pomatoceros</i> sp., Bryozoan crust, <i>Asterias rubens</i> , Hydrozoan / Bryozoan turf, | | NOT SABELLARIA REEF | NOT SABELLARIA REEF |

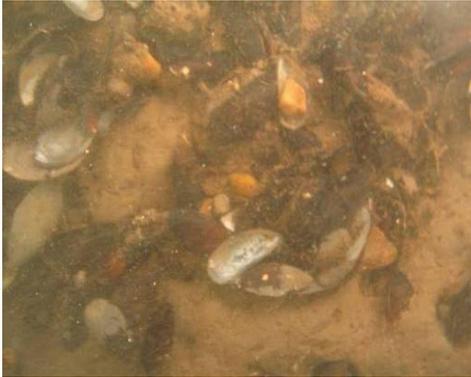
| Site | Sediment and <i>Mytilus edilus</i> / <i>Ampelisca diadema</i> aggregation description | Sabellaria characteristics | | | | | Image | Sabellaria reef definition based on Elevation | Sabellaria reef definition based on Patchiness |
|---|---|---|---|---|---|---|--|---|--|
| 22 | Slightly shelly muddy sand with occasional gravel.<br><br><b>Old mussel patch</b><br>(absolute percentage 17%). | Crusts (1% cover).<br><br>No reef. | x | x | x | <i>Hydrozoa</i> spp., <i>Asterias rubens</i> , <i>Bryozoan</i> crust, | | NOT SABELLARIA REEF | NOT SABELLARIA REEF |

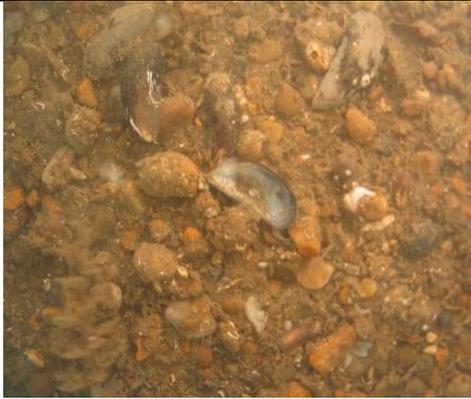
| Site | Sediment and <i>Mytilus edilus</i> / <i>Ampelisca diadema</i> aggregation description | Sabellaria characteristics | | | | | Image | Sabellaria reef definition based on Elevation | Sabellaria reef definition based on Patchiness |
|---|---|---|---|---|---|---|--|---|--|
| 23 | Shelly silty sandy gravel.<br><br>Old mussel patch with scattered dead mussels. No live individuals apparent. | Moribund loose tubes and Crusts (4% cover).<br><br>No reef. | x | x | x | <i>Pomatoceros</i> sp. Hydrozoan / Bryozoan turf, <i>Anthofoa</i> sp., <i>Sabella</i> tube. | | NOT SABELLARIA REEF | NOT SABELLARIA REEF |

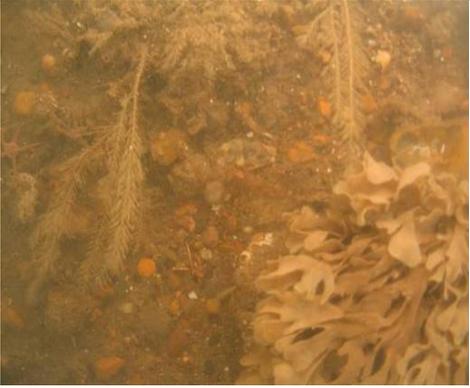
| Site | Sediment and <i>Mytilus edulis</i> / <i>Ampelisca diadema</i> aggregation description | Sabellaria characteristics | | | | | Image | Sabellaria reef definition based on Elevation | Sabellaria reef definition based on Patchiness |
|---|---|--|---|---|---|--|--|---|--|
| 24 | Gravelly silty sand with some pebbles. | Moribund loose tubes (1□ cover).<br>No reef. | x | x | x | <i>Crossaster papposus</i> ,<br>Hydrozoan / Bryozoan turf, <i>Pomatoceros</i> sp.,<br><i>Flustra foliacea</i> , <i>Ophiura albida</i> , <i>Ophiura</i> sp. | | NOT SABELLARIA REEF | NOT SABELLARIA REEF |

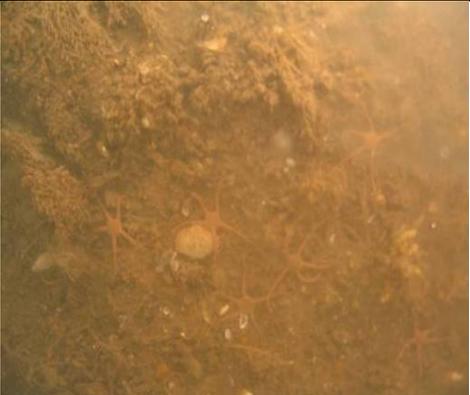
| Site | Sediment and <i>Mytilus edulis</i> / <i>Ampelisca diadema</i> aggregation description | Sabellaria characteristics | | | | | Image | Sabellaria reef definition based on Elevation | Sabellaria reef definition based on Patchiness |
|---|---|--|---|---|---|--|--|---|--|
| 25 | Slightly shelly, slightly gravelly silty sand. | Moribund loose tubes (3□ cover).<br>No reef. | x | x | x | <i>Ophiura albida</i> ,<br>Hydrozoan / Bryozoan turf, Anthozoa sp.,<br><i>Ophiura</i> sp. | | NOT SABELLARIA REEF | NOT SABELLARIA REEF |

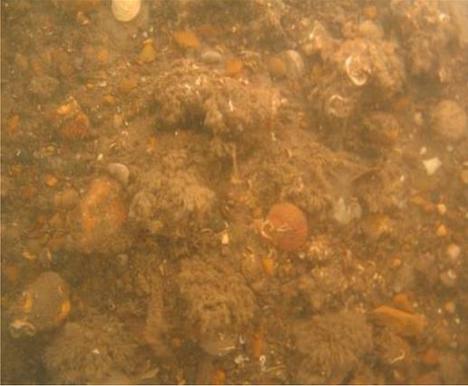
| Site | Sediment and <i>Mytilus edulis</i> / <i>Ampelisca diadema</i> aggregation description | Sabellaria characteristics | | | | | Image | Sabellaria reef definition based on Elevation | Sabellaria reef definition based on Patchiness |
|---|---|--|---|---|---|---|--|---|--|
| 26 | Silty sandy gravel with pebbles and occasional cobble. | Moribund loose tubes and encrusting sediment (1% cover).<br><br>No reef. | x | x | x | <i>Pomatoceros</i> sp., Hydrozoan/bryozoan turf, <i>Calliostoma</i> sp., <i>Pygospio</i> , <i>Flustra foliacea</i> . | | NOT SABELLARIA REEF | NOT SABELLARIA REEF |

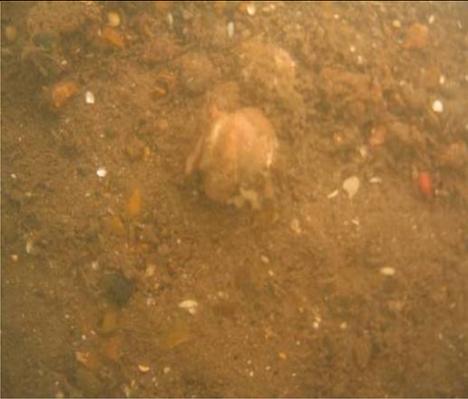
| Site | Sediment and <i>Mytilus edulis</i> / <i>Ampelisca diadema</i> aggregation description | Sabellaria characteristics | | | | | Image | Sabellaria reef definition based on Elevation | Sabellaria reef definition based on Patchiness |
|---|---|--|---|---|---|---|--|---|--|
| 27 | Slightly gravelly, slightly shelly silty sand with occasional pebbles. | Moribund loose tubes and encrusting sediment (4% cover).<br><br>No reef. | x | x | x | <i>Urticina</i> sp., <i>Macropodia</i> sp., Hydrozoan/bryozoan turf, <i>Pomatoceros</i> sp., <i>Ophiura albida</i> , <i>Crepidula fornicata</i> , <i>Galathea</i> sp. | | NOT SABELLARIA REEF | NOT SABELLARIA REEF |

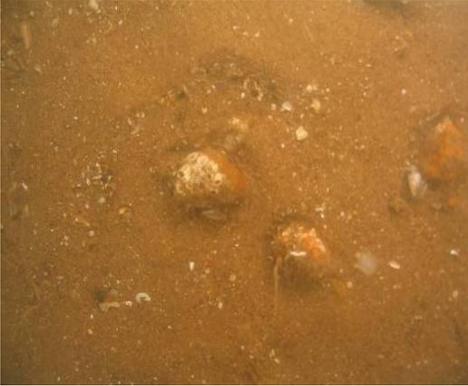
| Site | Sediment and <i>Mytilus edilus</i> / <i>Ampelisca diadema</i> aggregation description | Sabellaria characteristics | | | | | Image | Sabellaria reef definition based on Elevation | Sabellaria reef definition based on Patchiness |
|---|---|---|---|---|---|---|--|---|--|
| 29 | Slightly shelly sand with pebbles and some cobbles. Sand mobile - some ripples present. | Absent | * | * | * | Hydrozoan/Bryozoan turf, <i>Asterias rubens</i> , Hydrozoan/Bryozoan turf, <i>Flustra foliacea</i> , <i>Pomatoceros</i> sp. | | NOT SABELLARIA REEF | NOT SABELLARIA REEF |

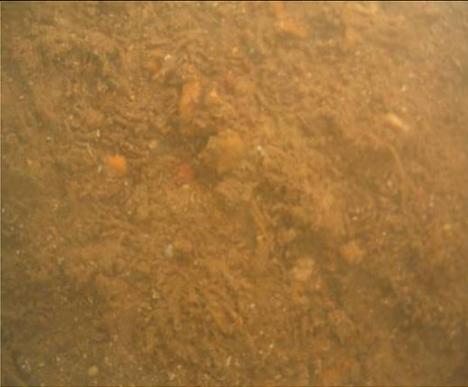
| Site | Sediment and <i>Mytilus edilus</i> / <i>Ampelisca diadema</i> aggregation description | Sabellaria characteristics | | | | | Image | Sabellaria reef definition based on Elevation | Sabellaria reef definition based on Patchiness |
|---|---|---|---|---|---|---|--|---|--|
| 30 | Slightly gravelly, silty sand with some pebbles. | Moribund loose tubes and encrusting sediment (11% cover).<br><br>No reef. | * | * | * | <i>Ophiura albida</i> , Hydrozoan/bryozoan turf., <i>Crossaster papposus</i> , <i>Urticina</i> sp, <i>Crepidula fornicata</i> , <i>Flustra foliacea</i> | | NOT SABELLARIA REEF | NOT SABELLARIA REEF |

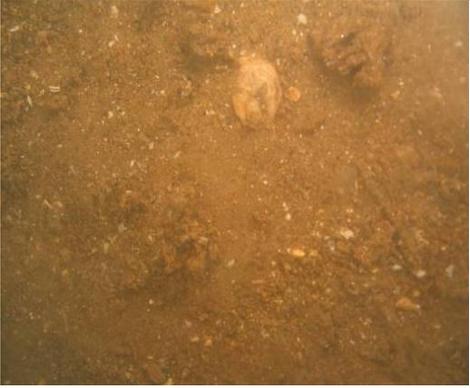
| Site | Sediment and <i>Mytilus edulis</i> / <i>Ampelisca diadema</i> aggregation description | Sabellaria characteristics | | | | | Image | Sabellaria reef definition based on Elevation | Sabellaria reef definition based on Patchiness |
|---|---|---|---|---|--|--|--|---|--|
| 31 | Slightly shelly mobile sand. Sand waves present. | Moribund loose tubes and a small Clump (2% cover).<br><br>No reef. | * | * | * | None | | NOT SABELLARIA REEF | NOT SABELLARIA REEF |

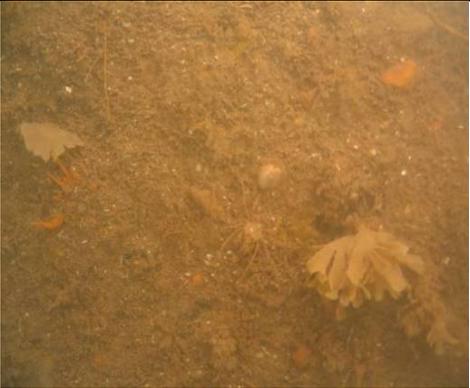
| Site | Sediment and <i>Mytilus edulis</i> / <i>Ampelisca diadema</i> aggregation description | Sabellaria characteristics | | | | | Image | Sabellaria reef definition based on Elevation | Sabellaria reef definition based on Patchiness |
|---|---|---|---|---|--|--|--|---|--|
| 32 | Slightly shelly slightly gravelly silty sand. | Moribund loose tubes and encrusting sediment (6% cover).<br><br>Potential Reef % not a continuous feature (5% cover), | ~3.5cm | 5% | Possible lowlying reef, though hard to assess as covered over by sediment. | <i>Antho<math>\square</math>oa</i> sp., <i>Flustra foliacea</i> ,<br><i>Hydro<math>\square</math>oan/Bryo<math>\square</math>oan</i> turf,<br><i>Ophiura albida</i> , <i>Antho<math>\square</math>oa</i> sp., <i>Porifera</i> sp., <i>Majidae</i> sp., <i>Psammechinus miliaris</i> , <i>Asterias rubens</i> . | | LOW | NOT SABELLARIA REEF |

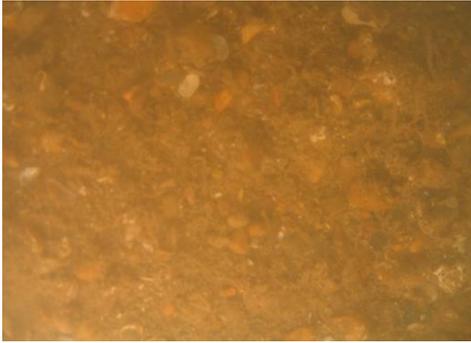
| Site | Sediment and <i>Mytilus edulis</i> / <i>Ampelisca diadema</i> aggregation description | Sabellaria characteristics | | | | | Image | Sabellaria reef definition based on Elevation | Sabellaria reef definition based on Patchiness |
|---|---|---|---|---|---|---|--|---|--|
| 34 | Gravelly silty sand with occasional pebbles. | Crusts (1% cover).<br>No reef. | * | * | * | Hydroids / Bryozoan turf, <i>Ophiura albida</i> , <i>Pomatoceros</i> sp., <i>Urticina</i> sp., <i>Flustra foliacea</i> , <i>Paguridae</i> sp. | | NOT SABELLARIA REEF | NOT SABELLARIA REEF |

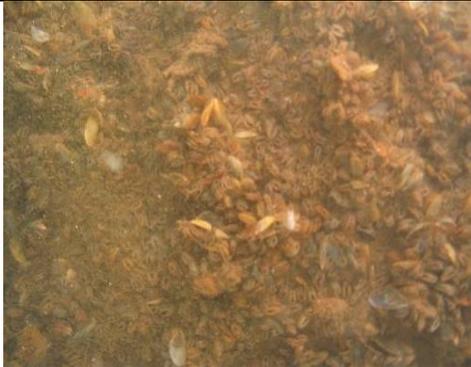
| Site | Sediment and <i>Mytilus edulis</i> / <i>Ampelisca diadema</i> aggregation description | Sabellaria characteristics | | | | | Image | Sabellaria reef definition based on Elevation | Sabellaria reef definition based on Patchiness |
|---|---|---|---|---|---|---|--|---|--|
| 35 | Silty muddy sand with some shell.<br><br>Seed mussel bed. Consisting of smaller, apparently live individuals (absolute percentage 68%). Small patches of <i>Sabellaria</i> crust and possibly moribund loose tubes. | Moribund loose tubes and Crusts (2% cover).<br>No reef. | * | * | * | Anthoidea sp., Decapod sp., <i>Flustra foliacea</i> , <i>Sabella</i> tubes | | NOT SABELLARIA REEF | NOT SABELLARIA REEF |

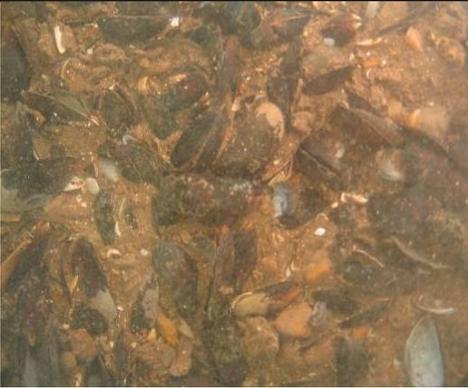
| Site | Sediment and <i>Mytilus edulis</i> / <i>Ampelisca diadema</i> aggregation description | Sabellaria characteristics | | | | | Image | Sabellaria reef definition based on Elevation | Sabellaria reef definition based on Patchiness |
|---|--|---|---|---|---|---|--|---|--|
| 37 | Gravelly muddy sand.<br><br>Old mussel patch with <i>Sabellaria</i> tubes and crusts.<br><br>Feature consists primarily of large, old mussels (absolute percentage 40%). Hard to assess if alive/dead. Up to 50% dead. | Crusts (2% cover).<br><br>No reef. | * | * | * | <i>Pomatoceros</i> sp.,<br><i>Asterias rubens</i> | | NOT SABELLARIA REEF | NOT SABELLARIA REEF |

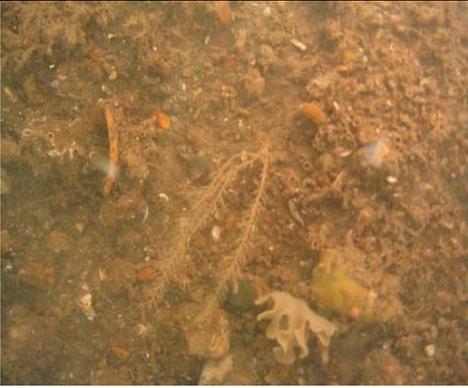
| Site | Sediment and <i>Mytilus edulis</i> / <i>Ampelisca diadema</i> aggregation description | Sabellaria characteristics | | | | | Image | Sabellaria reef definition based on Elevation | Sabellaria reef definition based on Patchiness |
|---|--|---|---|---|---|---|--|---|--|
| 38 | Silty sandy gravel with pebbles and occasional cobbles. | Moribund loose tubes, patchy Crusts and 1 small Clump (8% cover).<br><br>No reef. | * | * | * | <i>Pomatoceros</i> sp.,<br>Hydrozoan / Bryozoan turf, <i>Asterias rubens</i> ,<br><i>Flustra foliacea</i> , <i>Porifera</i> sp. | | NOT SABELLARIA REEF | NOT SABELLARIA REEF |

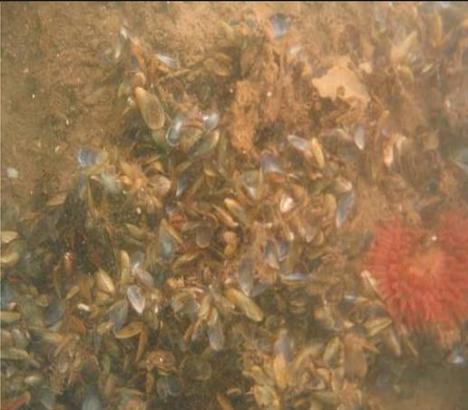
| Site | Sediment and <i>Mytilus edulis</i> / <i>Ampelisca diadema</i> aggregation description | Sabellaria characteristics | | | | | Image | Sabellaria reef definition based on Elevation | Sabellaria reef definition based on Patchiness |
|---|--|--|---|---|---|---|--|---|--|
| 39 | Shelly silty sand.<br><br>Possible mussel and <i>Sabellaria</i> reef feature.<br><br>Feature consists primarily of large, old mussels. Hard to assess if alive/dead. Absolute percentage of mussels 74%. Up to 50% dead. | Moribund loose tubes, Crusts and Clump (3% cover).<br><br>Some potential patchy Reef (3% cover). | ~3.5cm | 3% | Low lying reef, low-med density, abundance and consolidation. Possibly moribund in areas. | <i>Sabella</i> spp. Bryozoan / Hydrozoan turf, <i>Asterias rubens</i> , <i>Flustra foliacea</i> , <i>Anthofoa</i> sp., <i>Buccinum undatum</i> , <i>Urticina</i> sp., <i>Pomatoceros</i> sp., <i>Crassoster papposus</i> , <i>Macropodia</i> sp., | | LOW | NOT SABELLARIA REEF |

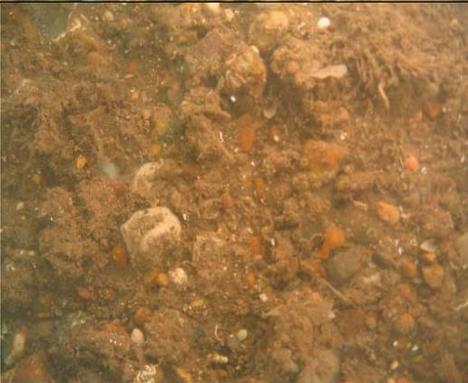
| Site | Sediment and <i>Mytilus edulis</i> / <i>Ampelisca diadema</i> aggregation description | Sabellaria characteristics | | | | | Image | Sabellaria reef definition based on Elevation | Sabellaria reef definition based on Patchiness |
|---|--|--|---|---|---|---|--|---|--|
| 41 | Silty sandy gravel with pebbles and occasional cobbles. | Moribund loose tubes and patchy Crusts on sediment (6% cover).<br><br>No reef. | * | * | * | <i>Cirripedia</i> sp., Hydrozoan / Bryozoan turf, <i>Flustra foliacea</i> , <i>Asterias rubens</i> , <i>Pomatoceros</i> sp., <i>Porifera</i> sp. | | NOT SABELLARIA REEF | NOT SABELLARIA REEF |

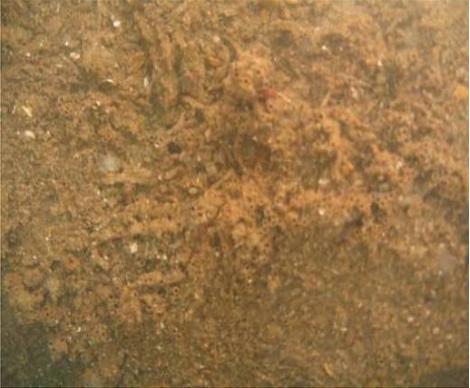
| Site | Sediment and <i>Mytilus edilus</i> / <i>Ampelisca diadema</i> aggregation description | Sabellaria characteristics | | | | | Image | Sabellaria reef definition based on Elevation | Sabellaria reef definition based on Patchiness |
|---|---|---|--|---|--|---|--|---|--|
| 42 | Silty sandy gravel with pebbles in places. | Moribund loose tubes, Crusts and Clumps (16% cover).<br><br>Potential Reef not a continuous feature (12% cover). | ~3.5cm<br><br><i>Sabellaria</i> in grab - clumps, 2cm high. Percentage cover within grab bite ~1%. | 12% | Not a continuous feature. <i>Sabellaria</i> tubes, crusts, clumps and reef. Some possibly moribund. Low consolidation, low abundance and density. Clumps of <i>Sabellaria</i> in grab (~10cm diameter, low consolidation). | Hydrozoan/Bryozoan turf, <i>Porifera</i> sp., <i>Flustra foliacea</i> , <i>Urticina</i> sp., <i>Majidae</i> sp., <i>Asterias rubens</i> , <i>Sabella</i> tube | | LOW | LOW |

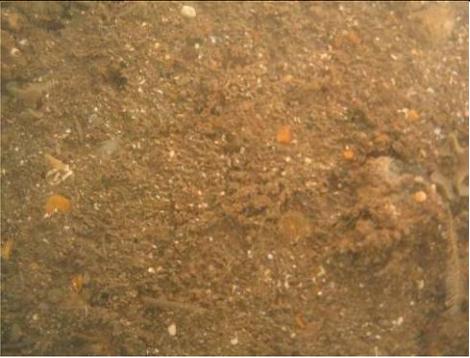
| Site | Sediment and <i>Mytilus edilus</i> / <i>Ampelisca diadema</i> aggregation description | Sabellaria characteristics | | | | | Image | Sabellaria reef definition based on Elevation | Sabellaria reef definition based on Patchiness |
|---|---|---|--|---|--|---|--|---|--|
| 43 | Slightly shelly, slightly gravelly silty sand with some pebbles.<br><br>Patches of <i>Ampelisca/Sabellaria</i> mix encrusting sediment. | Crusts (25% cover). In addition, grab sample contained 2 <i>Sabellaria</i> clumps (3cm diameter, 5cm high, ~5% cover within grab bite, little consolidation).<br><br>No reef. | x | x | x | Hydrozoan/Bryozoan turf, <i>Pometoceros</i> sp., <i>Flustra foliacea</i> , <i>Sabella</i> sp., <i>Anthozoa</i> sp., | | NOT SABELLARIA REEF | NOT SABELLARIA REEF |
