# Lynn and Inner Dowsing Hydrographic Monitoring Survey

Issue Date: 14<sup>th</sup> December 2009

Report No: 09/□1/02/1495/0925

| <b>Title: Lynn and Inner Dowsing Hydrographic Monitoring Survey</b> | | | |
|---|---|---|---|
| Client Name | : Centrica Renewable Energy Limited | | |

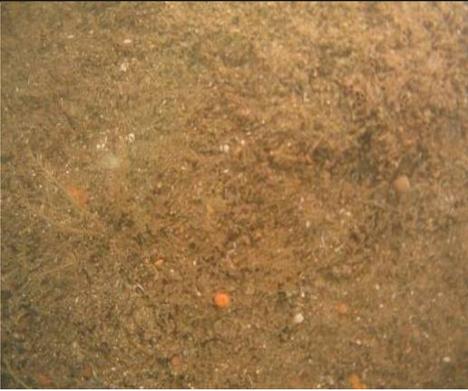
| Site | Sediment and <i>Mytilus edilus</i> / <i>Ampelisca diadema</i> aggregation description | Sabellaria characteristics | | | | | Image | Sabellaria reef definition based on Elevation | Sabellaria reef definition based on Patchiness |
|---|---|--|--|---|--|--|--|---|--|
| 44 | Gravelly silty sand with some pebbles. | Crusts and Clumps (15% cover).<br>Potential Reef (not a continuous feature) (37%). | ±3.5cm<br><i>Sabellaria</i> in grab (crusts and potential reef, 2cm high). | 37% | Not a continuous feature. Mix of <i>Sabellaria</i> crust and reef proud of seabed ±3.5cm. Low/medium abundance and density. Low consolidation. Some areas possibly moribund.<br><i>Sabellaria</i> in grab (little concretion of substratum). | Hydrozoan / Bryozoan turf, <i>Pomatoceros</i> sp., <i>Asterias rubens</i> , <i>Flustra foliacea</i> , <i>Crepidula fornicata</i> , <i>Macropodia</i> sp. | | LOW | HIGH |

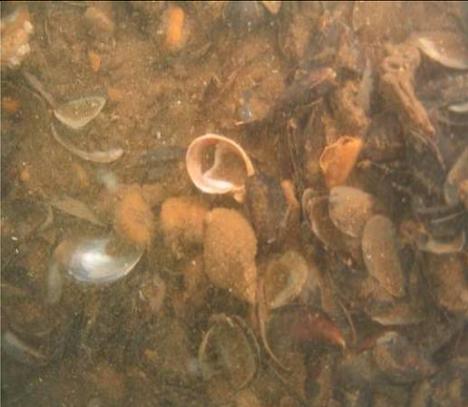
| Site | Sediment and <i>Mytilus edilus</i> / <i>Ampelisca diadema</i> aggregation description | Sabellaria characteristics | | | | | Image | Sabellaria reef definition based on Elevation | Sabellaria reef definition based on Patchiness |
|---|---|--|--|---|--|--|--|---|--|
| 48 | Silty muddy sand with patches of shell and some gravel.<br>Old mussel patch with <i>Sabellaria</i> tubes and crust.<br>Primarily a mussel patch, consisting of large, old individuals (absolute percentage 55%). Hard to assess if alive/dead. At least 50% dead. | Moribund loose tubes and small patches of Crust (1% cover).<br>No reef. | * | * | * | Hydrozoan / Bryozoan turf, <i>Buccinum undatum</i> . | | NOT SABELLARIA REEF | NOT SABELLARIA REEF |

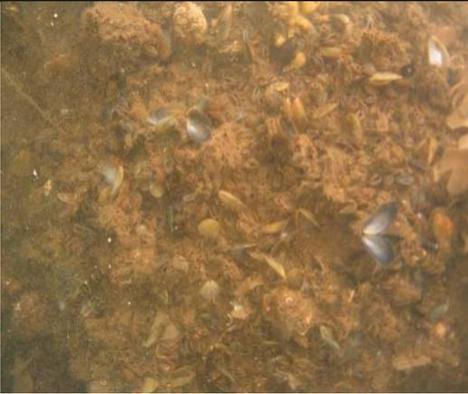
| Site | Sediment and <i>Mytilus edulis</i> / <i>Ampelisca diadema</i> aggregation description | Sabellaria characteristics | | | | | Image | Sabellaria reef definition based on Elevation | Sabellaria reef definition based on Patchiness |
|---|--|---|--|---|---|---|--|---|--|
| 49 | Silty muddy sand with shell.<br><br>Seed mussel and Sabellaria reef feature.<br><br>Feature consists primarily of smaller, apparently live mussels (absolute percentage 81%), mixed with Sabellaria. | Crusts (1% cover)<br><br>Potential Reef (13% cover). | ±3.5cm<br><br>Sabellaria in grab ± small clumps, 2cm high. Percentage cover within grab bite ±1% | 13% | Not a continuous reef. Low-medium consolidation, density and abundance of Sabellaria, Sabellaria crusts and low lying reef present. Clumps (±10cm diameter, low consolidation) in grab. | Antho <sup>zoa</sup> spp. Asterias rubens, Porifera sp., Ophiura albida, Calliostoma <sup>sp.</sup> yphinum, Flustra foliacea, Hydro <sup>zoan</sup> / Bryo <sup>zoan</sup> turf, Buccinum undatum, Shrimp. | | LOW | LOW |

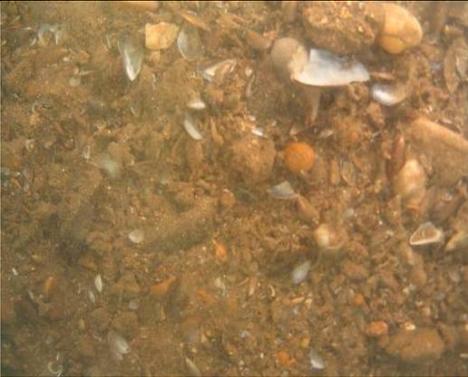
| Site | Sediment and <i>Mytilus edulis</i> / <i>Ampelisca diadema</i> aggregation description | Sabellaria characteristics | | | | | Image | Sabellaria reef definition based on Elevation | Sabellaria reef definition based on Patchiness |
|---|--|---|--|---|---|---|--|---|--|
| 50 | Shelly gravelly silty sand. | Moribund loose tubes and Crusts (6% cover).<br><br>No reef. | * | * | * | Hydro <sup>zoan</sup> / Bryo <sup>zoan</sup> turf, Macropodia sp., Flustra foliacea. | | NOT SABELLARIA REEF | NOT SABELLARIA REEF |

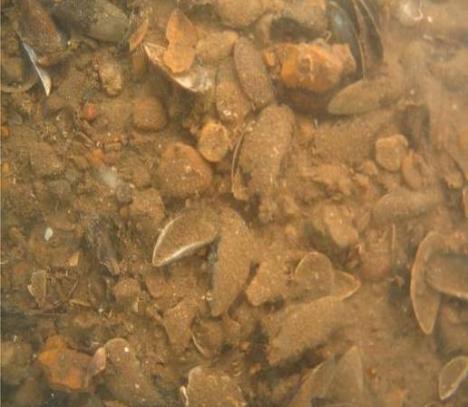
| Site | Sediment and <i>Mytilus edulis</i> / <i>Ampelisca diadema</i> aggregation description | Sabellaria characteristics | | | | | Image | Sabellaria reef definition based on Elevation | Sabellaria reef definition based on Patchiness |
|---|--|---|---|---|---|--|--|---|--|
| 51 | Shelly silty sandy gravel.<br><br>Old mussel patch with <i>Sabellaria</i> tubes and crusts.<br><br>Mussel patch consisting of large, old individuals (absolute percentage 26%). Hard to assess if alive or dead, the majority appear to be dead. | Moribund loose tubes and Crusts on dead mussel shell and sediment (3% cover).<br><br>No reef. | * | * | * | Hydrozoan / Bryozoan turf, <i>Flustra foliacea</i> , <i>Pomatoceros</i> sp. | | NOT SABELLARIA REEF | NOT SABELLARIA REEF |

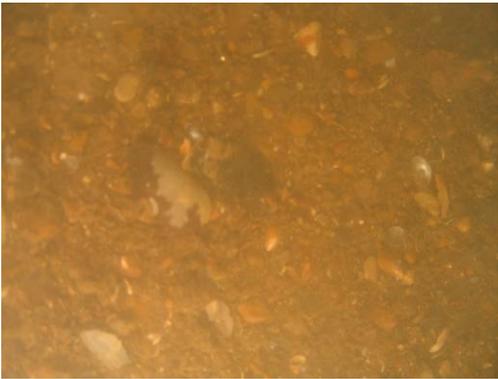
| Site | Sediment and <i>Mytilus edulis</i> / <i>Ampelisca diadema</i> aggregation description | Sabellaria characteristics | | | | | Image | Sabellaria reef definition based on Elevation | Sabellaria reef definition based on Patchiness |
|---|--|---|---|---|---|--|--|---|--|
| 52 | Shelly, silty sandy gravel. | Absent | * | * | * | Bryozoan crust, <i>Ophiura albida</i> , <i>Pomatoceros</i> sp., Hydrozoan / Bryozoan turf. | | NOT SABELLARIA REEF | NOT SABELLARIA REEF |

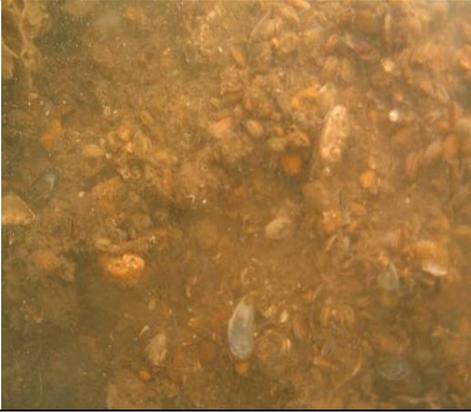
| Site | Sediment and <i>Mytilus edulis</i> / <i>Ampelisca diadema</i> aggregation description | Sabellaria characteristics | | | | | Image | Sabellaria reef definition based on Elevation | Sabellaria reef definition based on Patchiness |
|---|--|---|---|---|---|---|---|---|--|
| 53 | Shelly silty sand with gravel in some areas.<br><br>Seed mussel bed consisting of small, live individuals. Absolute percentage of mussels - 45%. | Moribund loose tubes, Crusts and Clumps (2% cover).<br><br>No reef. | * | * | * | <i>Flustra foliacea</i> ,<br>Hydrozoan / Bryozoan turf, <i>Pomatoceros</i> sp.,<br><i>Liocarcinus</i> sp., <i>Ophiura</i> sp., <i>Sabella</i> sp.,<br>Anthozoa indet,<br><i>Buccinum undatum</i> ,<br>Bryozoan crust, <i>Ophiura albida</i> . | | NOT SABELLARIA REEF | NOT SABELLARIA REEF |

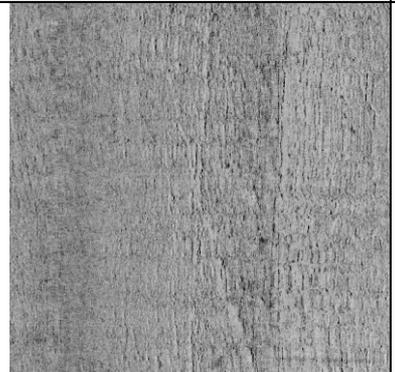
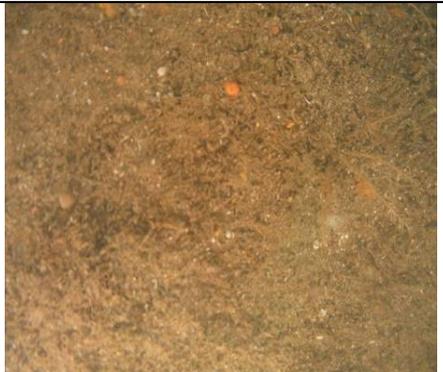
| Site | Sidescan Image | Static Video Image | Elevation | Patchiness |
|---|---|--|---|---|
| 44 | | | LOW | HIGH |

**Table 3.5.3 Example of an area of possible low lying reef from both sidescan sonar and video imagery**

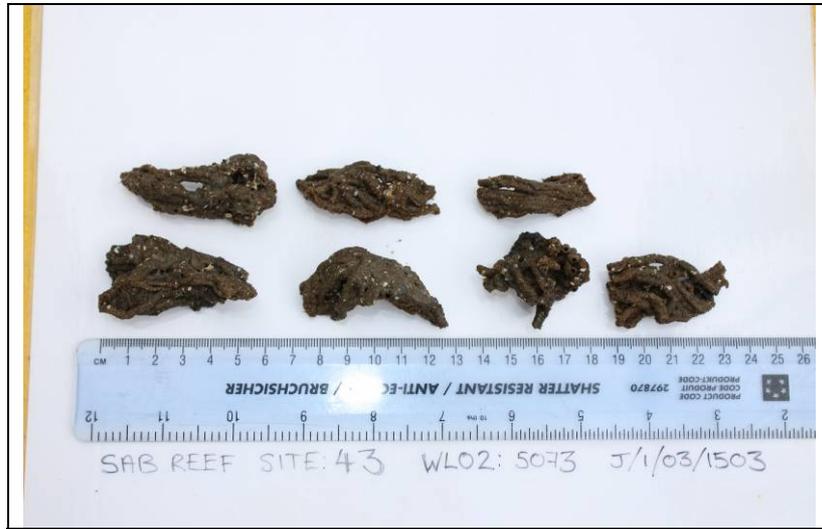
observed in the survey area. As such, it is suggested that Site 43 is probably on the boundary of *Sabellaria* reefs, possibly those identified to the south (Site 44) and to the east (Site 42).

**Figure 3.5.1** Example of *Sabellaria* aggregations from Site 43. A scale is given to assess tube height.

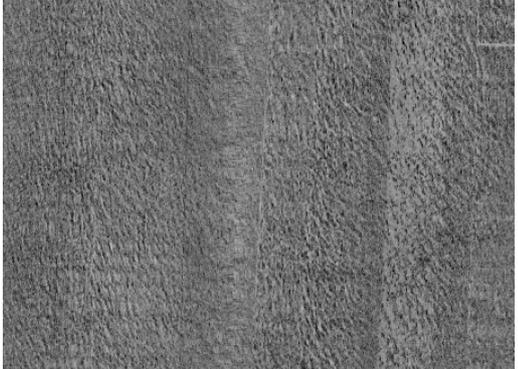
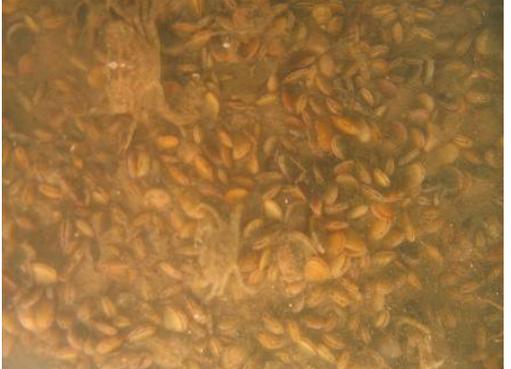
| Site | Sidescan Image | Static Video Image |
|---|---|--|
| 53 | | |

Two seed mussel beds with *Sabellaria* aggregations in tube, crust and clump form were observed (Sites 35 & 53) and a seed mussel and *Sabellaria* reef feature (Site 49). The latter feature and one of the seed mussel beds occurred in close proximity, at the eastern edge of the
