Field Observations During Wind Turbine Operations at the Block Island Wind Farm, Rhode Island

May 2019

HDR. 2019. Field Observations during Wind Turbine Operations at the Block Island Wind Farm, Rhode Island. Final Report to the U.S. Department of the Interior, Bureau of Ocean Energy Management, Office of Renewable Energy Programs. OCS Study BOEM 2019-028. 281pp.

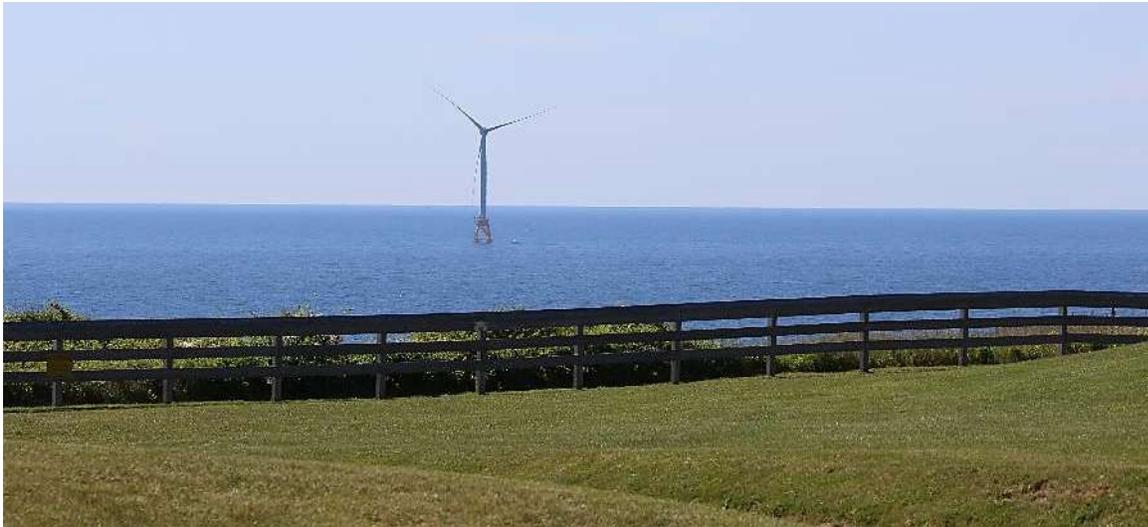
**Figure 4. WTG 3 as seen from the Southeast Lighthouse on a clear day (22 June 2017)
(Photograph taken with lowest camera focal length setting of 100 mm).**

- During daytime and under clear weather conditions, the turbines are noticeably visible from the Southeast Lighthouse shoreline on Block Island, which is approximately 4.6 kilometers (km; 2.83 miles [mi]) away.

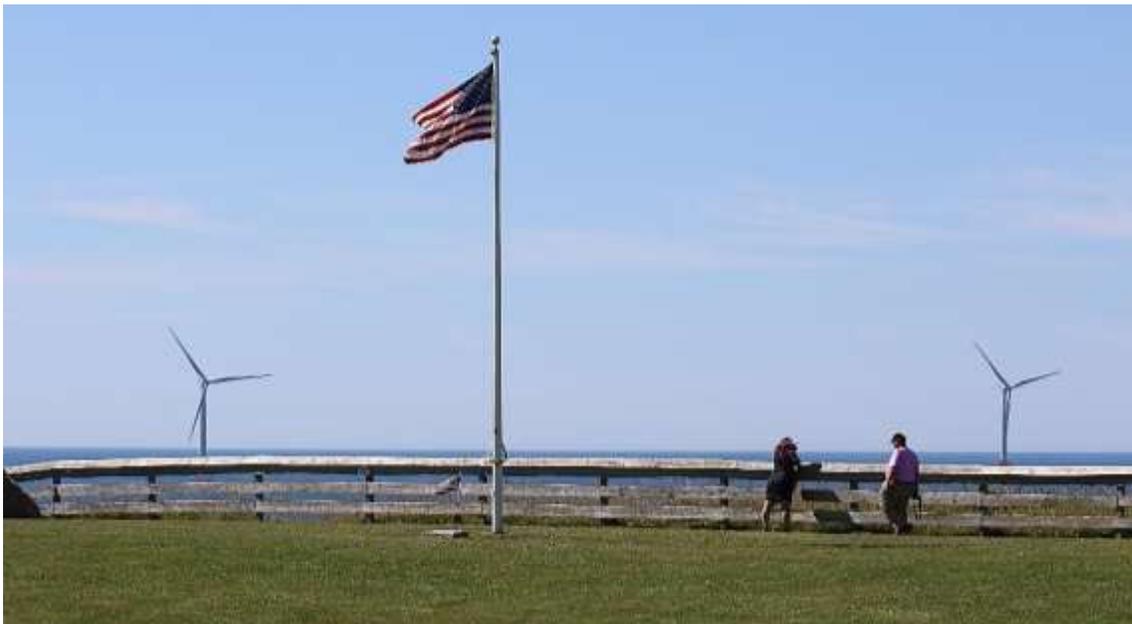
**Figure 5. WTGs 4 and 5 seen from the Southeast Lighthouse on a clear day (22 June 2017)
(Photograph taken with lowest camera focal length setting of 100 mm).**

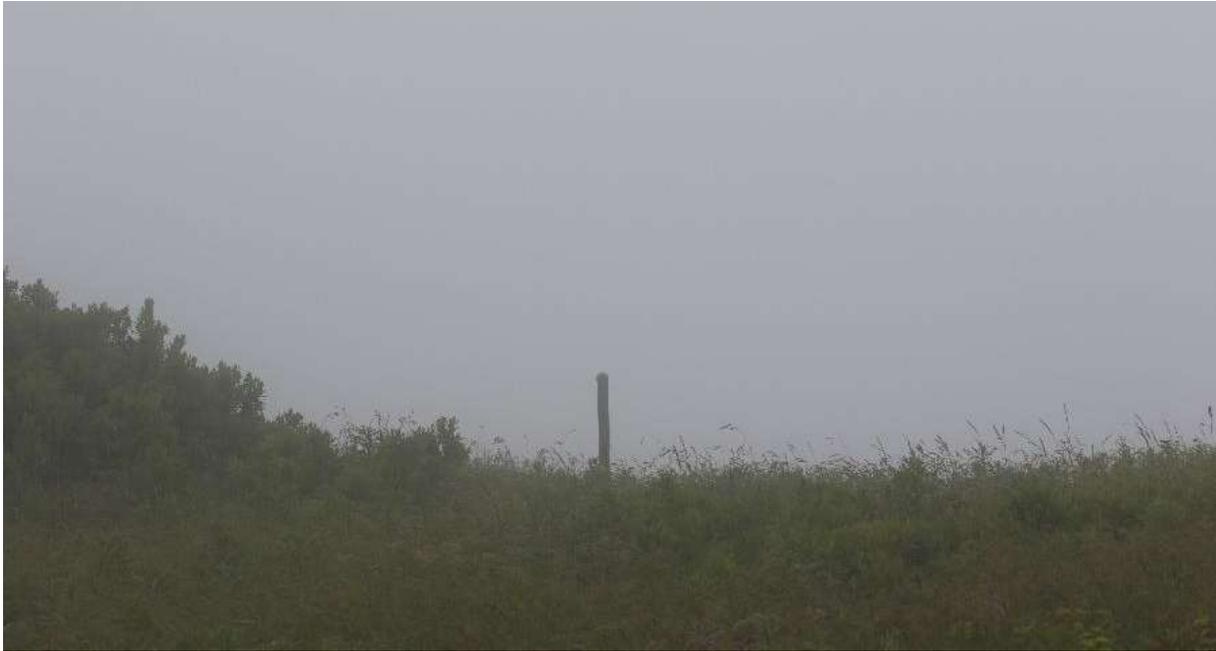
Figure 8. WTGs are not visible from Block Island because of heavy fog on 20 June 2017.

The area experienced heavy fog on 19 and 20 of June 2017 and under foggy conditions the turbines and its lights were not visible from approximately XX km (3 mi) away (**Figure 8**). **Figure 9** shows a photograph taken in the early morning of 22 June 2017 prior to the haze burning off from the water area. Conditions on Block Island were clear at this time.

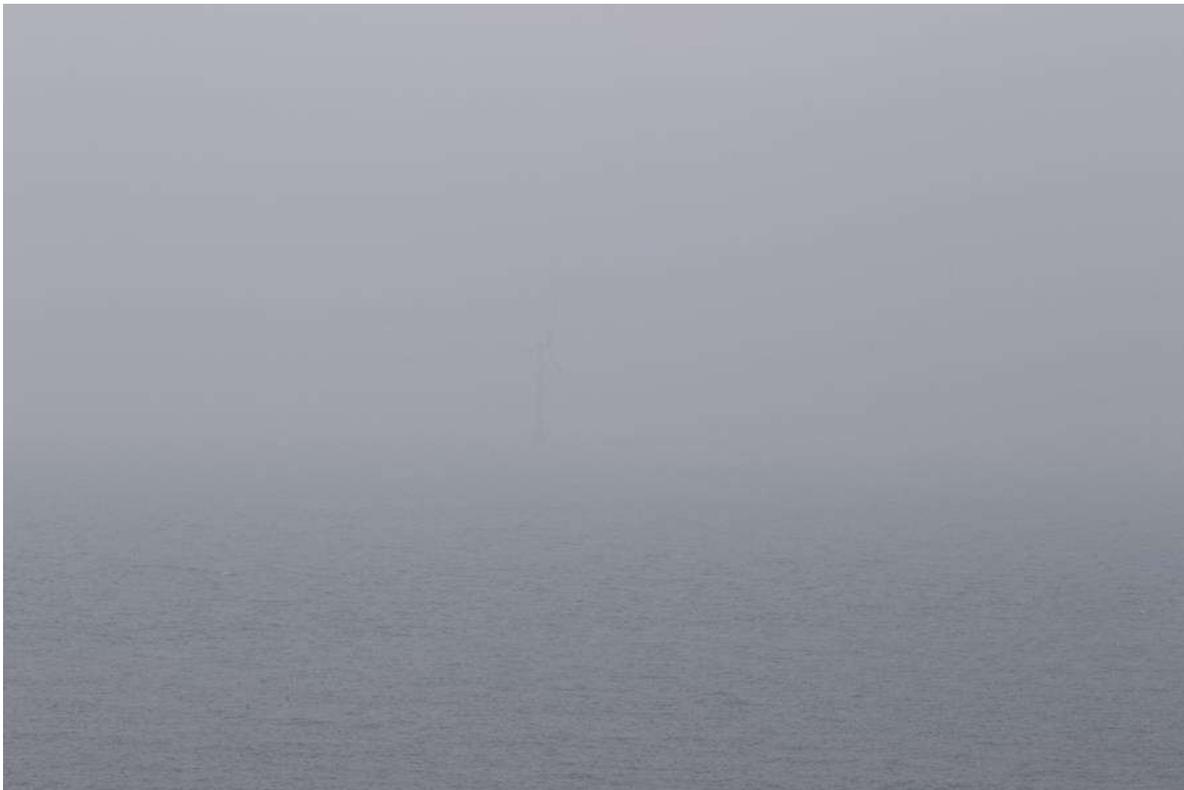
Figure 9. WTG 5 barely visible from Block Island because of haze on 22 June 2017.

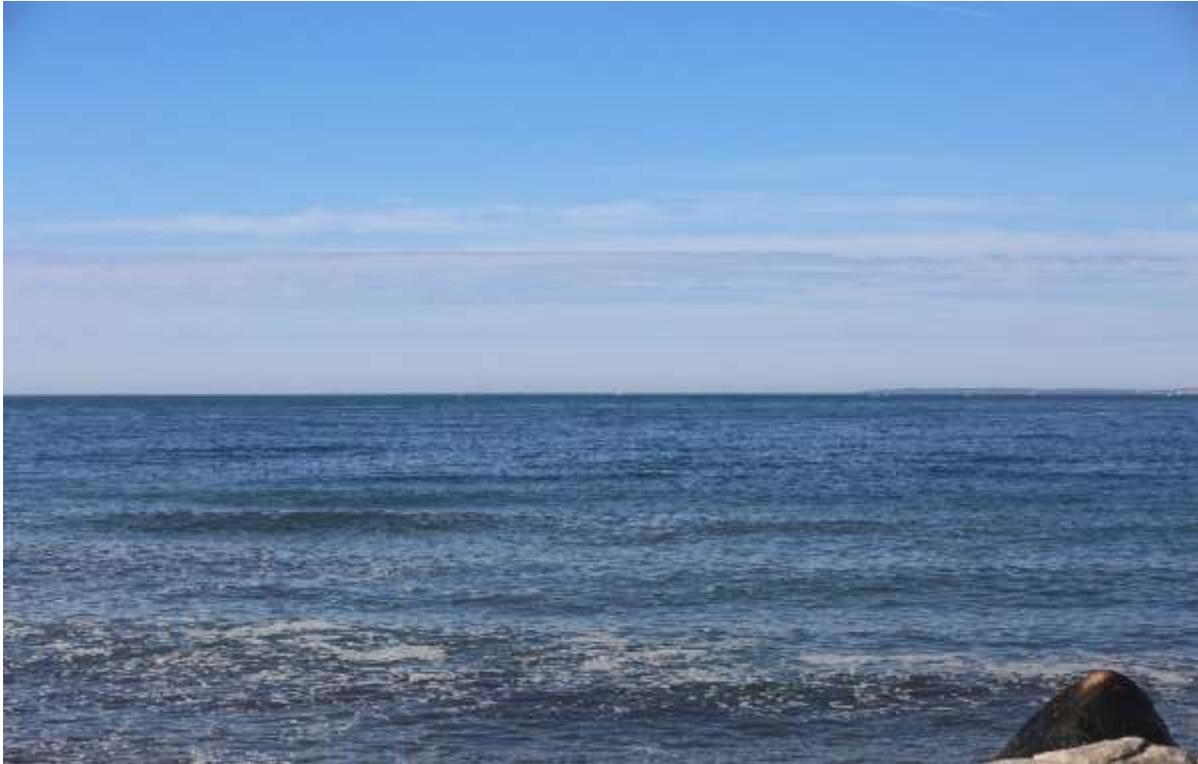
Figure 10. Block Island and the turbines as seen from the Point Judith monitoring station under clear conditions on 22 June 2017.

- During daytime and under foggy conditions, the turbines and its lights cannot be seen from approximately 4.6 km (2.83 mi) away.
- From the Point Judith shoreline, on a clear day, both Block Island and the turbines are visible with the naked eye during the day and at night.

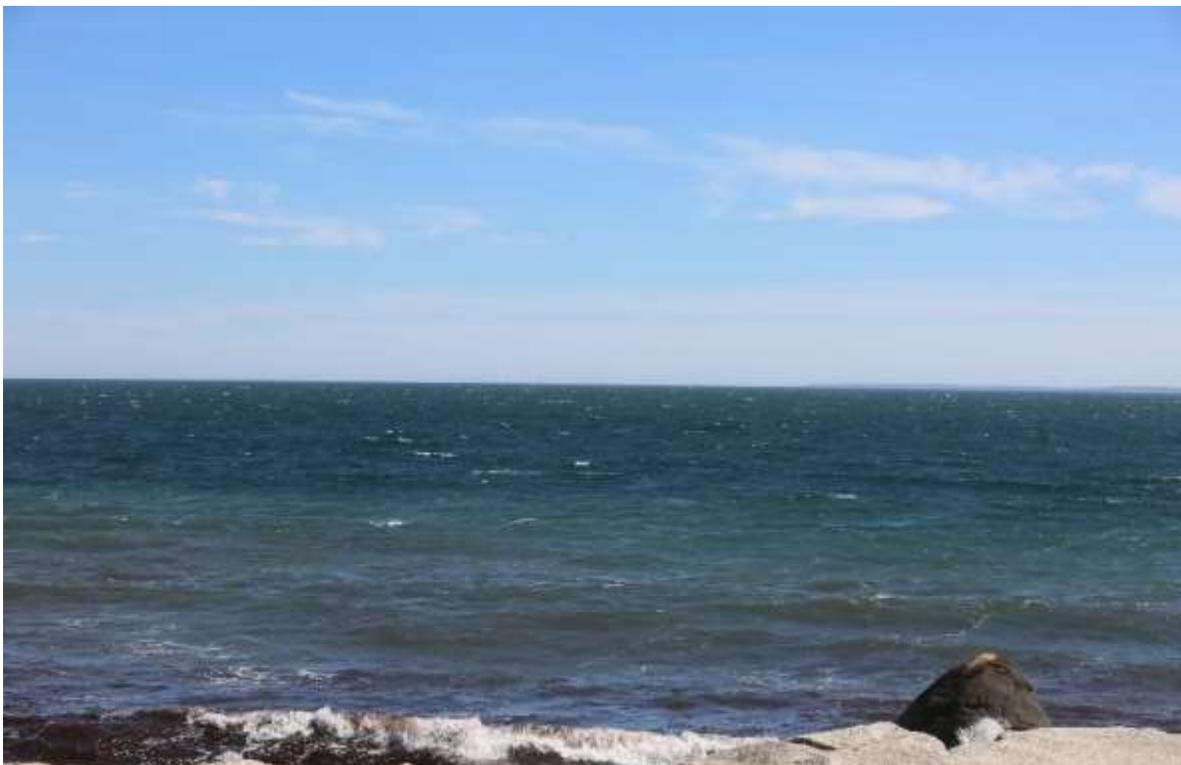
Figure 11. The five turbines as seen from the Point Judith monitoring station under clear conditions on 22 June 2017.

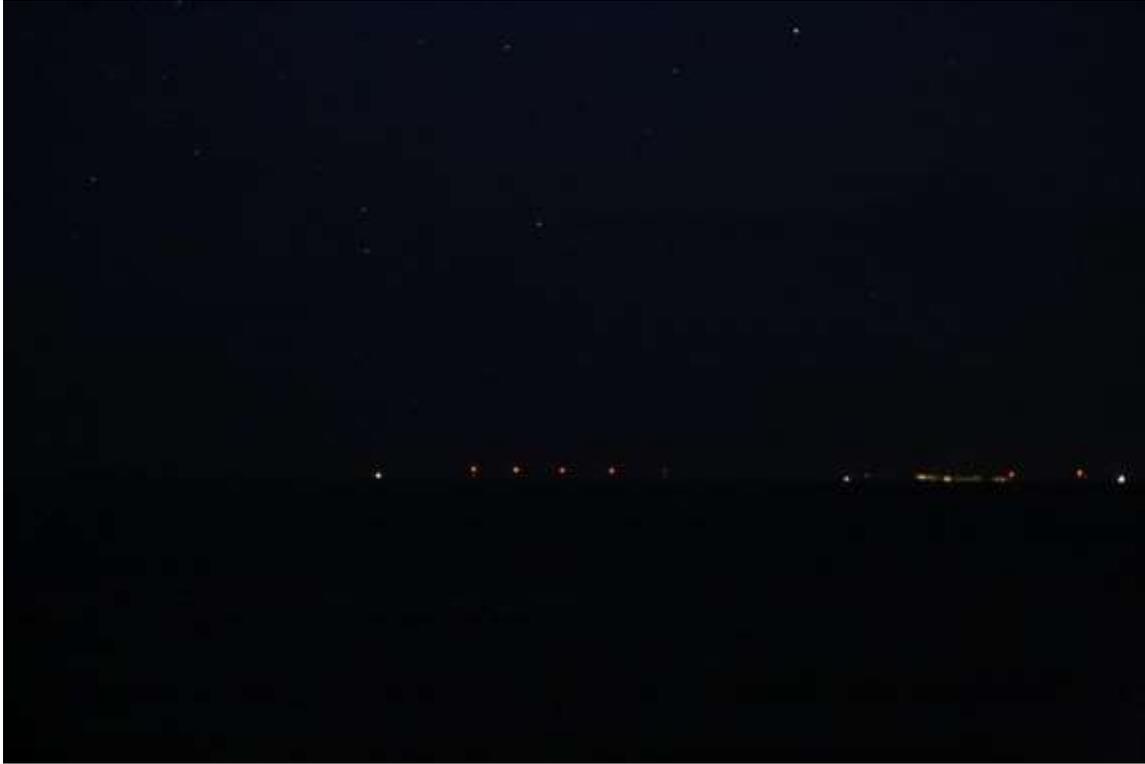
Figure 12. Nighttime view from Point Judith on 21 June 2017; all five WTGs visible along with lights on Block Island.

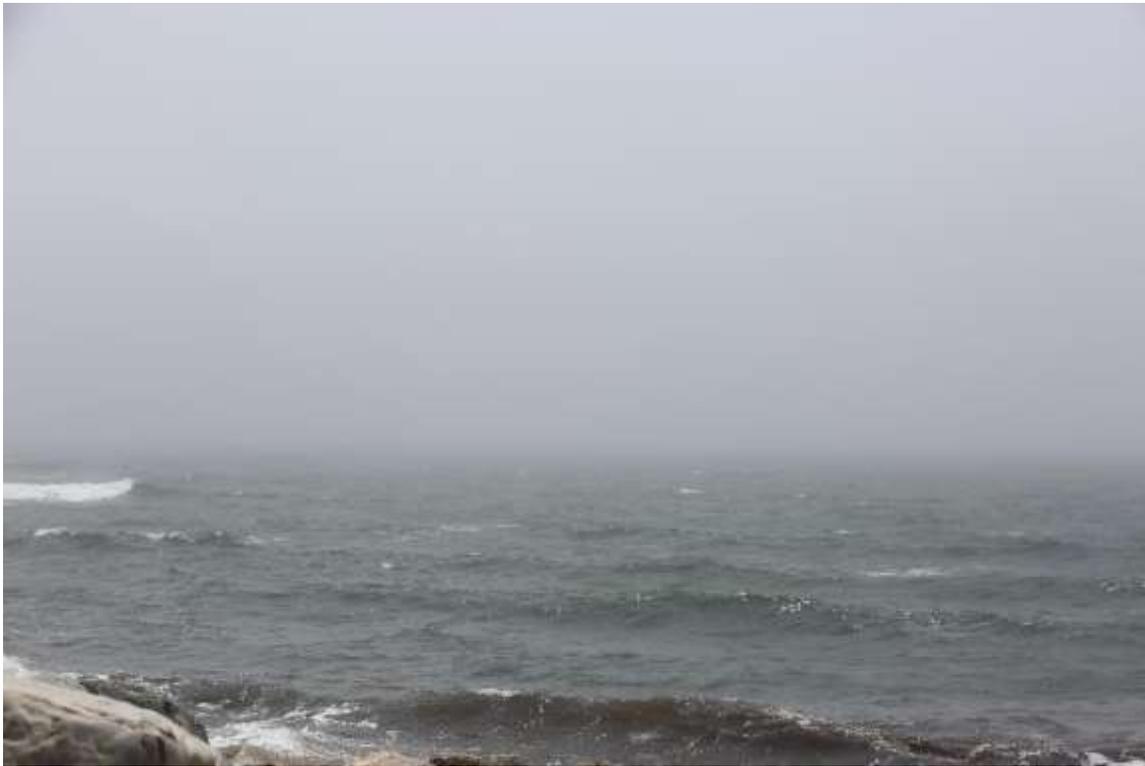
Figure 13. Turbines not visible from Point Judith under foggy conditions on 20 June 2017.

- Neither the island nor the turbines are visible from Point Judith under foggy conditions.
- During daytime, Block Island is barely visible from Brenton State Park, which is located approximately 38.28 km (23.79 mi) from the turbines and the turbines cannot be seen with the naked eye.

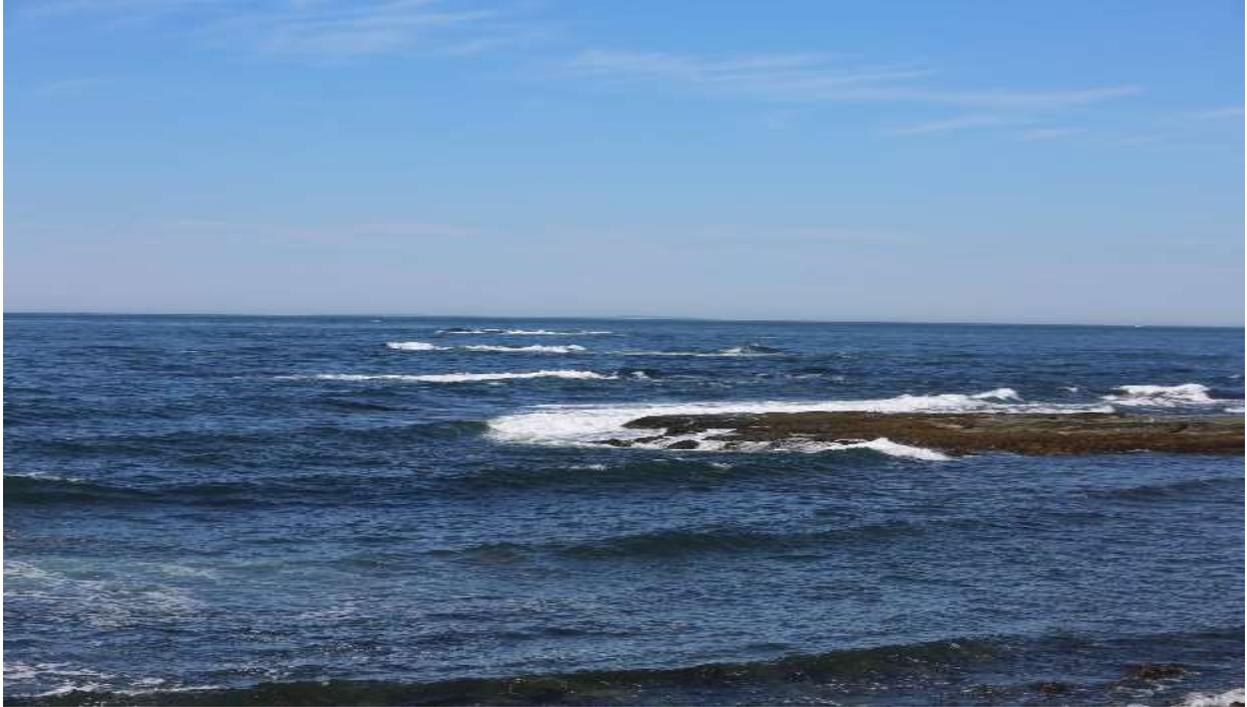
Figure 14. Turbines not visible from Brenton State Park during the day even under clear conditions.

During daytime, Block Island is barely visible from the park and the turbines cannot be seen with the naked eye (**Figure 14**). On a clear night, however, the WTG lights can be seen from the park (**Figure 15**).

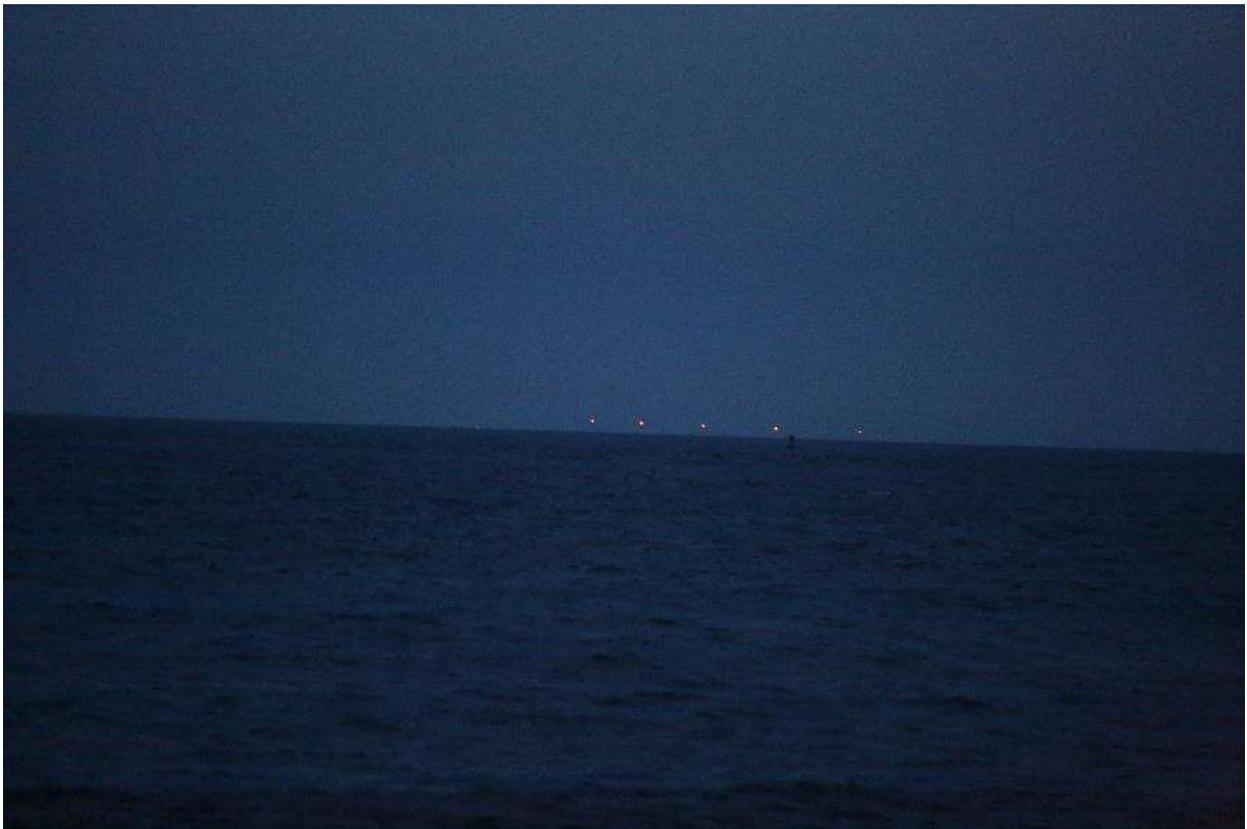
Figure 15. Lights on all five turbines are visible from Brenton State Park on a clear night.

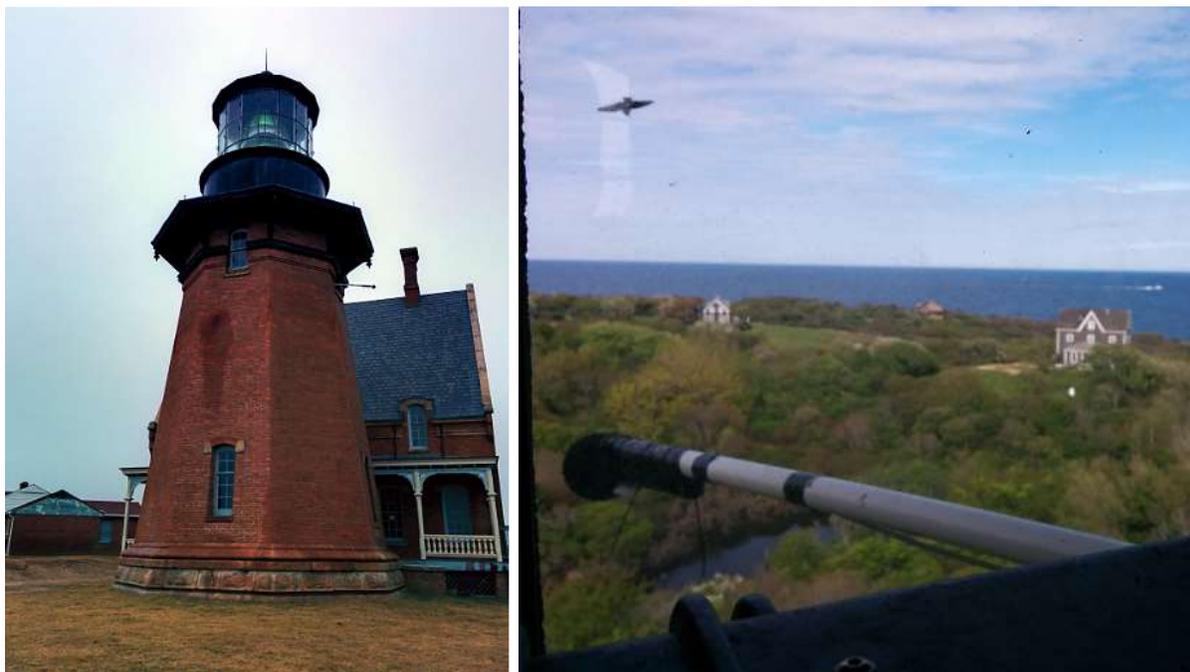
Figure 18. View of the Southeast Lighthouse with microphone protruding from the right of the lighthouse, above the roof line of the building behind the lighthouse. [Right] View of microphone from the lighthouse window.

Continuous airborne noise monitoring was conducted at an *onshore* location over a three-month period (8 February to 28 May 2017) to record noise levels emanating from the turbine operations. A Svantek 979 sound level meter, connected to an external power supply, was installed at the top of the Southeast Lighthouse, with the microphone extending 1 m (3.3 ft) from the side of a lighthouse window, with full view of the ocean to the south (**Figure 18**).

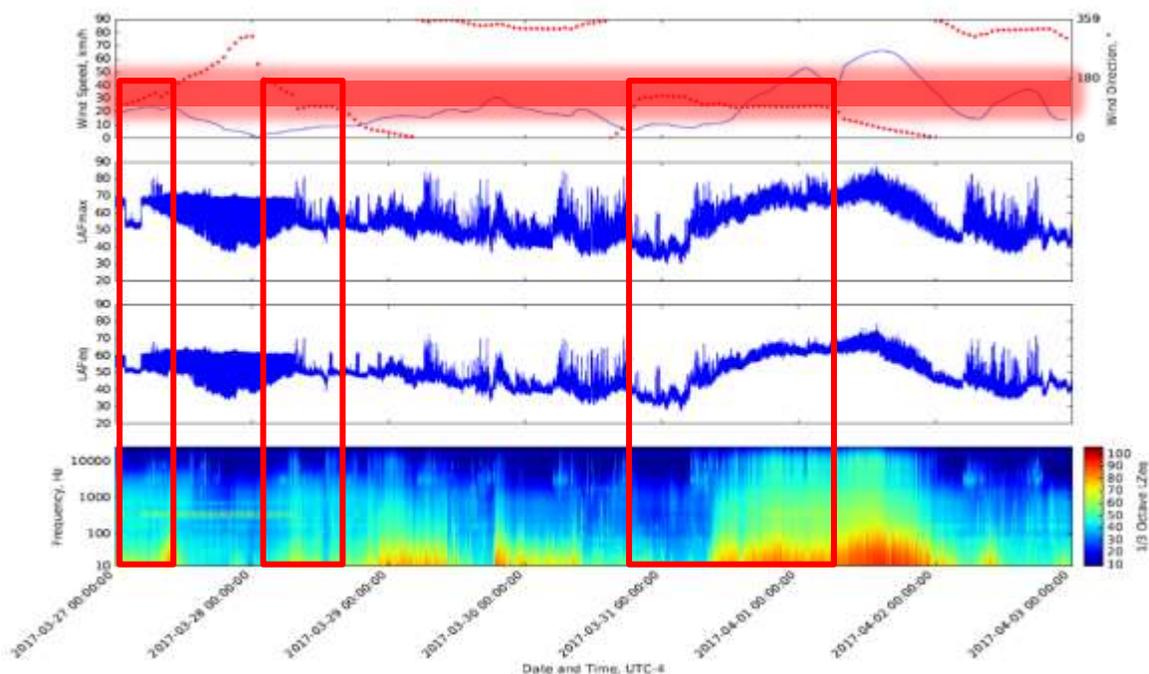
Figure 19. Noise measurement summary at the Southeast Lighthouse, 6 to 13, March 2017. Top chart: wind speed (blue line) and wind direction (red dots). Transparent red bar shows south-east orientation. 2nd chart: dB LAFmax⁵ noise level time history. 3rd chart: dB LAFeq (10 minute average) noise level time history. Bottom chart: LAeq⁶ spectrogram showing frequencies between 10 Hz and 10 kHz.

Data from the 14-week survey indicated that airborne noise from turbine operations was inaudible at the monitoring location on Block Island. A representative dataset from the onshore monitoring is shown in **Figure 19**, which illustrates data from monitoring conducted in March and April 2017. Wind conditions are shown at the top of the figure for comparison. The horizontal red bar in the wind conditions chart identifies the southeast compass point. The red boxes show the times when the monitoring location was downwind of the BIWF, i.e., where the red dots coincide with the red bar.

In **Figure 19**, the continuous high noise levels observed on 27 March extending into 28 March are caused by the foghorn warning system near to the lighthouse. This also appears on the night of 1 April but is lost in the loud background noise, caused by high winds.

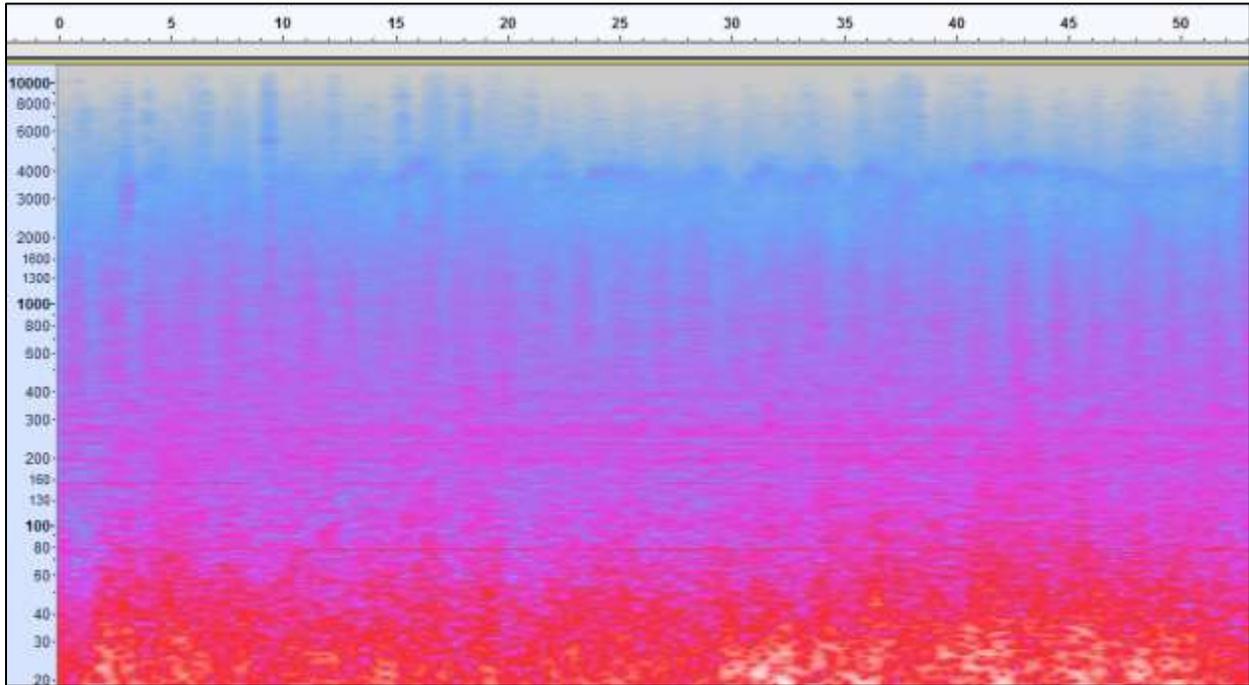
Figure 20. Spectrogram showing narrow-band analysis of offshore noise measurement, 19 October 2017, at approximately 50 m downwind of BIWF WTG 5 to show characteristics. Horizontal axis: Time (seconds); Vertical axis: Frequency (Hz).

An illustrative sample is shown in **Figure 20**. Fluctuating wind noise as it blows around the tower and blade structure causes increases between 3,000 and 4,000 Hz. Blade passes (swish) can be seen as mid-frequency vertical bars approximately every second; this may imply an airborne-water noise path contribution to the noise from the wind turbine. Any noise directly generated by the turbine machinery appears to be limited to frequencies below 50 Hz, with most noise produced by the movement of air.

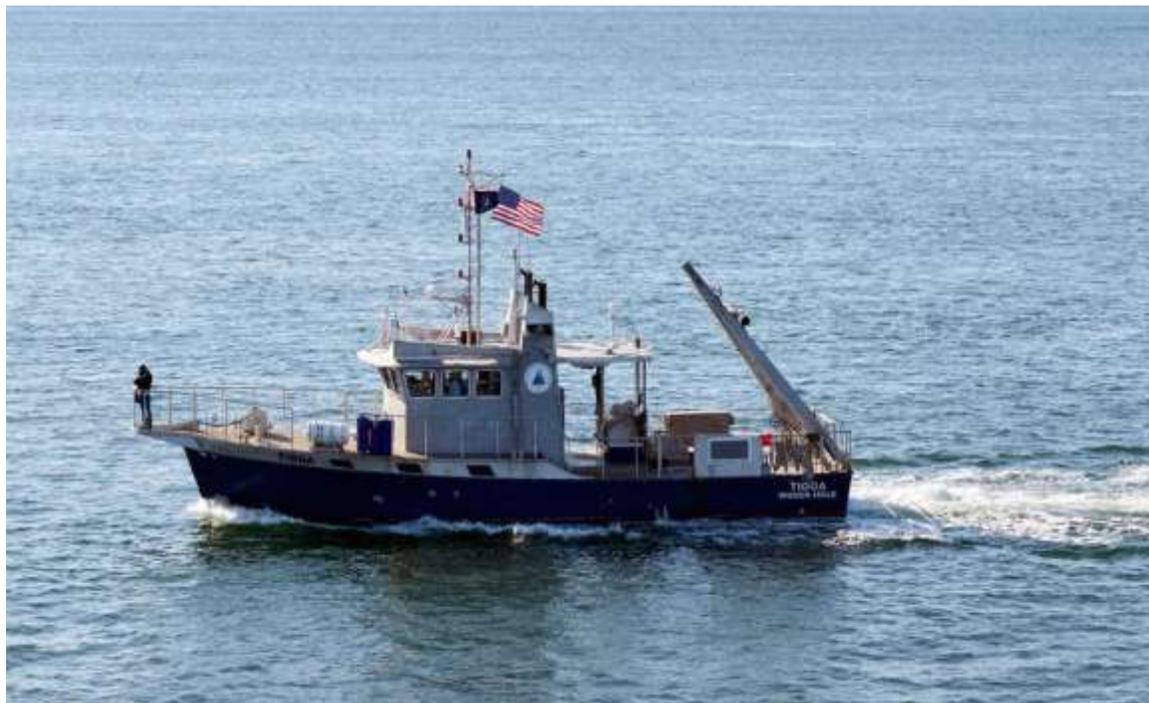
Figure 21. WHOI Research Vessel R/V *Tioga*.

All moorings were deployed and recovered from the Woods Hole Oceanographic Institution (WHOI) vessel R/V *Tioga* (**Figure 21**). This vessel is equipped with an on-board GPS tracking system, sea surface sensors and a calibrated conductivity, temperature, and depth (CTD) sensor.

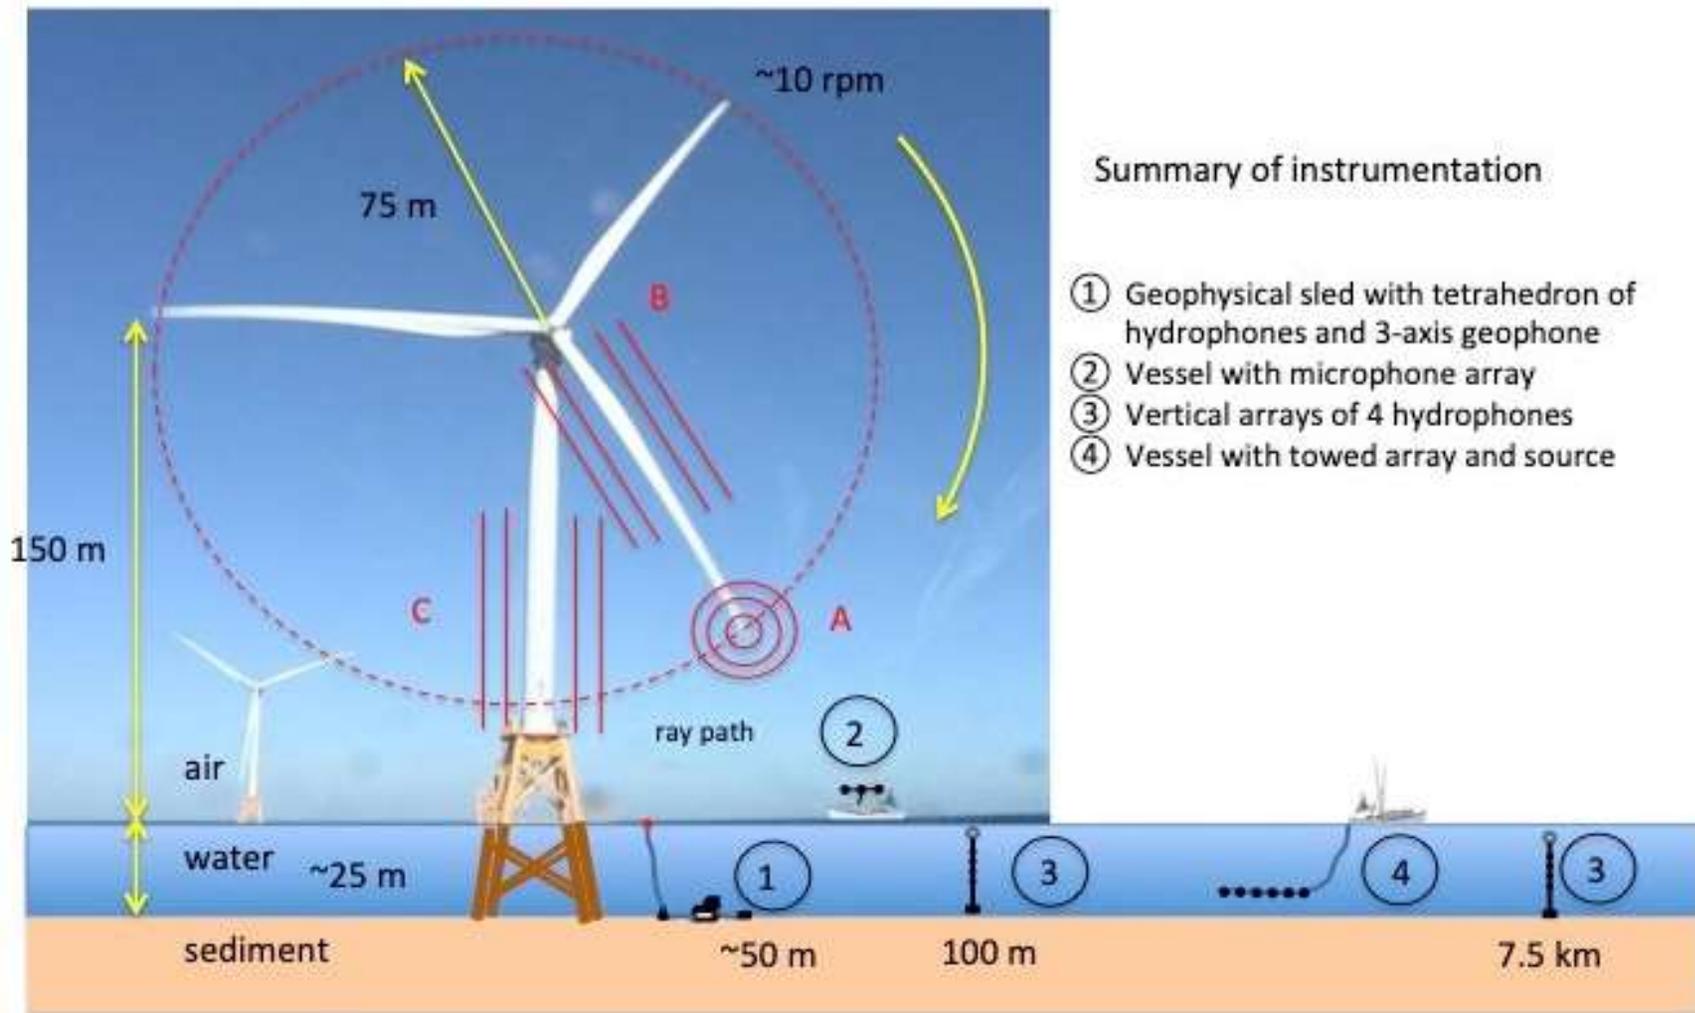
Figure 22. Schematic showing relative placement of the various monitoring sensors for measurement of acoustic and seismic signals during offshore WTG operations (nominal ranges).

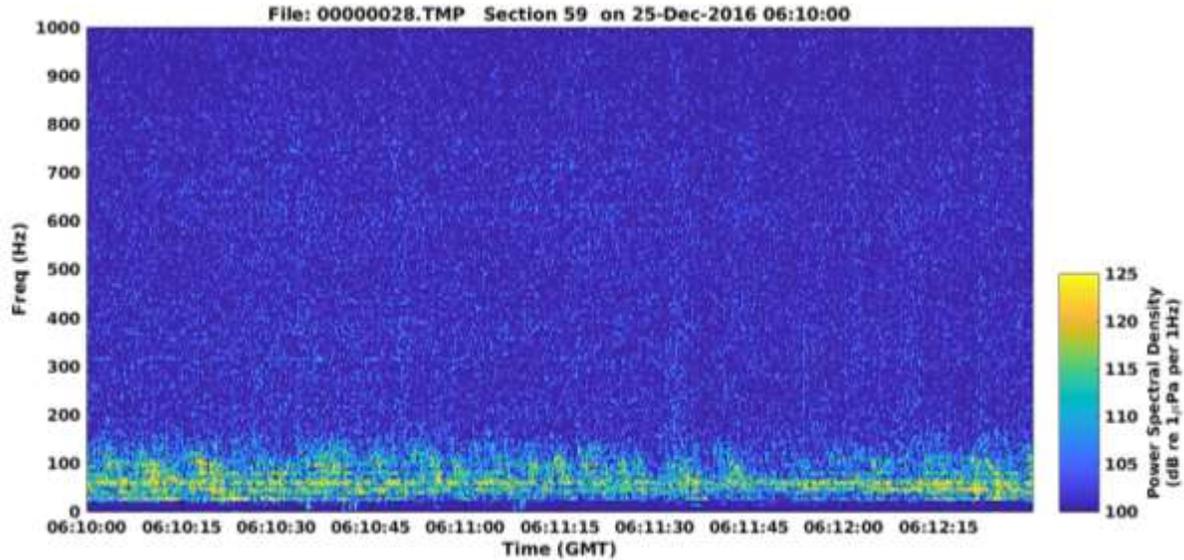
Figure 27. HLA hydrophone spectrogram from a calm sea winter day showing low frequency sounds from distant vessels.

As expected, the VLA and HLA monitoring data indicated that the underwater soundscape during the turbine operations was dominated by winter weather conditions. **Figure 27** shows a calm sea period recorded from the HLA hydrophone. The low frequency signals from approximately 60 Hz to approximately 120 Hz seen in this spectrogram are representative of distant ship noise, and these signals were recorded throughout the 2016 winter monitoring dataset.

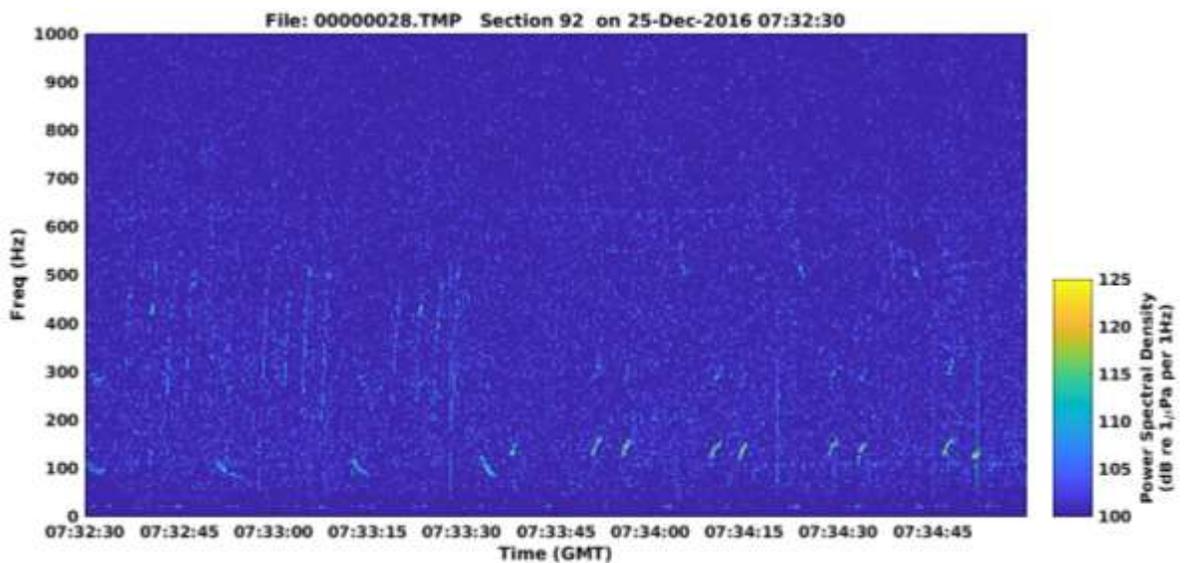
Figure 28. HLA hydrophone spectrogram when the turbines are apparently not operating and the appearance of marine mammal vocalizations.

Figure 28 shows a spectrogram with no obvious low frequency signature but an increase in marine mammal vocalizations. No sound from the operating turbines was recorded at the HLA location even under calm weather conditions, which would allow long range underwater sound propagation.

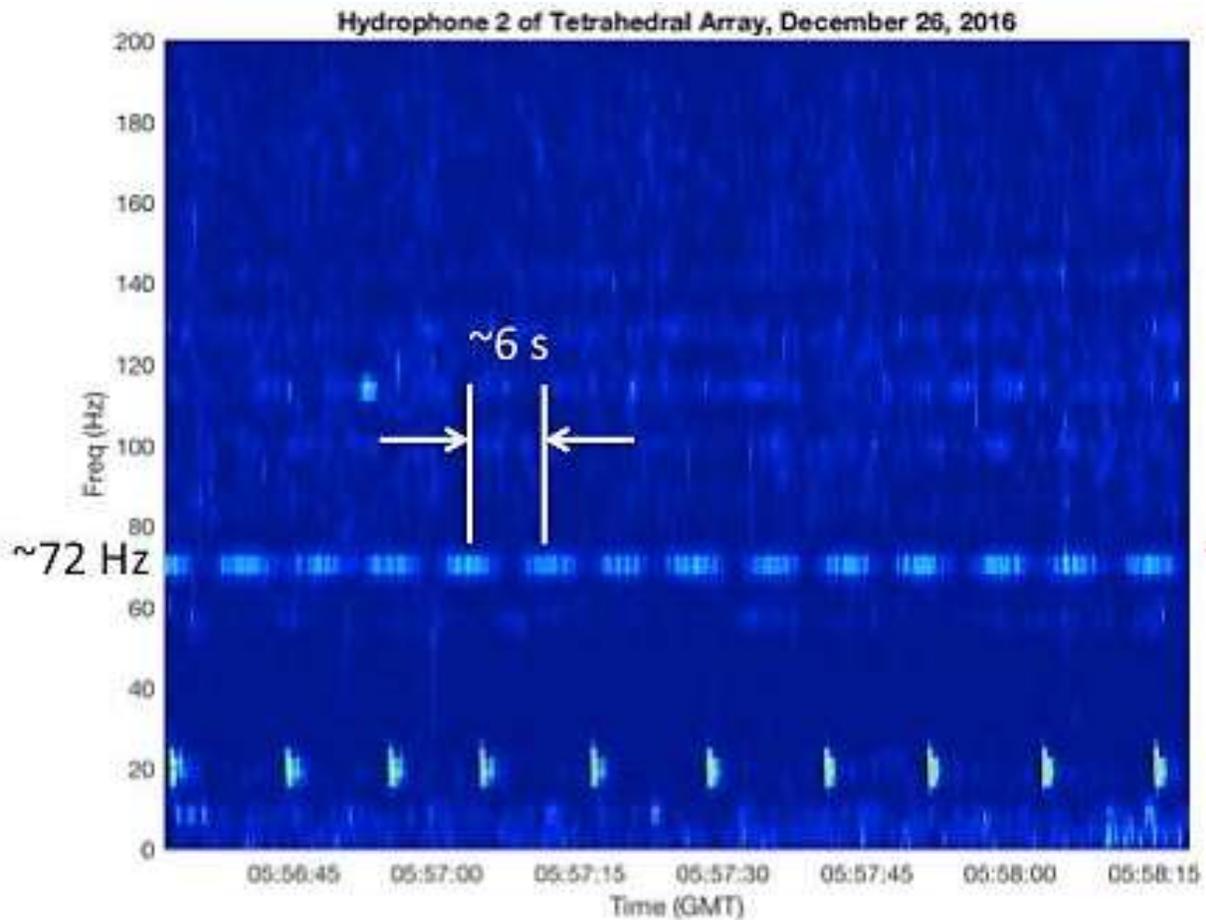
Figure 29. WTG operational sound spectrogram from the tetrahedral array hydrophone. Probable tonal sound from the turbine is seen at approximately 71 Hz. The intense acoustic signature at 20 Hz is from a vocalizing fin whale.

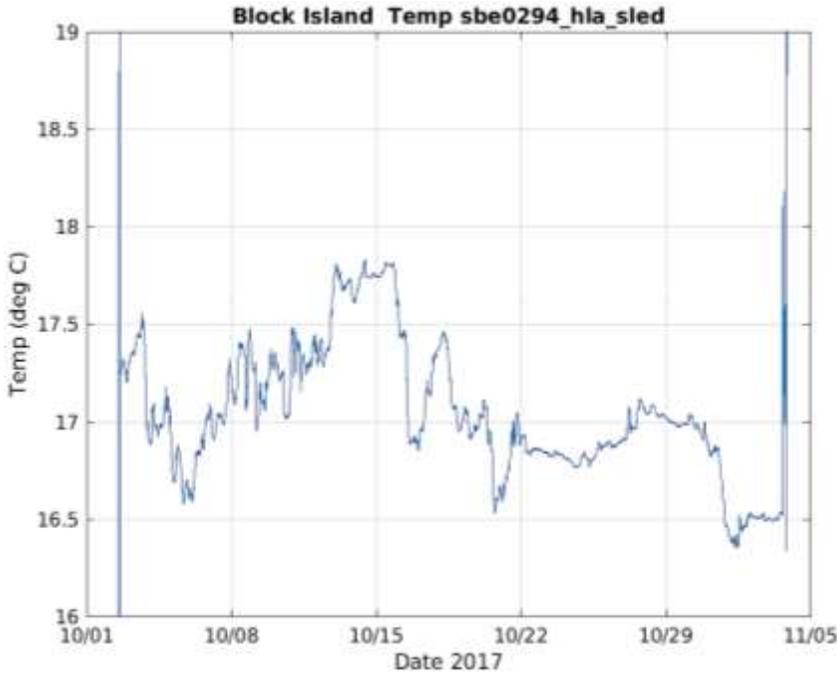
Figure 34. HLA SBE39 T/P temperature record at WTG 5. The temperatures recorded during this time were twice as high as those recorded during winter deployments.

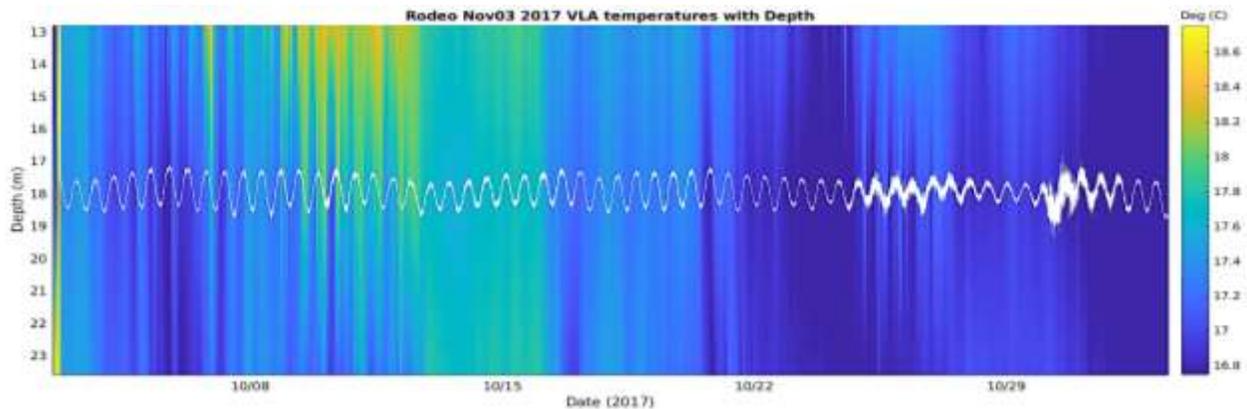
Figure 35. VLA temperature profiles from an array of sensors attached to the VLA with an overlay (white) with water depths at WTG1.

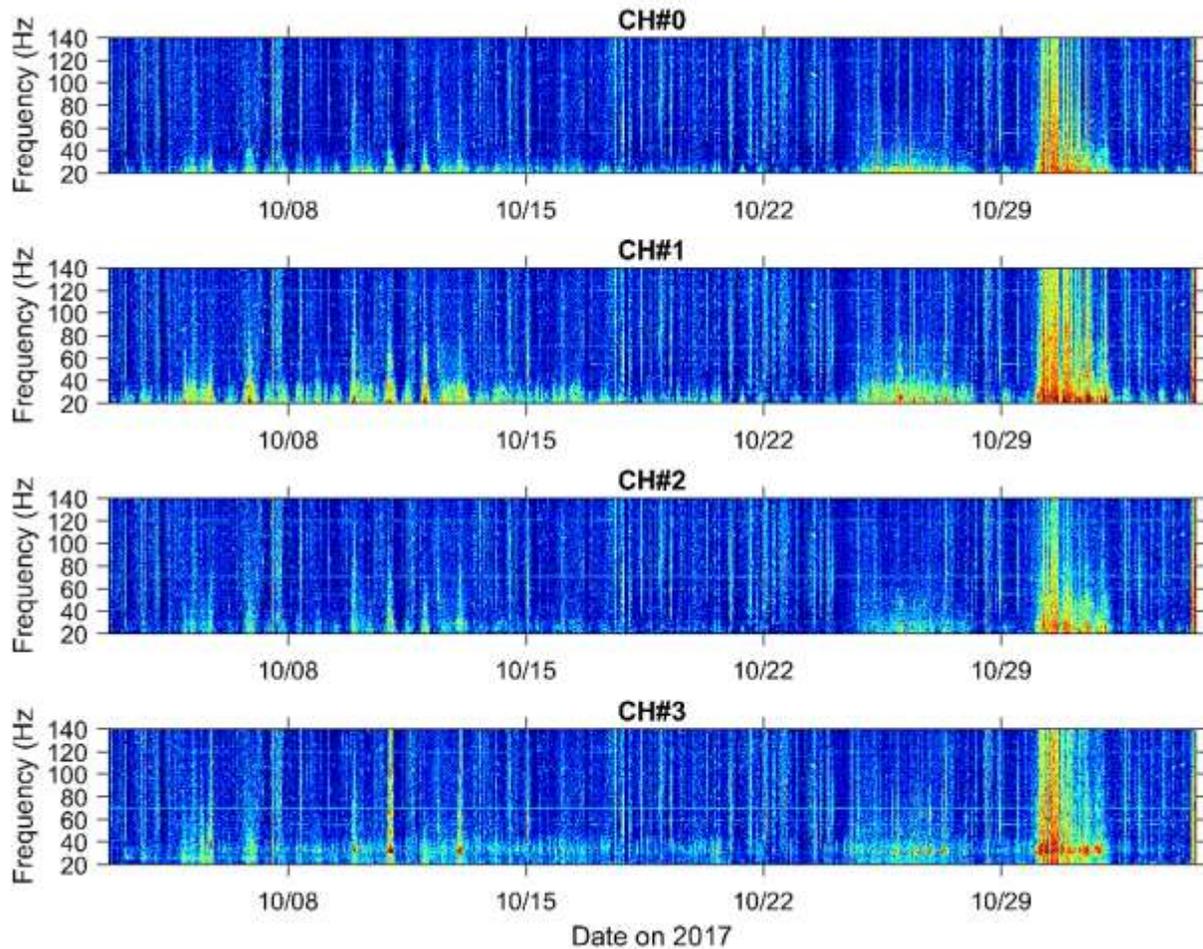
Figure 38. Spectrograms at 20 to 140 Hz from each VLA sensor at WTG1.

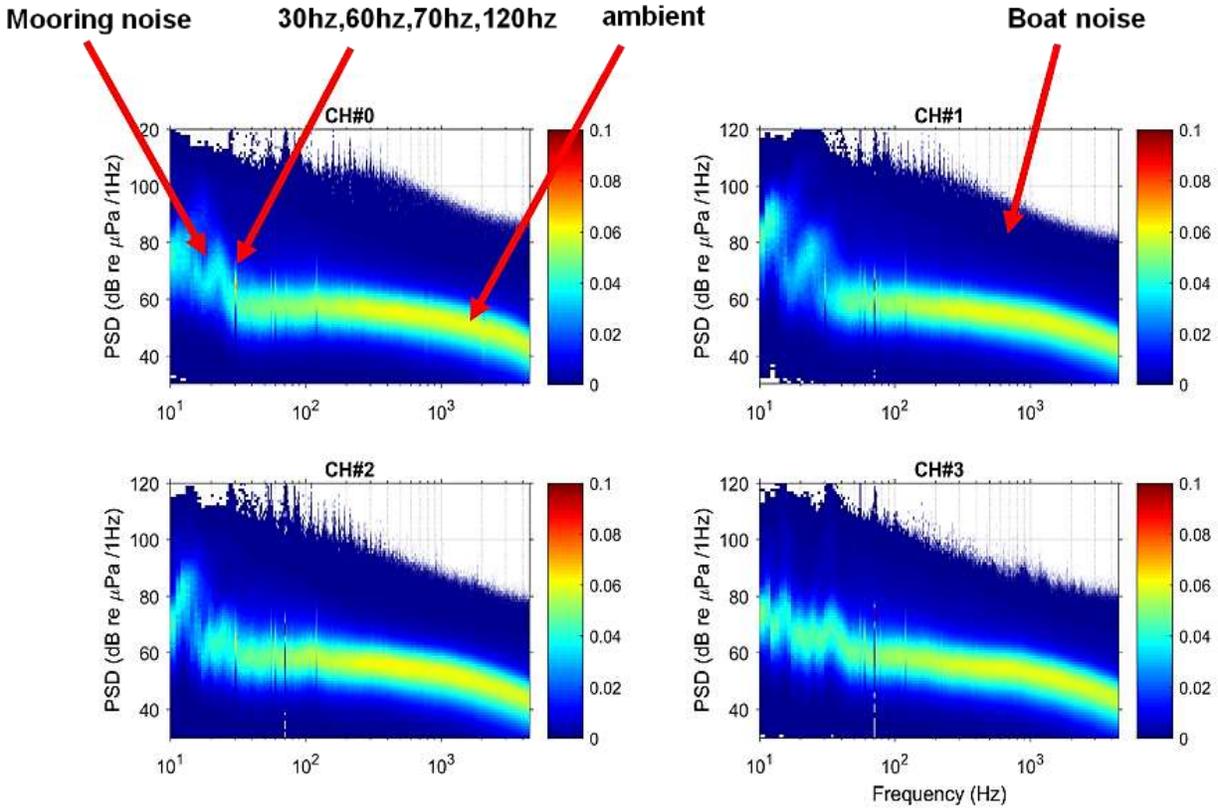
Figure 39. Frequency distributions from all four hydrophones on the VLA at WTG1.

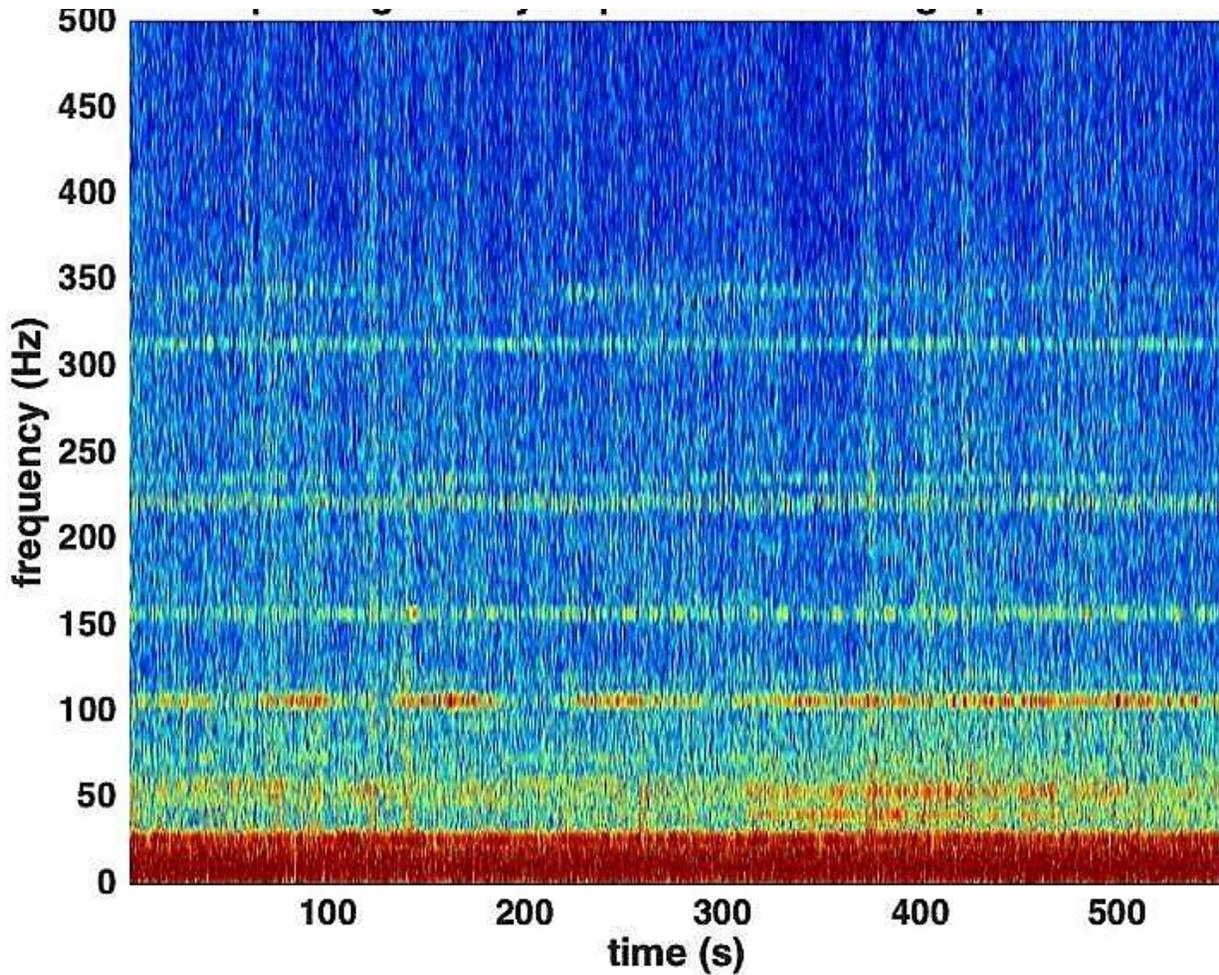
Figure 40. Spectrogram of the acoustic data collected during the operational phase of the turbine on 16 October 2017 at 03:46 UTC time. Note the intense sound below 25 Hz and tonals.

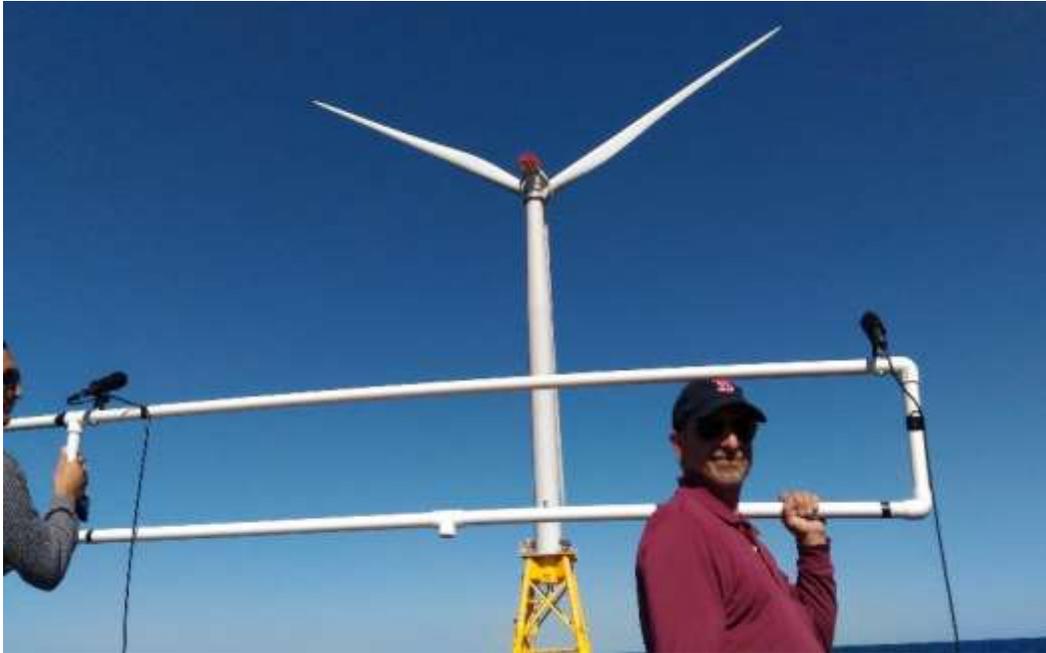
Figure 44. Customized omni-directional microphone array used for concurrent recording of air/water sound measurements.
