Field Observations During Wind Turbine Operations at the Block Island Wind Farm, Rhode Island

May 2019

HDR. 2019. Field Observations during Wind Turbine Operations at the Block Island Wind Farm, Rhode Island. Final Report to the U.S. Department of the Interior, Bureau of Ocean Energy Management, Office of Renewable Energy Programs. OCS Study BOEM 2019-028. 281pp.

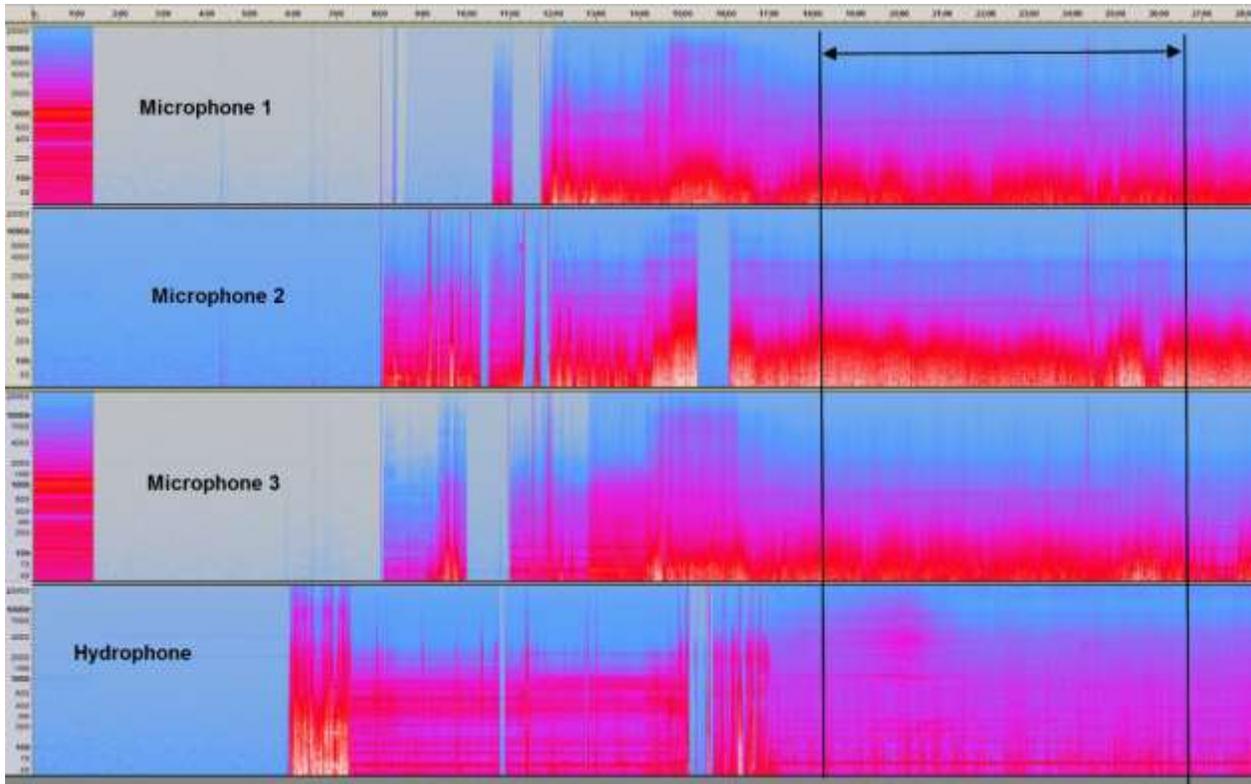
Figure 46. Spectrograms from three microphones and a hydrophone that were recording simultaneously.

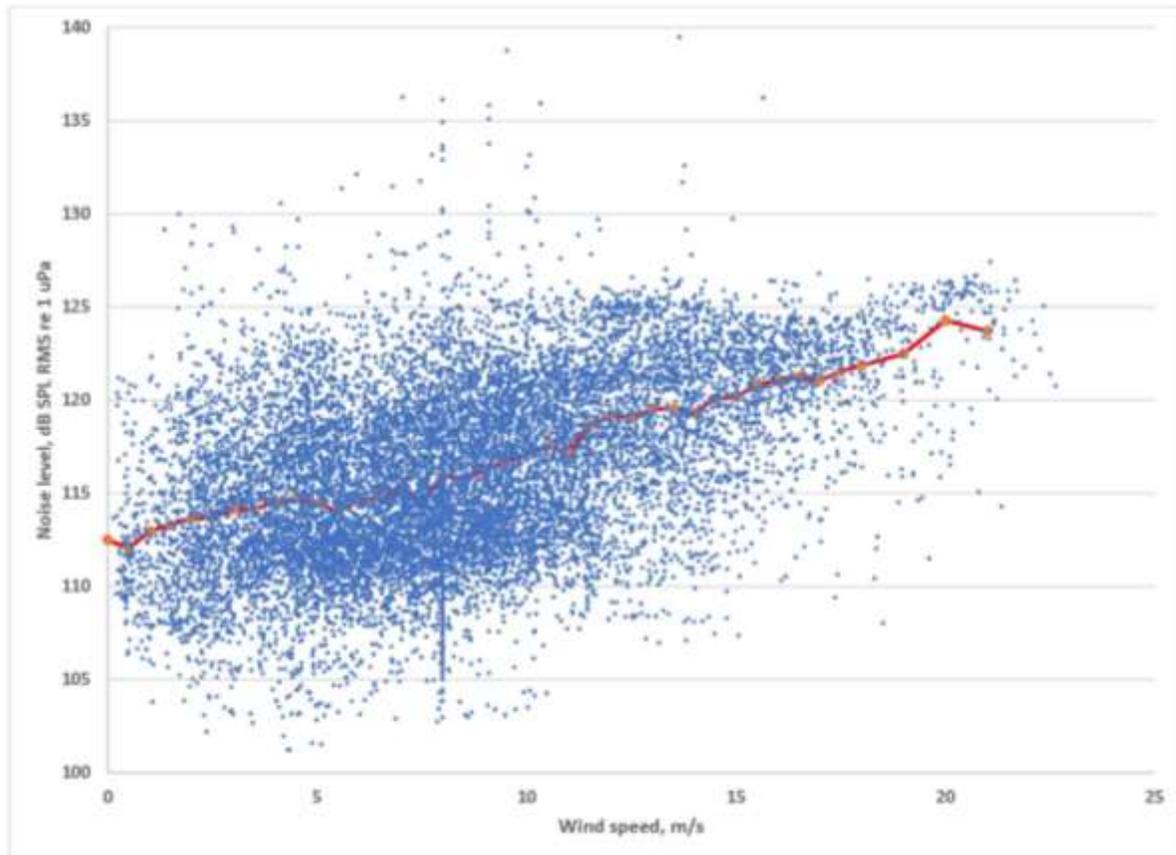
Figure 54. Sampled sound levels (10 Hz to 8 kHz) for July to October 2017 survey period against wind speed with 0.5 m/s interval average.

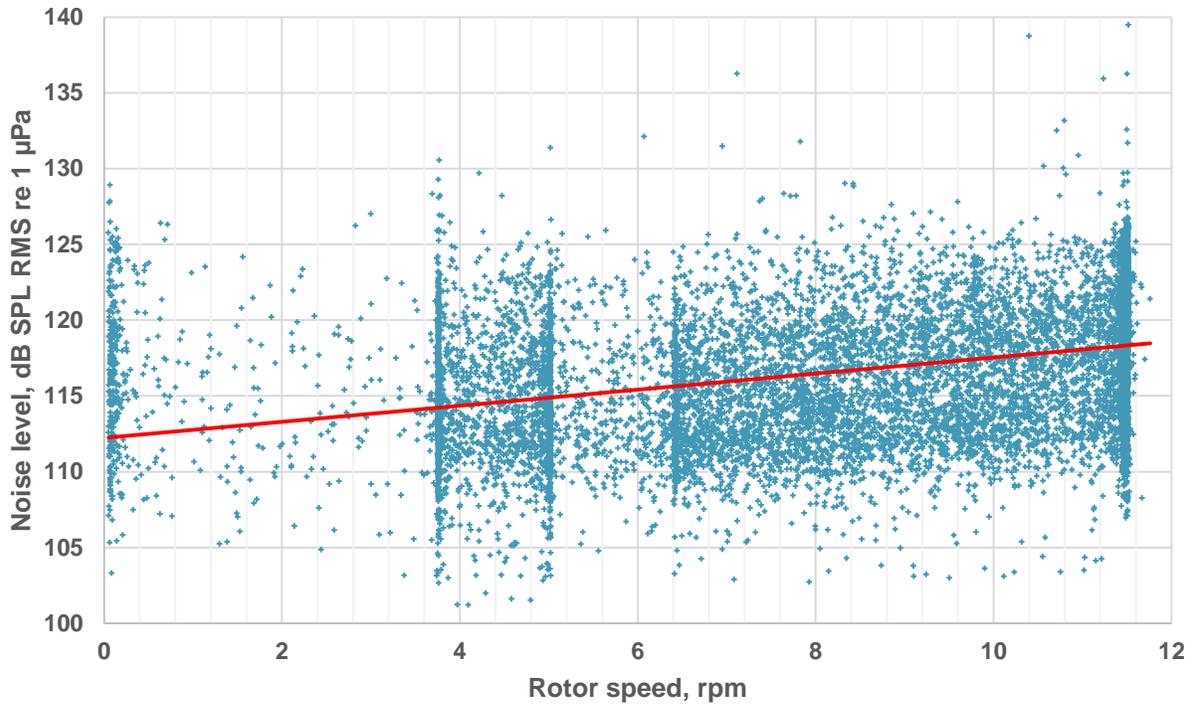
Figure 58. Sampled overall sound levels (10 Hz to 8 kHz) against blade rotation speed with linear average. Full dataset.

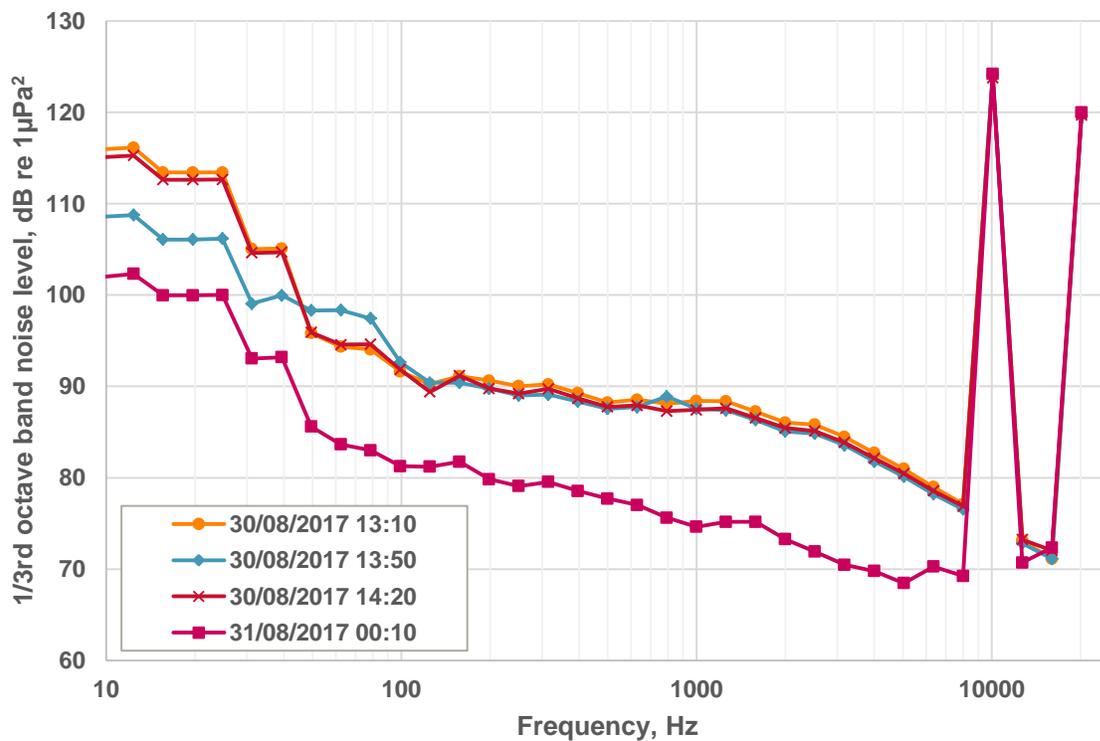
Figure 60. 1/3rd octave band center frequency spectra for [RED and ORANGE] turbine active, maximum rotor speed, approximately 18 m/s wind speed, [BLUE] shut-down, no rotation, approximately 15 m/s wind speed; [PINK] no rotation, calm wind. No vessel traffic.

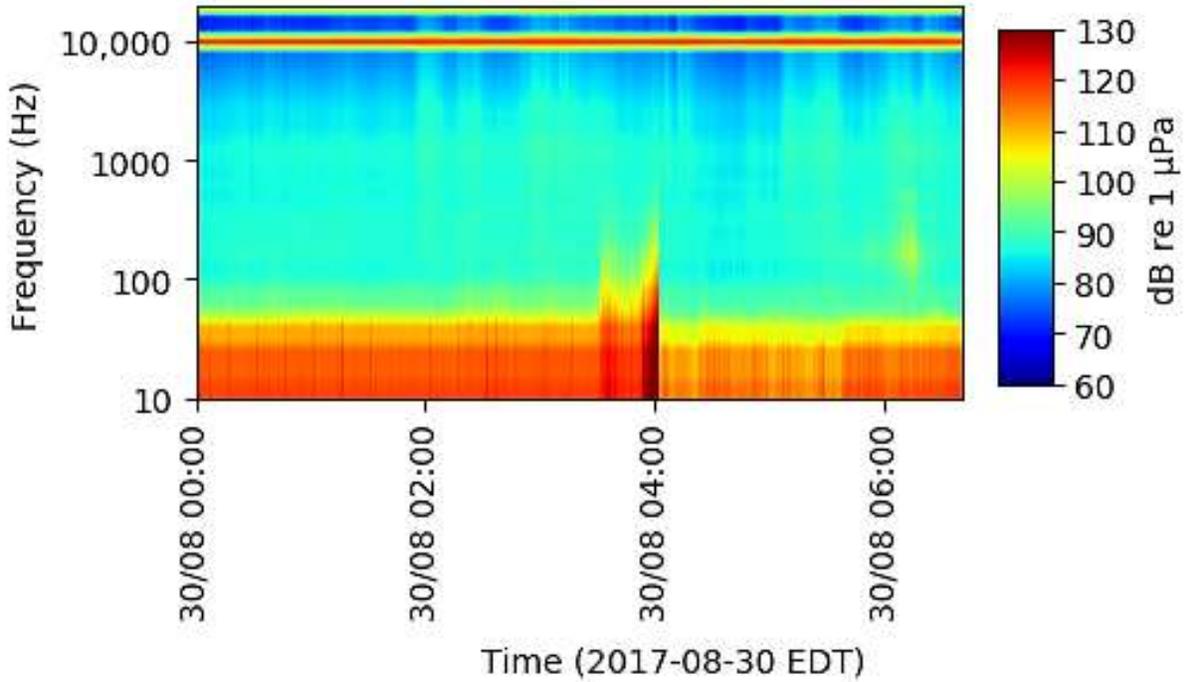
Figure 64. Spectrogram highlighting the 4 AM event on 30 August 2017.

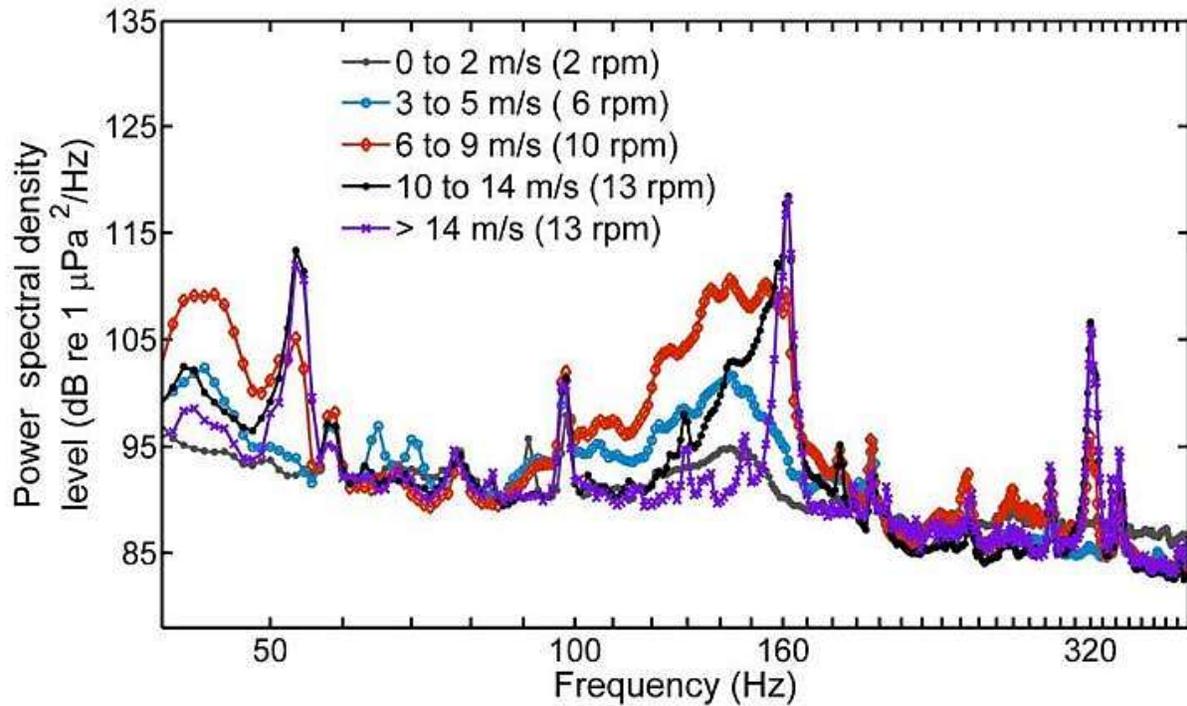
Figure 69. Image from Pangerc et al. (2016) showing underwater sound measured at the Sheringham Shoal offshore wind farm in the United Kingdom. Low frequency limited to 40 Hz.

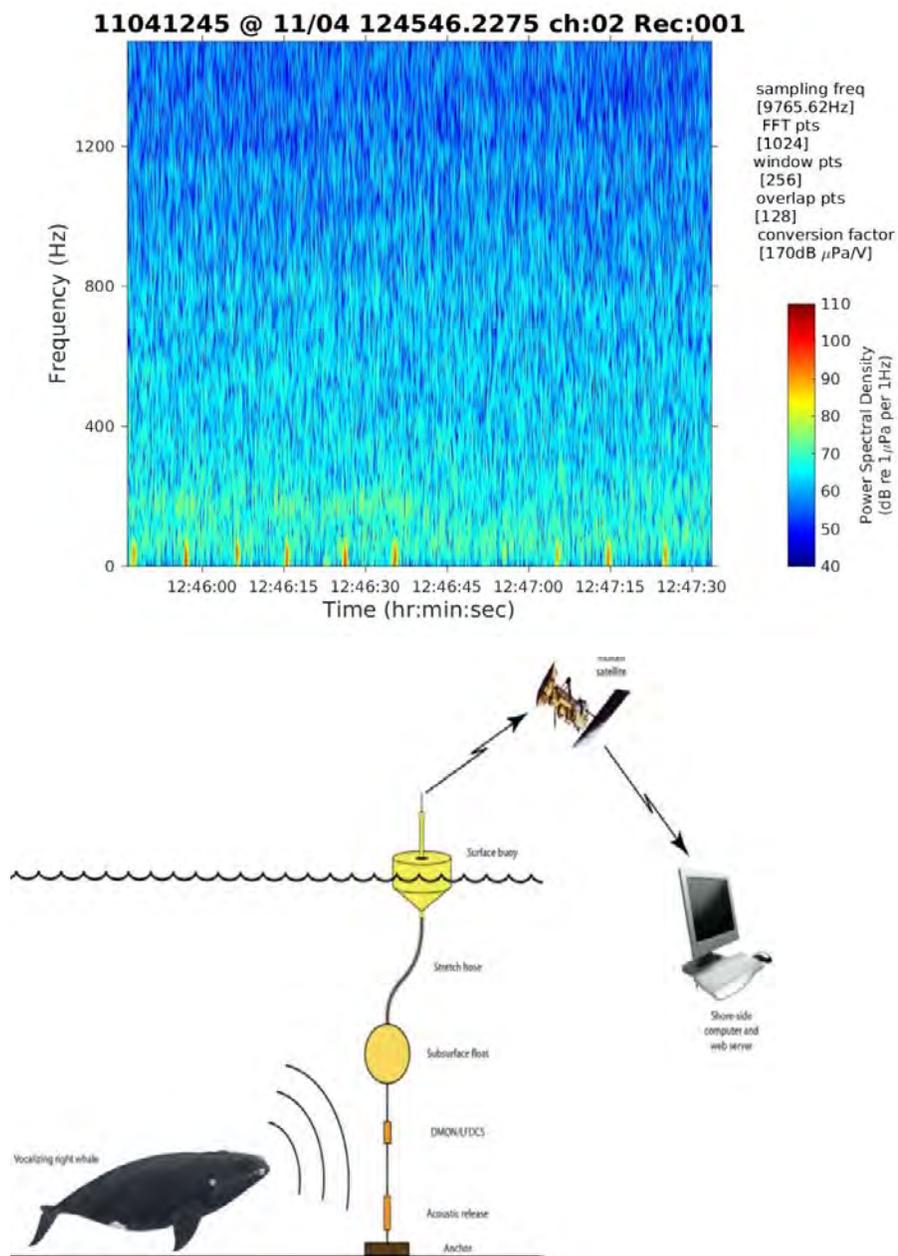
Figure 8. Spectrogram of the acoustic data recorded on the 15-km vertical array mooring on November 4, 2015 showing fin whale calls centered at 20 Hz.

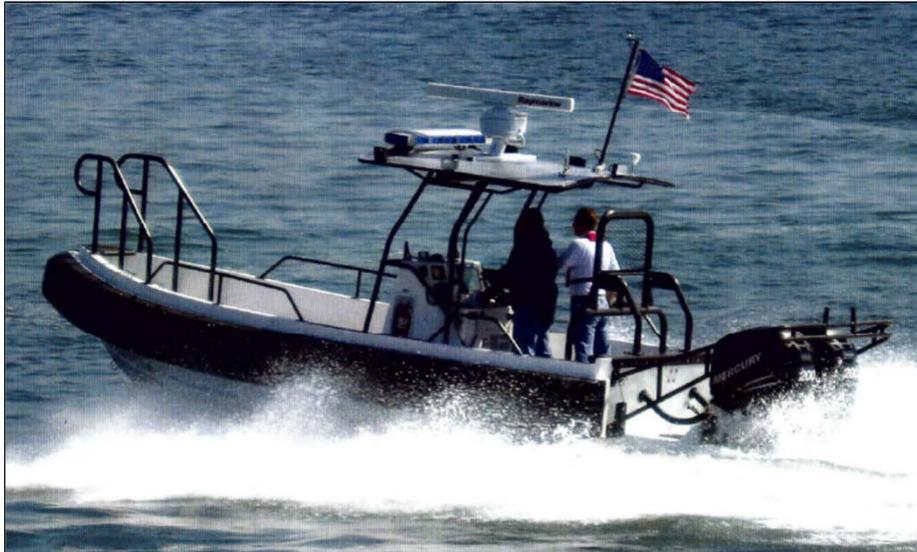
R/V McMaster Sportcraft –URI owned, length 30' R/V McMaster is a 30' Sportcraft owned by URI It has an A-frame and a windlass that can be used for various sampling and deployment and retrieval of instruments. URI always uses ~600-700 lbs as our safe working weight for the A-frame. It was repowered with an inboard Mercruiser engine 5 years ago and has all required electronic equipment

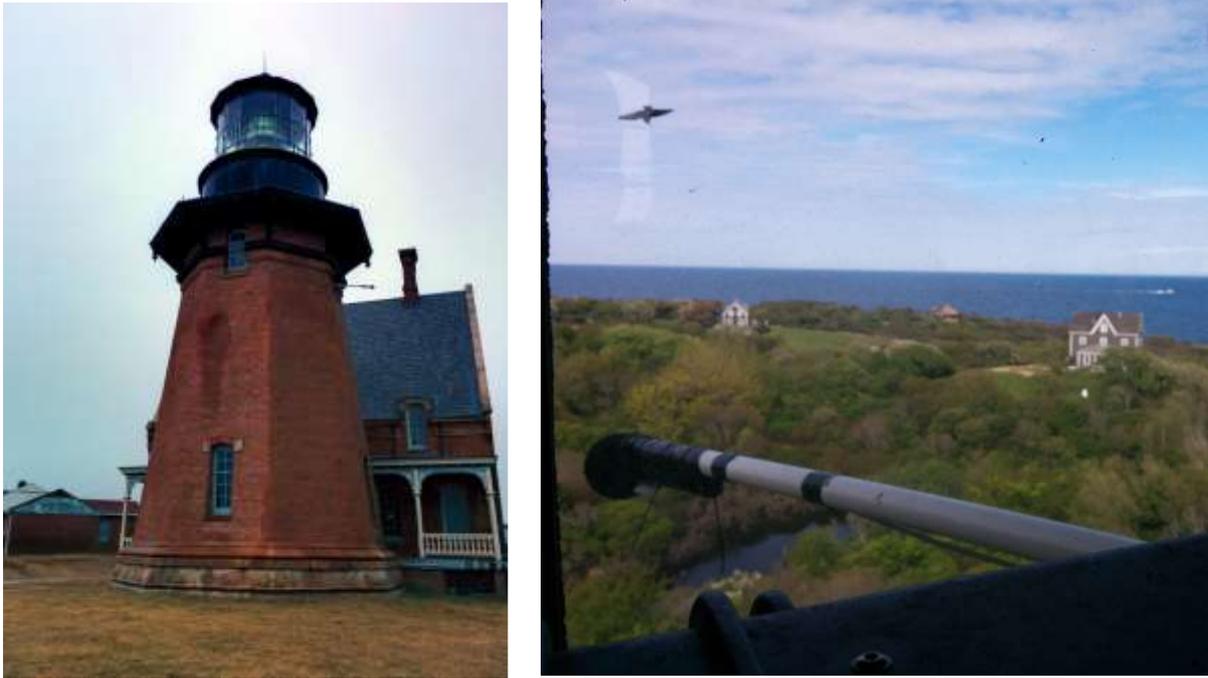
Figure 2-1. [Left] View of Southeast Light with microphone protruding from the right of the lighthouse, above the roof line of the building behind the lighthouse. [Right] View of microphone from the lighthouse window.

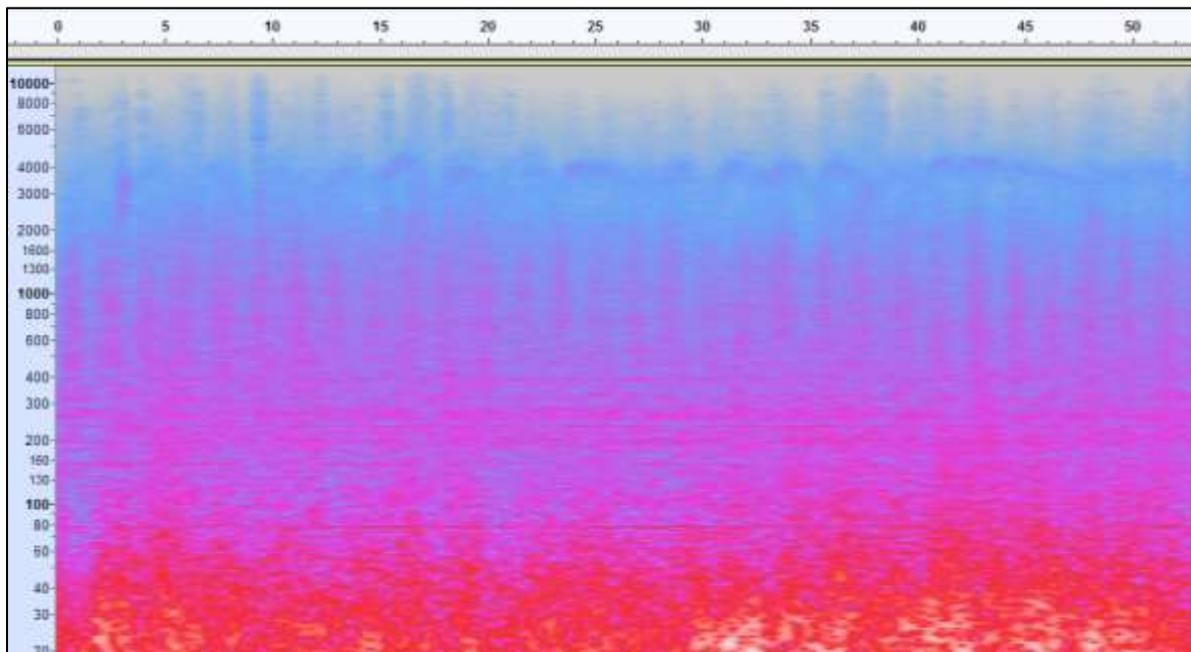
Figure 3-1. Spectrogram showing narrow-band analysis of offshore noise measurement, Oct 19, 2017, at approximately 50 m downwind of BIWF WTG #5 to show characteristics.
 Horizontal axis: Time (seconds)
 Vertical axis: Frequency (Hz)

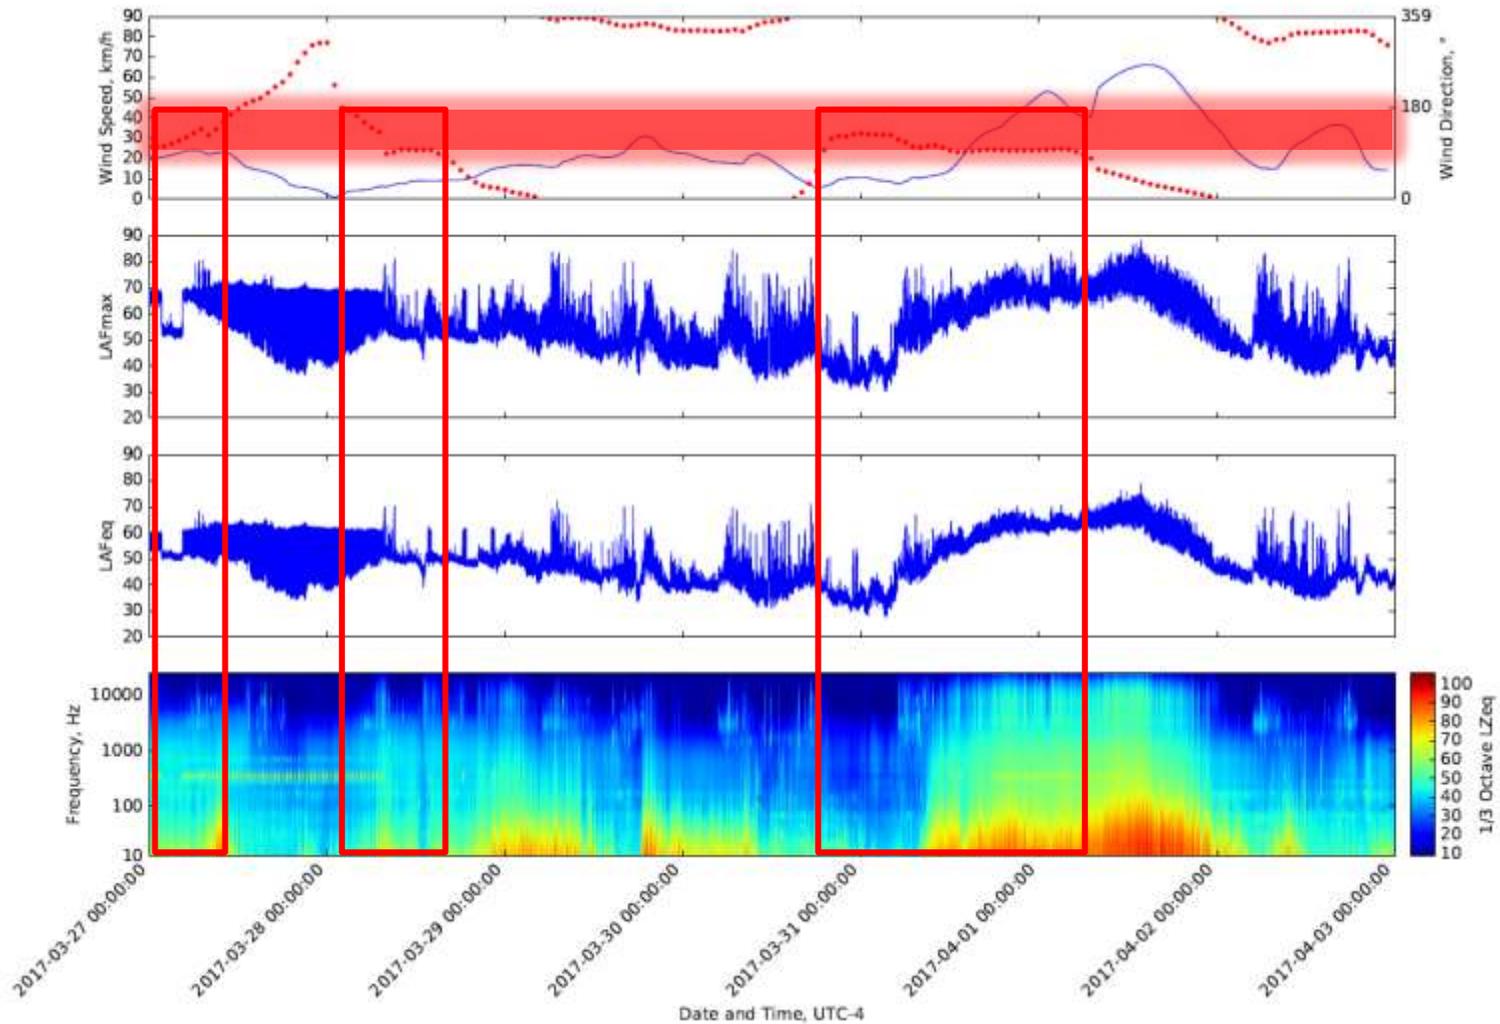
Figure 3-2. Noise measurement summary at the Southeast Light, March 27 to April 3, 2017 with annotations. Top chart: wind speed (blue line) and wind direction (red dots). Transparent red bar shows south-east compass point, with red boxes identifying time when monitor was downwind. 2nd: dB L_{AFmax} noise level time history. 3rd: dB L_{AFeq} (10 minute average) noise level time history. Bottom chart: L_{eq} spectrogram showing frequencies between 10 Hz and 10 kHz.

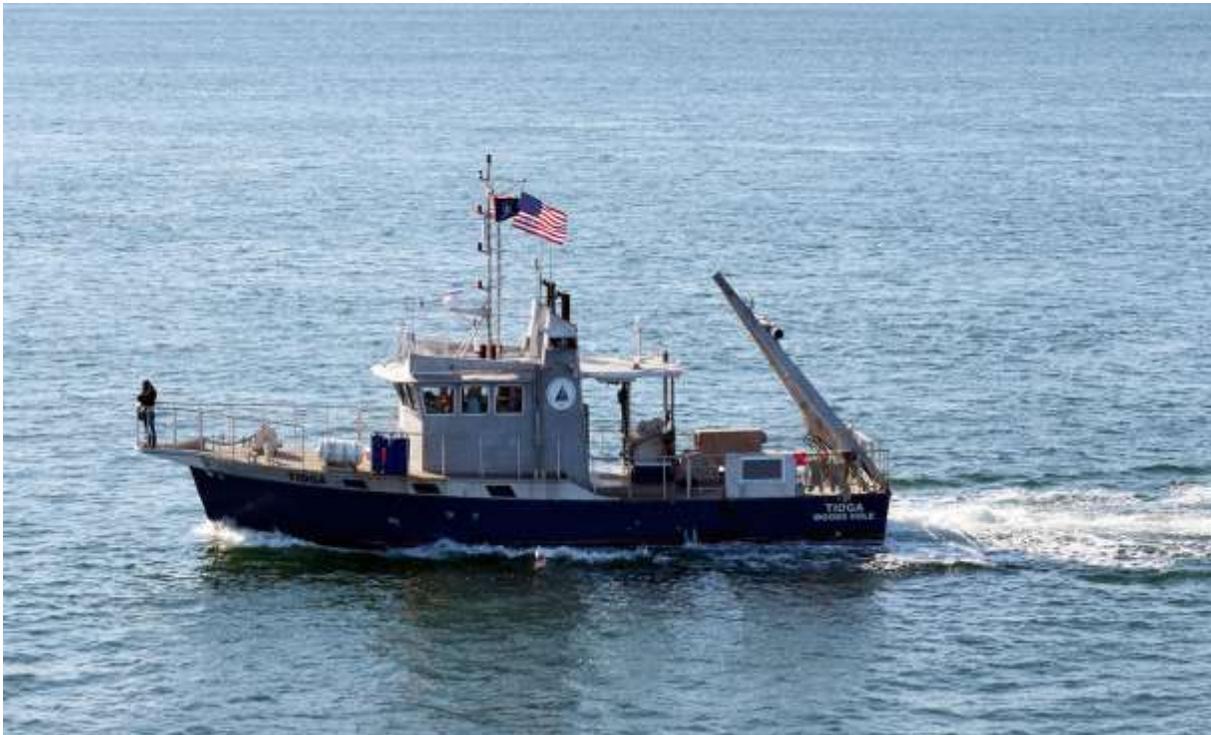
Figure 1: WHOI research vessel R/V Tioga.

All mooring deployment and recovery was performed from the Woods Hole Oceanographic Institution (WHOI) vessel R/V Tioga (Figure 1) which contained on-board GPS tracking, sea surface sensors and a calibrated Conductivity, Temperature, and Depth (CTD) sensor to probe the water environment.

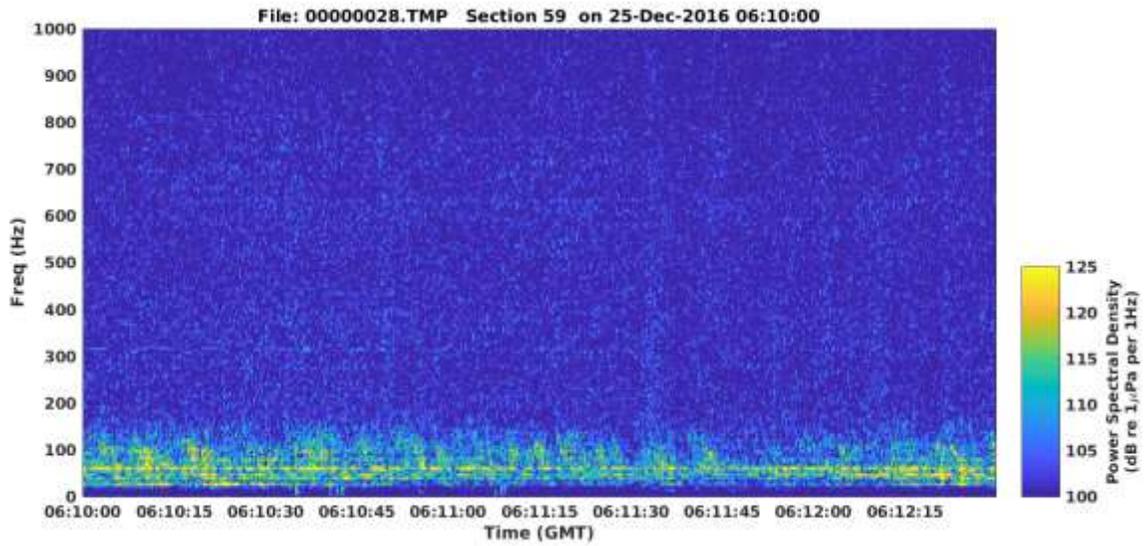
Figure 2: Spectrogram from a hydrophone on the horizontal line array at WTG5 during a good winter weather day showing low frequency noise from the wind turbine.

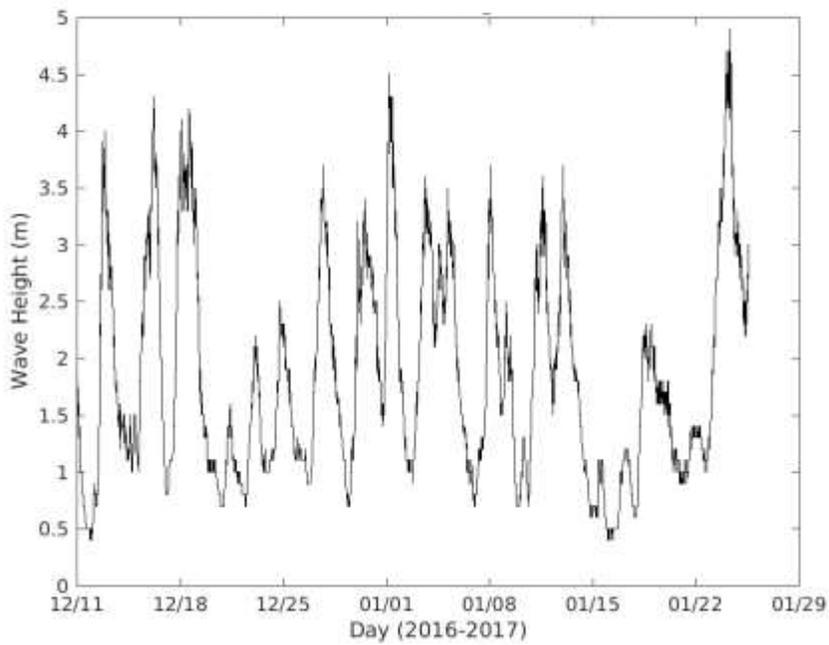
Figure 9: Wave height in meters from mean low tide from a nearby NDBC buoy showing very stormy winter season.

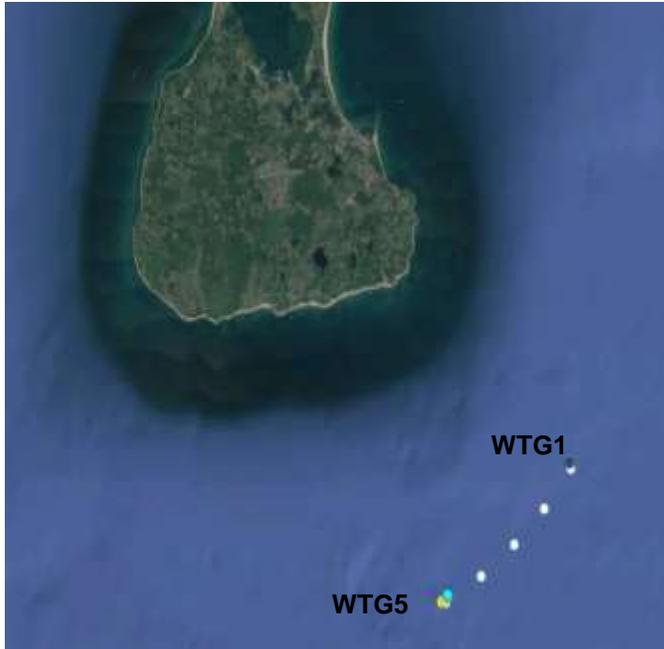
Figure 10: Image of Block Island wind turbine area. The wind turbine generators are indicated in white, the horizontal line array placement in cyan at WTG5, and the vertical line array in gray at WTG1.

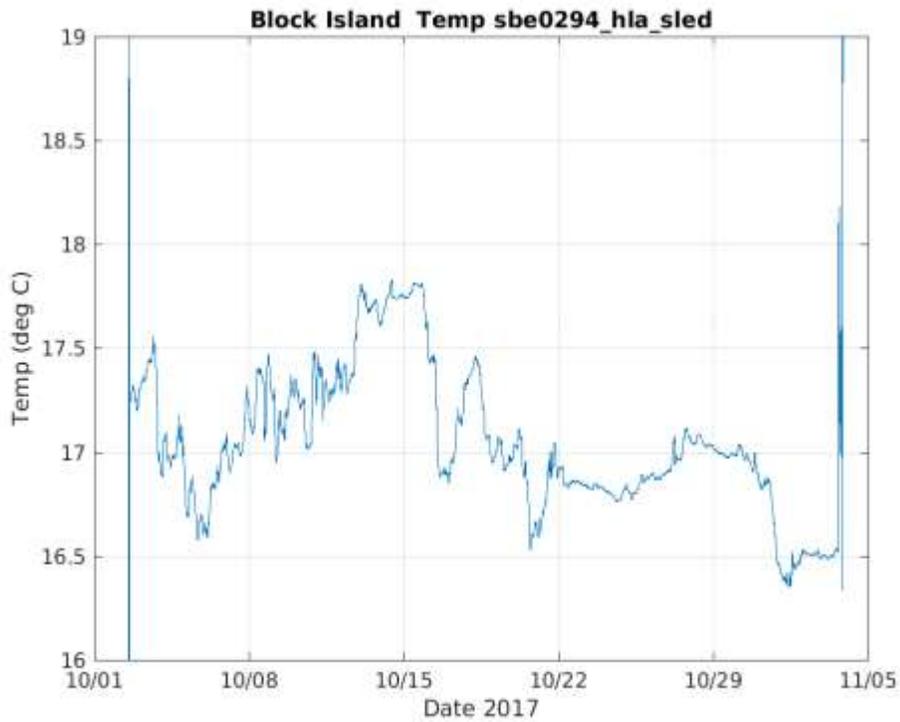
Figure 13: HLA SBE39 T/P temperature record at WTG5. The temperatures recorded during this time were twice that were found during the previous winter deployments.

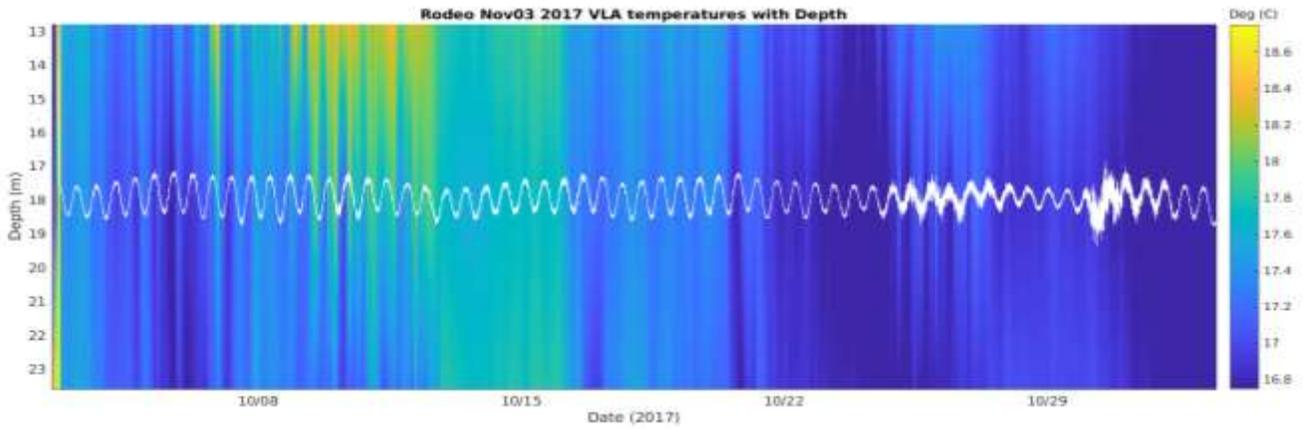
Figure 14: VLA temperature profiles from an array of sensors attached to the VLA with an overlay (white) with water depths at WTG1.

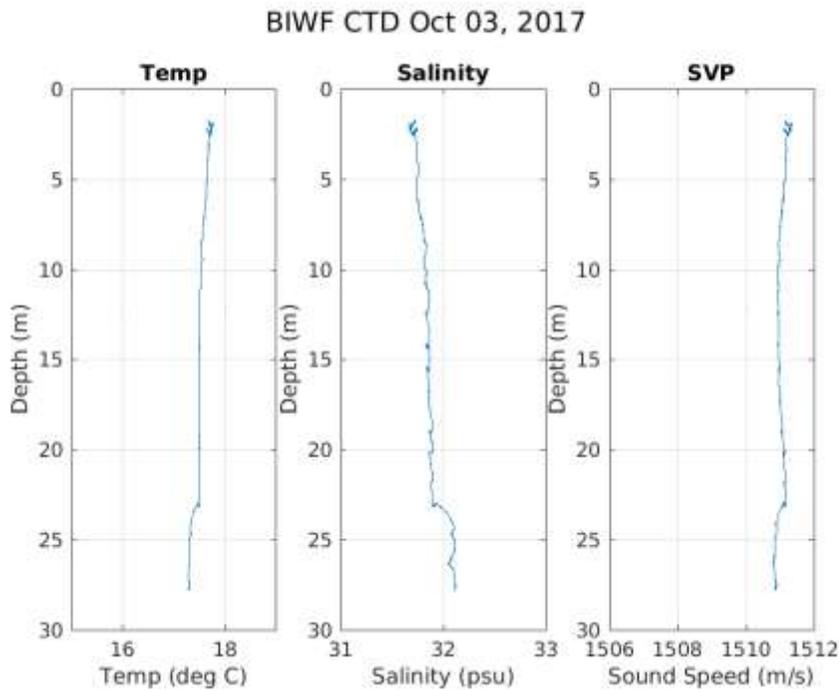
Figure 15: CTD cast from the R/V Tioga showing a well-mixed water column due to winter storms. The cast was performed on Oct. 2 2017 at 17:21 UTC at WTG5

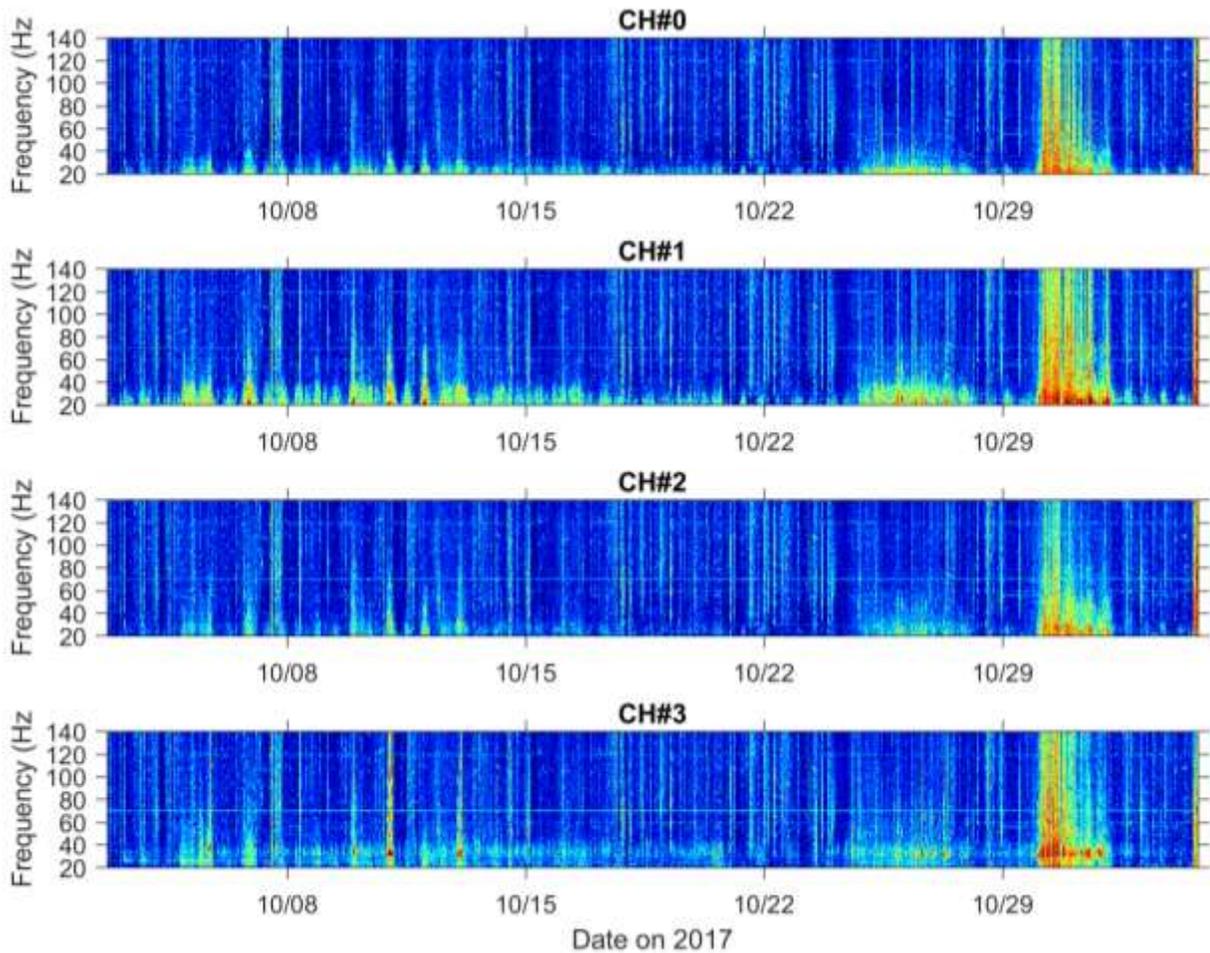
Figure 16: Spectrograms at 20 Hz to 140 Hz from each VLA sensor. Note higher level of noise during storms after 10/23.

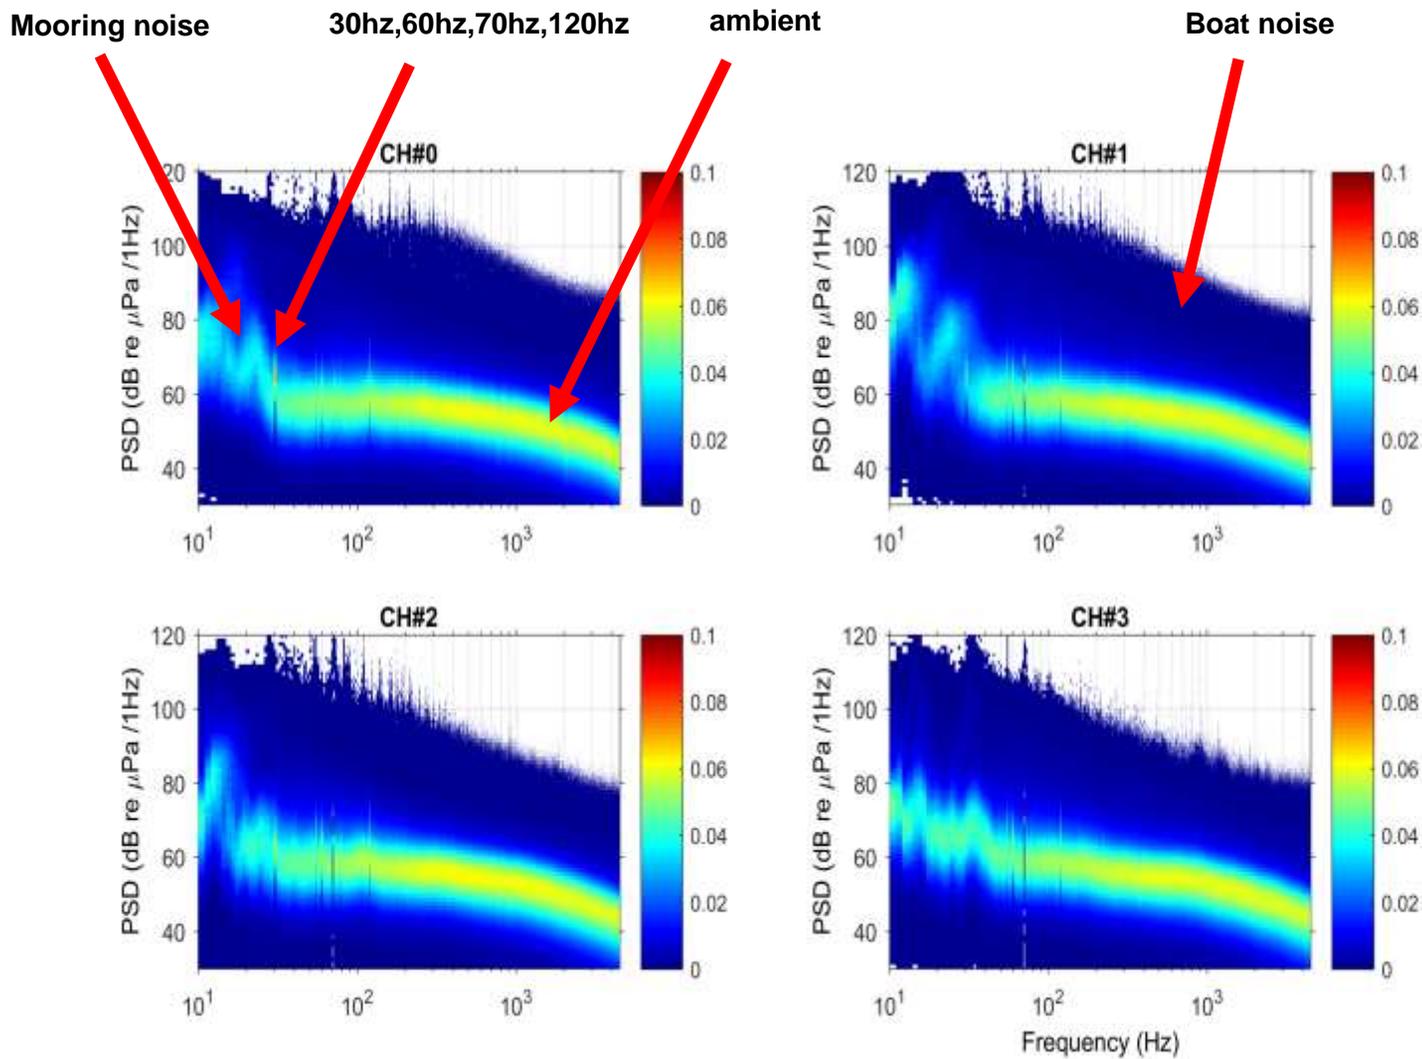
Figure 17: Frequency distributions from all four hydrophones on the VLA at WTG1. The low frequencies are dominated by mooring noise and the higher frequencies show the levels of ambient noise. Signals at 30,60,70 and 120Hz was recorded throughout the entire record. Boat noise made longer delay times in the density estimate.

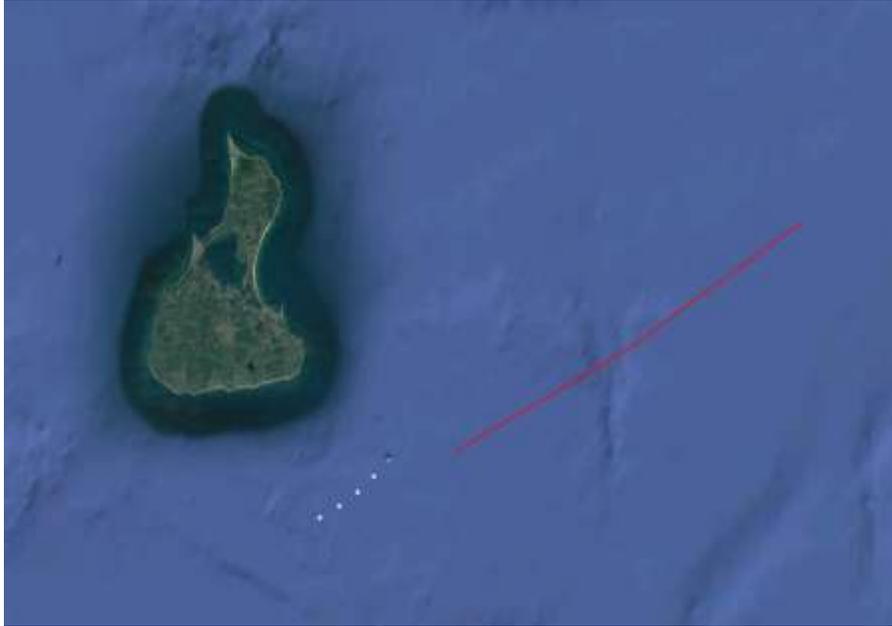
Figure 18: This figure shows the Block Island area. The five turbines are marked in white, and the vertical line array is marked in gray at turbine #1. The red line is the track of the R/V Tioga towing a sound source for playback operations.

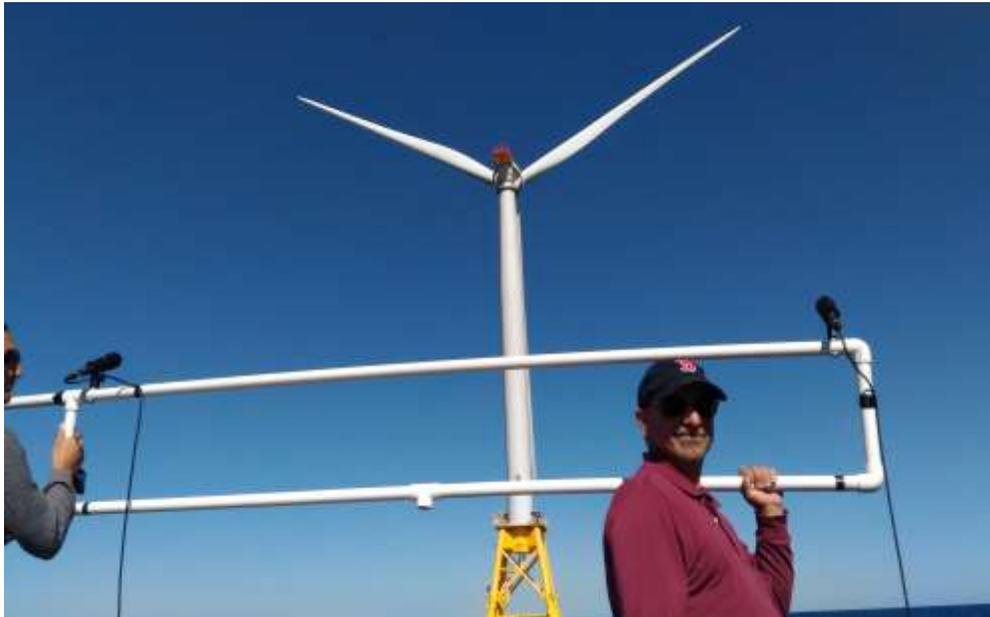
Figure 24: Holding the omni-directional microphone array at WTG1.

A GoPro video camera was also attached to the array for blade speed rates. From GoPro video, the blade rate for a complete cycle at WTG1 during the recording was measured to be 14 seconds or 4.6 seconds per blade. The GoPro compresses (normalizes) the audio recorded to its highest value, thus making the audio unusable due to wind and

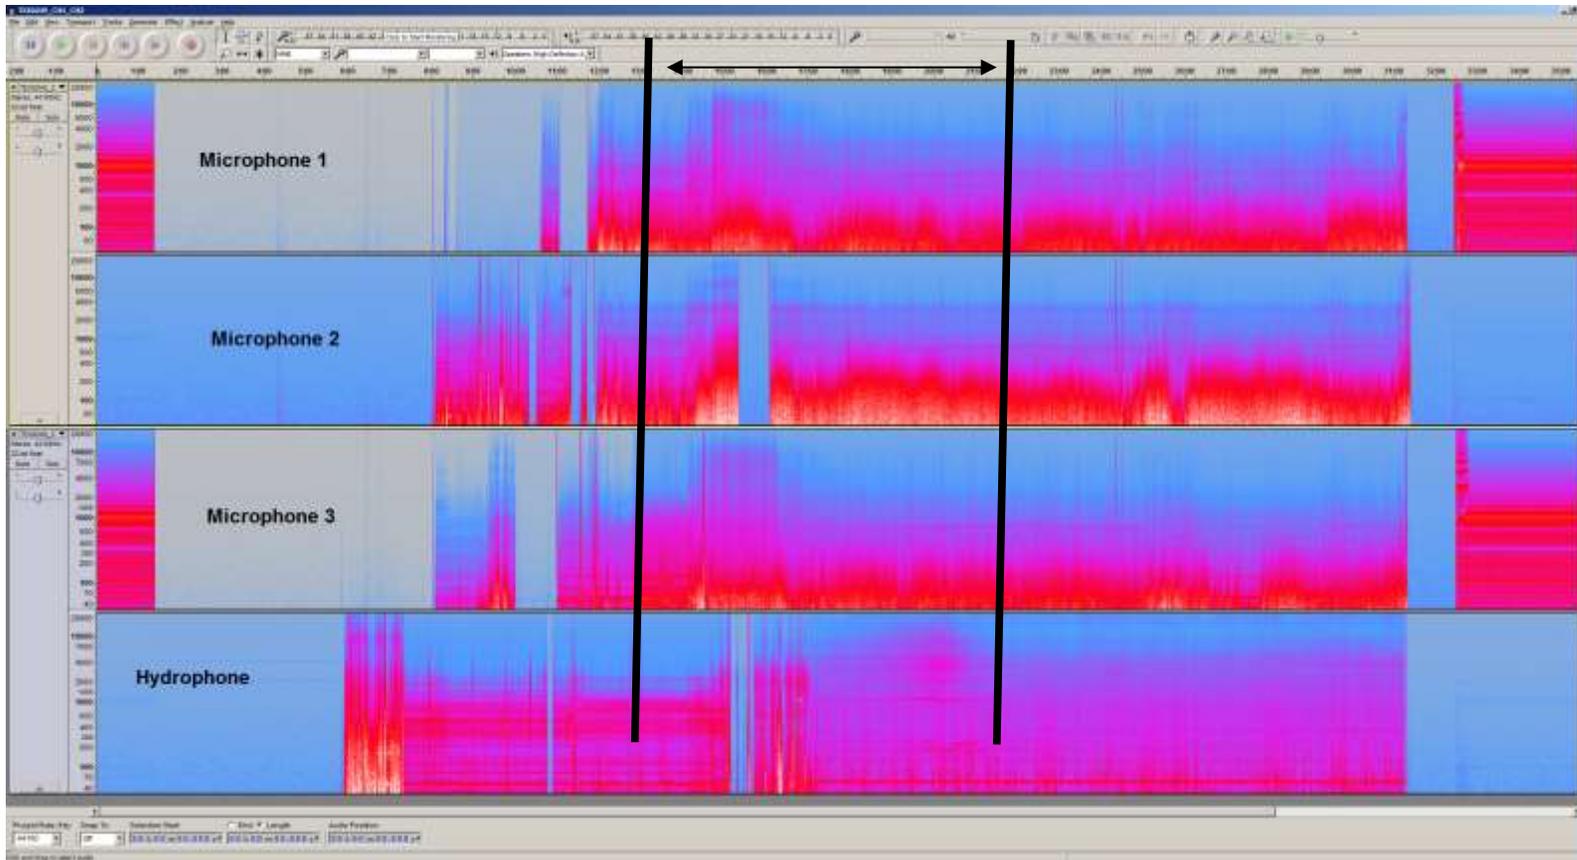
Figure 26: Spectrograms from three microphones and a hydrophone that were recording simultaneously. The black lines mark the section where the ship was drifting and the WTG1 generator noise inspected. The frequency band seen here is from 75Hz to 20kHz.

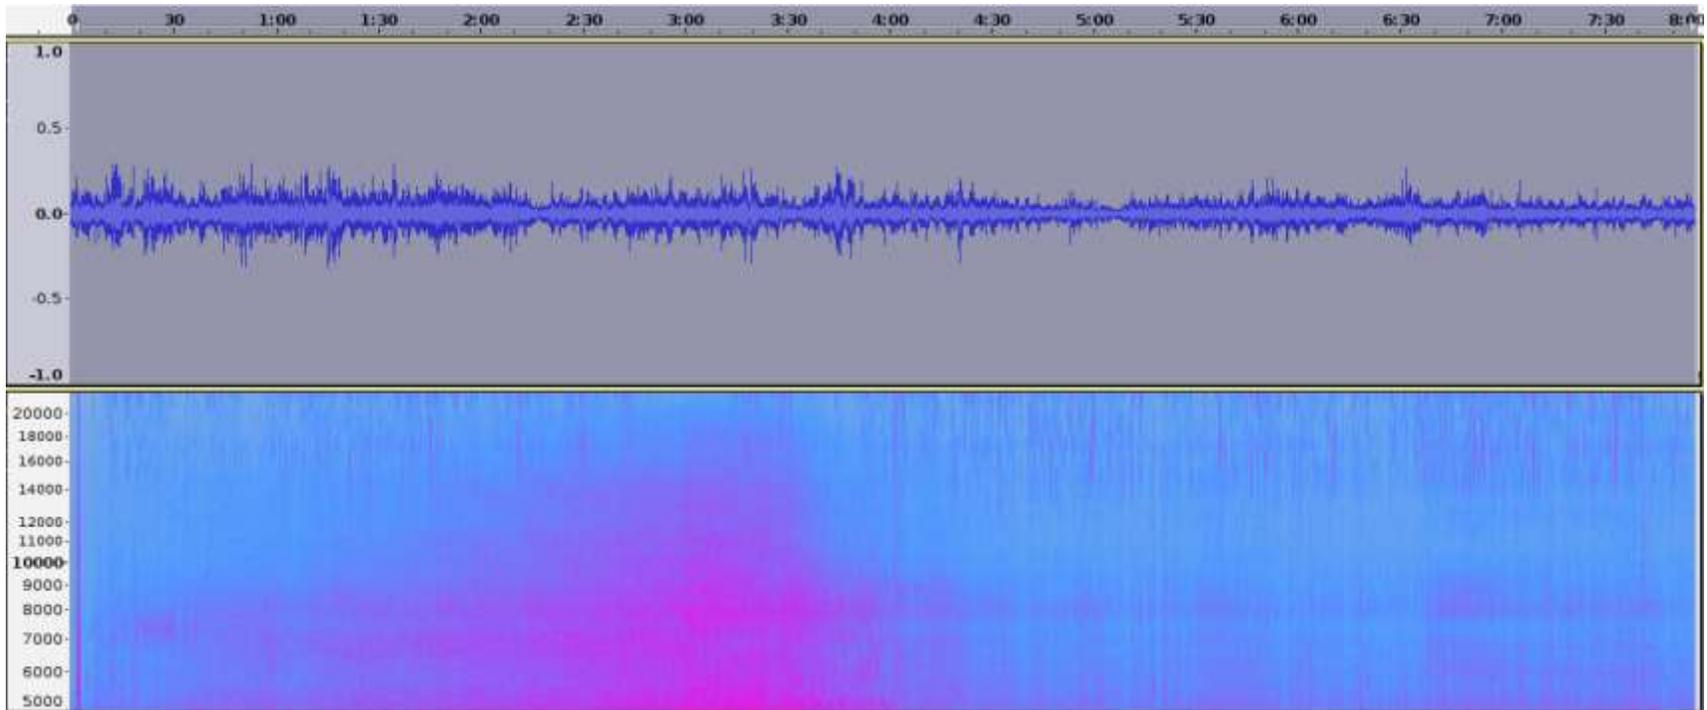
Figure 27: This figure is a look at the higher frequencies from the turbine noise from microphone #3. The top panel is the recorded signal; the bottom panel is a spectrogram from 5 kHz to 20 kHz.
