Field Observations During Wind Turbine Operations at the Block Island Wind Farm, Rhode Island

May 2019

HDR. 2019. Field Observations during Wind Turbine Operations at the Block Island Wind Farm, Rhode Island. Final Report to the U.S. Department of the Interior, Bureau of Ocean Energy Management, Office of Renewable Energy Programs. OCS Study BOEM 2019-028. 281pp.

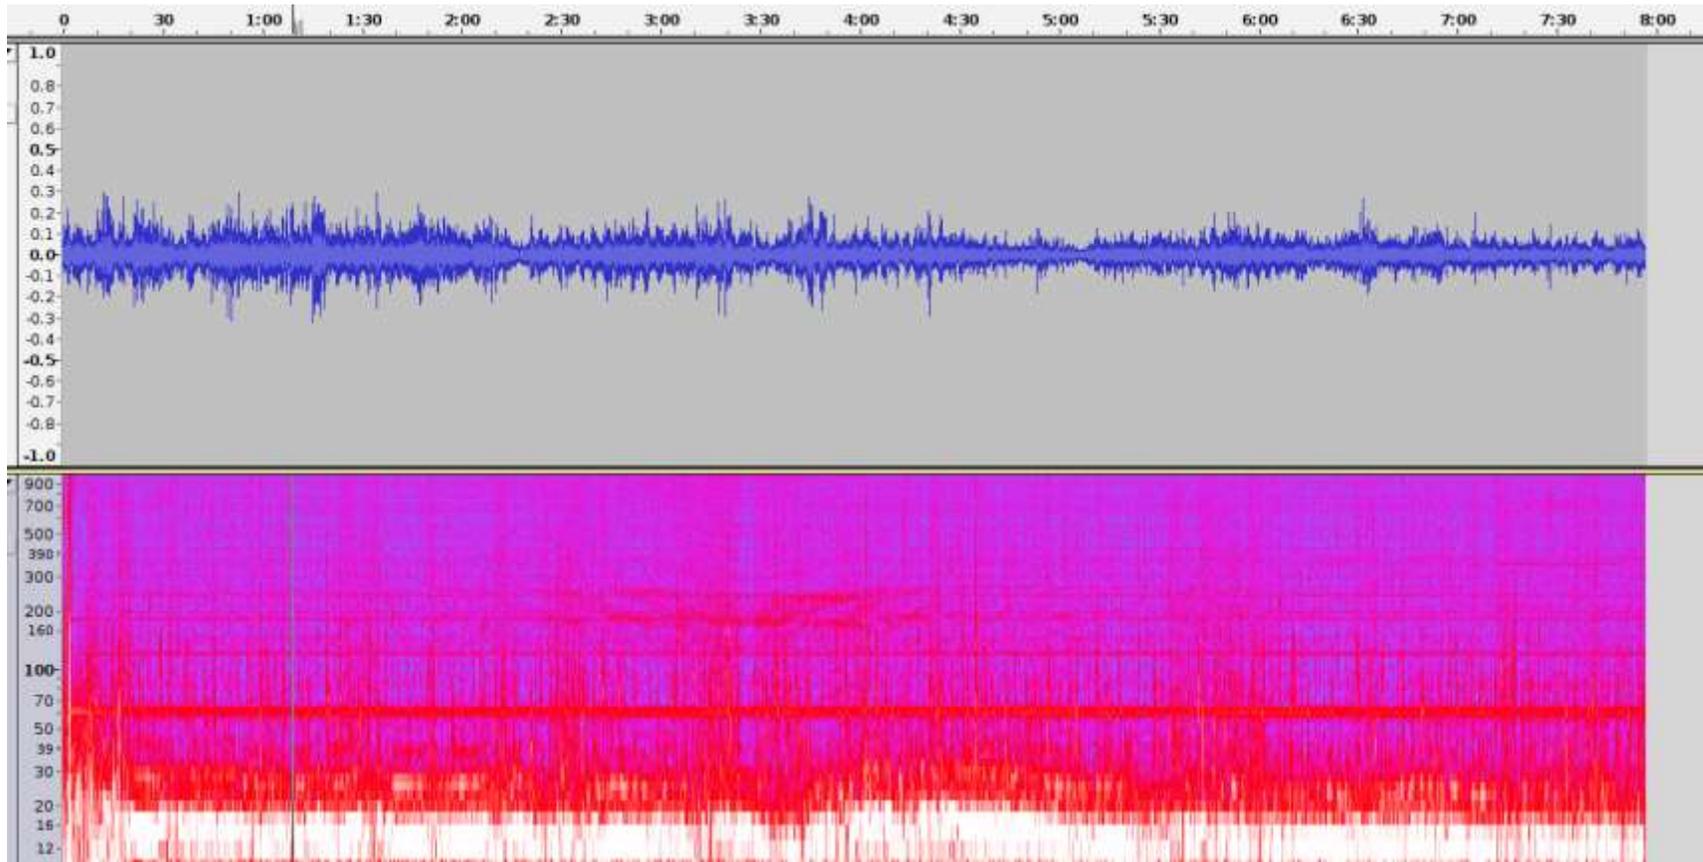
Figure 28: This figure zooms into the lower frequencies from the same signal as Figure 32 from microphone #3. It shows the low frequency noise from the turbine operation. The upper panel is the turbine signal. The lower panel is a spectrogram from 10Hz to 900Hz. Notice frequency bands in the lower frequencies.

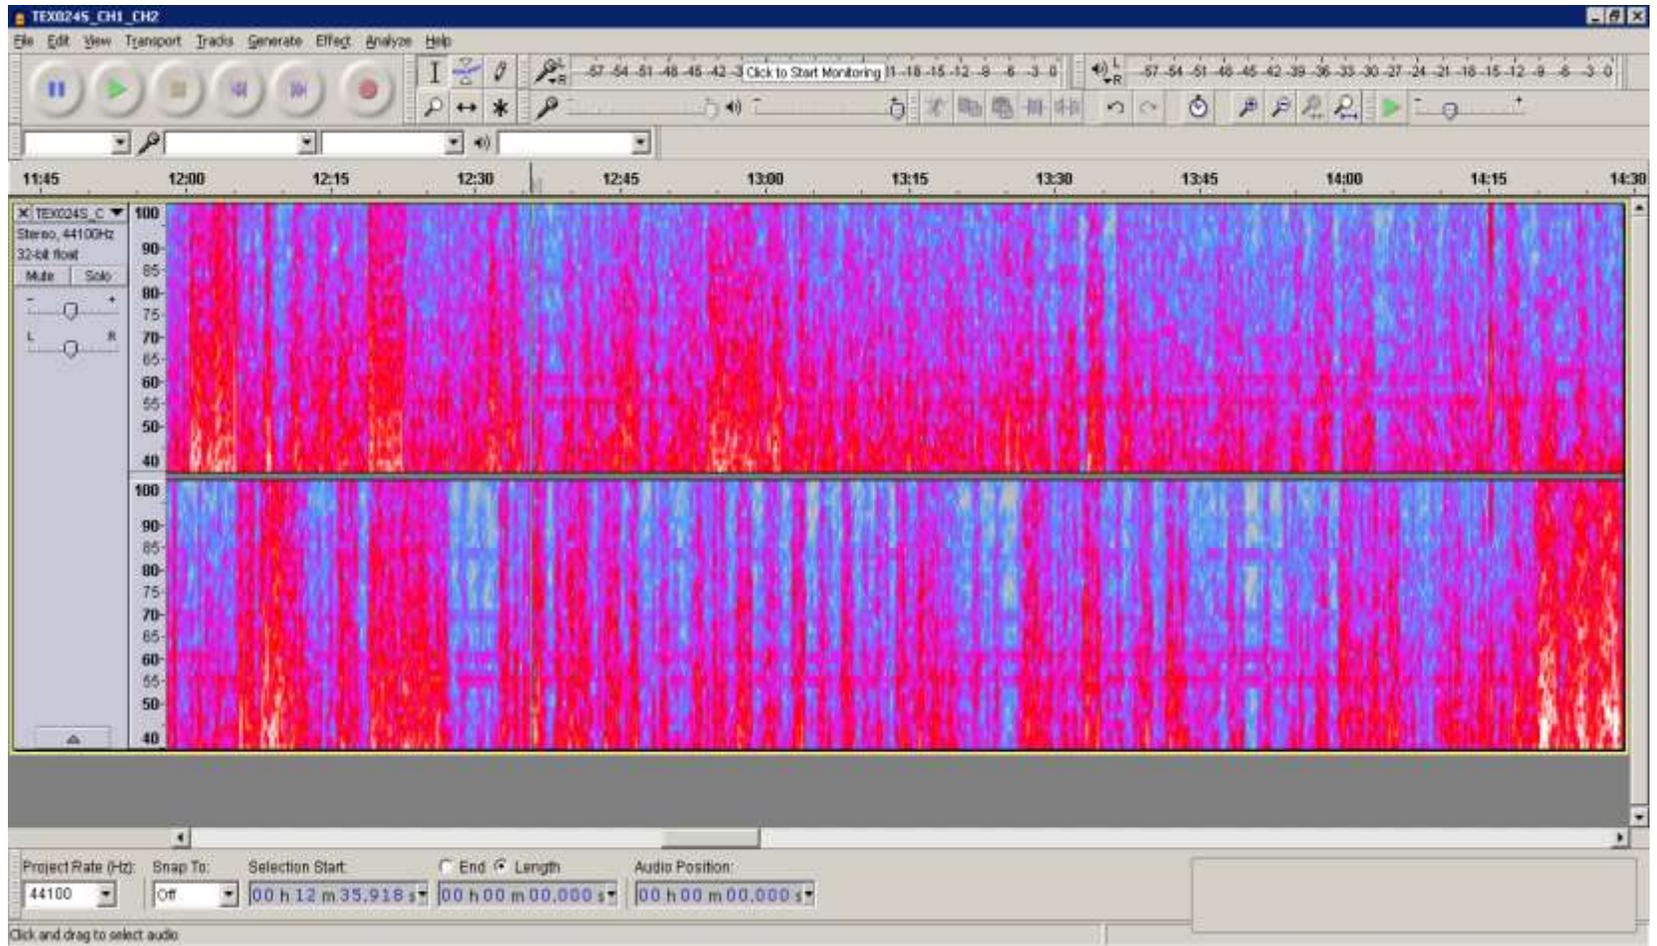
Figure 29: Comparison of low frequency signals from microphone #3 and the hydrophone 5 meters under water. The top panel is the spectrogram from microphone #3. The lower panel shows the spectrogram from the underwater hydrophone. The frequencies show here range from 40Hz to 100Hz. Periodic saturated noise from wind and waves is evident but frequency bands in the same levels are noticed in both air and water.
