Deep Green Project EIA: Coordination

Deep Green Project - Holyhead Deep

Project and Export Cable Route – Offshore Survey

Volume 1 – Operations Report

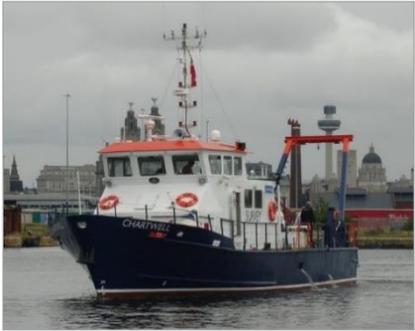
Category	Details	Comments
<p>24hr Coastal Survey Vessel.</p> <p>MCA SVC Category 1 available for specified contract (up to 150 miles from a safe haven)</p> <p>MCA SCV Category 2 (up to 60 miles from safe haven).</p>	<p style="text-align: center;">MV Chartwell</p>

<p>Completely refitted in 2009, Chartwell is a 26m purpose built survey vessel, ideal for coastal geophysical investigations.</p> <p>She has a cruising speed of 15 knots and with a draft of 2.1m she has a minimum safe working water depth of 4m. Chartwell can accommodate 9 people and has a 5 to 7 day operational capacity.</p>

MV Chartwell is a 26m 24hr coastal survey vessel which carries Category 2 certification under the current MCA Code of Practice for Small Workboats and Pilot Boats. Details of vessel specifications can be found at the following address: <http://www.bibbyhydromap.com/vessels/>

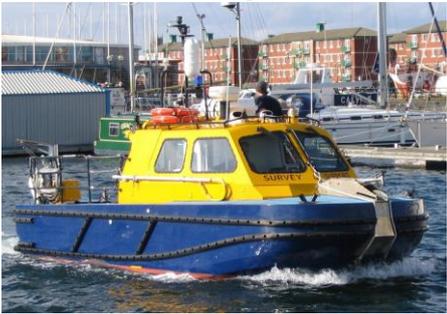
Category	Details	Comments
<p>12h Coastal Survey Vessel.</p> <p>MCA SCV Category 3 (up to 30 miles from safe haven).</p>	<p style="text-align: center;">MV Eagle</p>

<p>Eagle is a purpose built shallow drafted survey vessel launched in 2003. Eagle is a heavy duty GRP, Halmatic, shallow drafted water jet propulsion catamaran with dimensions of 8.9m by 2.9m with a draft of 0.5m. The vessel has twin inboard engines which provide a fast cruising speed of over 15 knots, in optimum sea conditions. Eagle was purpose built for the Maritime Coastguard Agency (MCA) to the highest of build and fitting standards in 2003.</p>

MV Eagle is a 5m 12hr shallow water jet drive survey vessel. Her draft of 0.5m and the ability to dry out makes her suited for very shallow water intertidal surveys. Water jet propulsion enables Eagle to have an extremely high level of manoeuvrability and slow speed control. Eagle carries Category 3 certification under the current MCA Code of Practice for Small Workboats and Pilot Boats. Details of vessel specifications can be found at the following address:

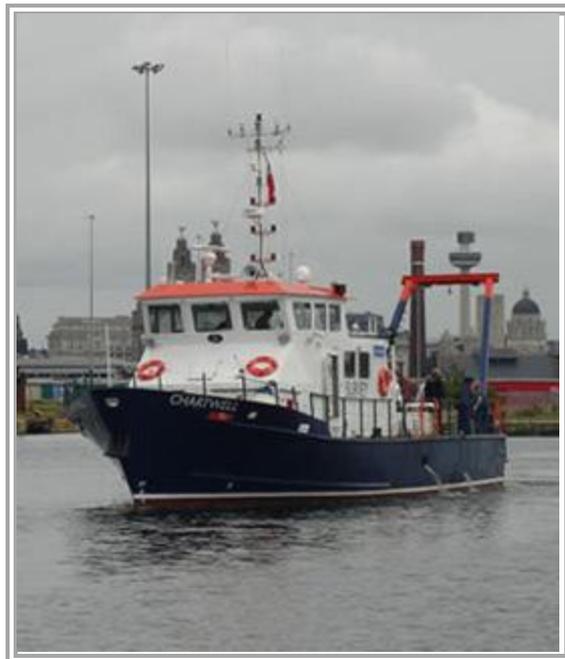
MV Chartwell is a purpose built mono-hull survey vessel. The vessel has dimensions of 26.5m by 5.8m and a draft of 2.2m, providing a stable working platform. Further information regarding this vessel is presented in Appendix 1 to this report.
