# North Carolina Collaborative Archaeological Survey: Wilmington East and West Wind Energy Areas

February 2020

Prepared collaboratively under Interagency Agreement M15PG00003

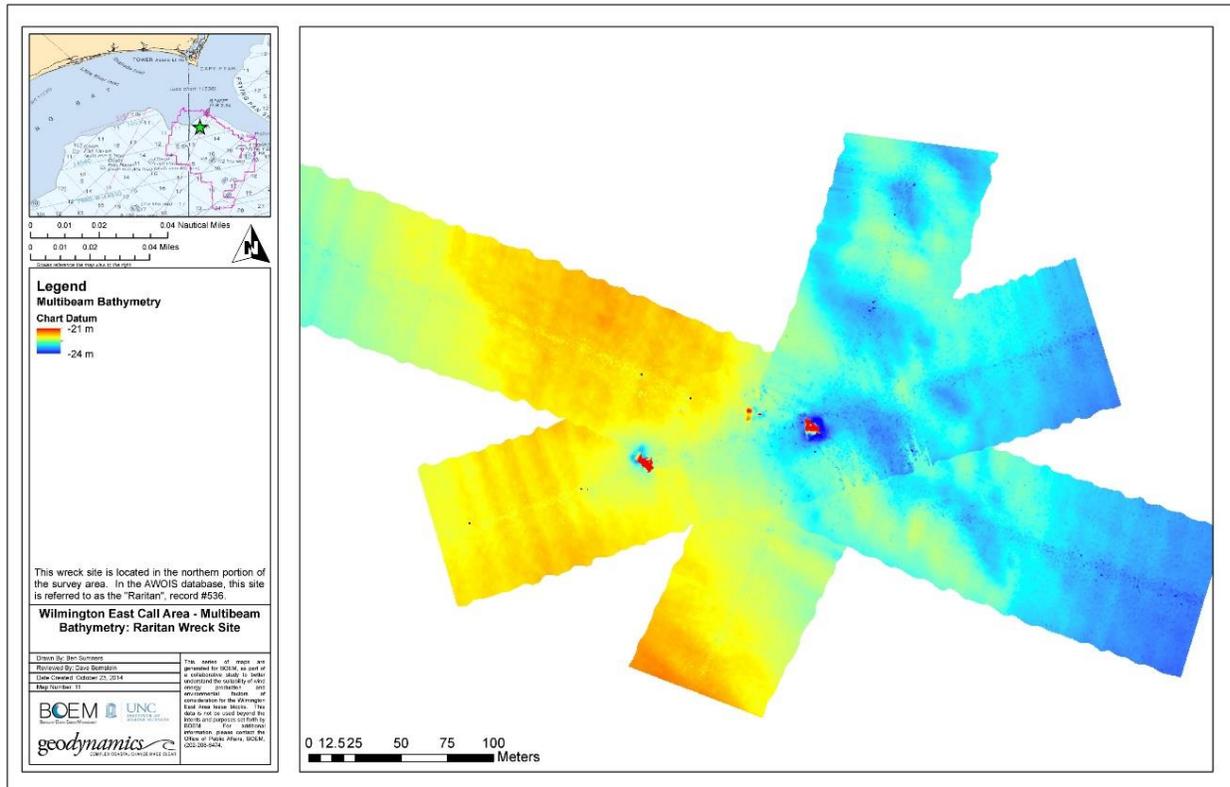
**Figure 5: Multibeam Imagery of *Raritan* (Taylor, et al. 2016).**

As visible in the remote sensing imaging, the site is roughly oriented along an east-west axis and consists of two main features of high relief representing the bow section (located to the west) and stern section (located to the east). The total length of the wreck site is approximately 100 m (328 ft). The bow and stern sections each measure approximately 12 to 15 m (39 to 49 ft) in length and are approximately 5 to 7.5 m (16.4 to 24.6 ft) wide, respectively. Both the bow and stern sections measure approximately 5 to 7 m (15 to 20 ft) of relief above the seafloor.

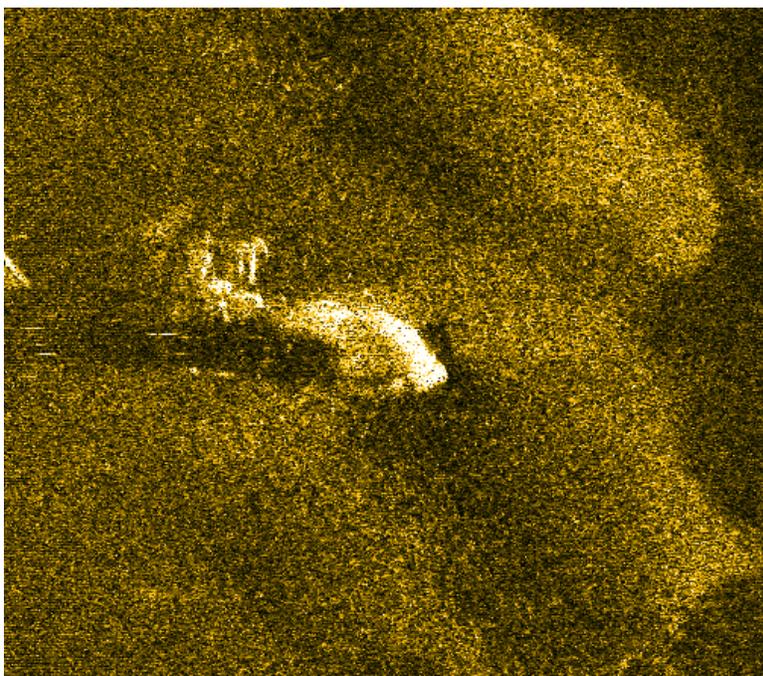
**Figure 6: Side scan sonar image of *Raritan* (Taylor, et al. 2016).**

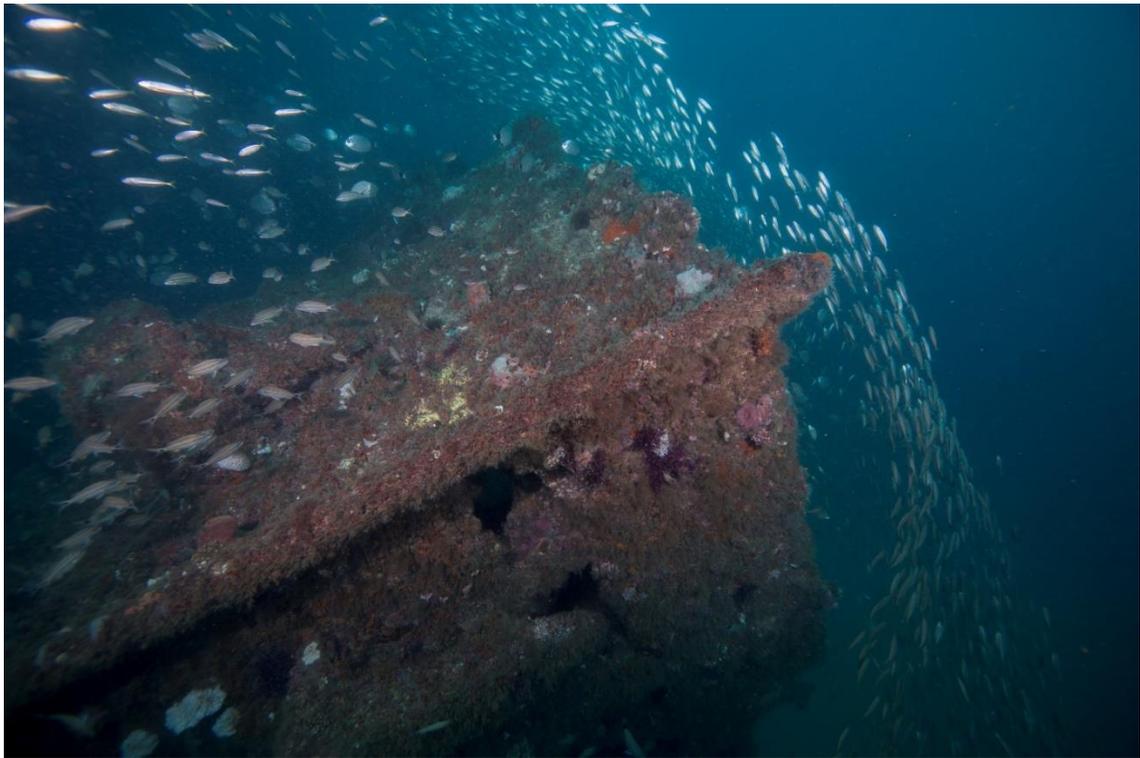
The bow section is resting on its port side (Figure 7) with the bow anchors in place at the hawseholes and intact winch and deck machinery visible. The stern section is partially resting on its port side with remains of the steering quadrant visible (Figure 8). The single screw appears to have been removed or salvaged and portions of the rudder assembly are still intact (Figure 9). Further midships from the stern section rests the remains of the boilers and the triple expansion engine (Figure 10).

Figure 7: Bow of *Raritan*.

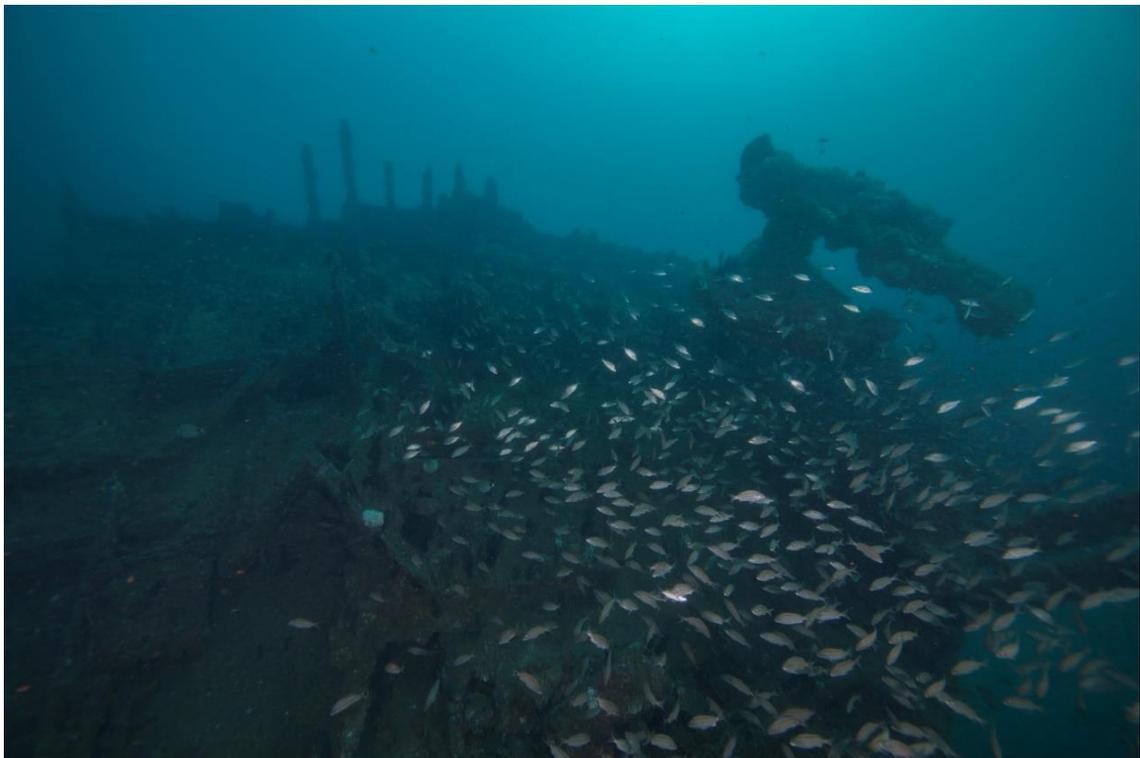
Figure 8: Steering mechanism at the stern of *Raritan*.

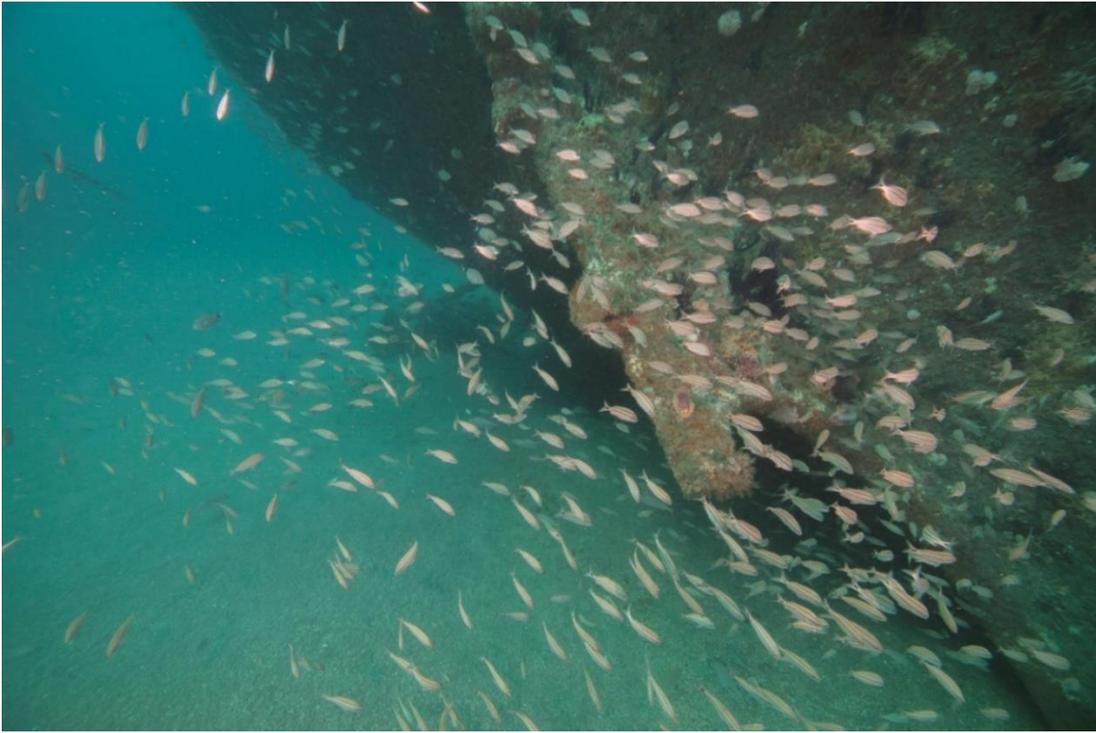
Figure 9: Rudder post at stern of *Raritan*.

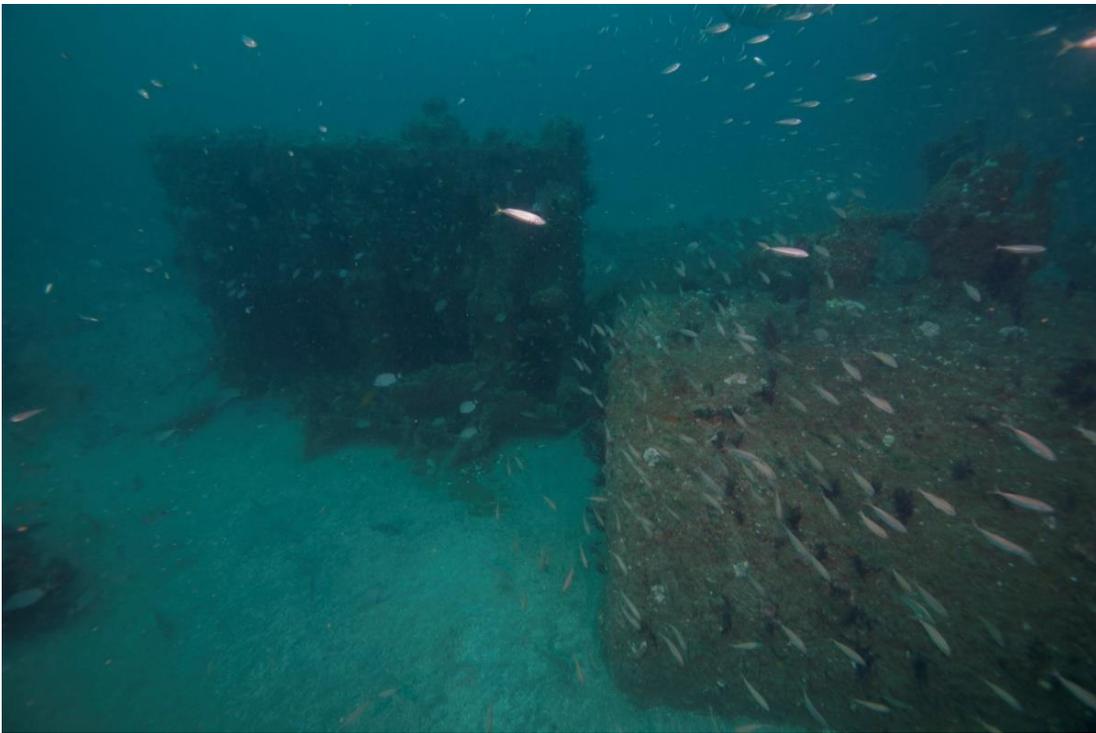
Figure 10: Triple expansion engine (visible in the background) and one of the boilers (visible in the foreground) of the *Raritan*.

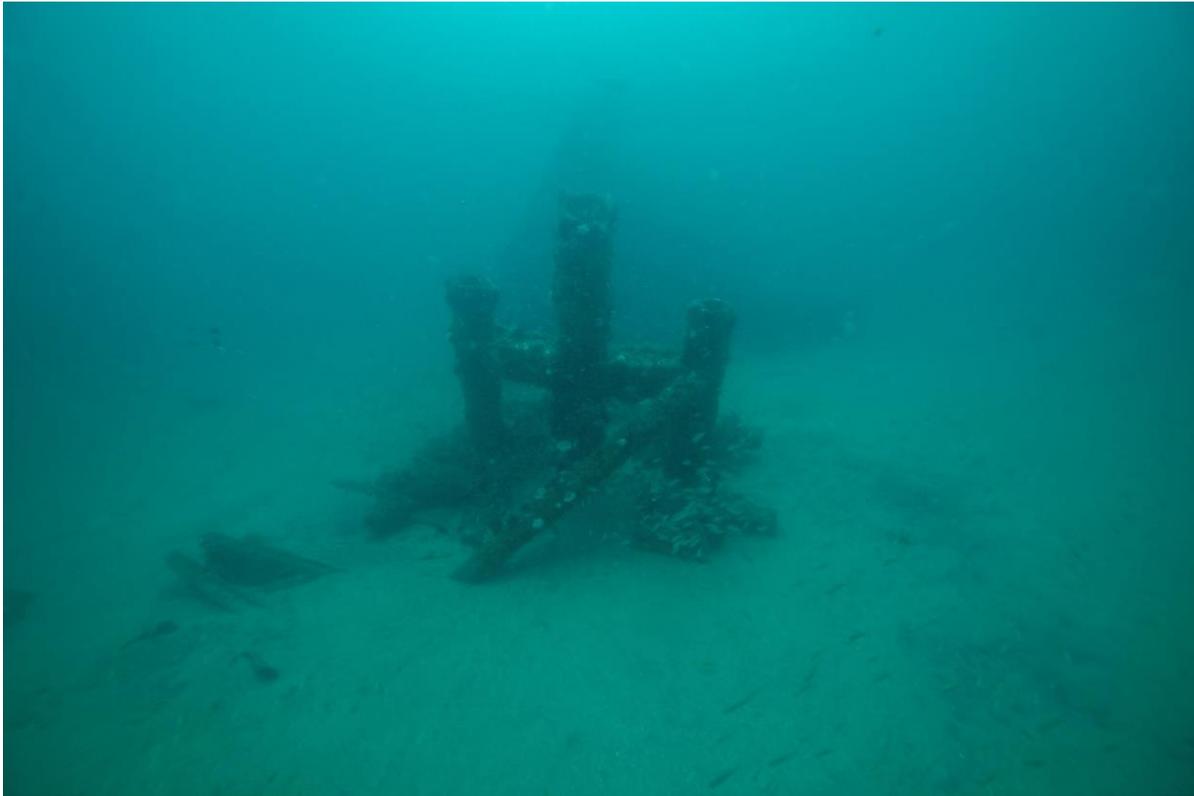
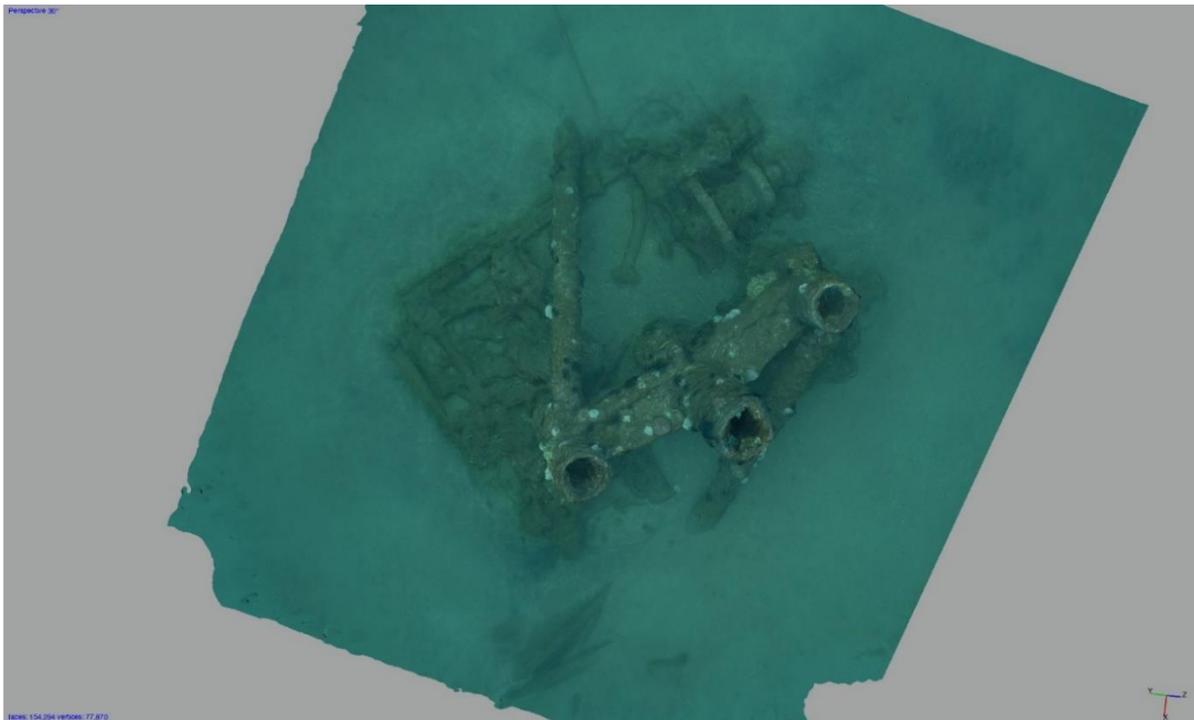
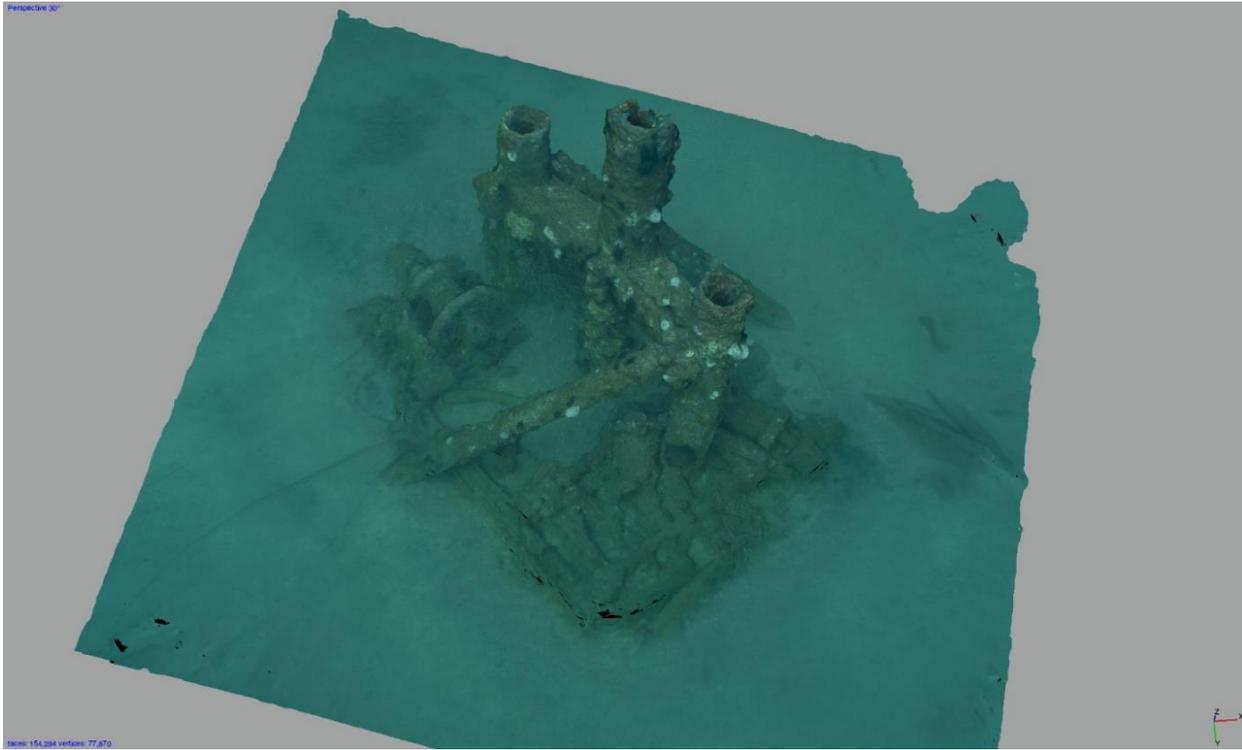
Adjacent to both the bow and stern sections are the remains of possible cargo winches or derrick booms on the main deck (Figure 11, Figure 12, and Figure 13). The remainder of the mid-section of the vessel appears to be missing or, possibly, covered by the sandy substrate. No evidence of the superstructure is visible and may have been removed during subsequent salvage or site clearing activities.

**Figure 11: Possible cargo winch feature of Raritan.**

**Figure 12: Plan view orthomosaic of cargo winch feature.**

**Figure 13: Oblique view orthomosaic of cargo winch feature.**

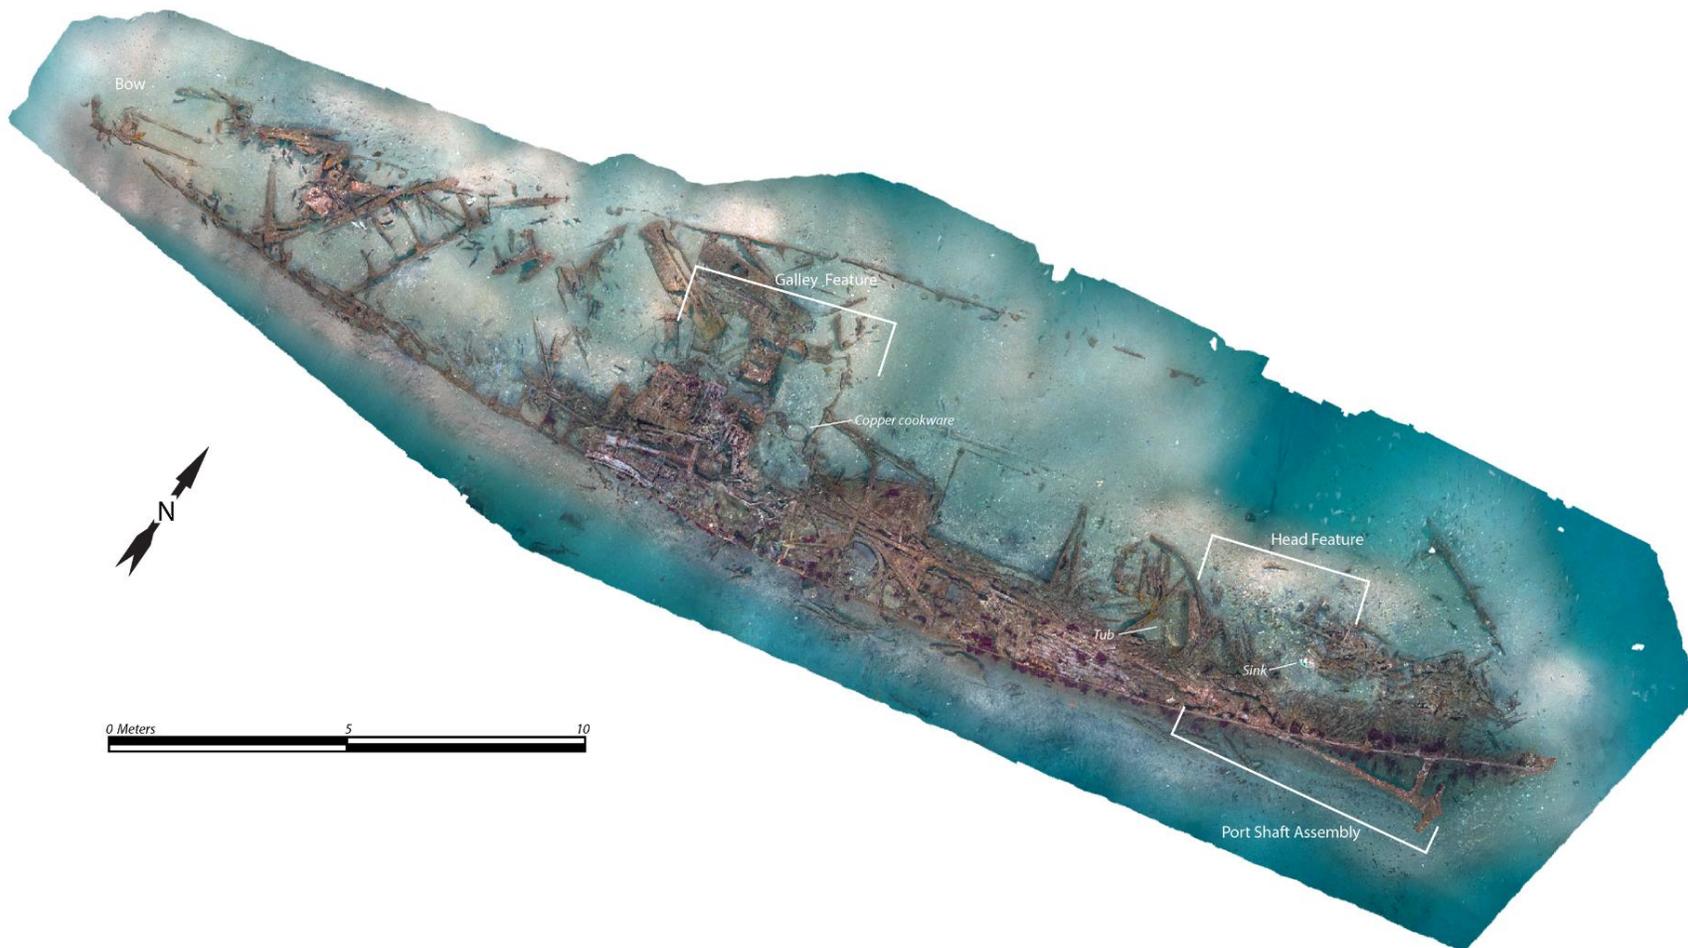
As visible in the photogrammetric model (Figure 15), the site consists of the intact lower portion of a metal-hulled, twin-screw vessel. The wreck is resting on its starboard side at approximately 45 degrees with the port propeller and shaft exposed (Figure 16 and Figure 17). The port side of the vessel exhibits up to 1 meter (3 feet) of relief, while the starboard side of the vessel appears to be buried below the sand (Figure 18). Based on measurements taken from the scaled photogrammetric model, the overall length of the vessel was determined as approximately 33.6 m (110.24 ft) with a beam of approximately 6.54 m (21.46 ft).

Figure 15: Orthomosaic site plan of site 6537K\_1.

Based on the size, hull characteristics, and visible artifact assemblage, this site likely represents the remains of an early twentieth century pleasure yacht. Compared to the UAB shipwreck database, no obvious candidates for the identity of this vessel were located based on the size, vessel type, and location. Additional research is recommended to ascertain the identity of the vessel.

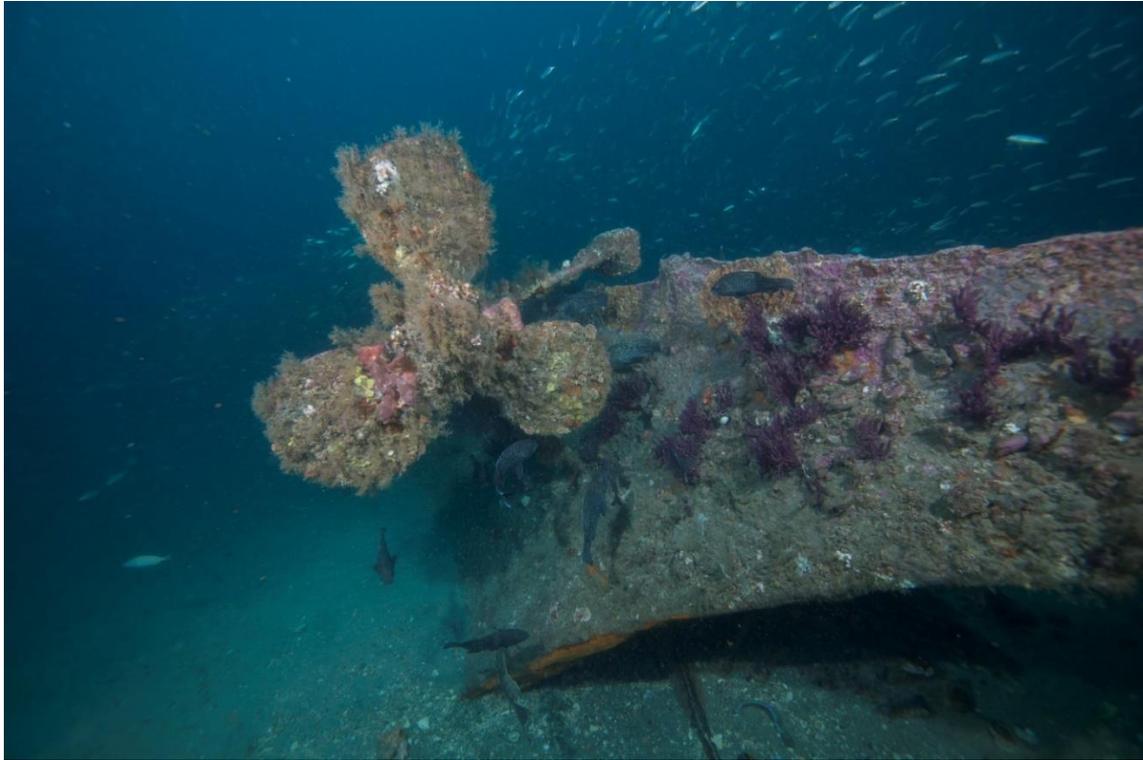
Figure 17: Port propeller and shaft of 6537K\_1.

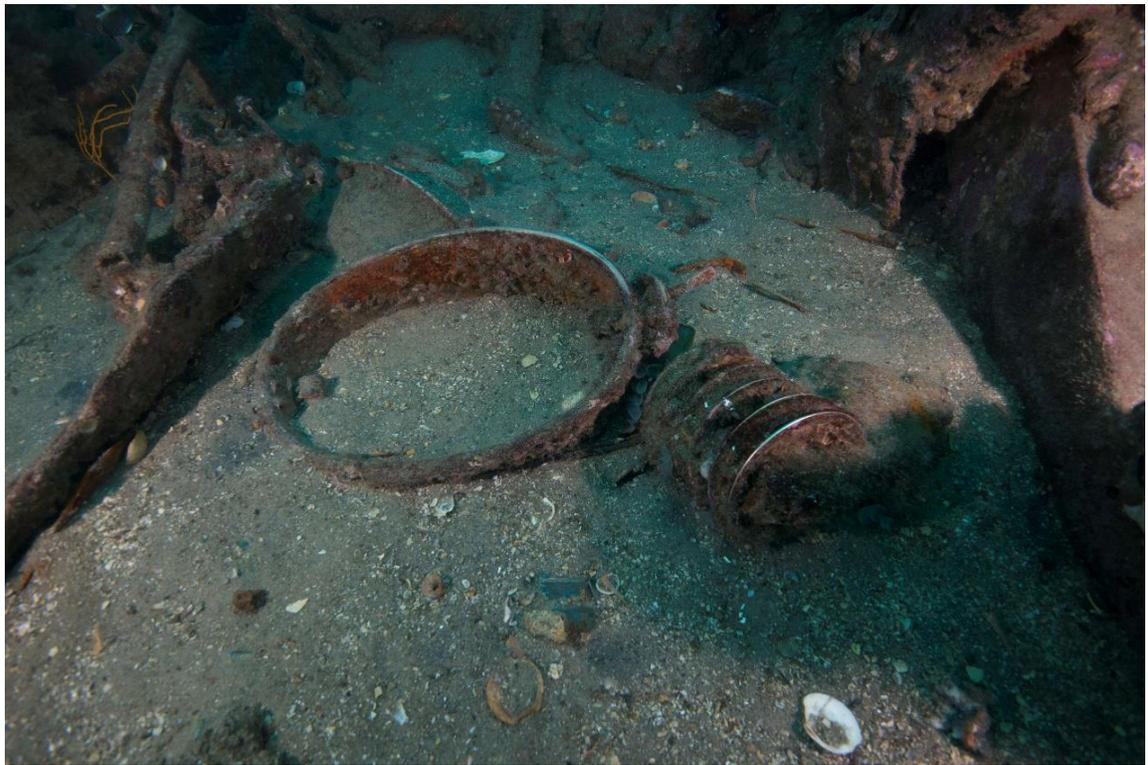
Figure 19: Copper cookware exposed at site of 6537K\_1.

The site has a high degree of integrity and does not appear to have been extensively disturbed or subjected to subsequent looting. Internal spaces of the lower hull are identifiable including the presence of a galley towards the bow, as evidenced by stacked copper cooking pots and white earthenware plates (Figure 19 and Figure 20), and a head toward the stern, as evidenced by a white granite sink and tub (Figure 21 and Figure 22). The propeller shaft is visible extending through the hull to an area of machinery debris and stack of nickel iron or Edison-style batteries (Figure 23).

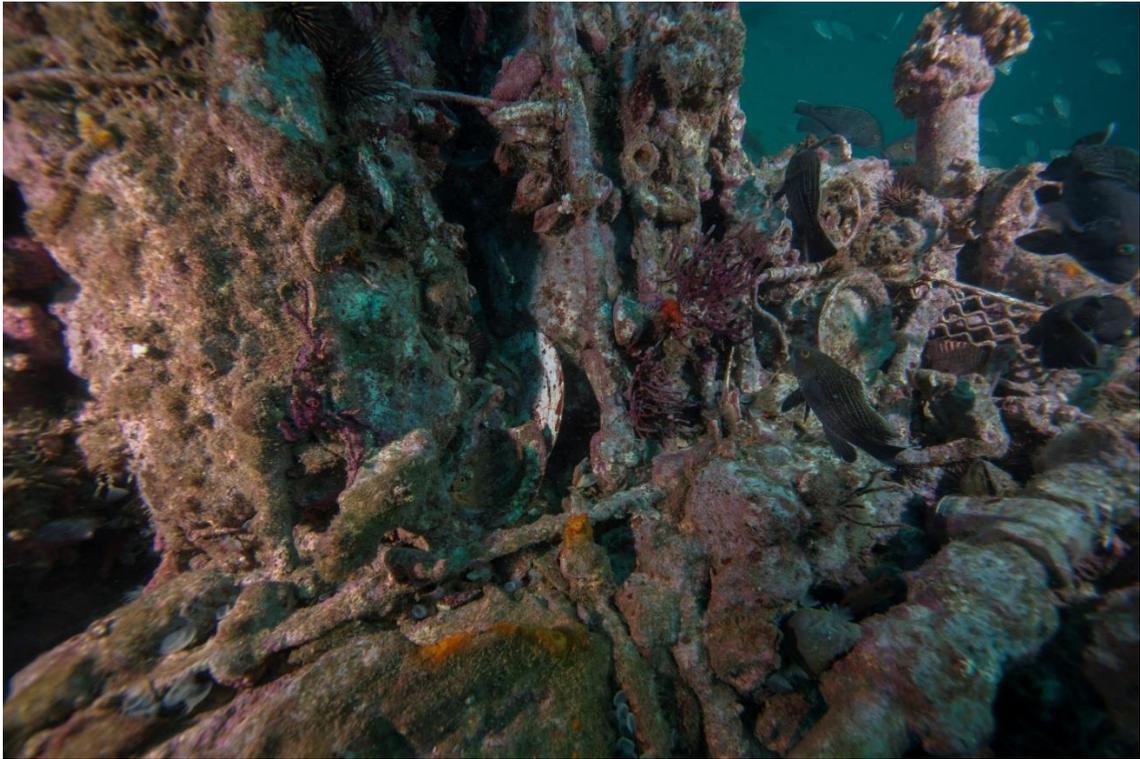
**Figure 20: White earthenware plate within engine machinery remains at site of 6537K\_1.**

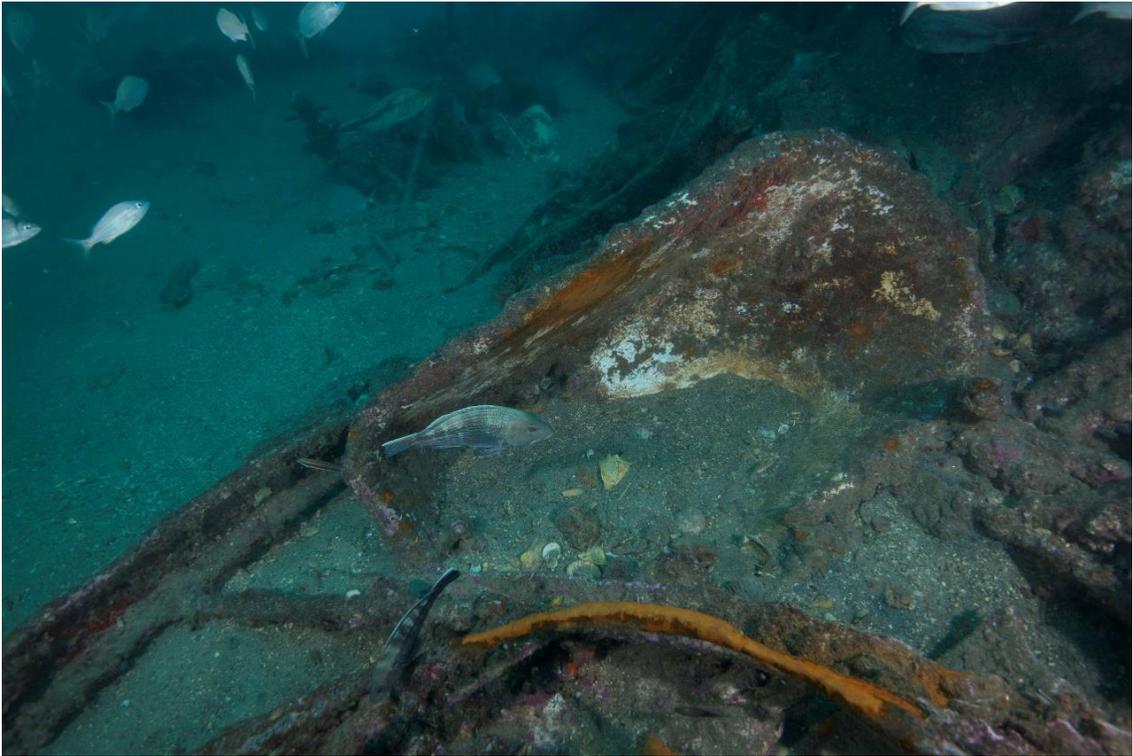
Figure 22: Exposed ceramic tub at site of 6537K\_1.

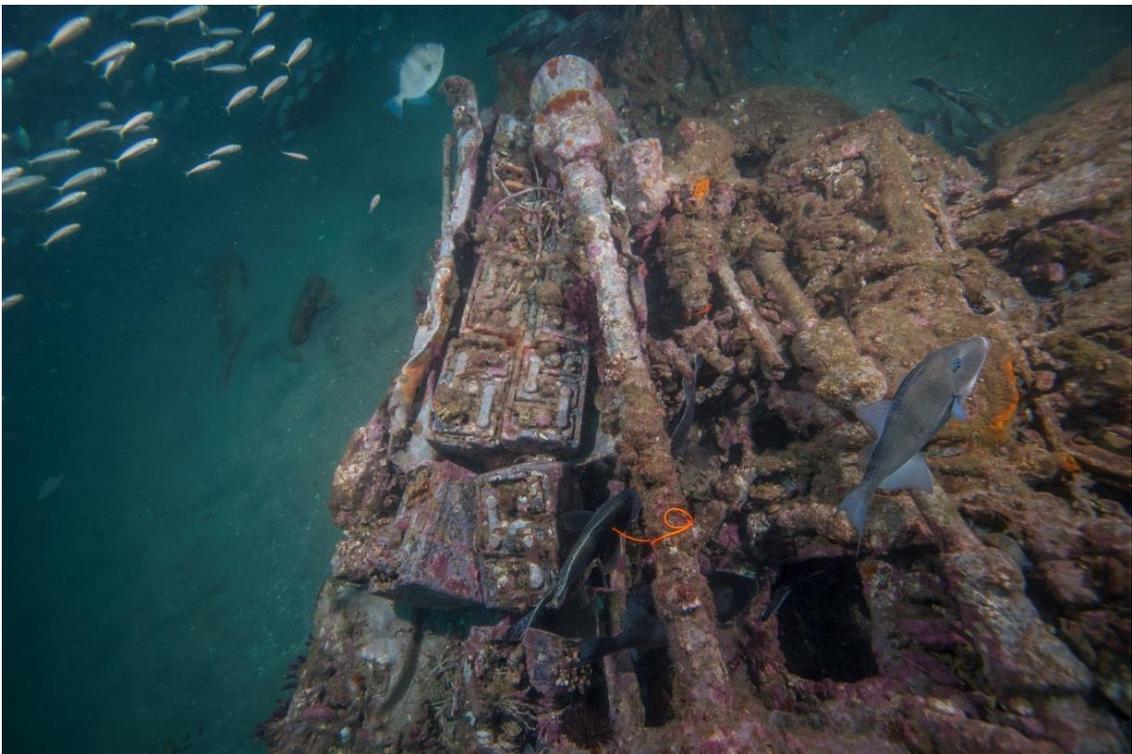
Figure 23: Batteries located on port side of site of 6537K\_1.

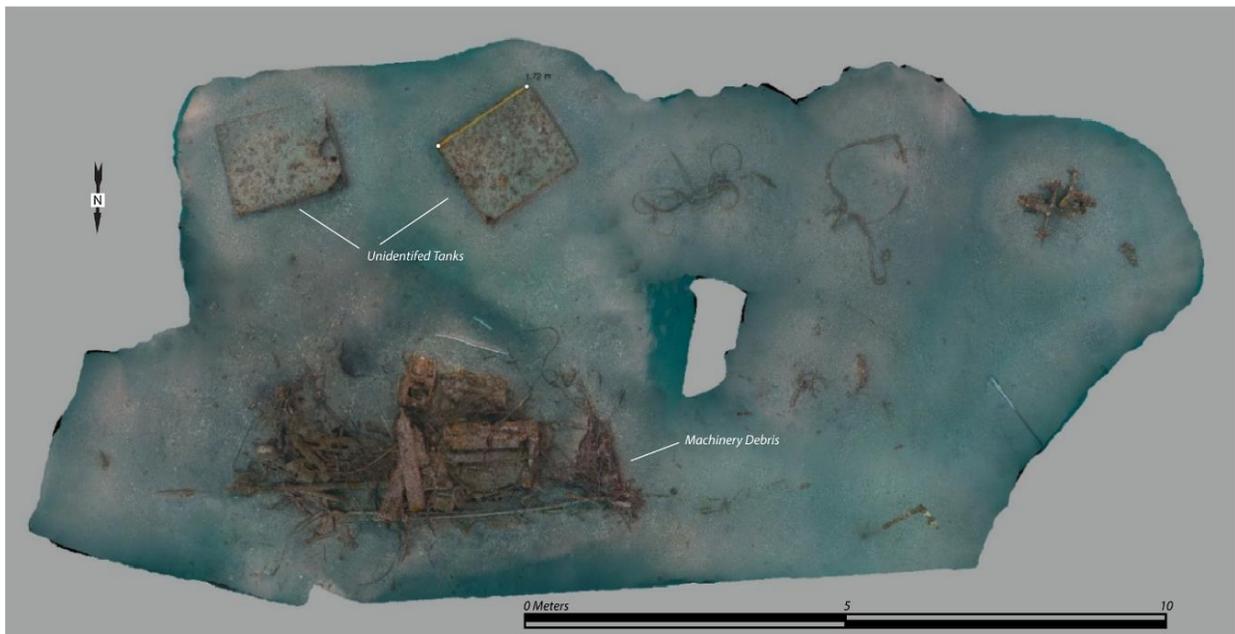
The site was investigated on July 27, 2017 with two dive rotations completed. Located at a depth of 30 m (100 ft), the site consists of a scatter of visible surface features. During the dive rotations, a photogrammetric model of the site was completed (Figure 24). No visible remains of the vessel's hull were observed, and the site debris extends over an area 17.1 m (56.1 ft) east to west by 8.18 m (26.83 ft) along a north to south axis. Multibeam echosounder survey in the area, completed in 2013 from NOAA ship *Ferdinand R. Hassler*, may also indicate that additional site features are located to the north and east of the main debris area mapped during the 2017 investigation (Figure 25). The site has generally low relief with the largest feature of engine debris standing approximately 1 m (3 ft) above the seafloor (Figure 26). As visible in the photogrammetric model, the prominent features of the site include two rectangular tanks, possibly fuel or water tanks, measuring 1.72 m (5.64 ft) in length, and an area of engine or other machinery debris extending approximately 7 m (22.9 ft) in length (Figure 27). Modern marine-grade electrical wiring or hose is visible within the engine debris indicating that the wreck likely represents a recent loss (Figure 28).

Figure 24: Orthomosaic site plan of *Lady Margaret*.

Additional investigation is recommended to confirm if the site identified is conclusively that of *Lady Margaret*. A historical background and brief account of the wrecking event of *Lady Margaret* is provided in support of future research. This narrative is based on first-person accounts from Gary Schaible and Dan Jackman (2019, pers. comm.), who served as crew members on the last cruise of the vessel; Jack Schockemoehl (2019, pers. comm.), USCG pilot who served as Second Officer on the C-130 involved in the rescue effort; and Thomas Ochiltree, a Panax Newspapers correspondent and passenger on the last cruise who published a firsthand account in *Seapower Magazine* (Ochiltree 1977). Scott Schaible, son of Gary Schaible, additionally produced the short documentary film *The Lady Margaret, The Last Voyage* (Schaible 2016), which was based on interviews with the surviving crew members.

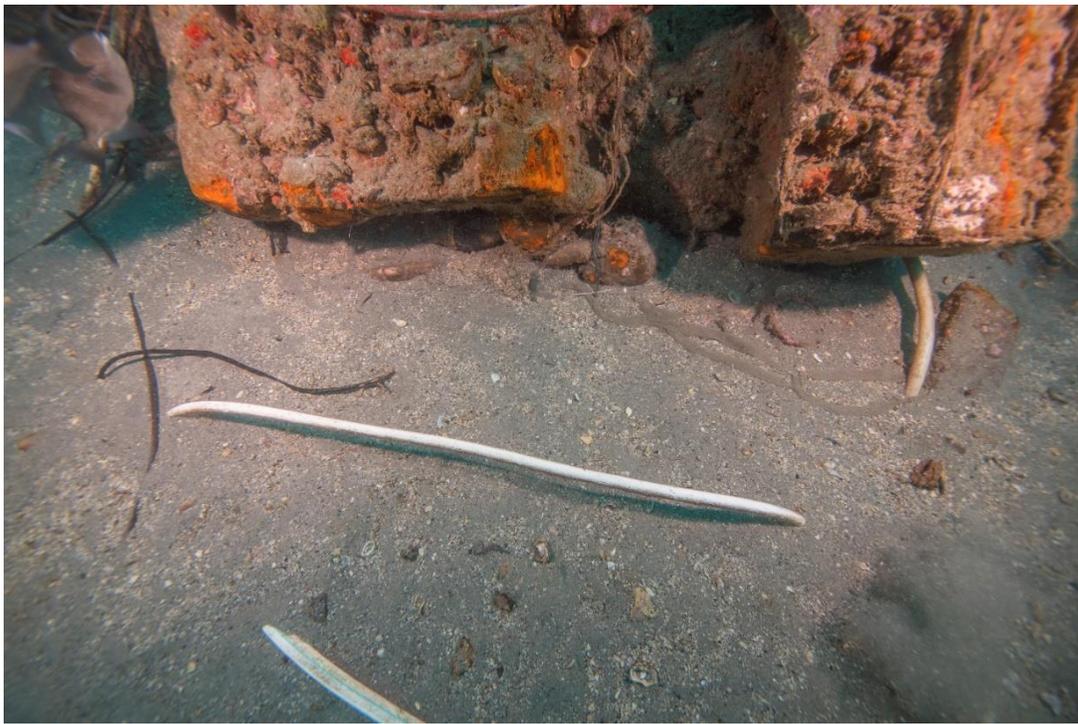
**Figure 28: Marine-grade hose or wiring within machinery debris at *Lady Margaret* site.**

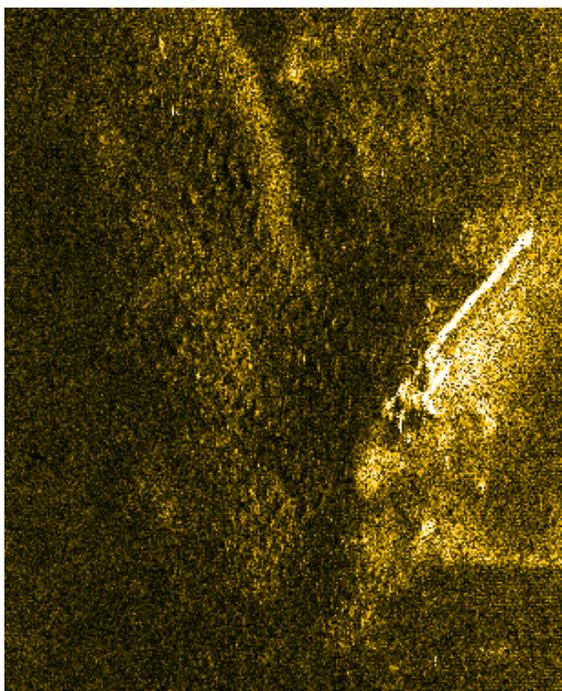
(Figure 30) and side scan sonar image (Figure 31), the site is generally intact and with the bow oriented towards the southwest. The site measures an overall length of 169.30 feet (51.60 m) and 23.90 feet (7.30 m) at beam with approximately 10 feet (3 m) of relief.

**Figure 31: Side scan imagery of the “Known Wreck” site.**

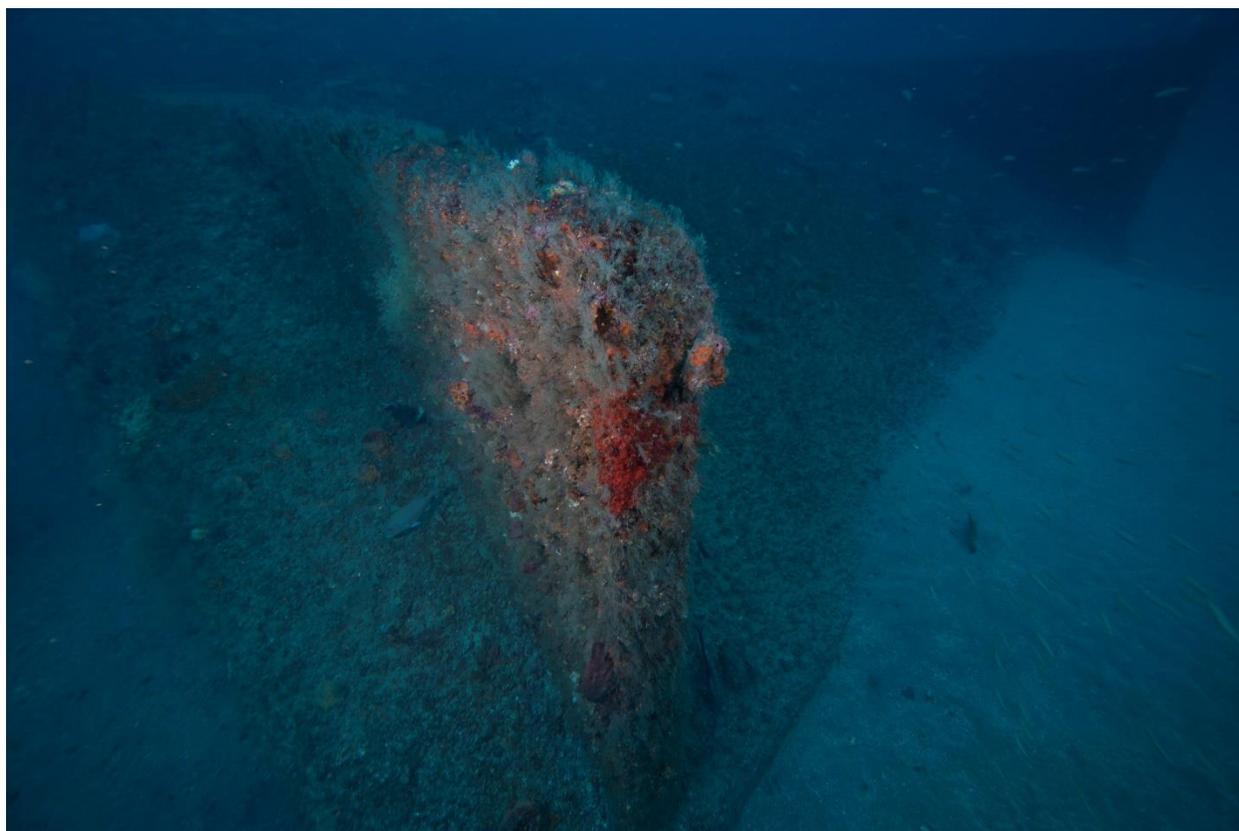
There are two skegs identifiable at the stern (Figure 32), which is rounded, but evolves into a flat bottom. Framing features were visible through open holes of the deteriorated hull (Figure 33). Toward the bow, which was broken and incomplete, interior cargo spaces are visible. No engine or machinery equipment were located on the site, further identifying the remains as a barge, of similar layout to a modern example, as illustrated in Figure 34.

**Figure 32: Starboard skag of “Known Wreck” site; barge is upside down.**

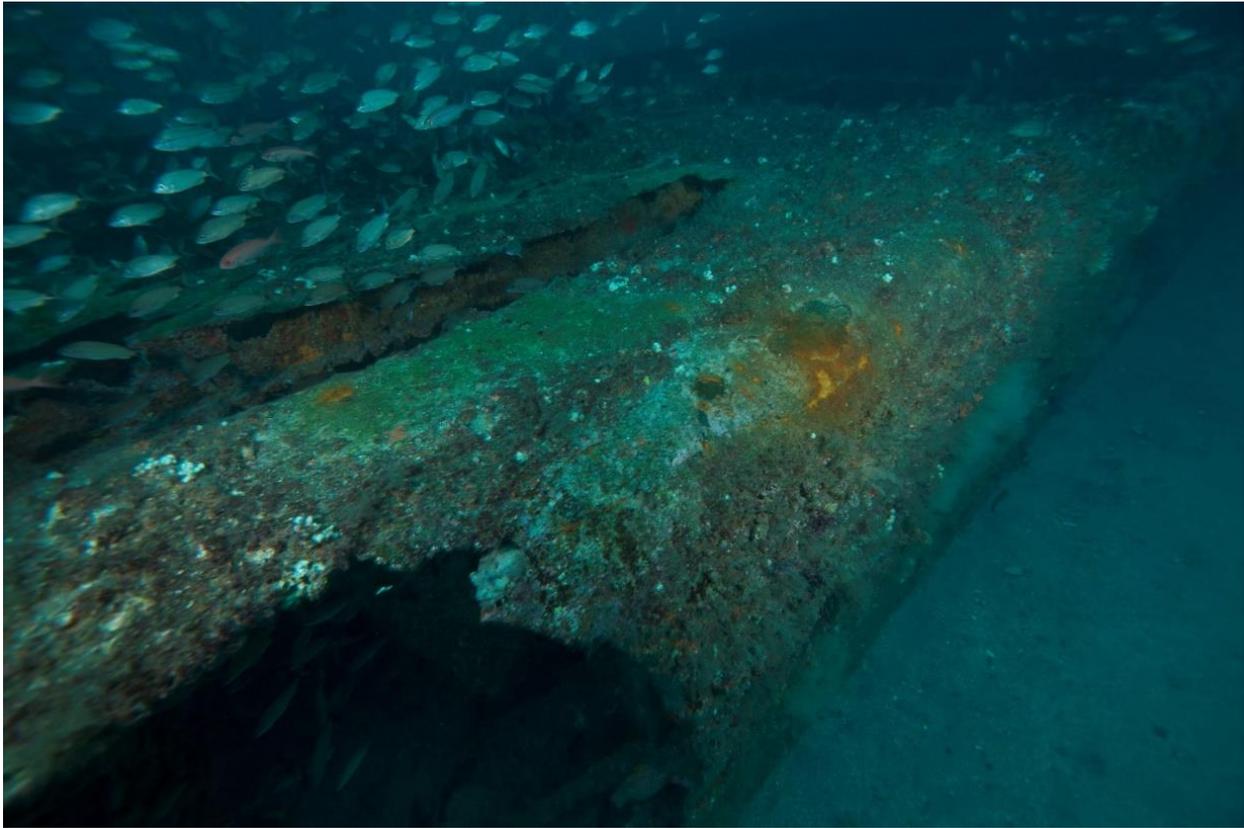
Figure 33: Outer hull and exposed framing of “Known Wreck” site.

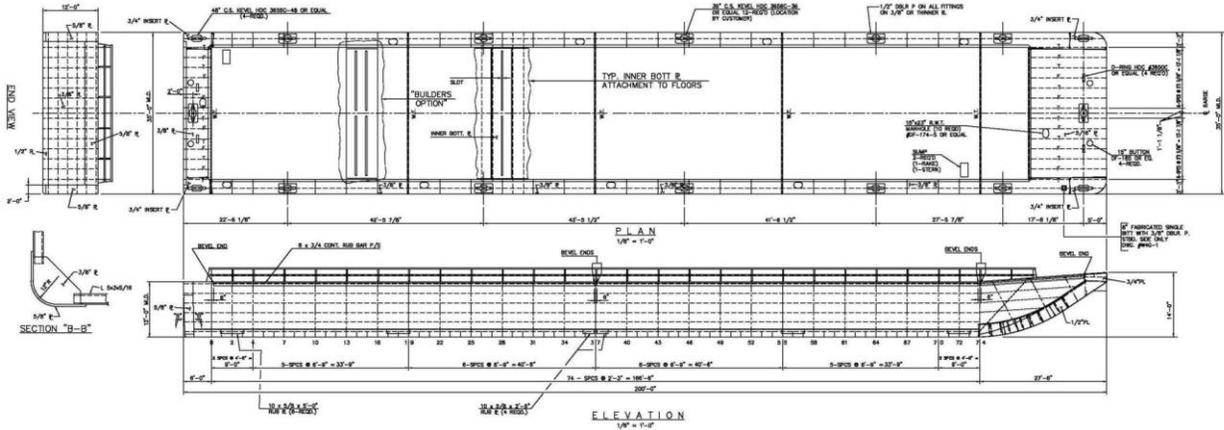
Figure 34: Plans for a 200-foot barge with similar hull shape to the “Known Wreck” site. Image courtesy of Trinity Marine Products, Inc.

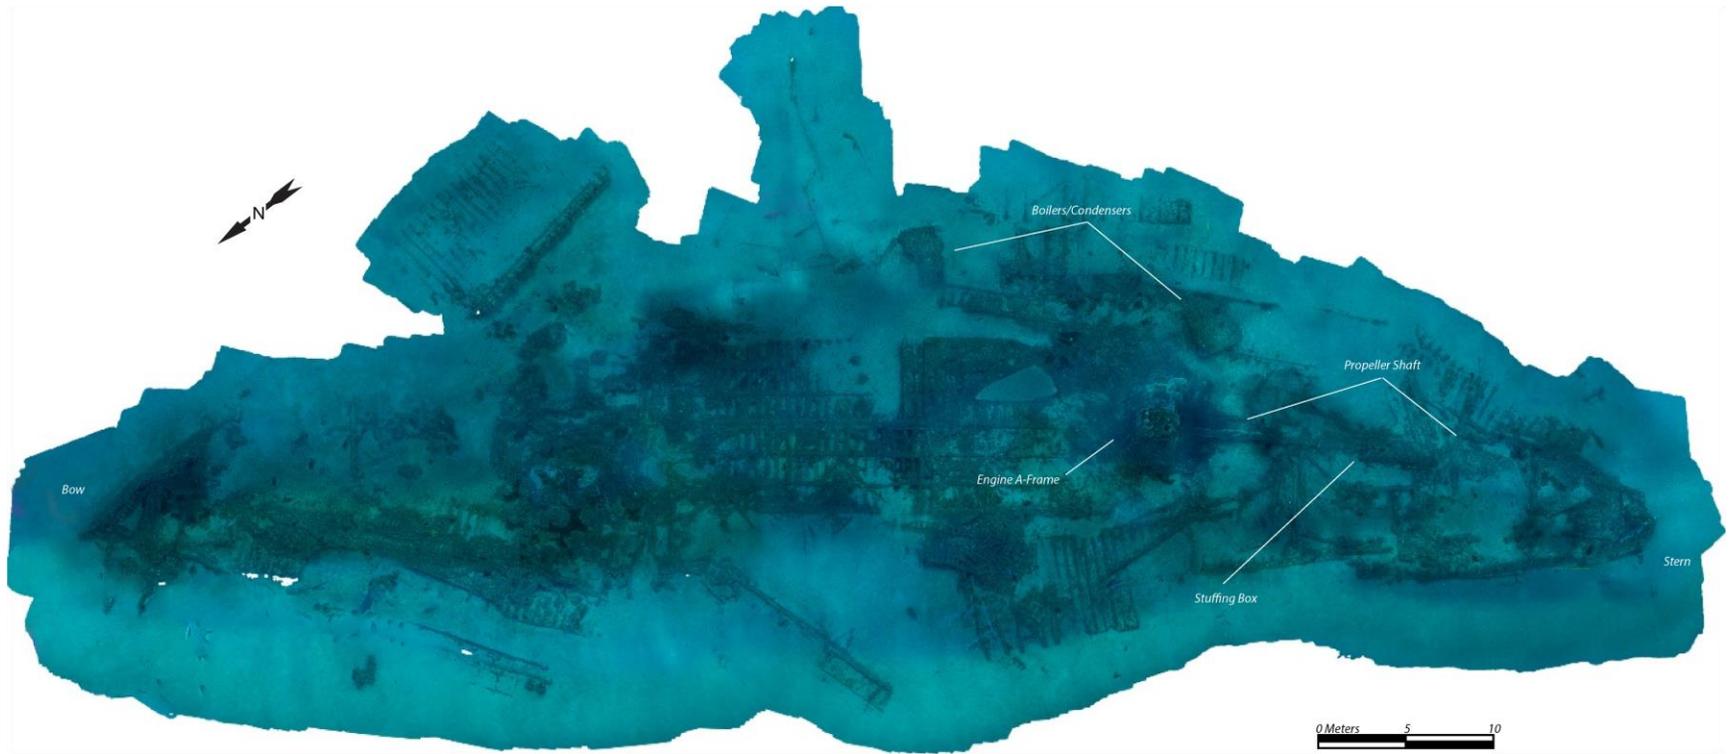
Four dive rotations and a photogrammetric model of the site were completed on August 2, 2017, (Figure 36). Located at a depth of approximately 30 m (100 ft), remains of the vessel were spread in a debris field of low relief over an area extending approximately 93.5 m (306.7 ft) by 41 m (134.5 ft), with the exception of the steam engine A-frame, which was the most dominant site feature rising approximately 7.6 m (25 ft) above the seafloor (Figure 37). The site was oriented along a northeast to southwest axis, with the bow

facing toward the northeast. Based on measurements taken from the scaled photomodel, the overall length of the vessel was determined as approximately 293.30 ft (89.40 m) in length with a beam of 31.46 ft (9.59 m) measured from the turn of the bilge. Other exposed features associated with steam engine include boilers (Figure 38) and a stuffing box assembly housing the shaft extending from the A-frame to the vessel's propeller (Figure 39). Throughout the midships section, lower portions of the hull were partially intact with articulated sections of the keelson and framing visible (Figure 40 and Figure 41). The upper sections of the hull framing had collapsed to the exterior creating the surrounding debris field. At the stern, the remains of a rudder post were visible (Figure 42).

Figure 36: Orthomosaic site plan of *City of Houston*.

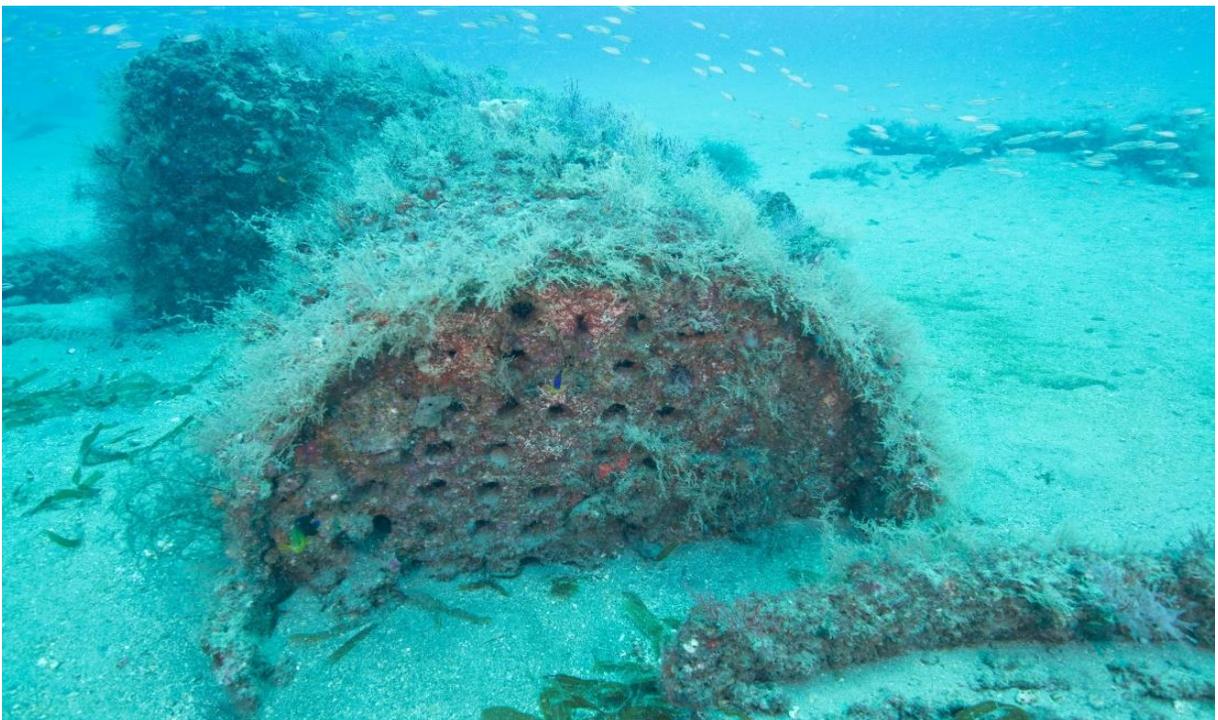
Figure 38: Exposed boilers of *City of Houston*.
