# North Carolina Collaborative Archaeological Survey: Wilmington East and West Wind Energy Areas

February 2020

Prepared collaboratively under Interagency Agreement M15PG00003

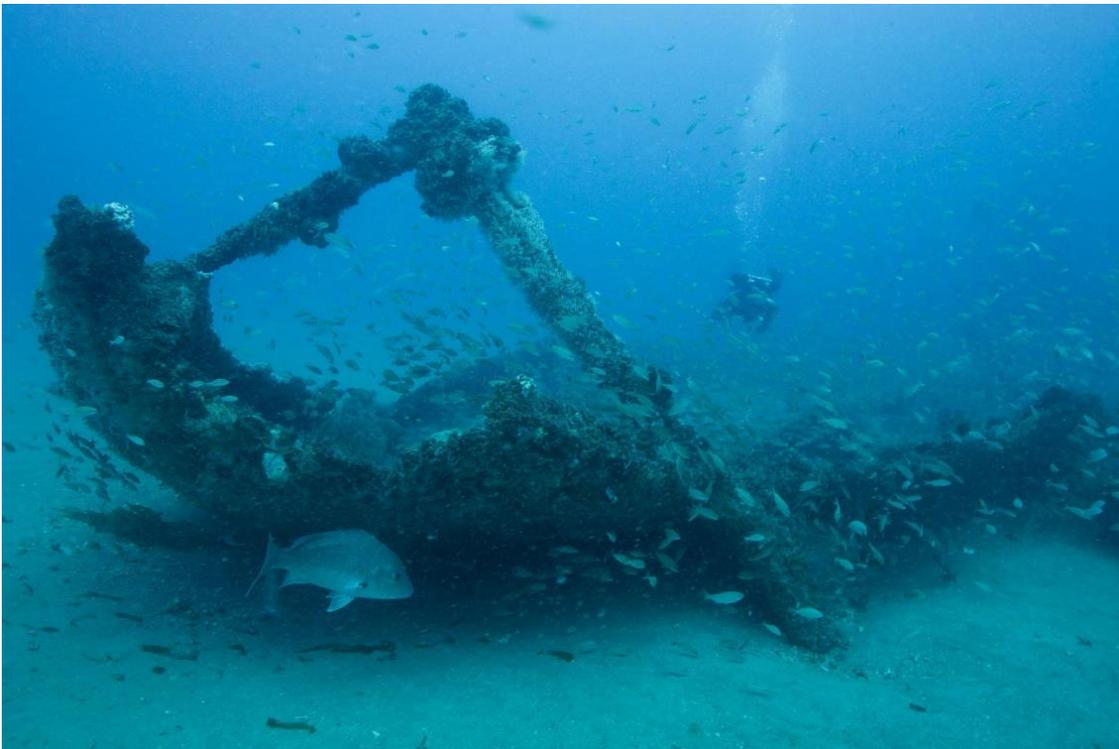
facing toward the northeast. Based on measurements taken from the scaled photomodel, the overall length of the vessel was determined as approximately 293.30 ft (89.40 m) in length with a beam of 31.46 ft (9.59 m) measured from the turn of the bilge. Other exposed features associated with steam engine include boilers (Figure 38) and a stuffing box assembly housing the shaft extending from the A-frame to the vessel's propeller (Figure 39). Throughout the midships section, lower portions of the hull were partially intact with articulated sections of the keelson and framing visible (Figure 40 and Figure 41). The upper sections of the hull framing had collapsed to the exterior creating the surrounding debris field. At the stern, the remains of a rudder post were visible (Figure 42).

Figure 42: Stern section of *City of Houston* with potential rudder post remains.

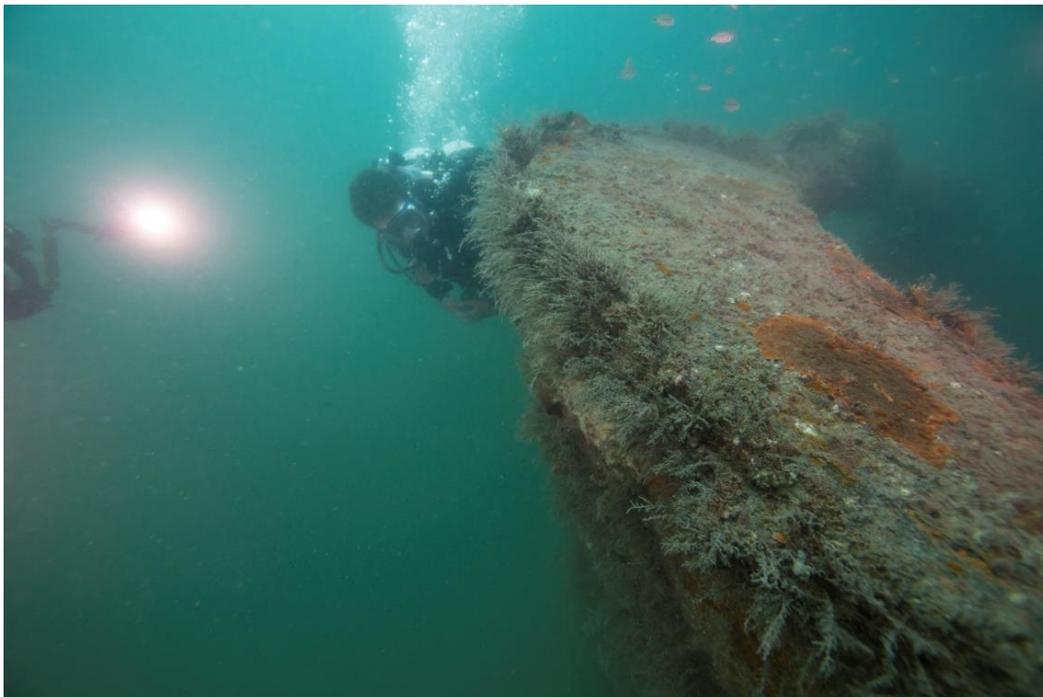
Figure 43: Diver inspecting the remains of purposely sunk modern fishing vessel *Jell II*.

*Jell II* is reported as part of the North Carolina Artificial Reef program. Located within Artificial Reef-445, known as the Dale McDowell Reef, *Jell II* is a 174-ft (53.03-m) vessel purposely sunk at the reef in 1991 along with other steel and fiberglass boat molds (Comer and Love-Adrick 2016). Subsequent additions to the area surrounding the artificial reef include concrete pipe, reef balls, and the purposely sunk 55-ft (16.7-m) tug, *Admiral Charlie*. One dive rotation was completed at *Jell II* on July 27, 2017 confirming the site’s location, which was reported to the North Carolina Artificial Reef Program (Figure 43). The site is located at a depth of approximately 18 m (60 ft).

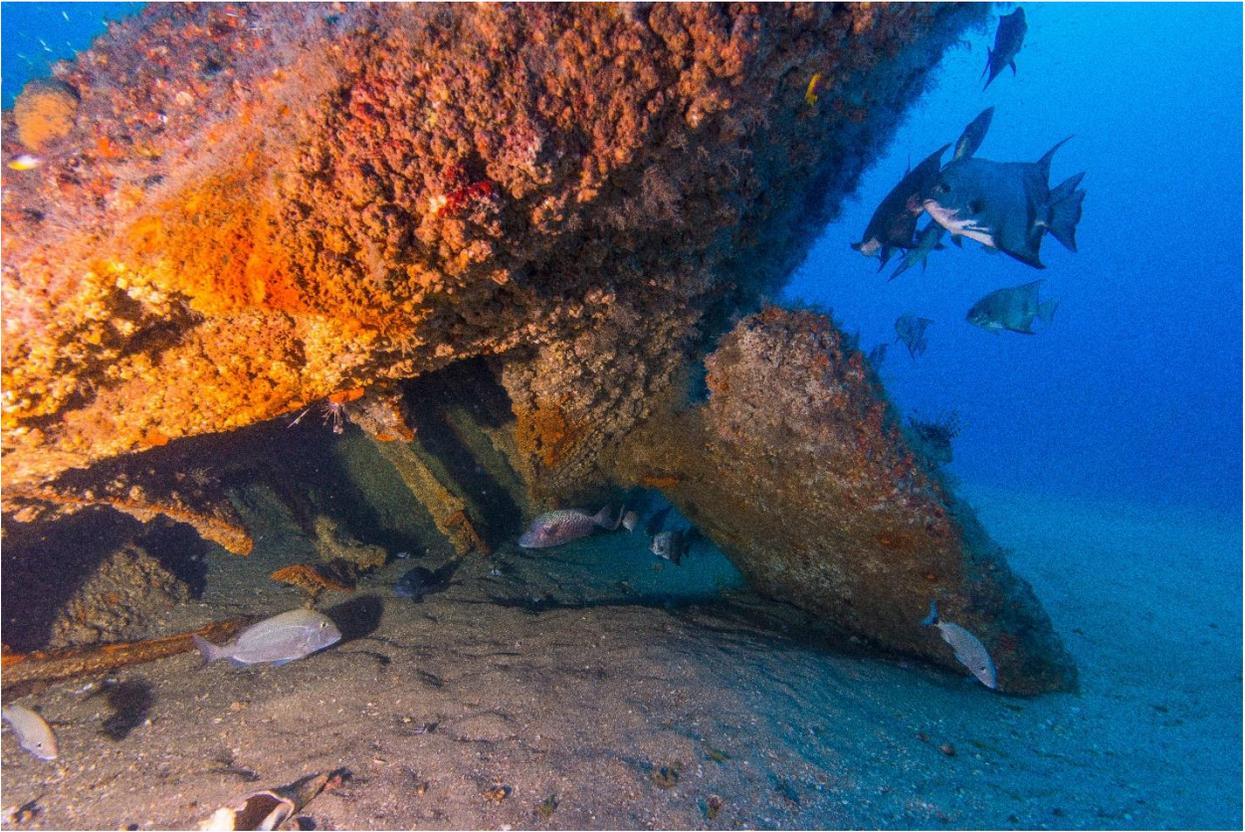
Figure 46: Stern of 27.162-meter Wreck.

As visible in the multibeam imagery (Figure 44), the site consisted of a contiguous wreck approximately 33 m (110 ft) in length resting at a depth of approximately 27 m (89 ft) and surrounded by a shallow scour depression. The site was oriented roughly along a northwest to southeast axis, with the bow toward the northwest. Based on the in-water investigation, the site consisted of the intact remains of a metal-hulled vessel resting on its port side, listing at approximately 45 degrees (Figure 45). The hull was generally intact up to the gunwale and exposed with only a portion of the keel and screw assembly buried in the sandy substrate (Figure 46). The stern had a distinctive fantail shape while the bow is vertical and topped with a vertical stem post. The cabin, wheelhouse, and any other above-deck superstructure were no longer extant. No debris field or other exposed features were observed surrounding the site.

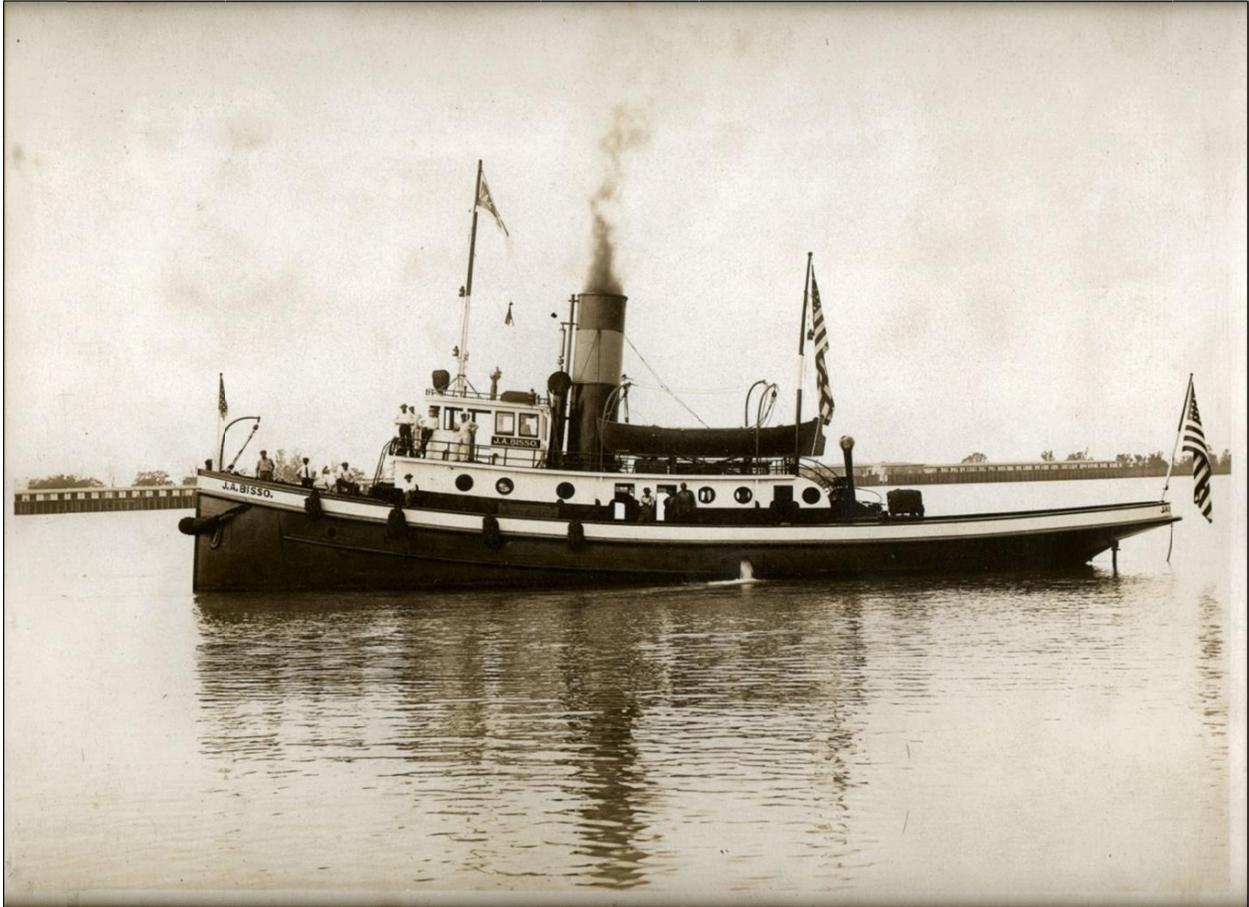
A comparative vessel with similar hull shape and deck configuration is *J.A. Bisso*, a steam, screw-propelled tugboat built in 1906 in Quebec (Figure 48) (US Treasury Department 1954). *J.A. Bisso* was lost during rough weather in 1957 in transit from Sabine, Texas to New Orleans, Louisiana, and the site was investigated and documented under a 2010 BOEM study (Evans et al. 2013). In particular, the distinctive deck-mounted stern steering quadrant, as seen on the *J.A. Bisso* site plan (Figure 49), appears to be a typical feature of tugs of the early twentieth century (Caldwell 1946; Evans et al. 2013:175).

**Figure 48: Undated photograph of *J.A. Bisso*. Courtesy of William “Cappy” Bisso and published in Evans et al. (2013).**
