LONDON ARRAY WINDFARM

EXPORT CABLE ROUTE POST-CONSTRUCTION SURVEY

MOBILISATION AND OPERATIONS REPORT

FINAL - REV1

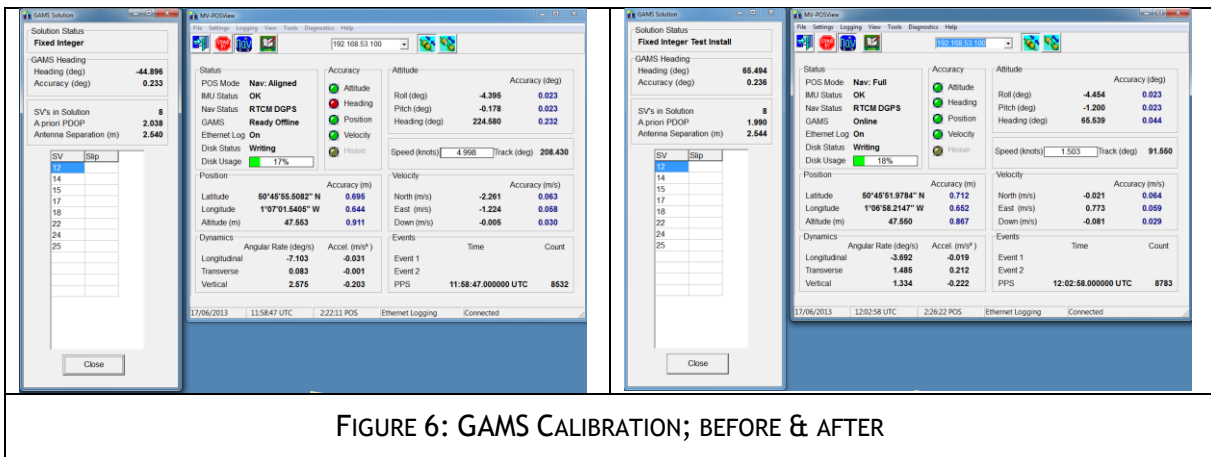
FIGURE 6: GAMS CALIBRATION; BEFORE & AFTER

The GPS Azimuth Measurement System (GAMS) calibration was performed on 17th June 2013 in accordance with manufacturer guidelines. During the GAMS calibration only the offsets of the primary (port) antenna were input into POSView 7.41. The vessel was manoeuvred through a series of tight turns / figure-of-eights until the heading accuracy reduced below the desired accuracy threshold. The vessel was then maintained on a constant heading whilst the automated calibration protocol cycled through to completion.

Once the GAMS solution was complete, the GAMS-computed baseline was compared to the results of the RFS. The GAMS- and RFS-calculated baselines agreed to within 4 decimal places (2.5361m). The GAMS calibration was, therefore, accepted and saved to the configuration file.

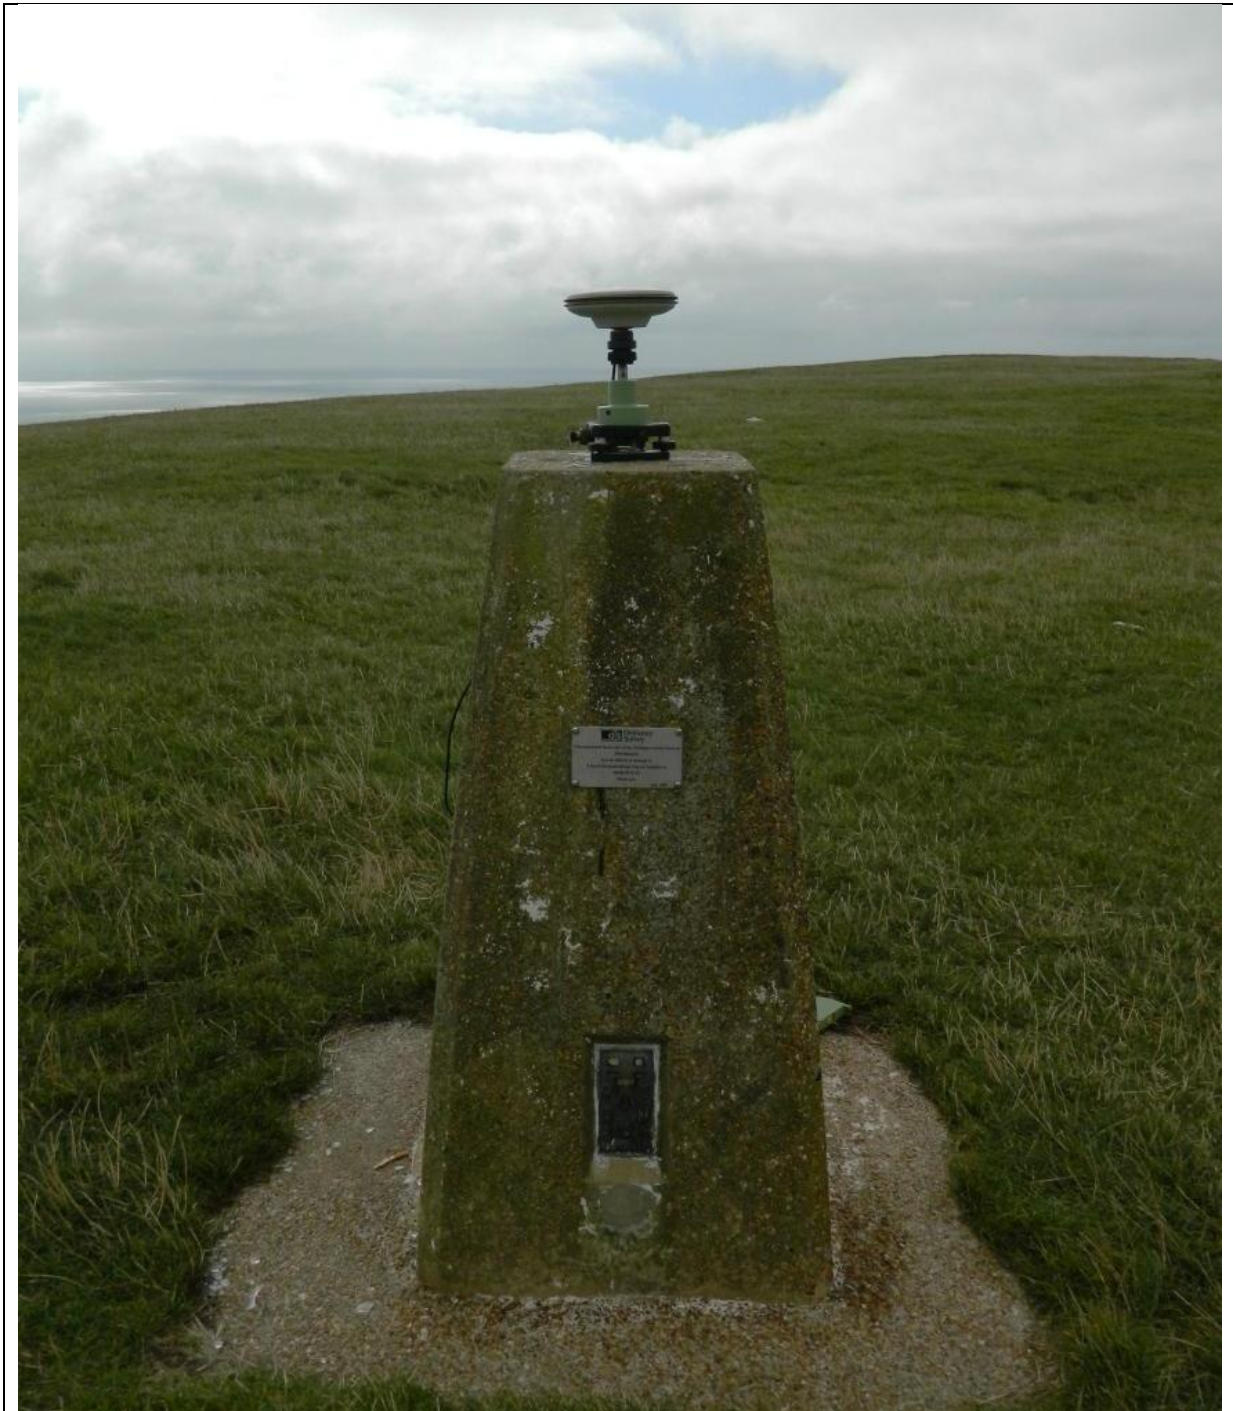
FIGURE 9: BEACHY HEAD PASSIVE STATION (C1TV5995) STATIC VERIFICATION

On the 28/06/13 the Leica 1200 (with SmarNet) was placed over the Beachy Head Ordnance Survey Passive Station (station number C1TV5995; Appendix B) and data were logged at 1Hz for 30 minutes. Data were acquired in OSGB36/ODN coordinates in order to perform a direct comparison with the established coordinates of the control point.

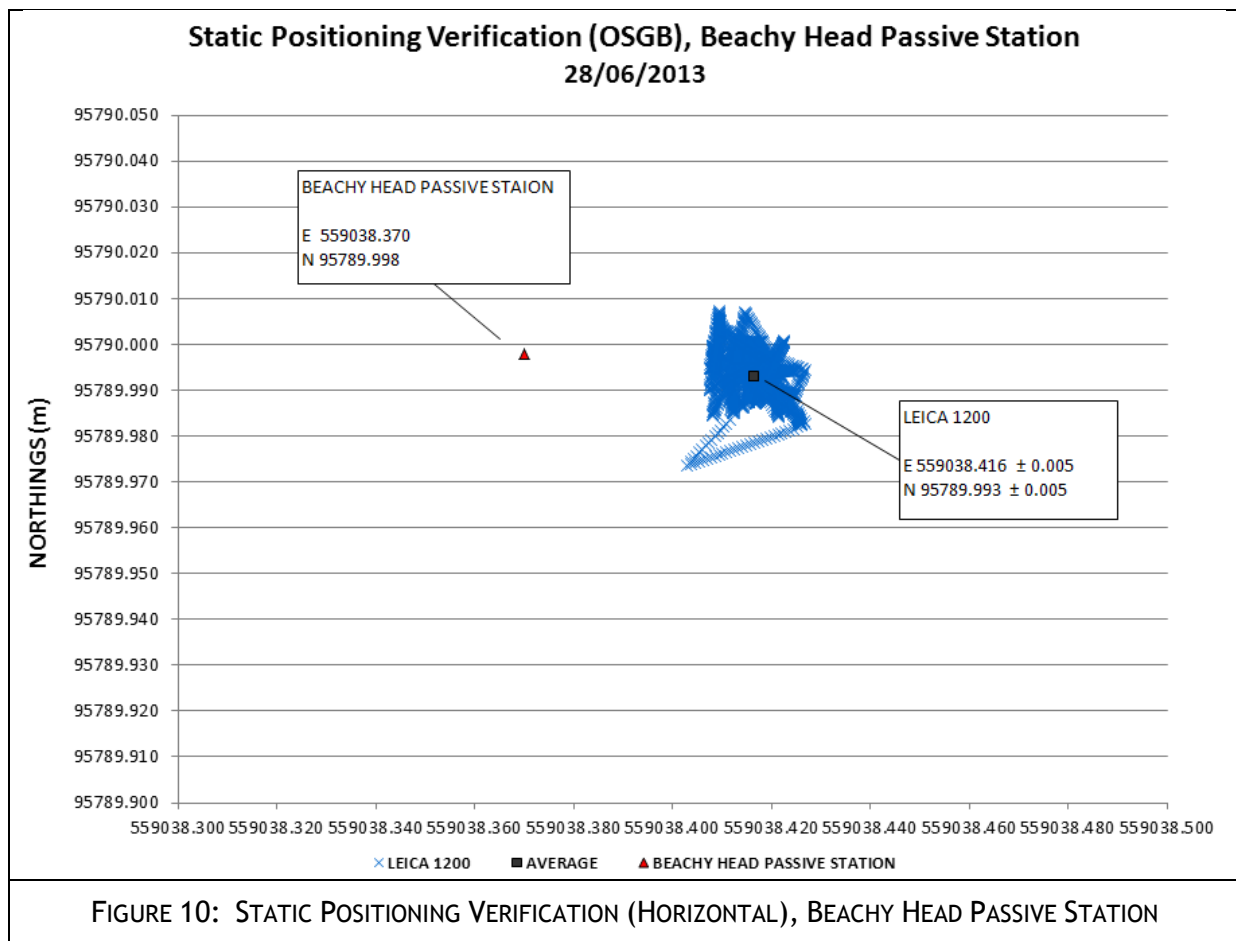
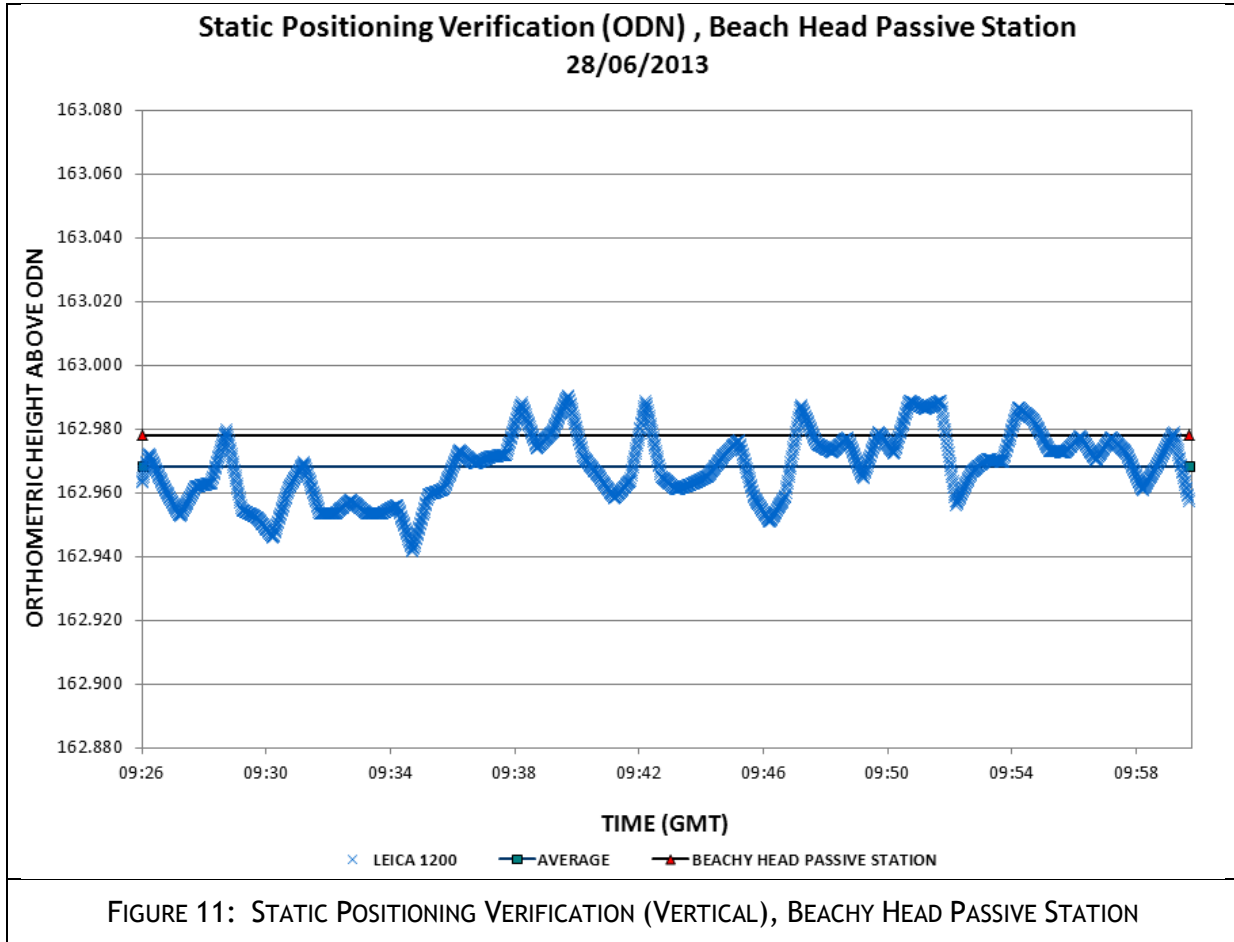
The Leica observations were subsequently plotted (Figure 10 and Figure 11) and average values compared with the position of Beachy Head Passive Station, established by the Ordnance Survey (Table 12).

The average difference between the OS surveyed position of Beachy Head Passive Station and the logged data was -0.046m in the Easting, 0.005m in the Northing and 0.010m in the vertical. The Leica 1200 (with SmartNet) was then used to survey Sovereign Harbour cill, as described in section 5.5.

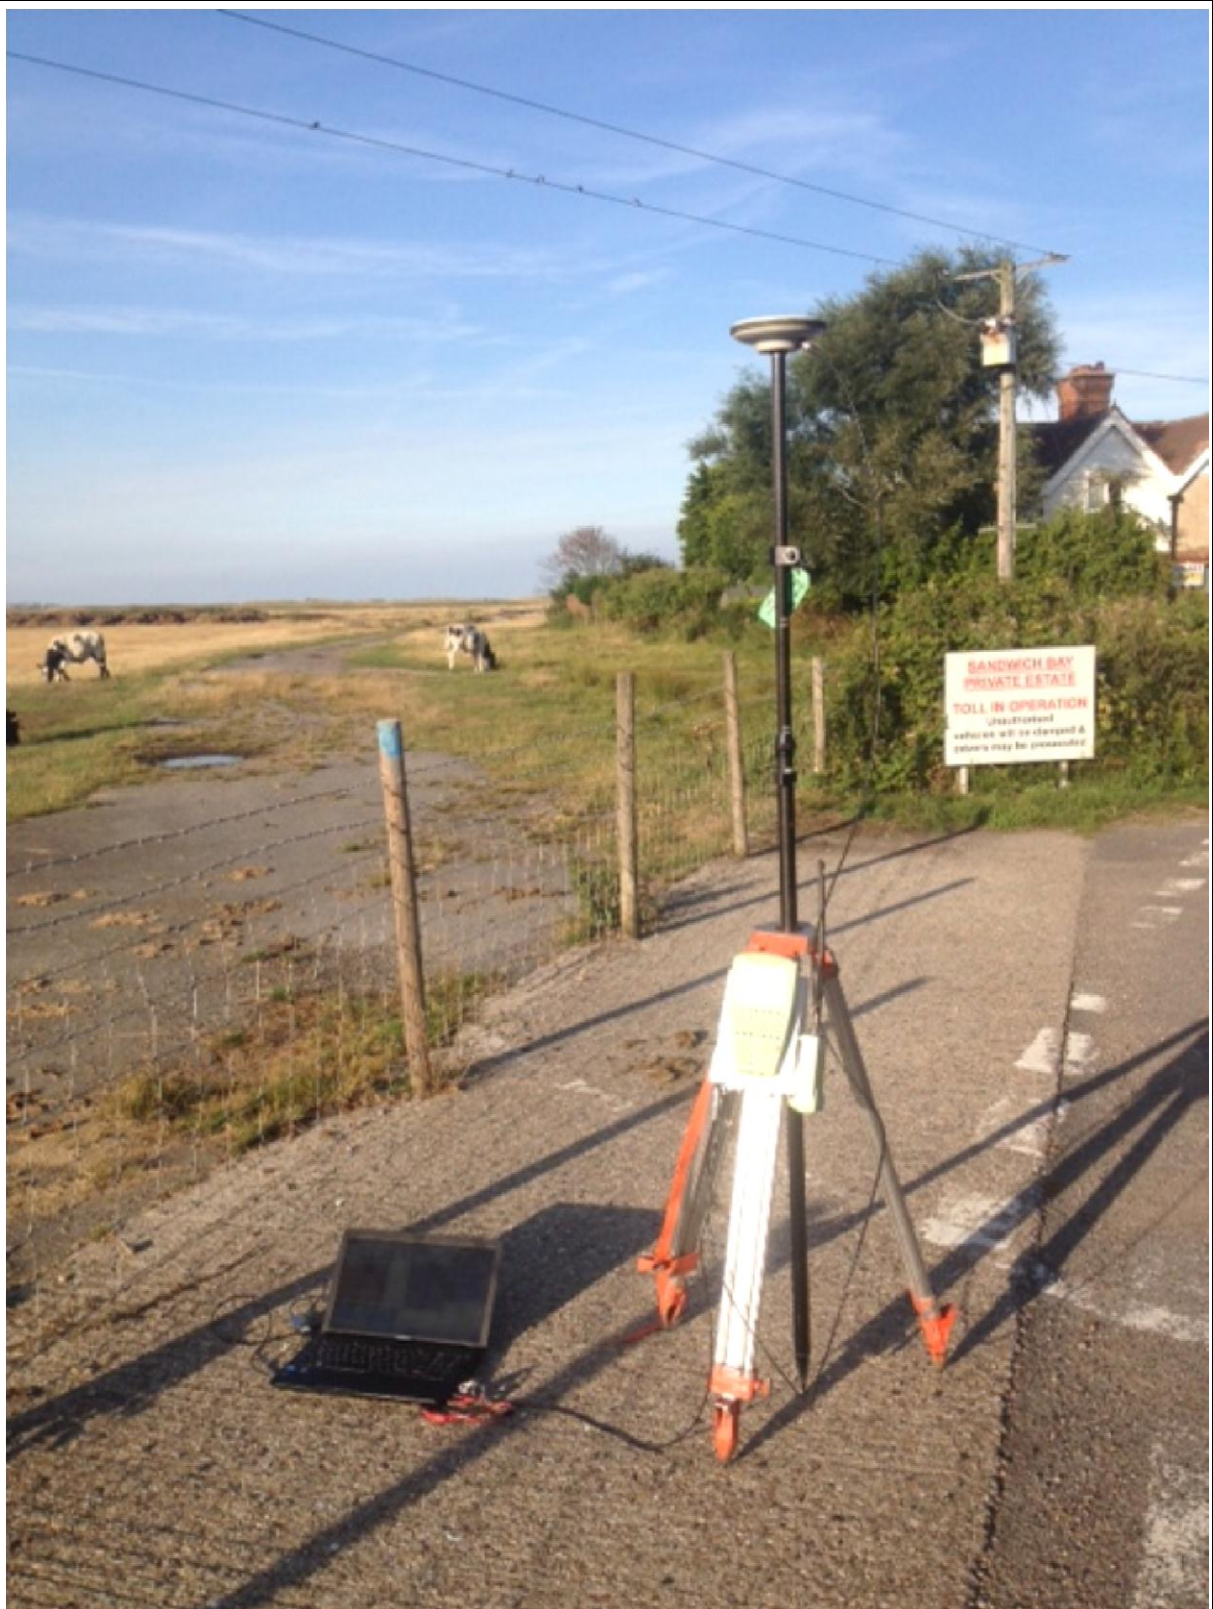
FIGURE 12: ROYAL ST GEORGES STATIC NAVIGATION CHECK LOCATION

On the 27th September the Leica 1200 antenna was placed over Royal ST Georges C1TR3557 an Ordnance Survey passive station (*Appendix B*), Sandwich Kent. Data were logged in QINSy for 20mins at 1.0Hz.

The results were plotted in UTM Zone 31 North and an overall mean calculated. The average of the observations was then compared with the position of the passive station, established by Ordnance Survey

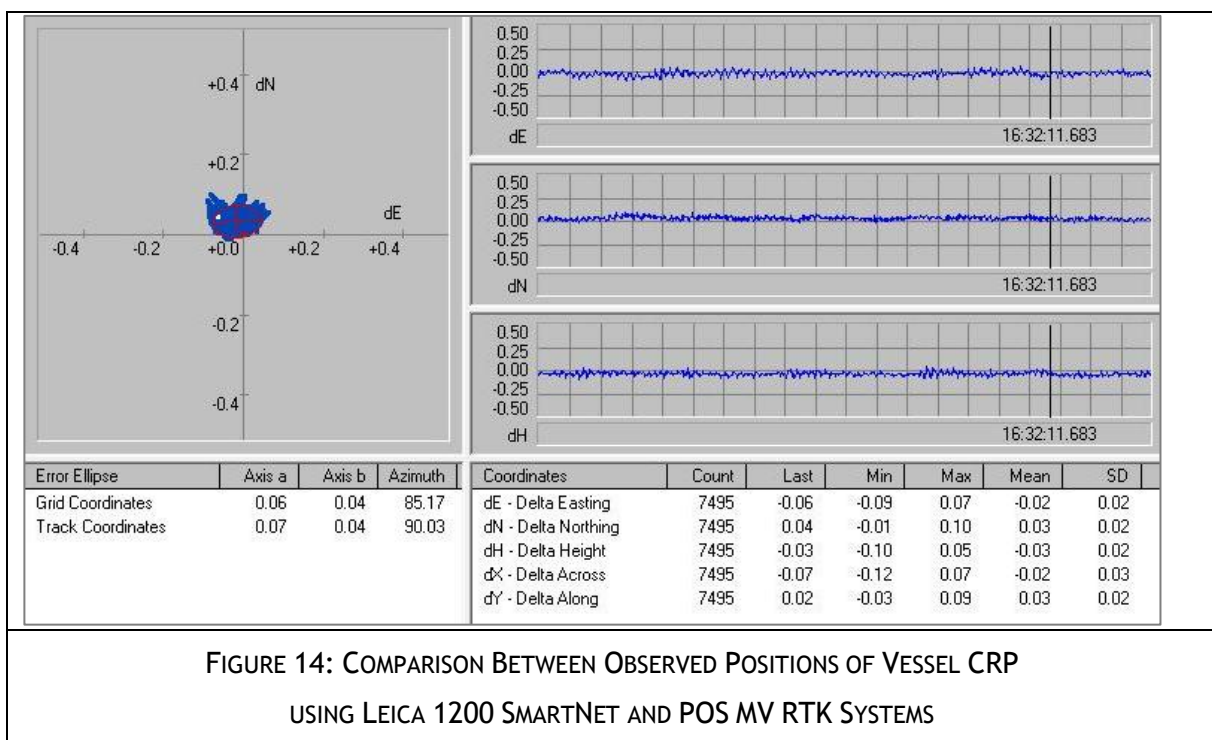
FIGURE 14: COMPARISON BETWEEN OBSERVED POSITIONS OF VESSEL CRP USING LEICA 1200 SMARTNET AND POS MV RTK SYSTEMS

The observed difference in the horizontal and vertical positions of the CRP output by both systems calculated in QINSy (Figure 14) acts as a ‘health check’ confirming that the correct lever arms, offsets and heading misalignments are entered. The results of this verification are summarised in Table 14, below.

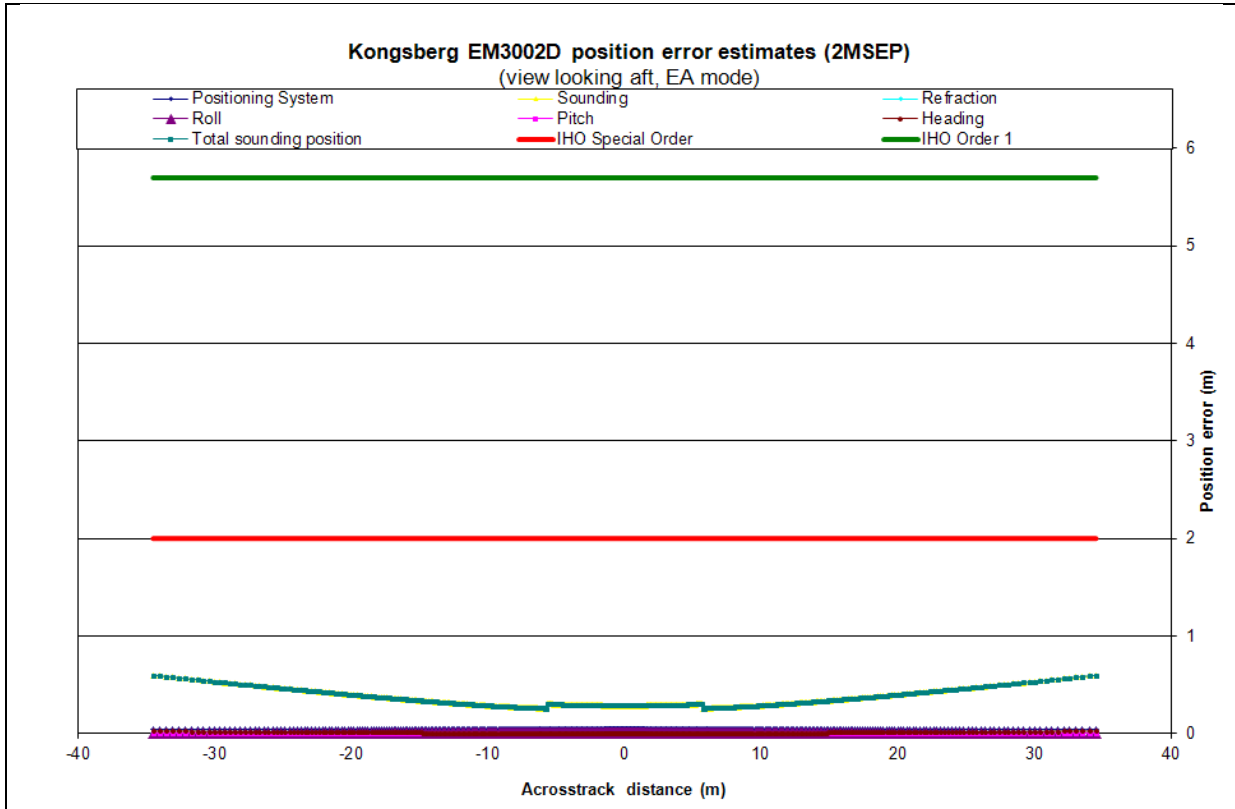
FIGURE 27: ERROR BUDGET - POSITION ERROR ESTIMATES

The error budget for MV Wessex Explorer demonstrates that the system is theoretically capable of exceeding IHO Special Order based on the input parameters listed in Table 21.

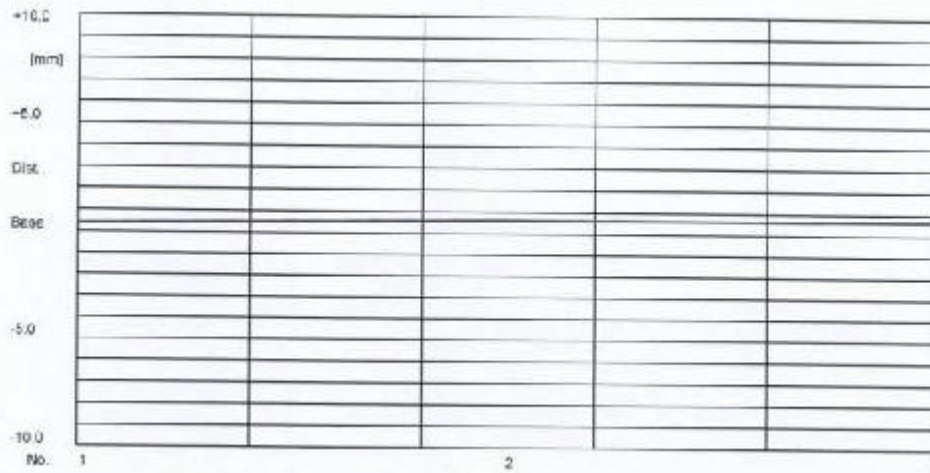
ELM Baseline: TORR1100plus / V2012.06 / 05.03.2013 / 65245	
Date: 06/03/2013 10:30:33	Instrument No.: 620673
Technician: chris	Customer: Geo-Spatial
Notes: Outgoing test	Test Result: ---

Measurement 1: 12.4905 [m]
 Single Dist: 12.4908 / 12.4908 / 12.4908 / 12.4908 / 12.4905 /
 Dist Mean: 12.49083 [m] Sigma: 0.12 [mm] Diff: 0.39 [mm] PPM: 15.1
 Measurement 2: 12.5231 [m]
 Single Dist: 12.5238 / 12.5236 / 12.5234 / 12.5235 / 12.5233 /
 Dist Mean: 12.52371 [m] Sigma: 0.16 [mm] Diff: 0.51 [mm] PPM: 15.1
 Measurement 3: 12.4905 [m]
 Single Dist: 12.4910 / 12.4909 / 12.4909 / 12.4906 / 12.4910 /
 Dist Mean: 12.49115 [m] Sigma: 0.04 [mm] Diff: 0.55 [mm] PPM: 15.1
