***WASHINGTON STATE PARKS CAPE DISAPPOINTMENT WAVE
BARRIER PROJECT***

**UNDERWATER SOUND LEVELS
ASSOCIATED WITH PILE DRIVING AT
THE CAPE DISAPPOINTMENT BOAT
LAUNCH FACILITY, WAVE BARRIER
PROJECT**

*Prepared by:
Jim Laughlin
Washington State Department of
Transportation
Office of Air Quality and Noise
15700 Dayton Avenue North,
P.O. Box 330310
Seattle, WA 98133-9710*

March 2006

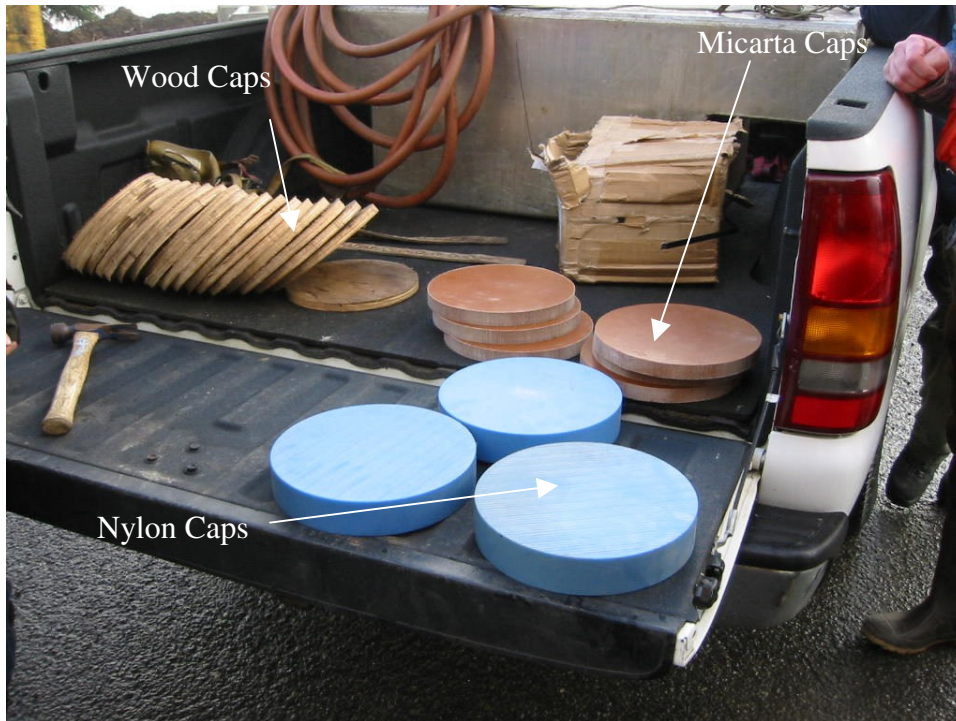
Figure 1: Pile cap types tested in this monitoring project (Conbest pile cap not shown).

Piles were driven using different pile cap materials and monitored to look for differences (in sound pressure?). The pile cap materials tested were wood (plywood), Conbest, Micarta, and Nylon. Piles were driven with an air hammer. Table 1 summarizes the results for each pile monitored. The bubble curtain was tested with the bubbles off and then on during the pile driving events.

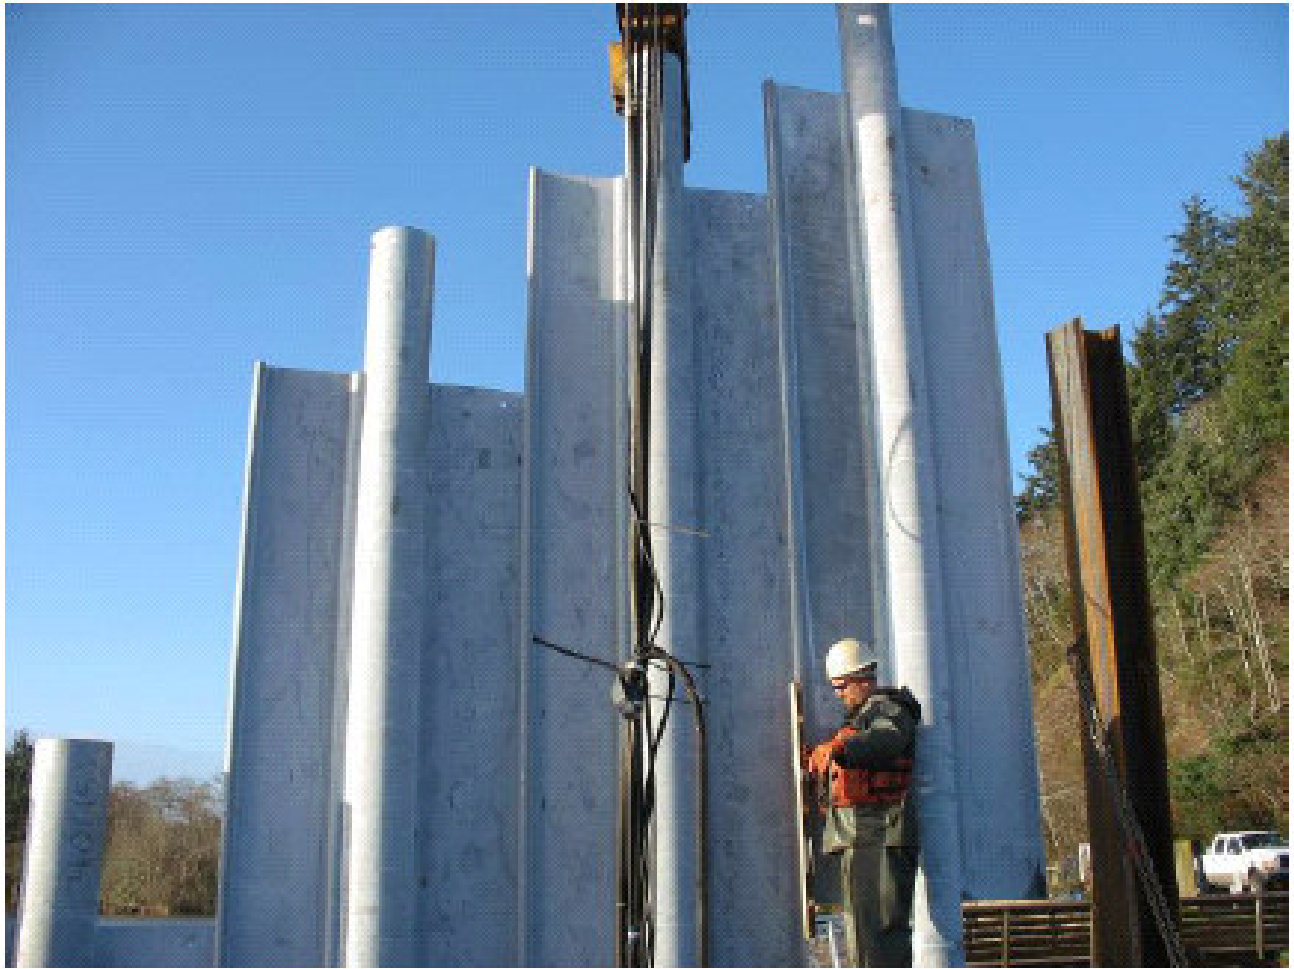
Figure 2: 12-inch diameter steel piles with interlocking ‘wings’ used to create the wave barrier (photo courtesy of Washington State Parks and Recreation, R. Johnson).

The piles were driven to replace the existing wood wave barrier. The five piles were monitored while being driven with different pile cap materials at different water depths at the facility. The pile cap materials used were wood (plywood), Conbest, Micarta, and Nylon (Figure 1). The Conbest material is not shown in Figure 1 but is similar to Micarta in size and thickness but looks like a layered aluminum disk in composition. The bubble curtain was tested with on/off cycles during each pile driving event. Figure 2 shows the piles with ‘wings’ and Figure 3 shows the locations of monitored piles.

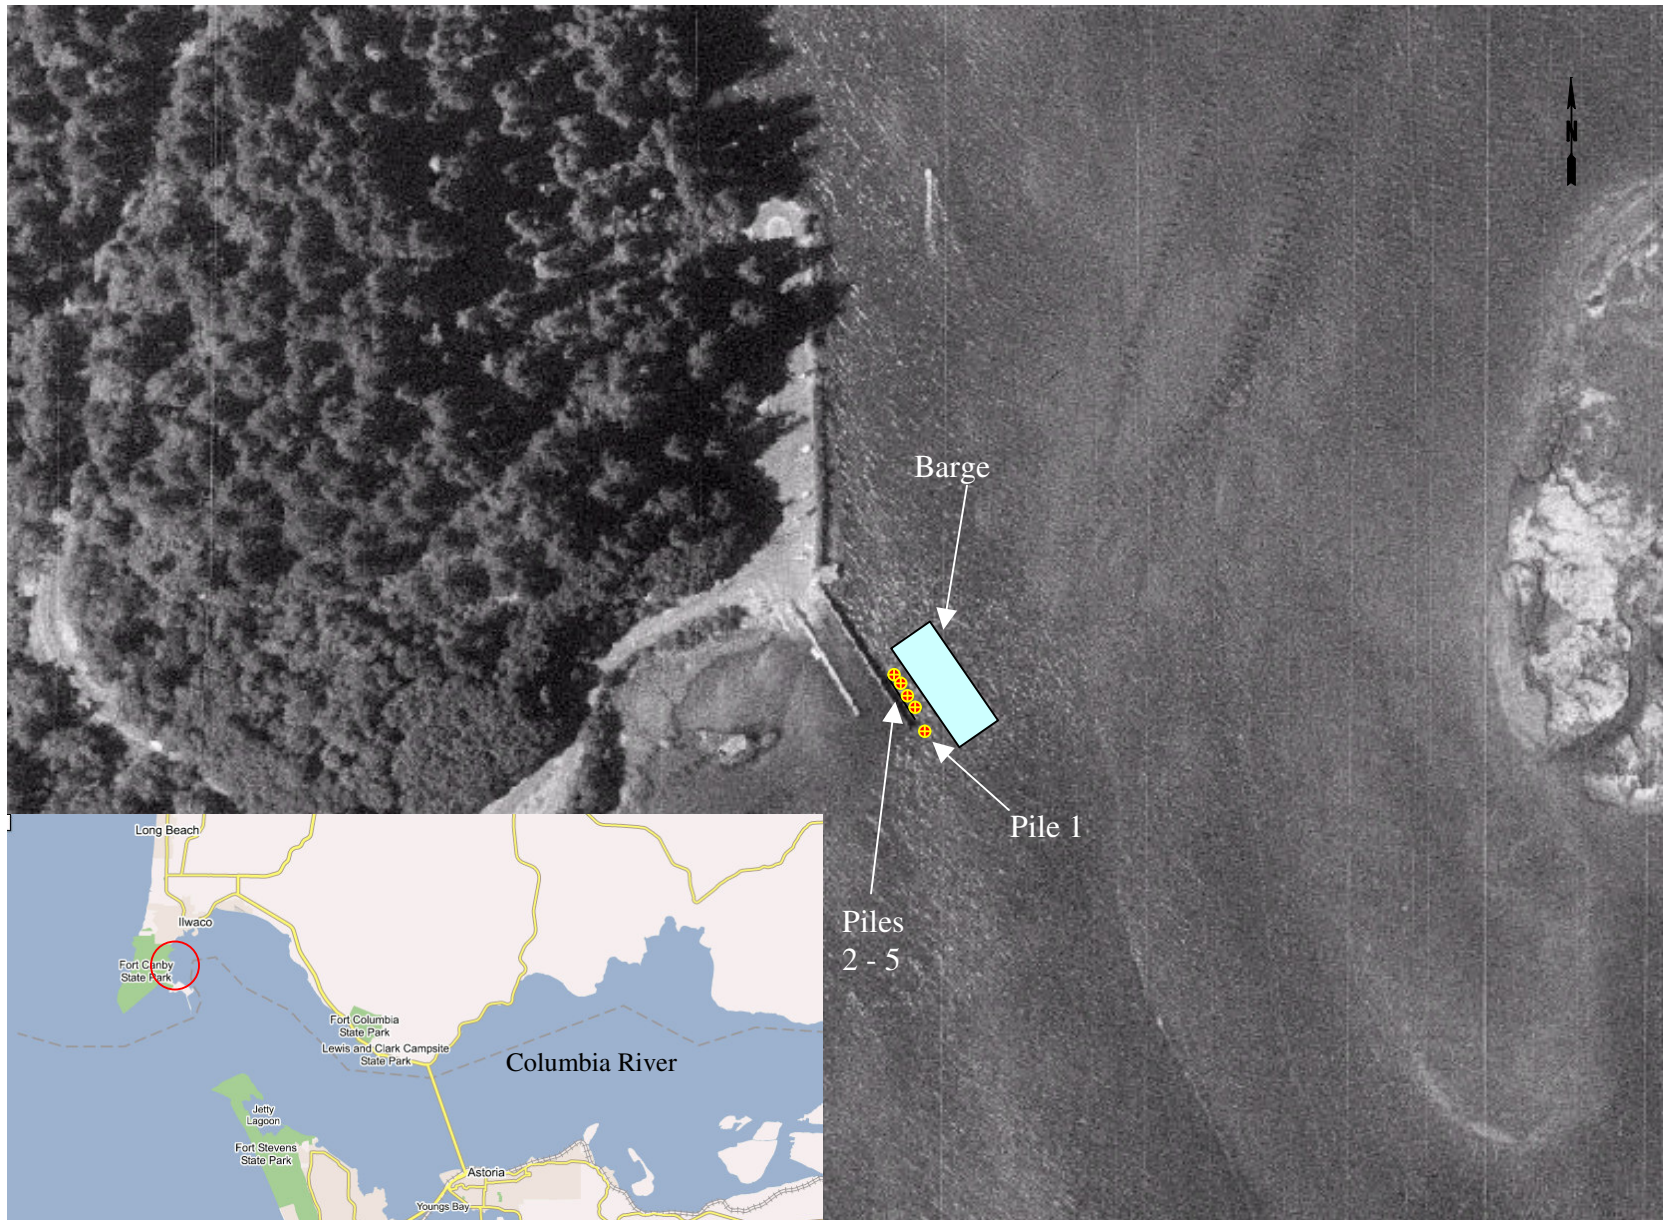
Figure 3: Location of underwater noise monitoring sites at the Cape Disappointment Wave Barrier project. Note: Piles are not to scale.

Located approximately 150 feet offshore at the farthest end of the new wave barrier (See Figure 1). The pile is located in 26 feet of water.

Piles 2 through 5 were driven while interlocked with three or more other piles starting approximately 10 feet inshore of pile 1. These piles ranged in depth between 16 and 12 feet of water dependent on tidal level.

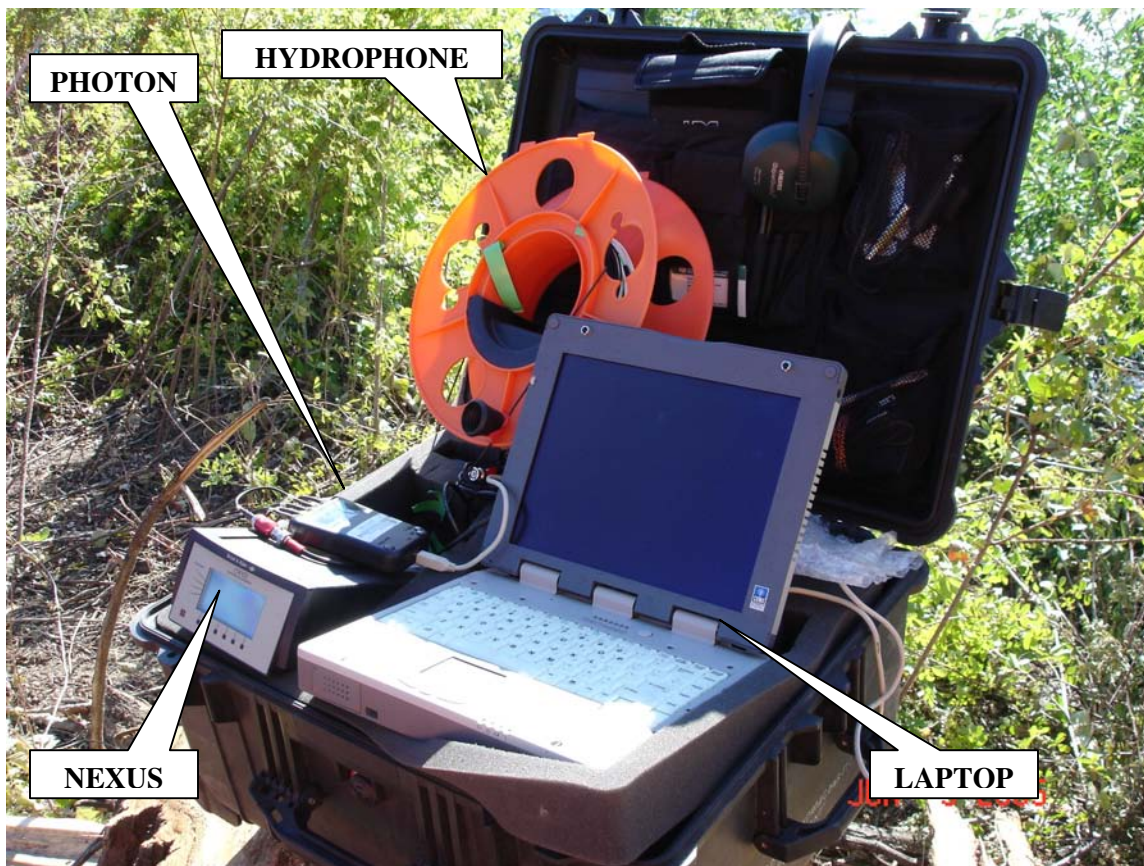
Underwater sound levels were measured using two Reson TC 4013 hydrophones. One hydrophone was positioned approximately at mid-water level. The second hydrophone was positioned approximately one foot from the bottom. The hydrophones were located at a distance of approximately 33 feet from the pile being monitored. The measurement system includes a Brüel and Kjær Nexus type 2692 4-channel signal conditioner, which kept the high underwater sound levels within the dynamic range of the signal analyzer (Figure 4). The output of the Nexus signal conditioner is received by a Dactron Photon 4-channel signal spectrum analyzer that is attached to an Itronix GoBook II laptop computer. The waveform of the pile strikes along with the number of strikes, overpressure minimum and maximum, absolute peak values, and RMS sound levels, integrated over 90% of the duration of the pulse, were captured and stored on the laptop hard drive for subsequent signal analysis. The system and software calibration is checked annually against a NIST traceable standard. The operation of the hydrophone was checked in the field using a GRAS type 42AC high-level pistonphone with a hydrophone adaptor. The pistonphone signal was 146 dB re: 1 μ Pa. The pistonphone signal levels produced by the pistonphone and measured by the measurement system were within 1 dB and the operation of the system was judged acceptable over the study period. A photograph of the system and its components are shown in Figure 4.

Figure 4: Underwater Sound Level Measurement Equipment

Signal analysis software provided with the Photon was set at a sampling rate of one sample every 41.7 μ s (9,500 Hz). This sampling rate is more than sufficient for the bandwidth of interest for

underwater pile driving impact sound and gives sufficient resolution to catch the peaks and other relevant data. The anti-aliasing filter included in the Photon also allows the capture of the true peak.

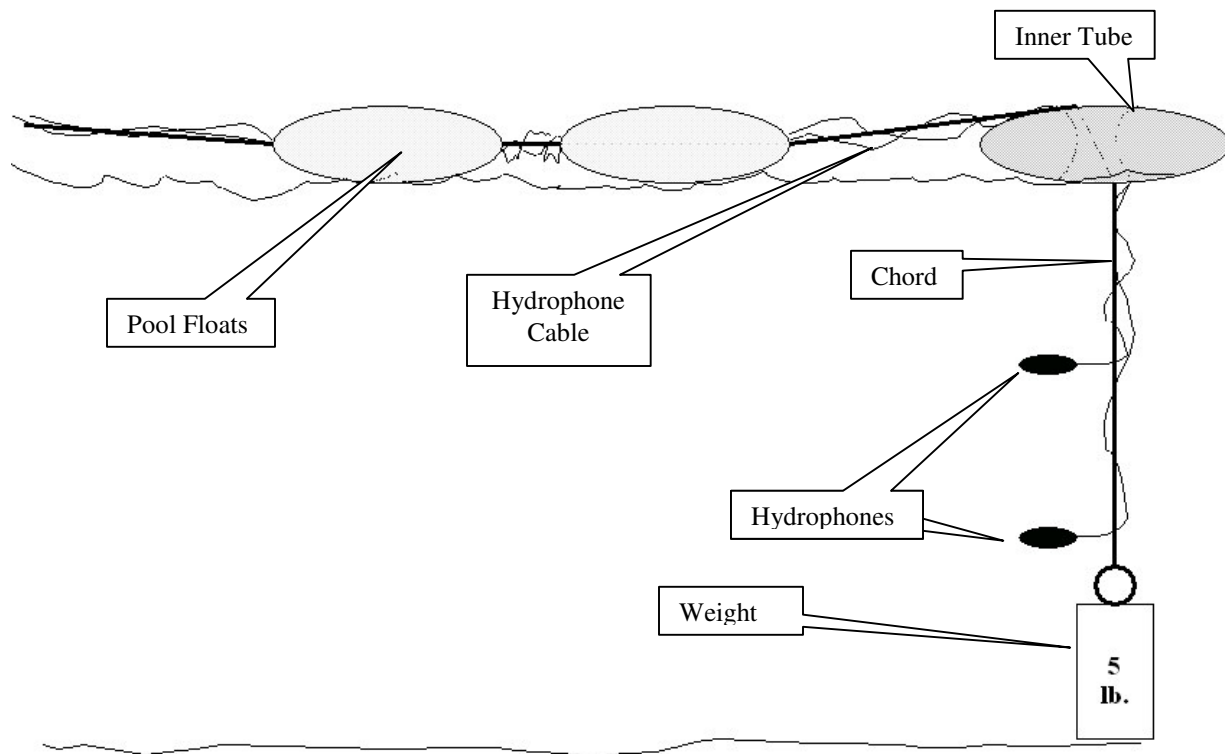
The location of the hydrophones is determined by allowing a clear line of sight between the pile and the hydrophone, with no other structures nearby. The distance from the pile to the hydrophone location was measured using a Bushnell Yardage Pro rangefinder. The hydrophone was attached to a weighted nylon cord anchored with a five-pound weight. The cord and hydrophone cables were attached to surface floats that kept the hydrophones at the proper location in the water column (Figure 5). For pile 1, the hydrophones were in a location with no other obstructions near it. For piles 2 through 5, the hydrophones were located between the pile and the barge.

Figure 5: Diagram of hydrophone deployment.

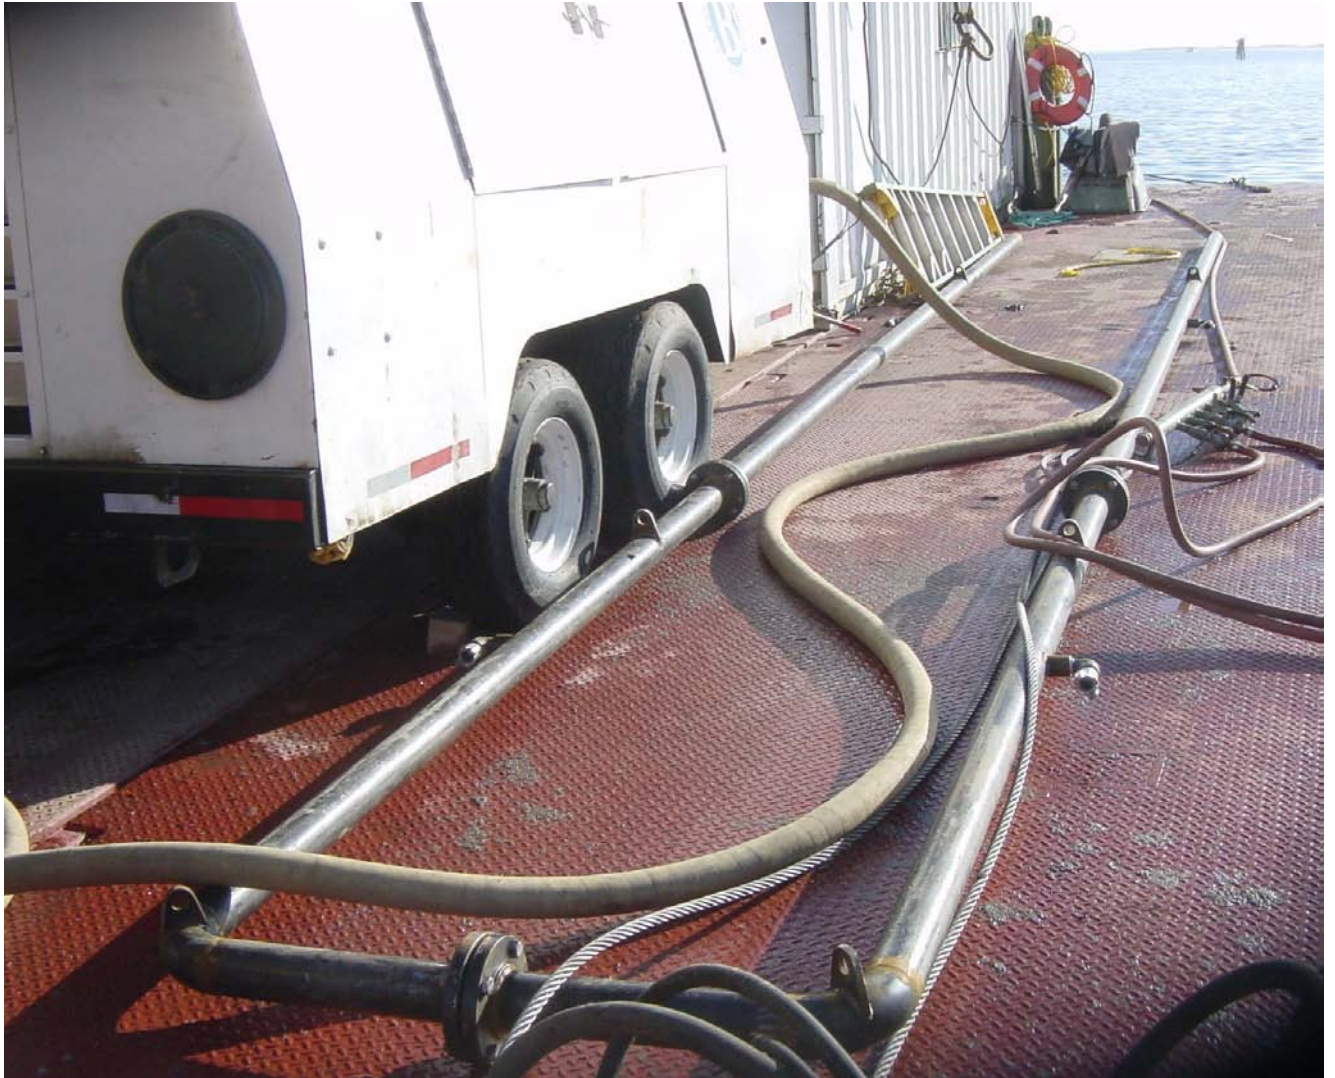
Two bubble curtain designs were used by the contractor at the Cape Disappointment Boat Launch facility. The first was a standard single ring placed at the bottom of pile 1 based on the design of Longmuir and Lively (2001). The second bubble curtain was a “U” shaped design that enabled the curtain to be fitted around the base of several piles that were interlocked together in a wall design (Figure 6).

Figure 6: “U” shaped bubble curtain for use on wave barrier piles.

It is important to note that during the use of the “U” shaped bubble curtain on piles 2 through 5 the tidal current swept some of the bubble curtain away from the pile being driven. This happened after high tide as water began to recede rapidly. However, as can be seen in the analysis that follows it had little or no impact on the effectiveness of the bubble curtain.

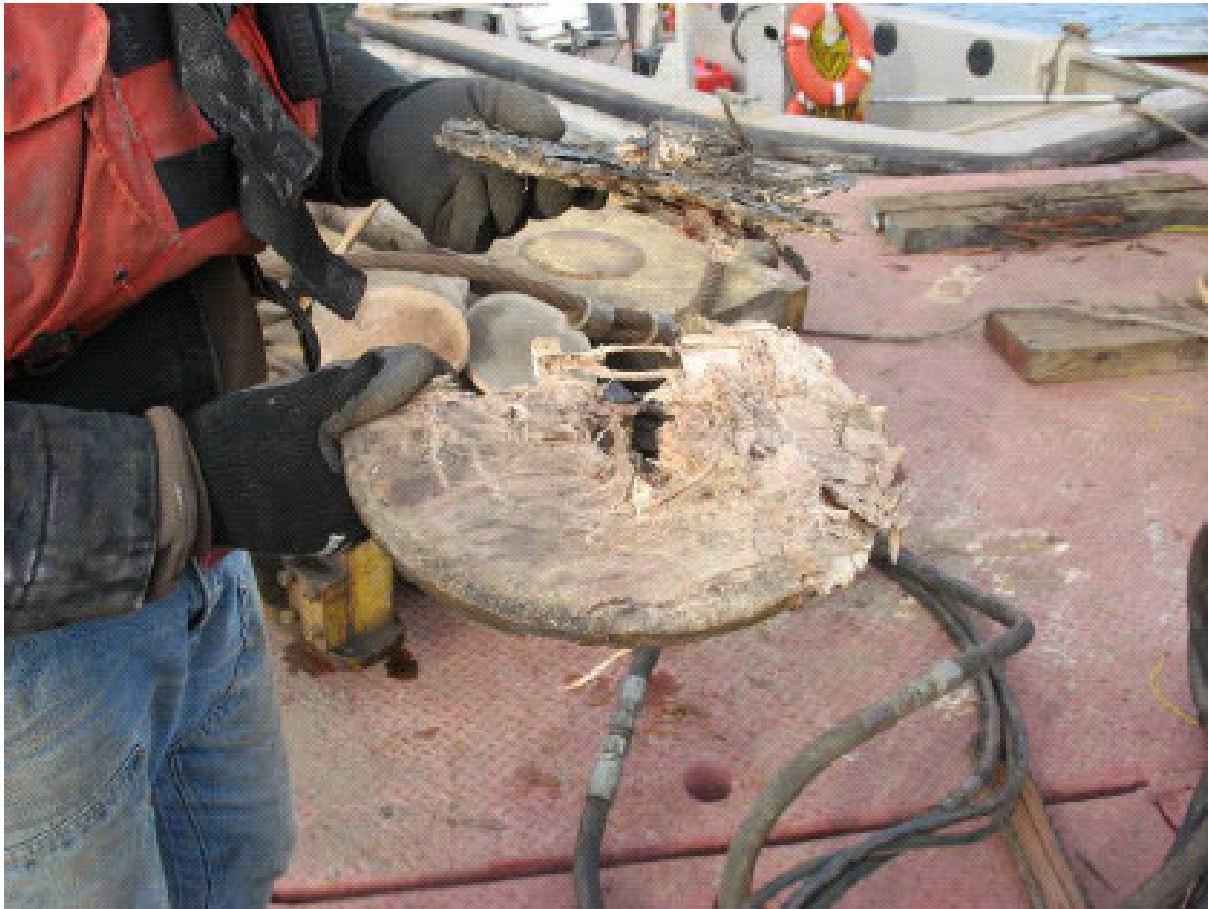
The highest absolute peak from the midwater and bottom hydrophones is 181 dB_{peak} for wood. The highest midwater RMS was 170 dB_{RMS} and bottom RMS was 169 dB_{RMS}. The highest midwater and bottom SEL for the peak strike were both 157 dB_{SEL}. Rise times for the wood pile cap were quite long indicating a substantial reduction of the transfer of energy from the hammer. Figure 7 shows a wood pile cap that has been compressed and shattered after use on only three piles.

Figure 7: Fractured and compressed wood pile cap after being used on piles 5, 6, and 7 (photo courtesy of Washington State Parks and Recreation, R. Johnson)

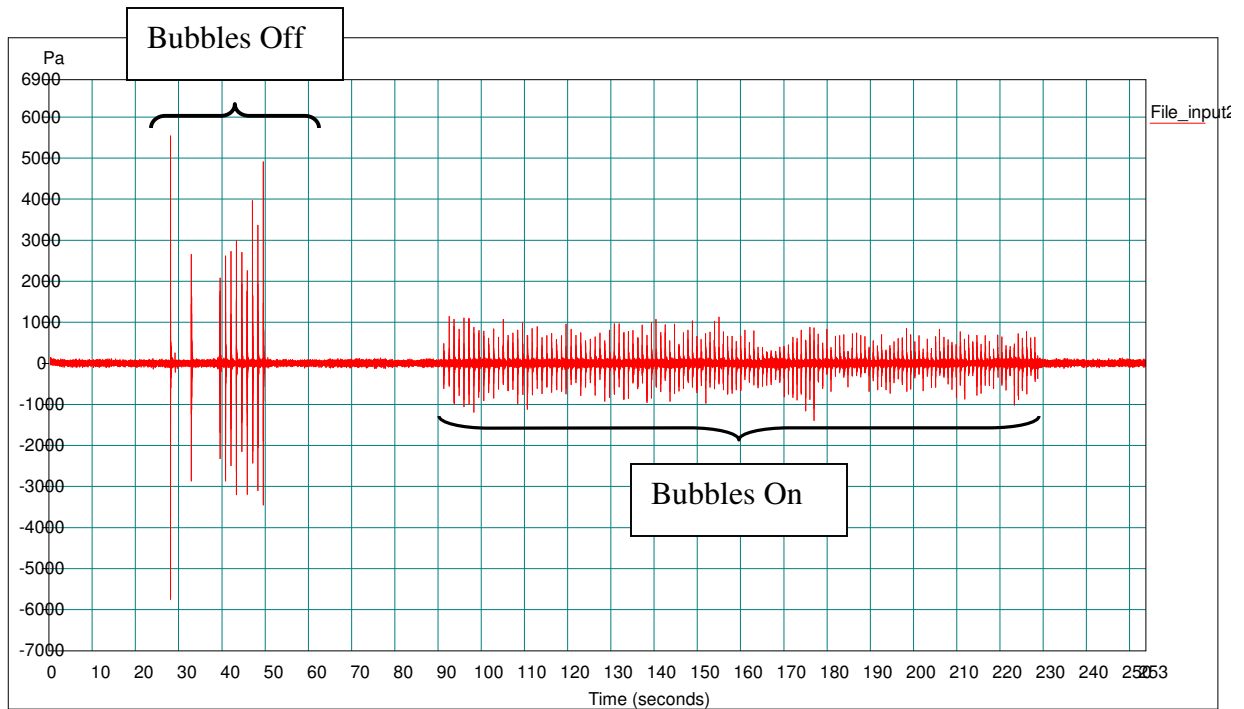
The average peak sound reductions achieved with the bubble curtain ranged between 7 and 11 dB. This can be seen visually in Figure 8. This indicates that the bubble curtain was functioning slightly better than anticipated.

Figure 8: Waveform recording indicating the effects on amplitude with bubble curtain on versus bubble curtain off for pile 3.

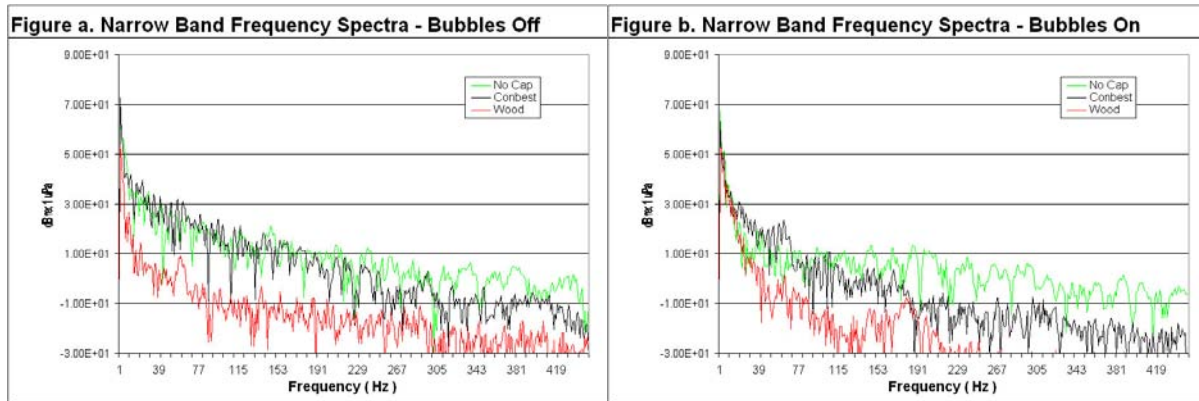
A spectral frequency analysis was conducted on the peak pile strike (Figures 9 and 10). Figure 9 indicates that for the single pile the wood pile cap as having the greatest effect of lowering the sound levels of all frequencies even with the bubble curtain off. The Conbest pile cap was able to reduce only the higher frequencies above approximately 600 Hz with the bubble curtain off. With the bubble curtain on the frequencies for Conbest were lowered from

approximately 190 Hz and above. With no pile cap there was little change in frequency levels with or without the bubble curtain.

Figure 9: Spectral Frequency Analysis comparing Conbest and wood pile caps versus no caps with bubble curtain on and off.

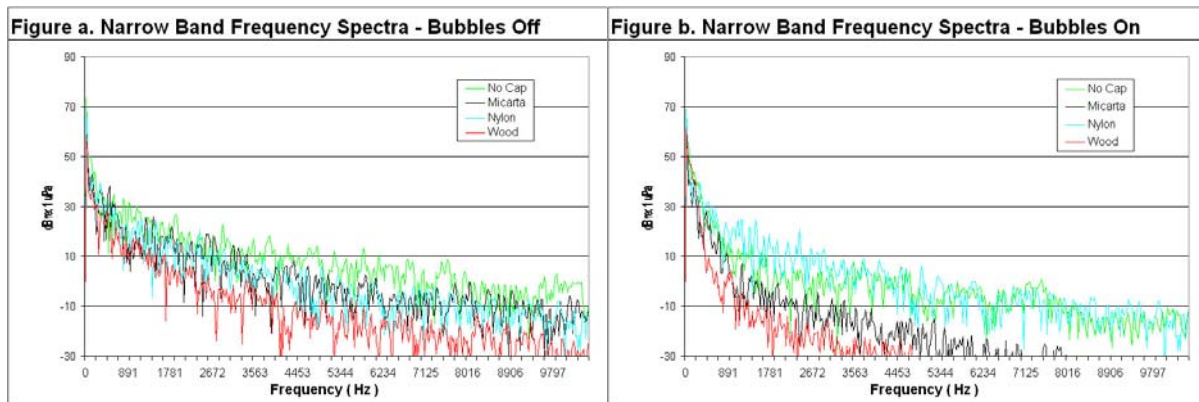
Figure 10: Spectral Frequency Analysis comparing Micarta, Nylon, and wood pile caps versus no caps with bubble curtain on and off.

Figure 10 indicates that for the piles with ‘wings’ when the bubble curtain is off the wood pile cap was able to reduce frequency levels at all frequencies. Nylon and Micarta were able to reduce frequencies above approximately 600 Hz, similarly to Conbest above. When the bubble curtain was turned on the performance of the wood and Micarta pile caps were enhanced whereas only a slight improvement was observed for Nylon. Micarta is able to reduce frequencies above approximately 450 Hz with the bubble curtain on. Nylon actually exhibited sound levels higher than with no cap at frequencies between approximately 900 and 3500 Hz and then no difference when compared to no cap with all other frequencies.

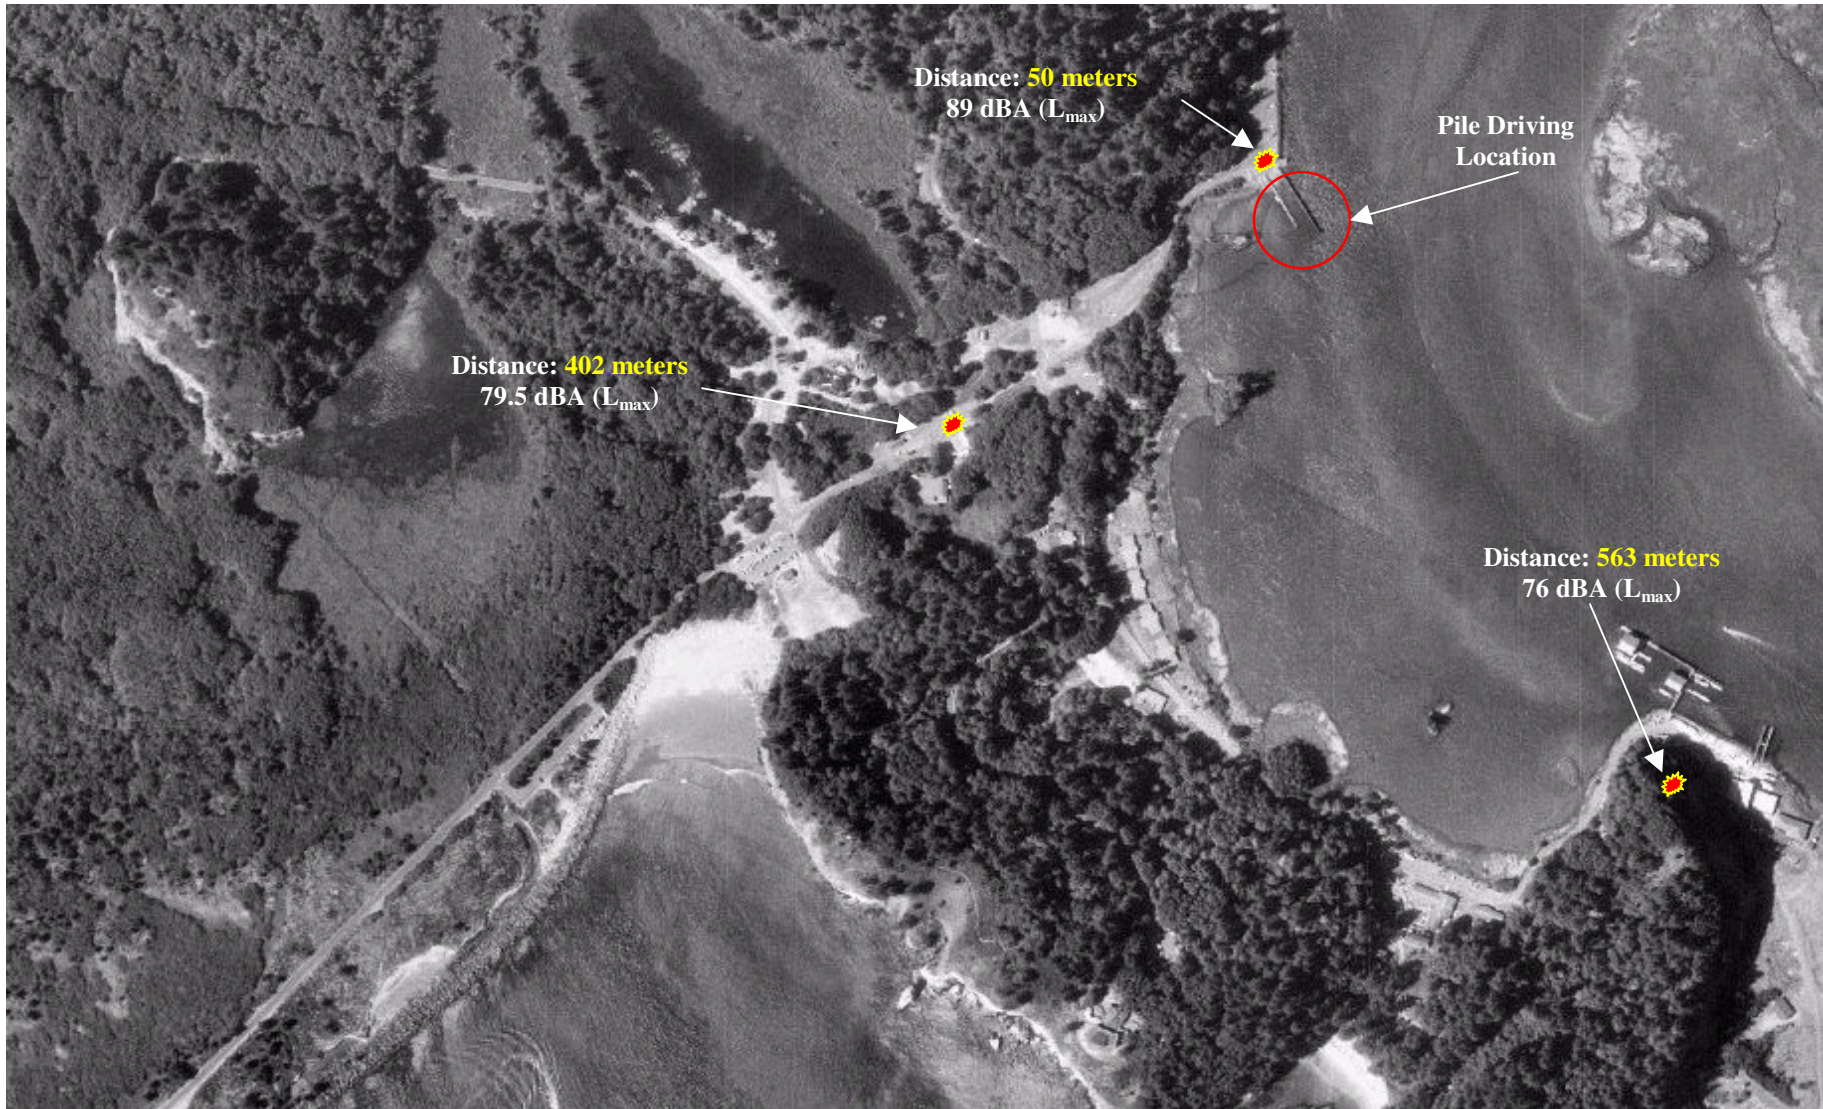
Figure 11: Airborne measurement locations (☀) with A-weighted maximum values.

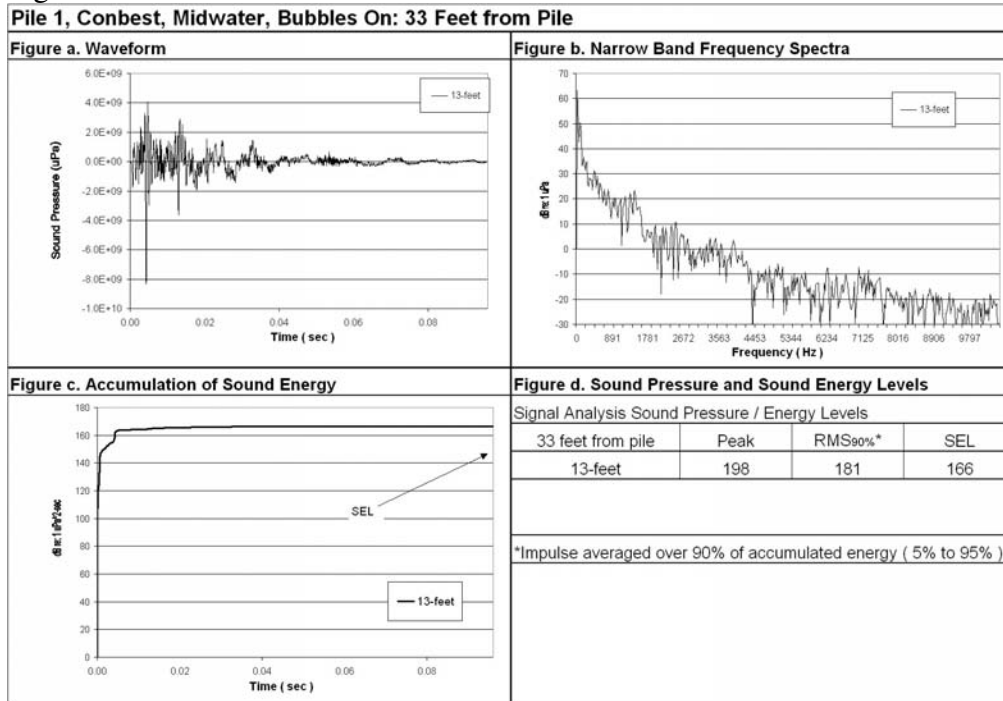
PILE 1 – CONBEST BUBBLE CURTAIN ON

Figure 13: Waveform Analysis of Pile 1 Sound Pressure Levels with Conbest Pile Cap and Bubble Curtain On, Midwater and Bottom.

The average sound reductions achieved with Conbest is 5 dB. The average peak sound reduction achieved with the bubble curtain was 5 dB. This indicates that the bubble curtain was providing a sound level reduction that is typical of most bubble curtains.

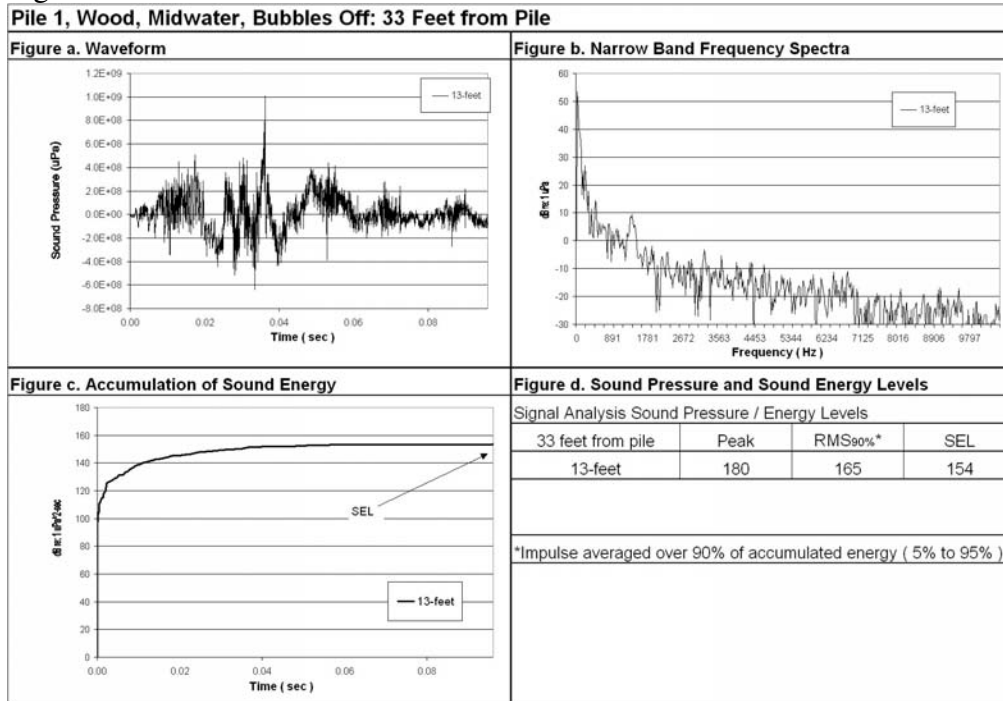
PILE 1 – WOOD BUBBLE CURTAIN OFF

Figure 14: Waveform Analysis of Pile 1 Sound Pressure Levels with Wood Pile Cap and Bubble Curtain Off, Midwater and Bottom.

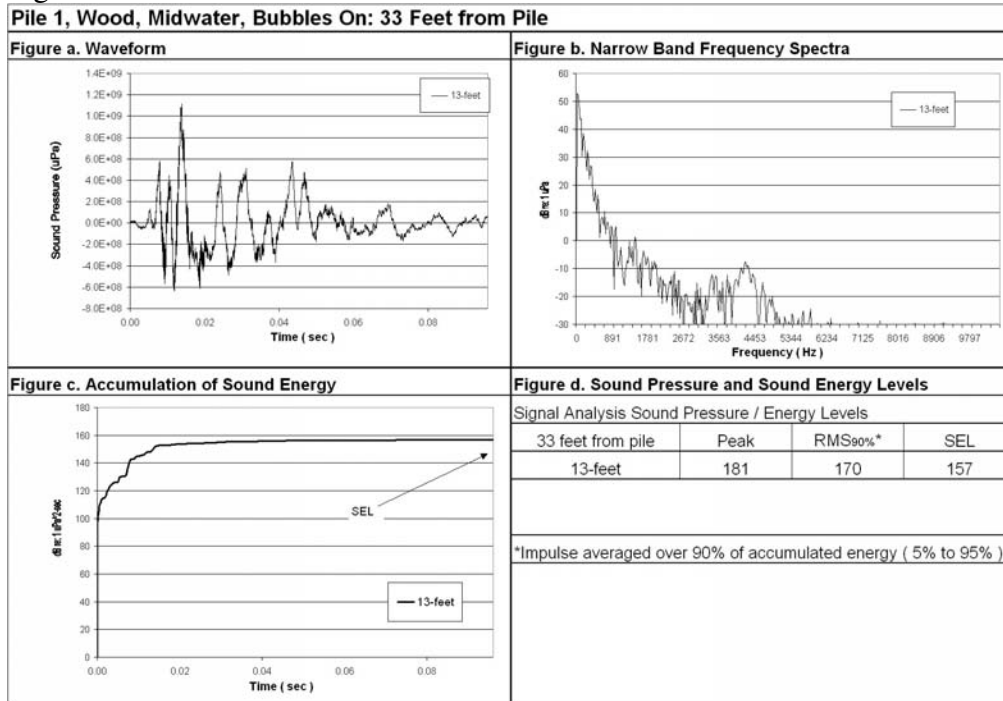
PILE 1 – WOOD BUBBLE CURTAIN ON

Figure 15: Waveform Analysis of Pile 1 Sound Pressure Levels with Wood Pile Cap and Bubble Curtain On, Midwater and Bottom.

The average sound reductions achieved with wood is 24 db. The average peak sound reduction achieved with the bubble curtain was 2 dB. This indicates that the bubble curtain was not functioning as well as anticipated.

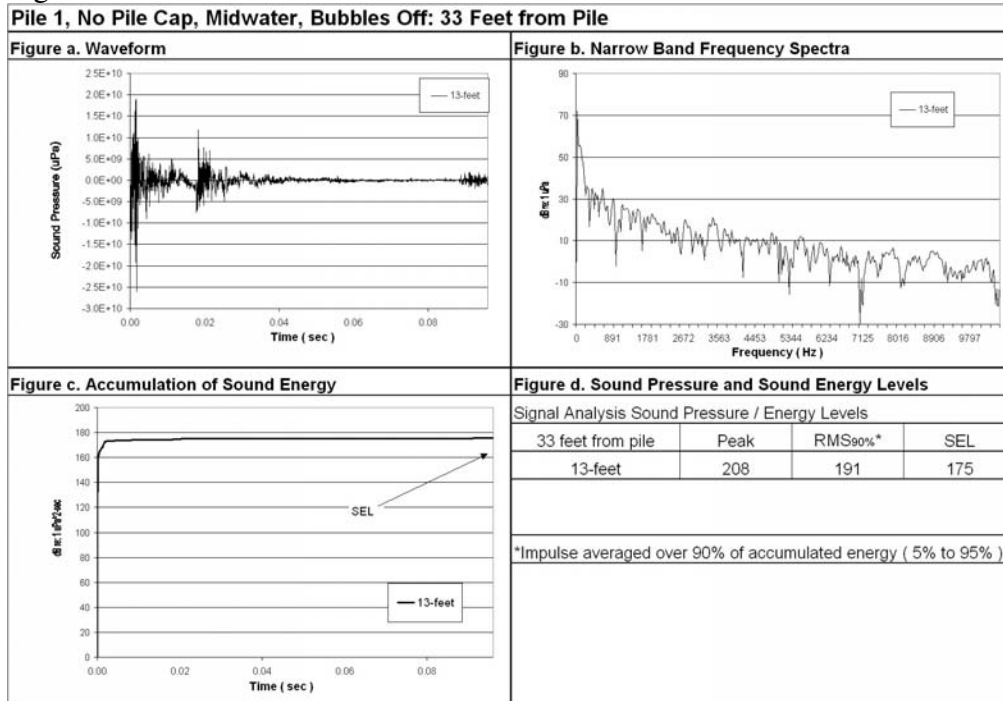
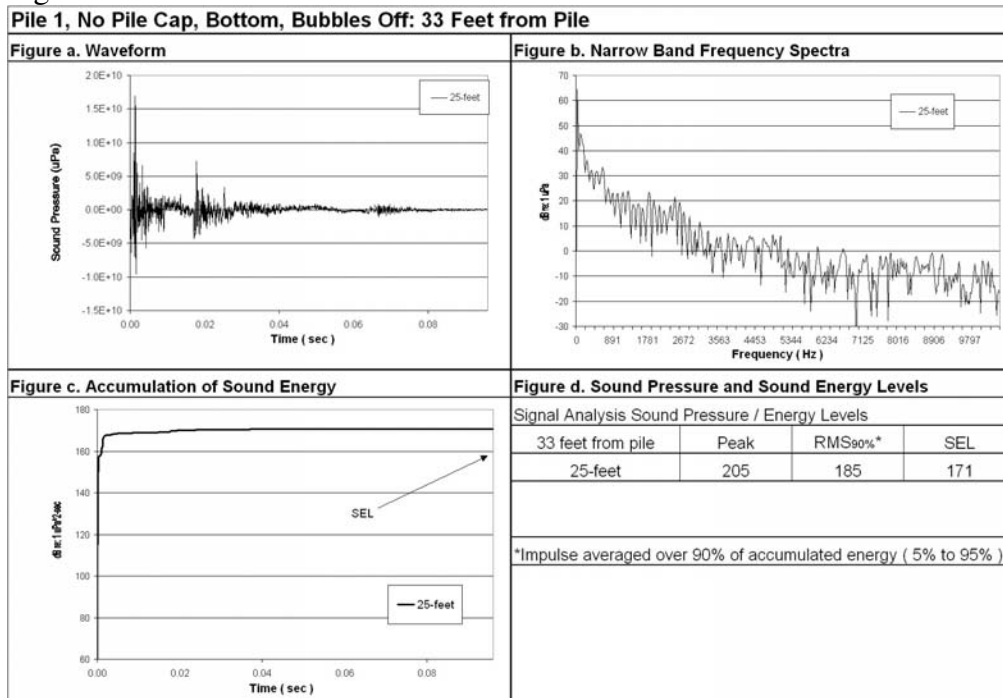
PILE 1 – NO PILE CAP BUBBLE CURTAIN OFF

Figure 16: Waveform Analysis of Pile 1 Sound Pressure Levels with No Pile Cap and Bubble Curtain Off, Midwater and Bottom.

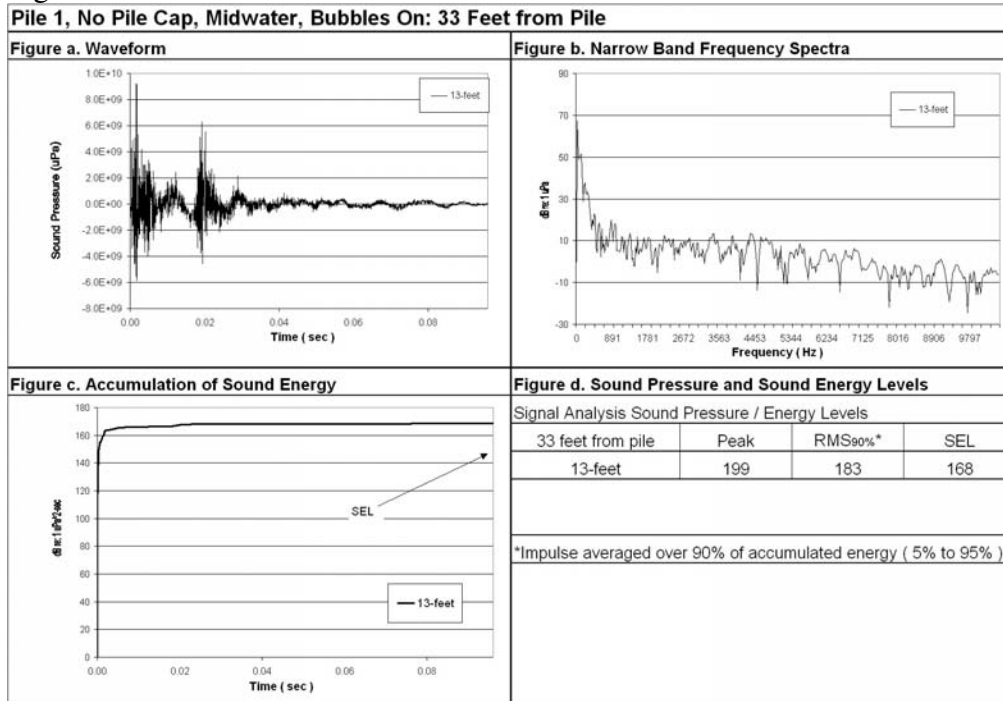
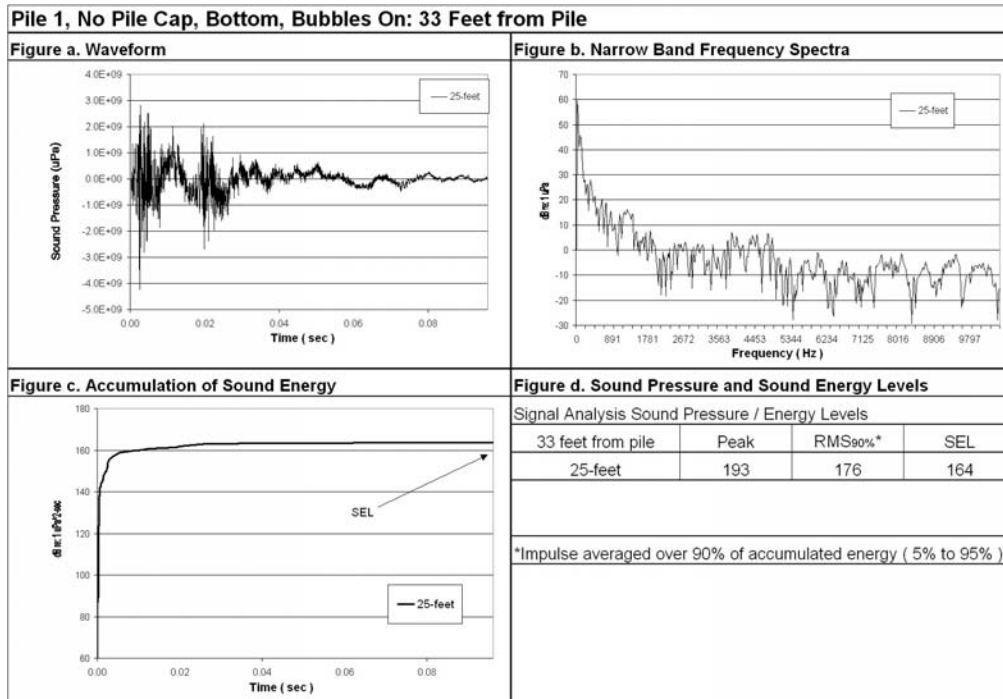
PILE 1 – NO PILE CAP BUBBLE CURTAIN ON

Figure 17: Waveform Analysis of Pile 1 Sound Pressure Levels with No Pile Cap and Bubble Curtain On, Midwater and Bottom.

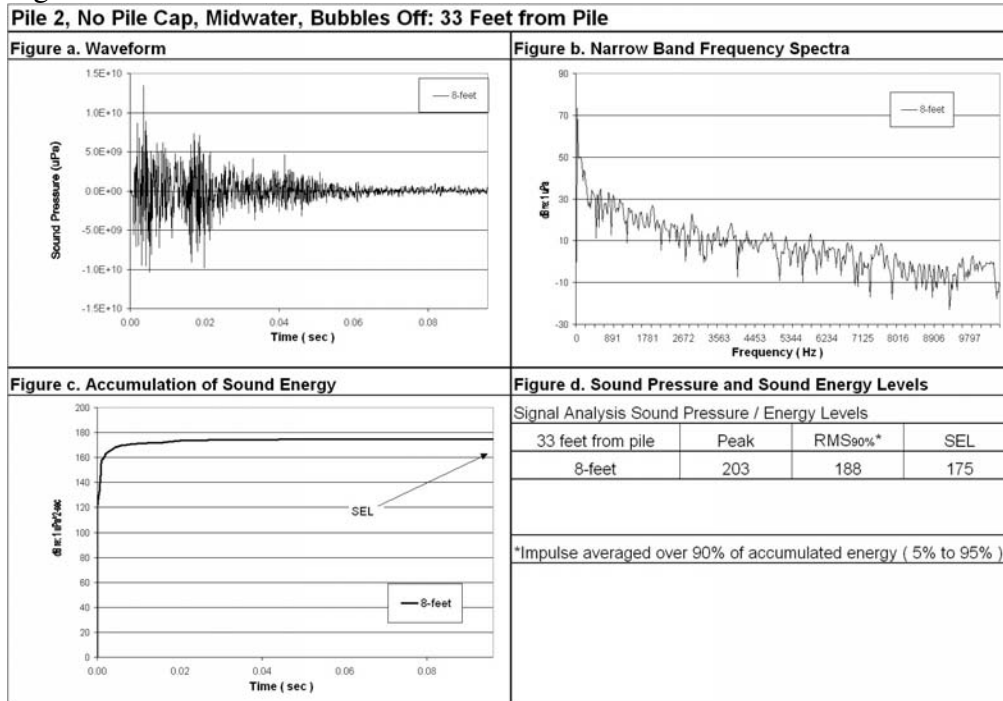
PILE 2 – NO PILE CAP, BUBBLE CURTAIN OFF

Figure 18: Waveform Analysis of Pile 2 Sound Pressure Levels with No Pile Cap and Bubble Curtain Final Off, Midwater and Bottom.

The highest absolute peak from the midwater hydrophone is 203 dB_{peak} and the absolute highest peak from the bottom hydrophone is 202 dB_{peak}. The highest midwater RMS was 188 dB_{RMS} and bottom RMS was both and 189 dB_{RMS} respectively. The highest midwater SEL was 175 dB_{SEL} and bottom SEL was 176 dB_{SEL} for the peak strikes. Rise times with no pile cap were relatively short with the bubble curtain turned off but then lengthened when the bubbles were turned on. 137 peak pile strike (71%) values exceeded 180 dB_{peak} for the midwater and bottom hydrophones with the bubble curtain on. Virtually all the RMS values exceeded 150 dB_{RMS} for both the midwater and bottom hydrophones.

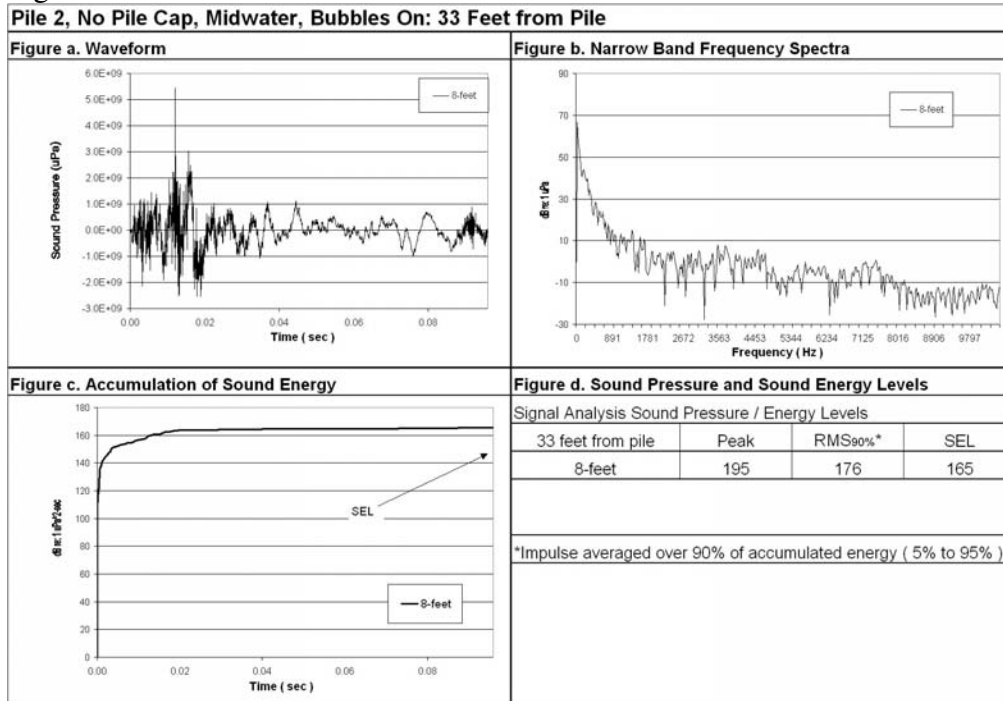
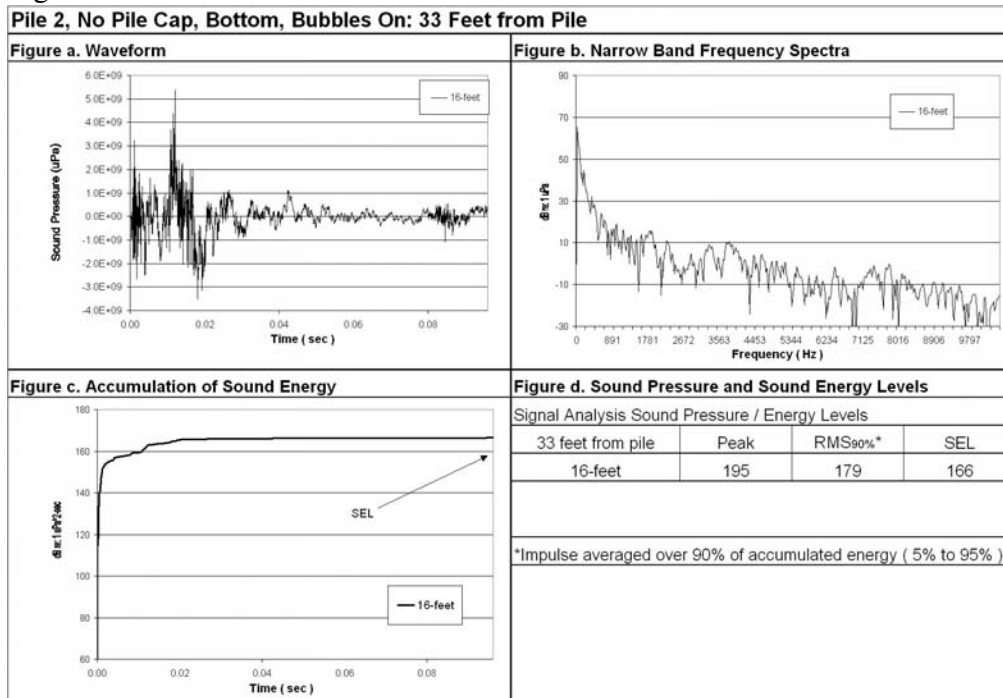
PILE 2 – NO PILE CAP, BUBBLE CURTAIN ON

Figure 19: Waveform Analysis of Pile Number 2 Sound Pressure Levels with No Pile Cap and Bubble Curtain On, Midwater and Bottom.

The average peak sound reductions achieved with the bubble curtain ranged between 11 and 14 dB. This indicates that the bubble curtain was providing sound reduction better than a typical bubble curtain.
