***WASHINGTON STATE PARKS CAPE DISAPPOINTMENT WAVE
BARRIER PROJECT***

**UNDERWATER SOUND LEVELS
ASSOCIATED WITH PILE DRIVING AT
THE CAPE DISAPPOINTMENT BOAT
LAUNCH FACILITY, WAVE BARRIER
PROJECT**

*Prepared by:
Jim Laughlin
Washington State Department of
Transportation
Office of Air Quality and Noise
15700 Dayton Avenue North,
P.O. Box 330310
Seattle, WA 98133-9710*

March 2006

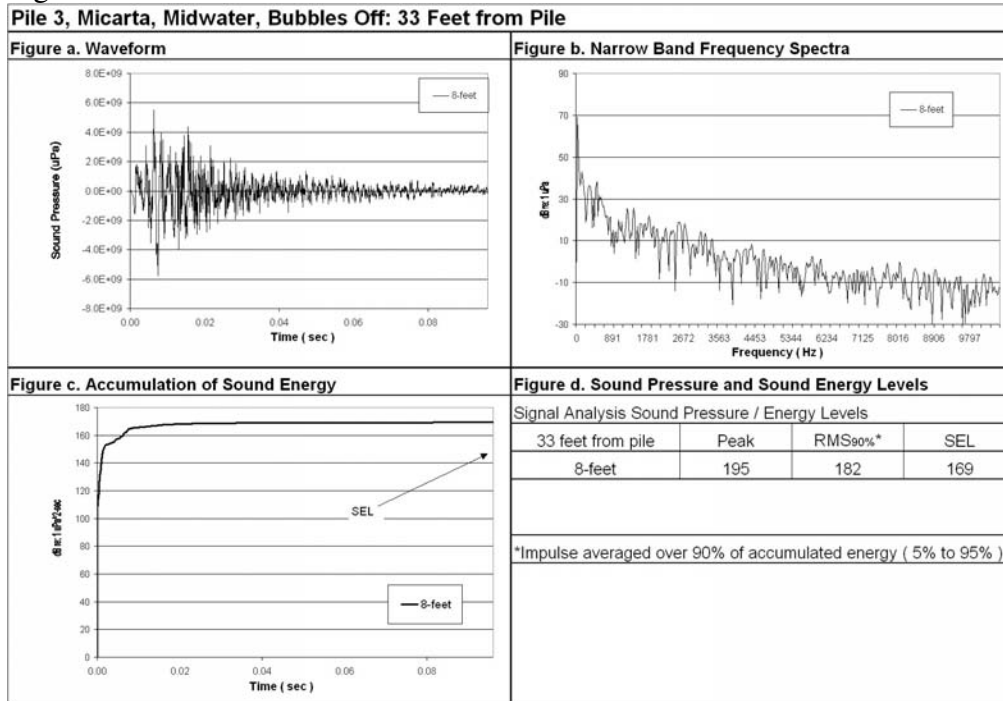
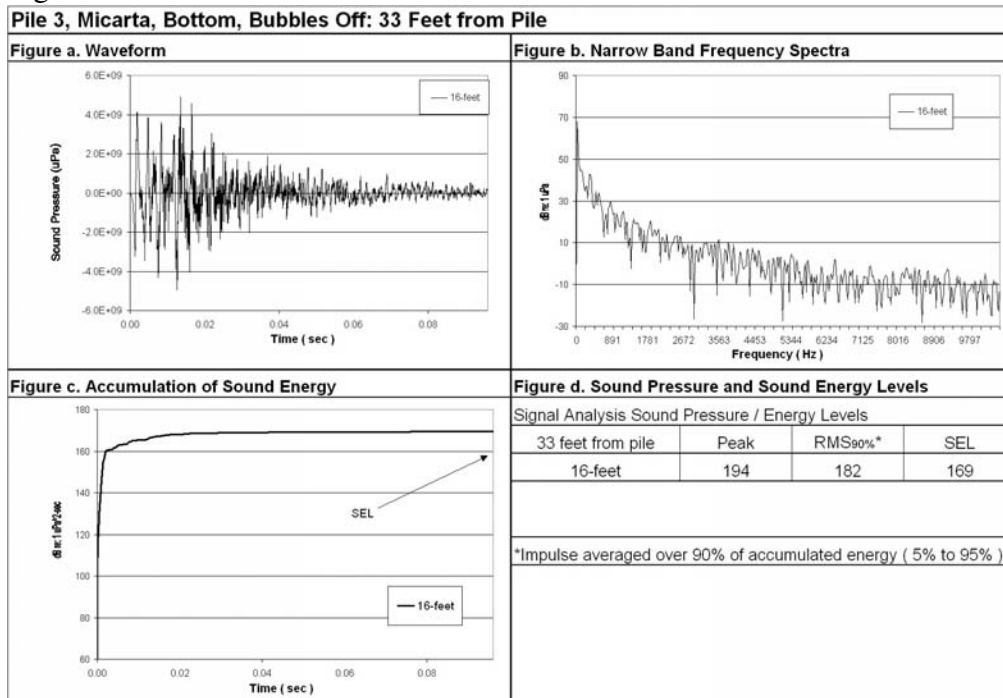
PILE 3 – MICARTA PILE CAP, BUBBLE CURTAIN OFF

Figure 20: Waveform Analysis of Pile Number 3 Sound Pressure Levels with Micarta Pile Cap and Bubble Curtain Off, Midwater and Bottom.

The highest absolute peak from the midwater hydrophone is 195 dB_{peak} and the absolute highest peak from the bottom hydrophone is 194 dB_{peak} for Micarta. The highest midwater and bottom RMS were both 189 dB_{RMS} and 188 dB_{RMS} respectively. The highest midwater and bottom SEL for the peak strike were both 169 dB_{SEL}. Rise time for the Micarta pile cap is relatively long indicating a reduction of the transfer of energy from the hammer. The highest midwater SEL for the peak strike was 178 dB_{SEL} and 180 dB_{SEL} for the bottom. Only 55 midwater pile strike peak values (37%) exceeded 180 dB_{peak} with the bubble curtain on. All but five bottom pile strike peak values exceeded 180 dB_{peak}. Virtually all pile strike RMS values exceeded 150 dB_{RMS} for both the midwater and bottom hydrophones.

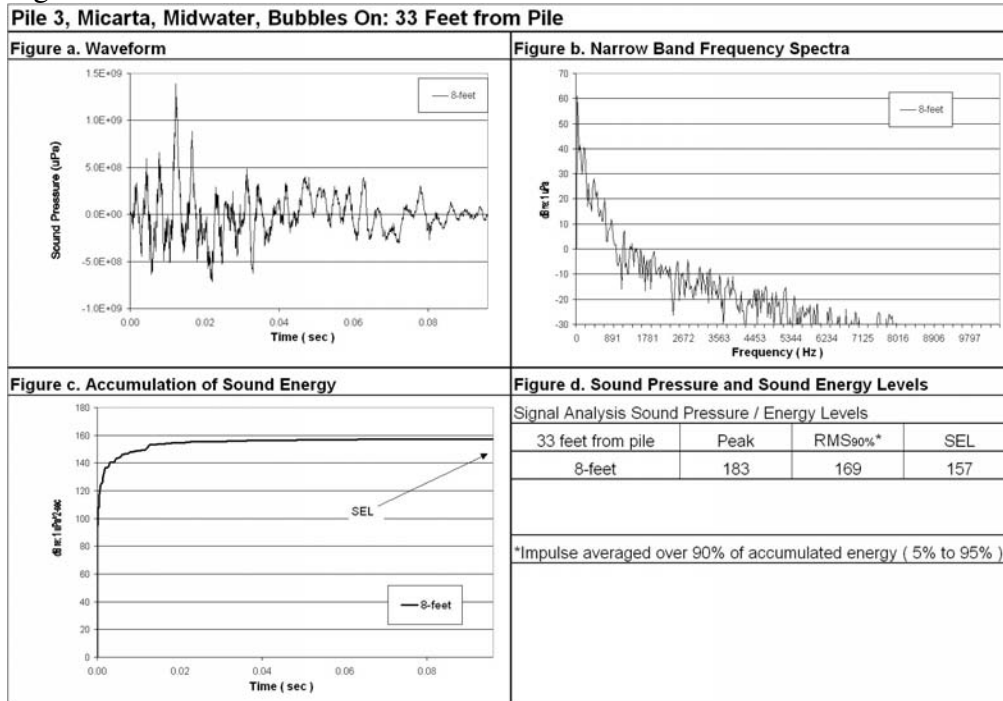
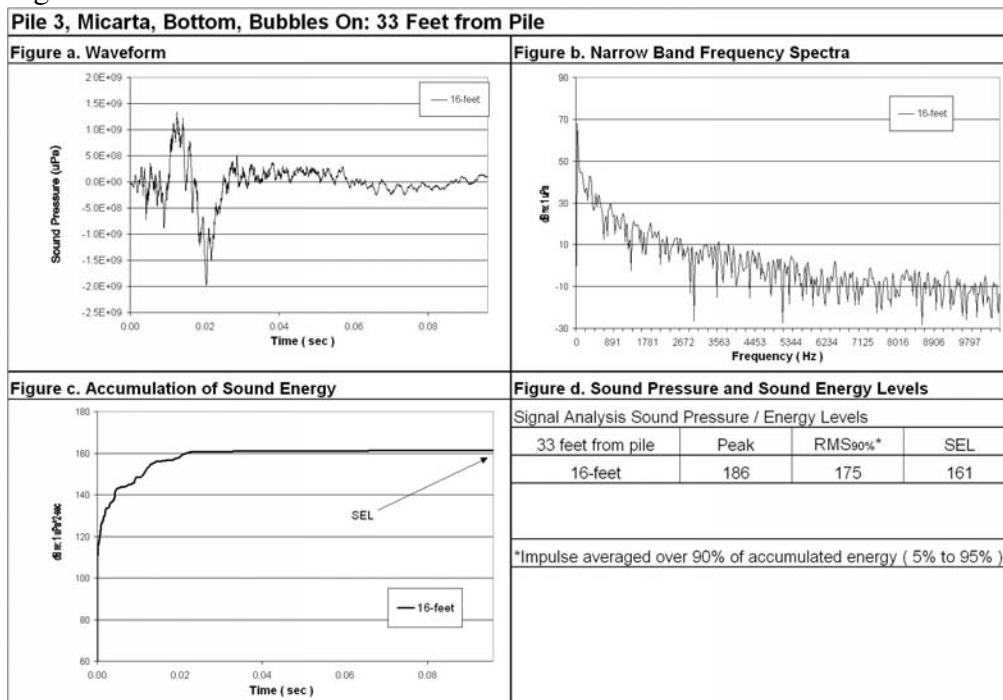
PILE 3 – MICARTA PILE CAP, BUBBLE CURTAIN ON

Figure 21: Waveform Analysis of Pile Number 3 Sound Pressure Levels with Bubble Curtain Second Off, Midwater and Bottom.

The average peak sound reductions achieved with the bubble curtain ranged between 7 and 11 dB. This can be seen visually in Figure 8. This indicates that the bubble curtain was functioning slightly better than anticipated.

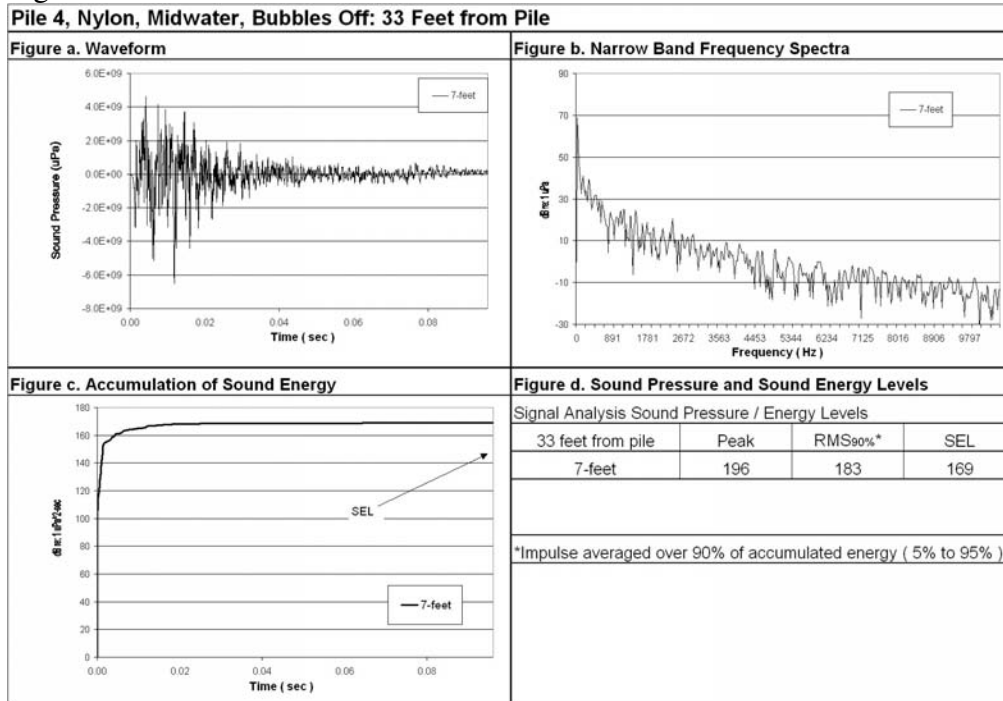
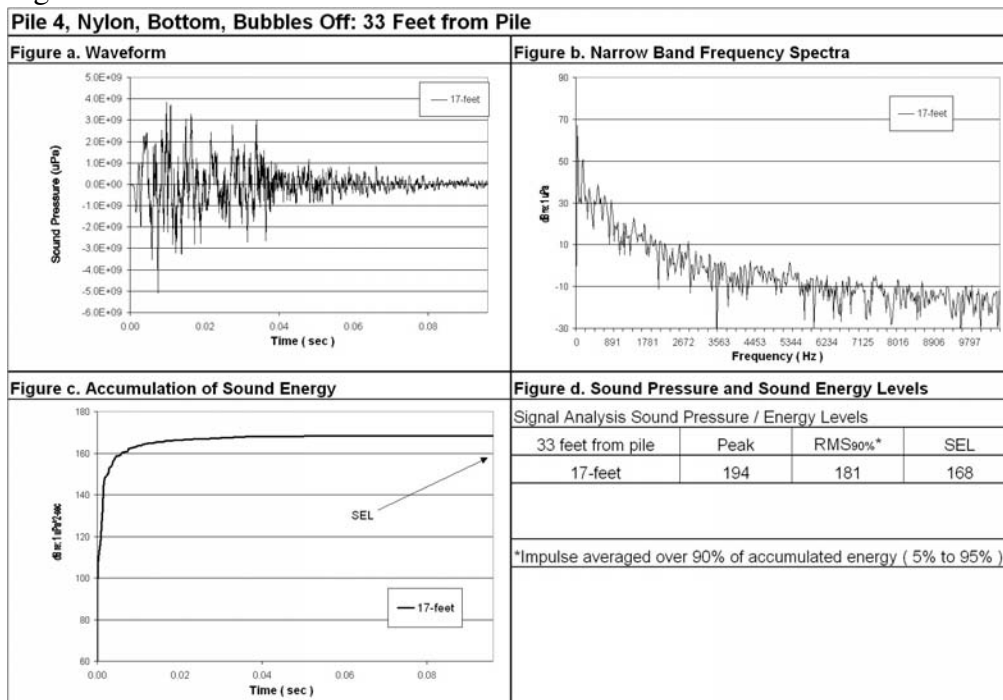
PILE 4 – NYLON PILE CAP, BUBBLE CURTAIN OFF

Figure 22: Waveform Analysis of Pile Number 4 Sound Pressure Levels with Nylon Pile Cap and Bubble Curtain Off, Midwater and Bottom.

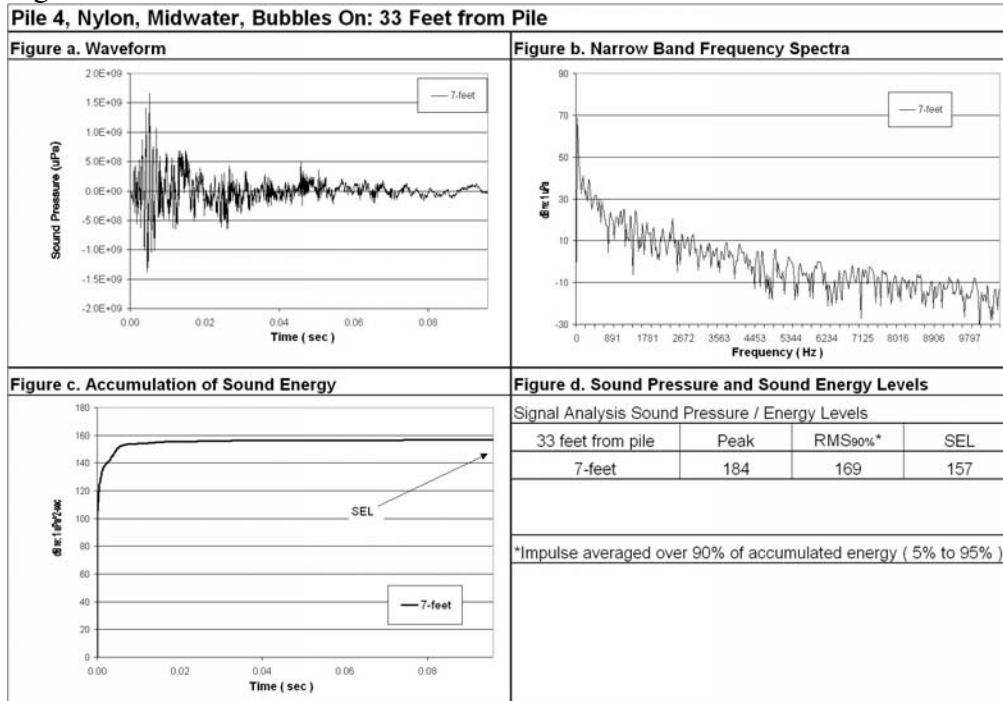
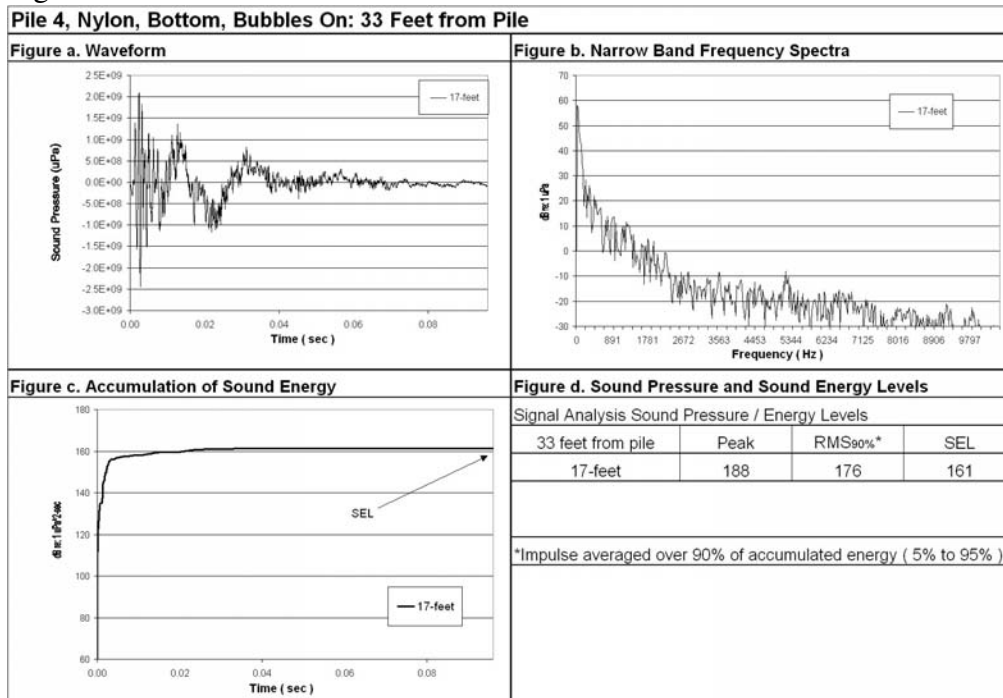
PILE 4 – NYLON PILE CAP, BUBBLE CURTAIN ON

Figure 23: Waveform Analysis of Pile Number 4 Sound Pressure Levels with Nylon Pile Cap and Bubble Curtain On, Midwater and Bottom.

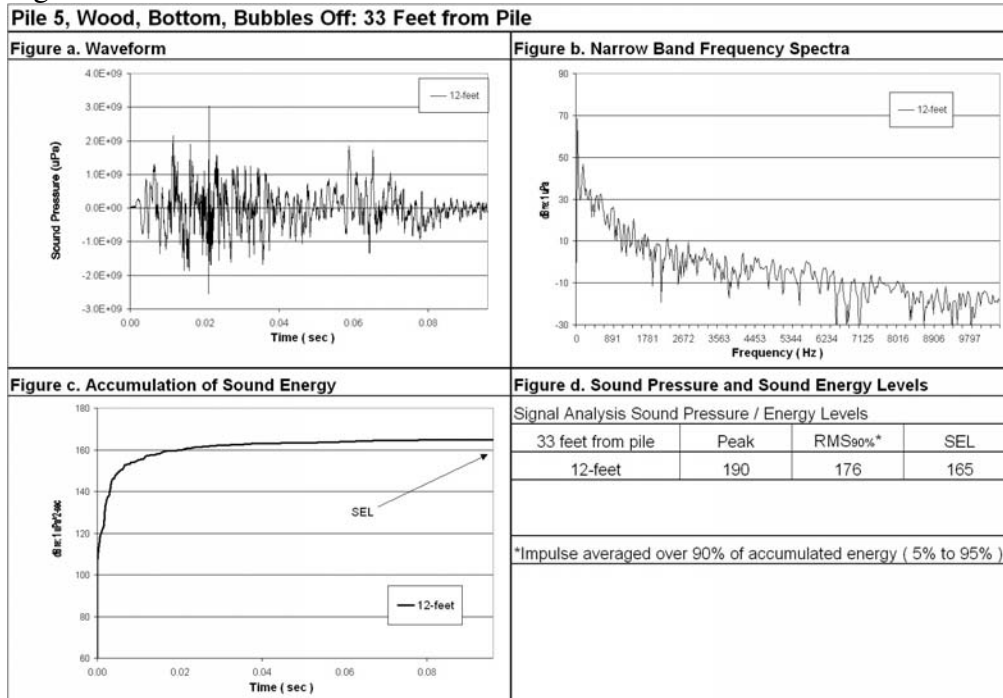
PILE 5 – WOOD PILE CAP, BUBBLE CURTAIN OFF

Figure 24: Waveform Analysis of Pile Number 5 Sound Pressure Levels with Wood Pile Cap and Bubble Curtain Off, Midwater and Bottom.

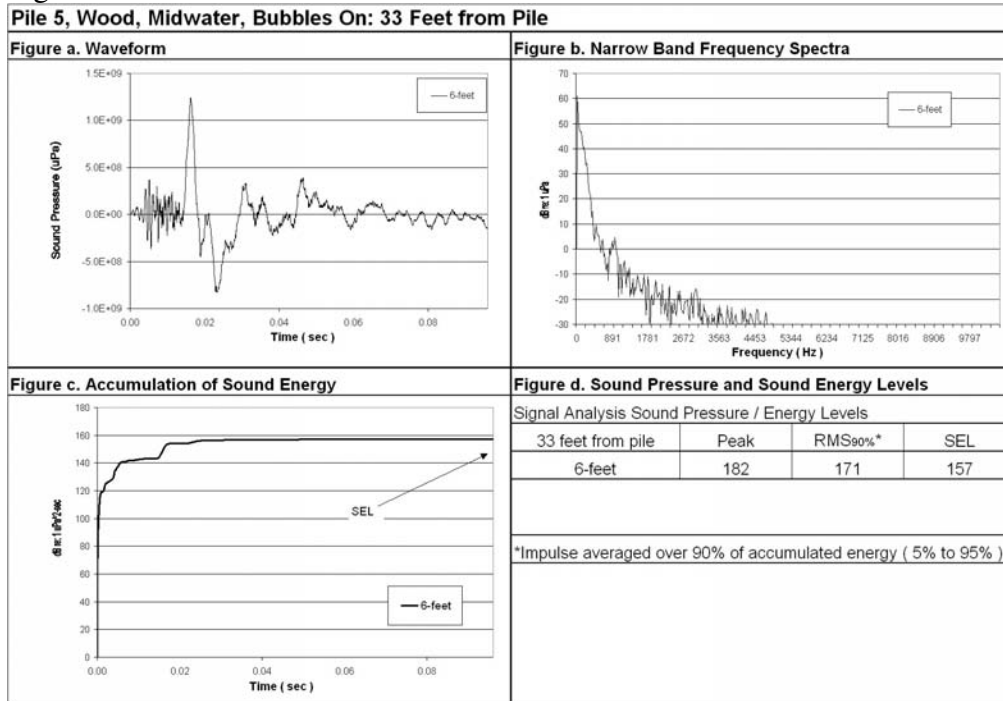
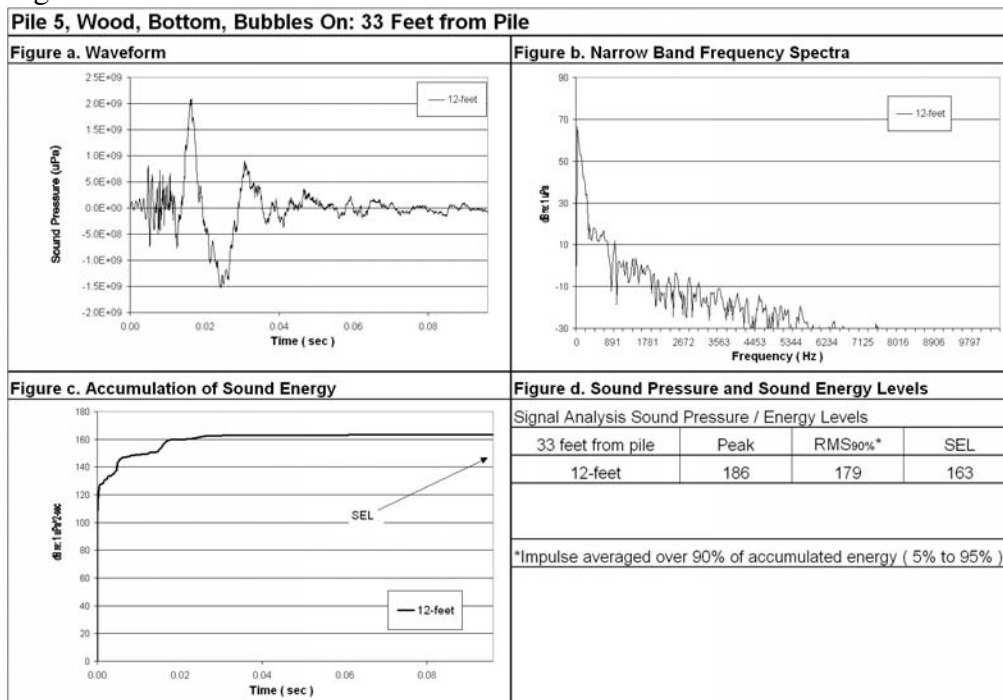
PILE 5 – WOOD PILE CAP, BUBBLE CURTAIN ON

Figure 25: Waveform Analysis of Pile Number 5 Sound Pressure Levels with Wood Pile Cap and Bubble Curtain On, Midwater and Bottom.
