MR 7.2.3: Report

Collision risk and impact study: Field tests of turbine blade-seal carcass collisions

Sea Mammal Research Unit
Report to
Scottish Government

July 2015 [version F1]

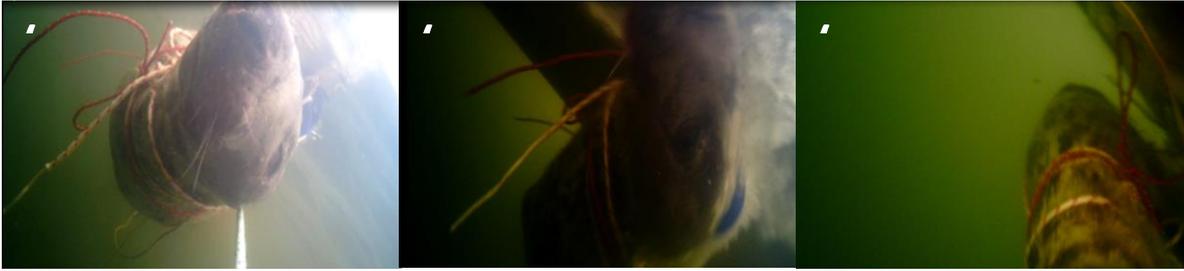
Figure 6. Underwater images of a collision to the abdomen showing (a) the seal suspended just below the surface, (b) the moment of impact with the carcass rolling away (clockwise in the 2D perspective) and (c) the carcass being pushed away and down into the water column by the continued momentum of the boat coupled with the angle of attack.

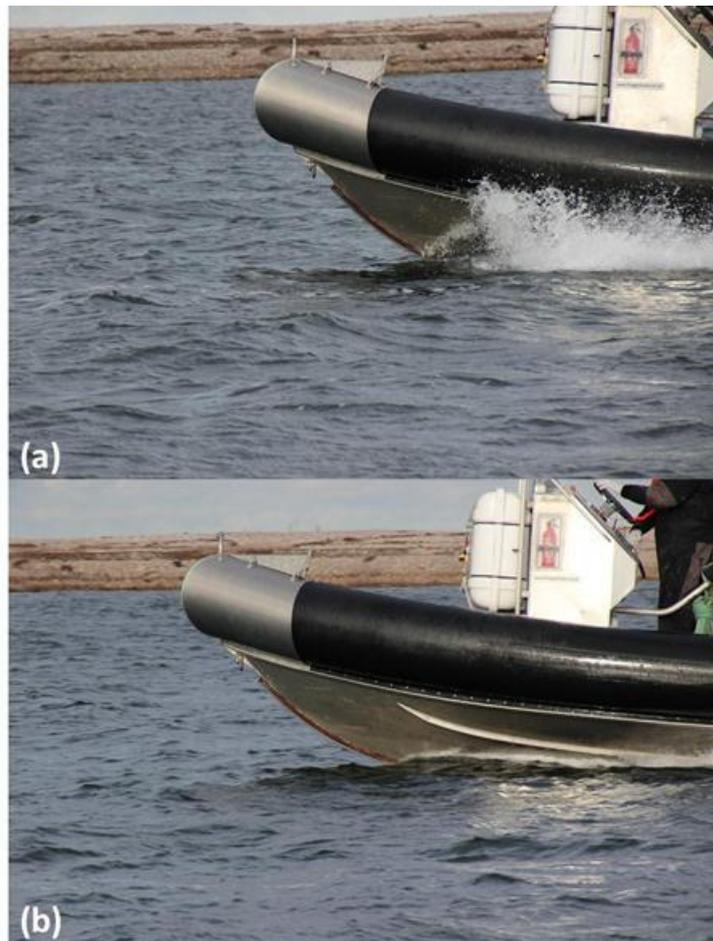
With the blade attached to a boat it was possible to accurately control point and speed of impact, but the curvature of the keel combined with changes in the trim angle of the boat at different speeds meant that the angle of attack and therefore effective collision speed varied between trials. Figure 7 demonstrates the elevation and angle of attack with relation to the water line for the ‘blade’ profile at the two different speeds used in the trials ($3\text{m}\cdot\text{s}^{-1}$ (6 kt) and $12\text{m}\cdot\text{s}^{-1}$ (24 kt)).

Figure 7. A perpendicular perspective of the blade profile at (a) 6 knots, and (b) 24 knots. Note the elevation of the boat hull with relation to the water surface and the resulting angle of attack of the blade.

Photographs of the boat passing at known speeds (Figure 7) were used to calculate angle of the blade at the impact point, assuming that the initial contact with the buoyed carcass was at 30cm above the surface. With the water surface acting as a flat, adjacent side to a right angle triangle, the impact angles for 3 m.s⁻¹ (6 kt), 6 m.s⁻¹ (12 kt), and 12 m.s⁻¹ (24 kt) were 43.7°, 33.9° and 28.2° respectively. Several photographs, perpendicular to the boat were used to confirm the angles were consistent. These angles were used to calculate an effective collision speed for each trial, calculated as:

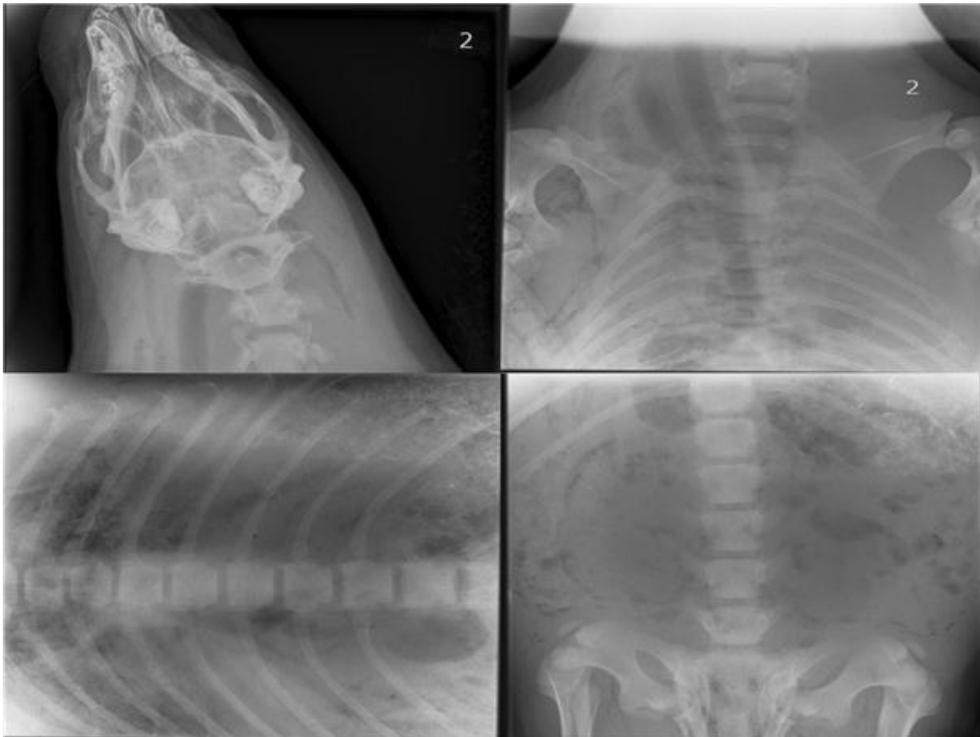
Post-trial radiographs of each juvenile showed no discernible evidence of skeletal damage; cranial, abdominal and pelvic bones remained intact (Figures 8, 9 and 10). This absence of skeletal damage was later confirmed by detailed necropsies.

Figure 8. Radiographic images of the head, torso and pelvis of juvenile 1.

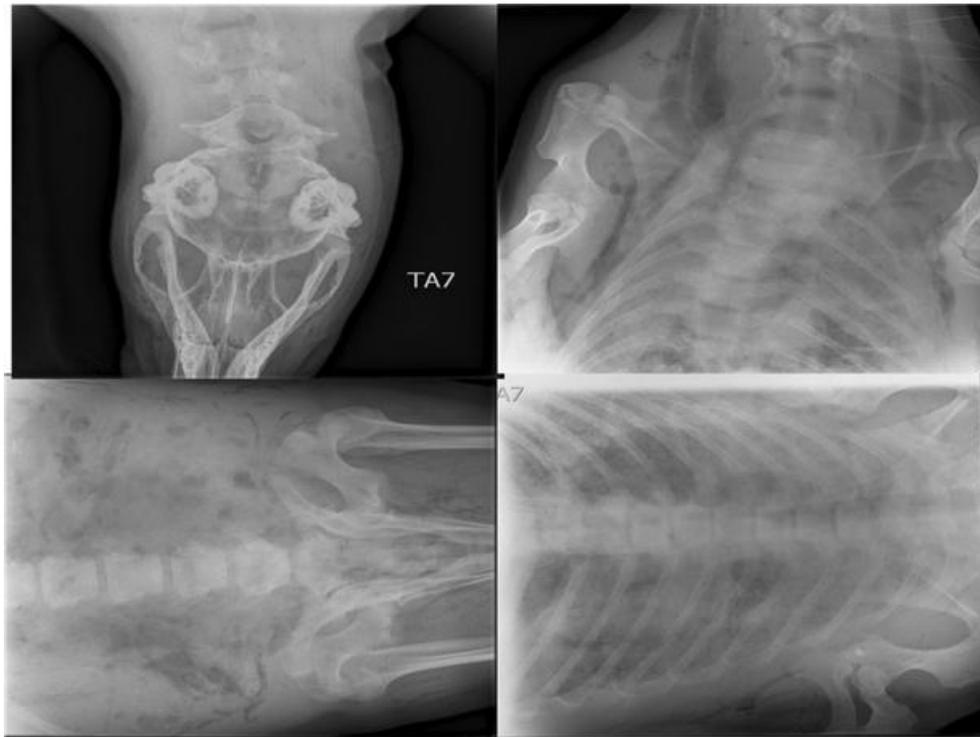
Figure 9. Radiographic images of the head, torso and pelvis of juvenile 2.
