# **Assessment of fish and wildlife presence near two river instream energy conversion devices in the Kvichak River, Alaska in 2014**

Gray Stassel Engineering, Inc.  
P. O. Box 111405,  
Anchorage, Alaska 99511-1405

December 2014

Matthew J. Nemeth, Justin T. Priest, and Heather M. Patterson

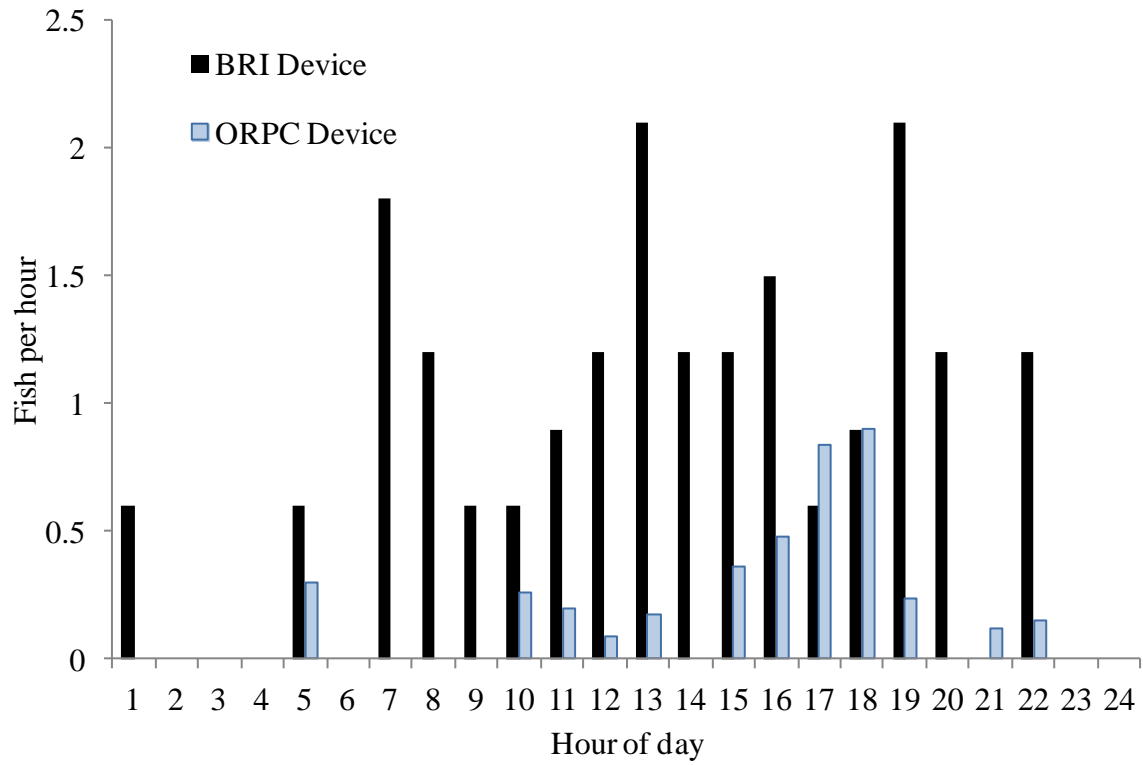
Figure 5. Fish detections by hour of the day at each RISEC device, standardized for review effort.

After standardizing for effort, sightings translated to 0.09 fish per hourly block at the device (52 fish divided by 555 hourly blocks among all cameras combined; Table 2). Sightings peaked between 1600 and 1800, accounting for over half of the sighting rate (Figure 5).

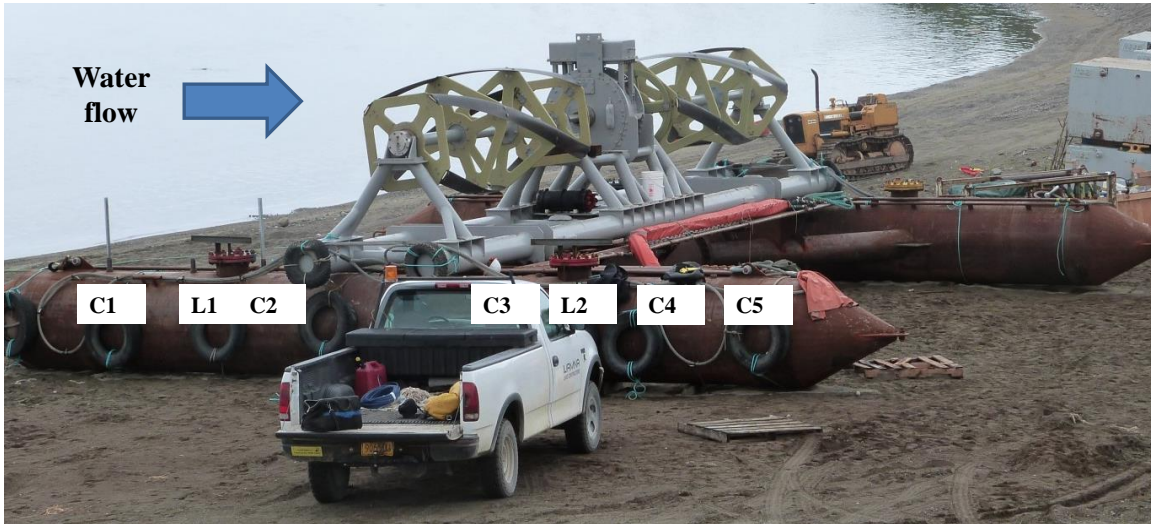
Photo 1. ORPC device before deployment, showing approximate mount locations of underwater cameras (C1 – C5) and lights (L1 – L2) in 2014. Water would flow from left to right.

Five cameras and two lights were used to monitor the ORPC device (Figure 3; Photo 1). Two cameras and one light were used to monitor the BRI device (Figure 4; Photo 2). Cameras and lights were affixed directly to the devices.

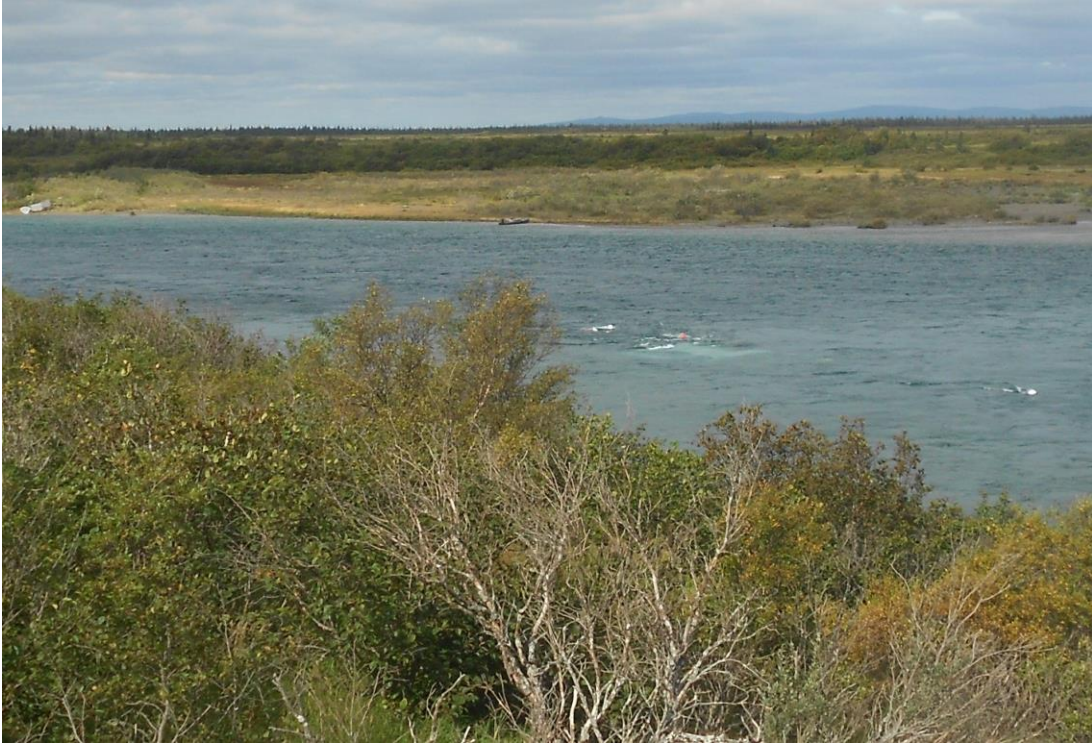
Photo 3. Surface view of the BRI device while submerged on September 1, 2014. Water flowing from right to left; device is the white object visible in right center of photo.

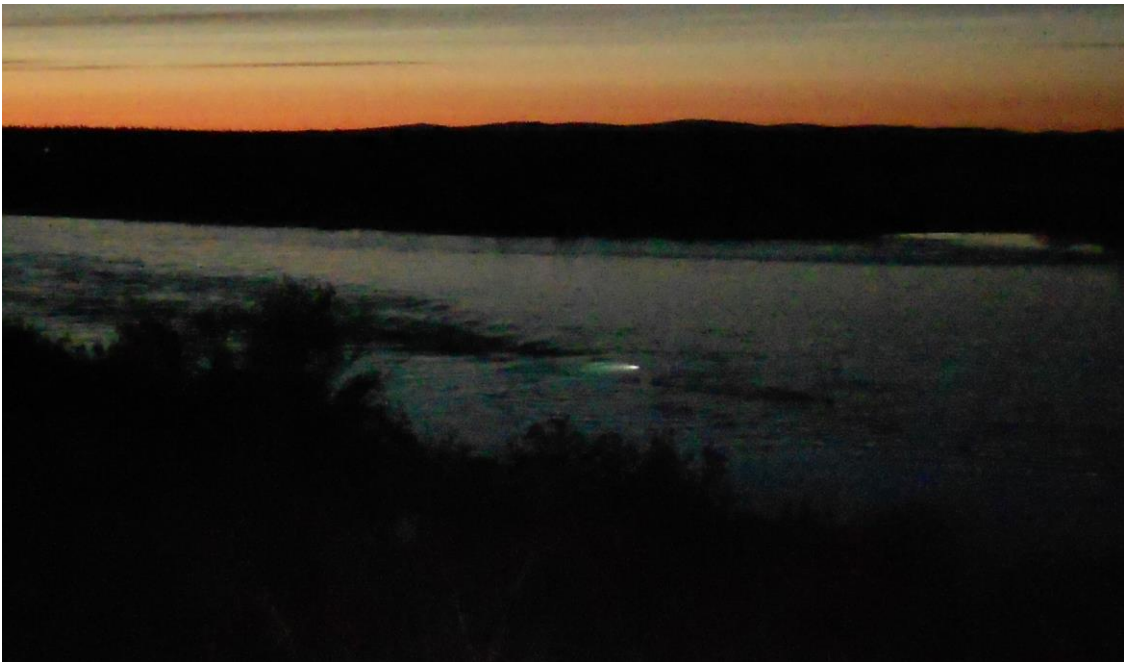
Photo 4. Surface view of the BRI device at night while submerged on August 30, 2014 at 11:00 pm. Illumination from underwater light attached to device is visible in right center of photo. Water flowing from right to left.

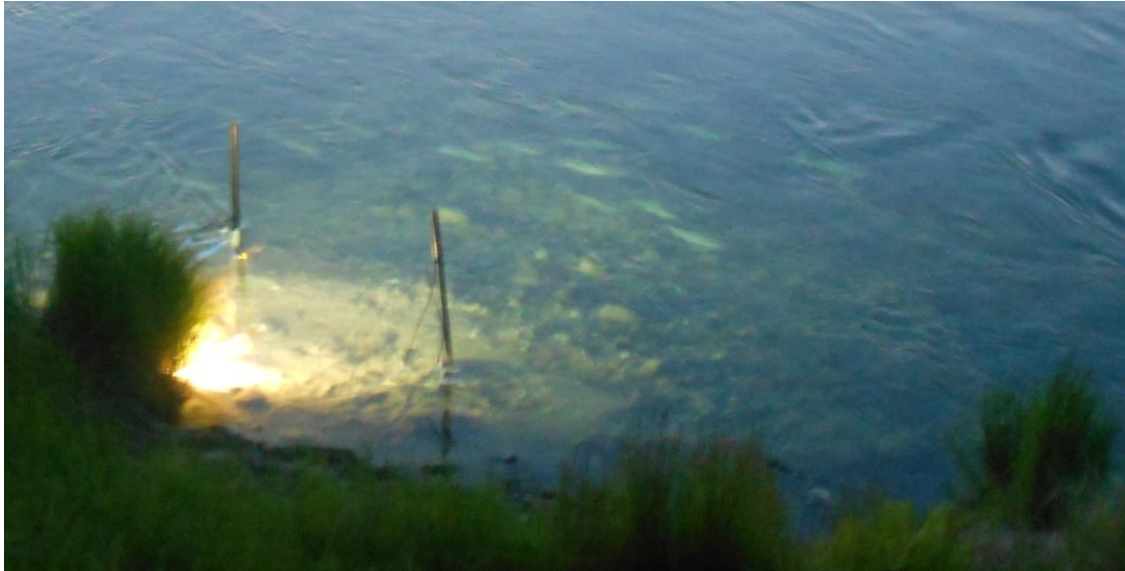
Photo 5. Surface view of pre-deployment testing of the underwater lights at 1:00 AM on July 3, 2014. Approximately ten sockeye salmon are seen migrating within the illumination field, at the top center of photo. Image is from a conventional (not underwater) camera, from about 20 m away.

Camera, lights, and recording equipment were tested prior to deployment (Photo 5). Once deployed, the equipment functioned reliably, with no breakdowns of camera gear or lighting. Inseason progress reports were delivered on July 10 and August 5, and a season summary was delivered September 30 (Appendix B). Final effort and results are summarized by device, below.

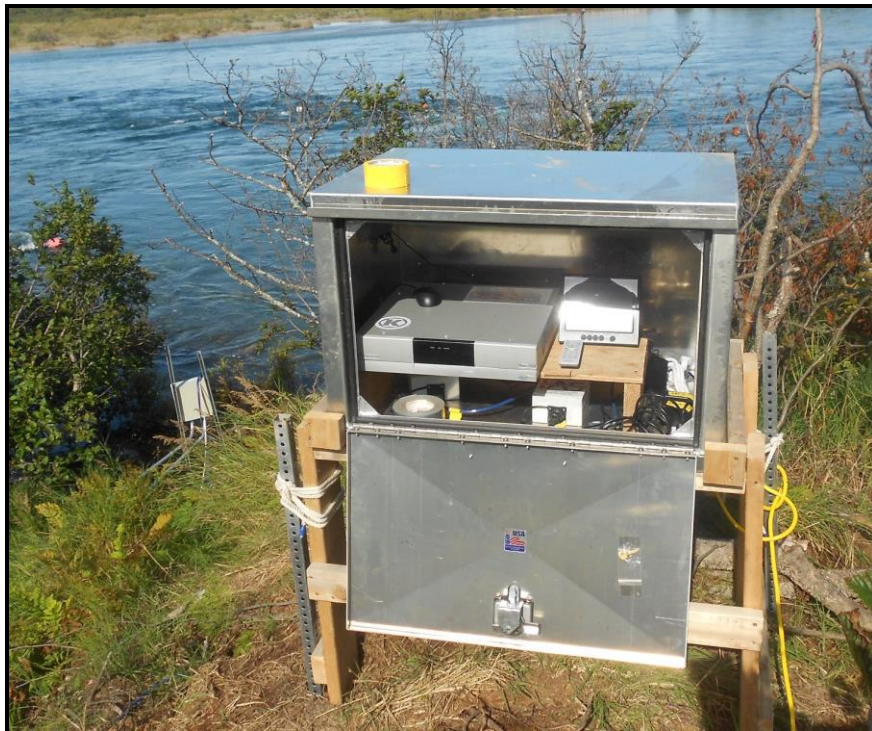
Photo 6. Shoreside cabinetry that housed the video recording system and power link for the BRI RISEC device in 2014. Marker buoys for the submerged device can be seen at top left of photo.

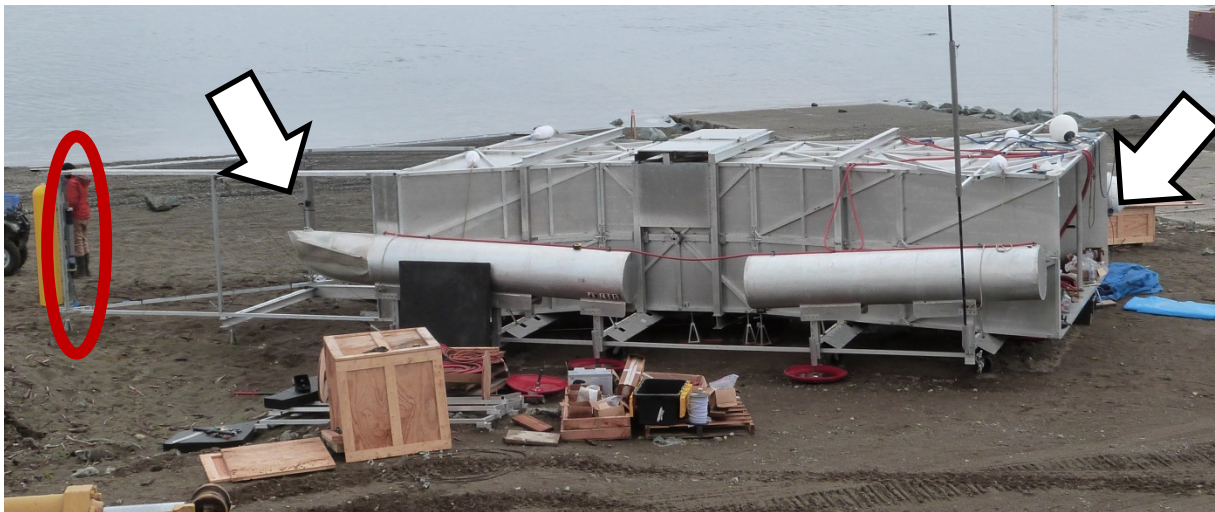
Figure 1. Location of mounts for two cameras (white arrows) and one light (red oval) on the BRI device. Water would flow from left to right.

Gear	Code	Location	Direction of view	Tested
Camera	BRI-1	Starboard bow, midway up debris guard	Down	OK
Camera	BRI-2	Starboard stern, at device exit	Across and down	OK
Camera	BRI-3	Mobile	TBD	OK
Camera	TBD	Mobile	TBD	Problems
Light	BRI	Center, bow, upstream end	Downstream	OK
Light	BRI	Mobile	TBD	OK
Camera	ORPC-1	Port side, bow, upstream	Across	OK
Camera	ORPC-2	Port side, bow, midway	Across	OK
Camera	ORPC-3	Port side, bow, near turbine	Across and down	OK
Camera	ORPC-4	Port side, stern, near turbine	Across and up	OK
Camera	ORPC-5	Port side, stern, midway	Across	OK
Camera	ORPC-6	Port side, stern, downstream	Downstream	OK
Light	ORPC	Port side, bow, midway	Across and down	OK
Light	ORPC	Port side, stern, midway	Across and up	OK

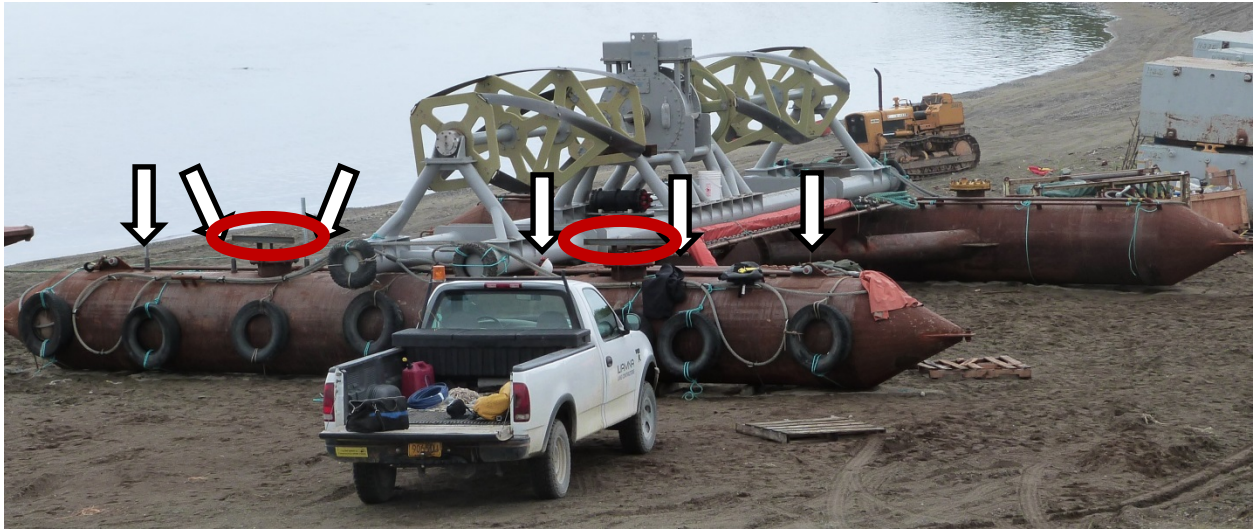
Figure 2. Location of mounts for six cameras (white arrows) and two lights (red ovals) on the ORPC device. Water would flow from left to right.
