Annual work report 2018

Offshore wind energy power plant

Nobelwind

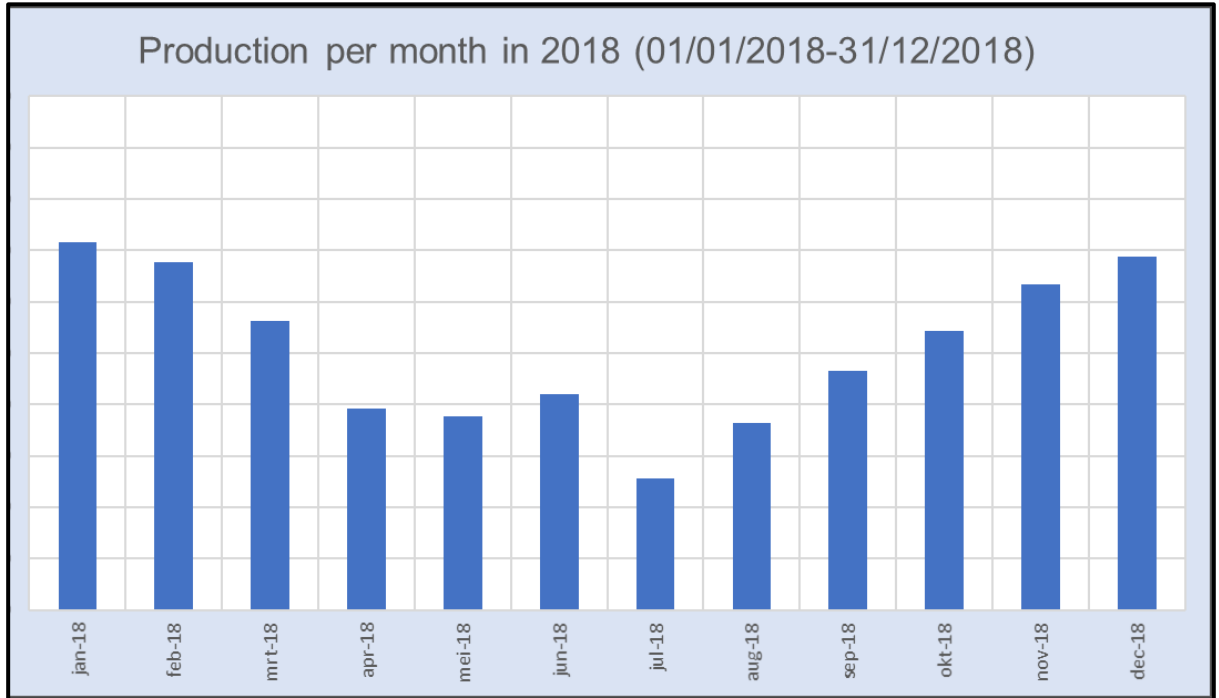
Monthly production V112 2018

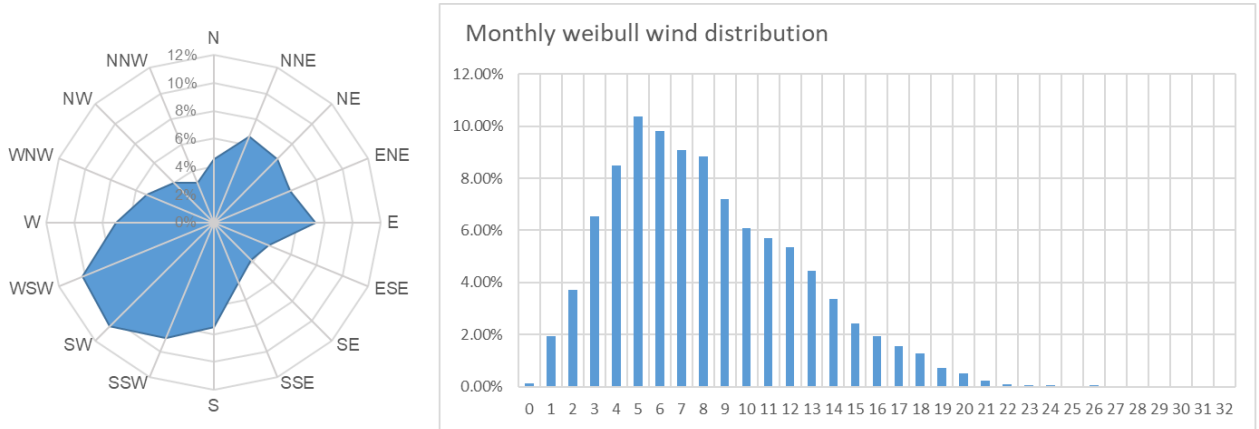
Wind graphs 2018

The displayed wind rose is a graphical representation of the wind speed and direction measured all over the wind park. The wind speed is calculated as an average from all turbines. For all wind speed categories, the wind direction WSW prevails.
