Operations Report 2007

Document No: OWEZ_R_000_20081023

Date: October 2008

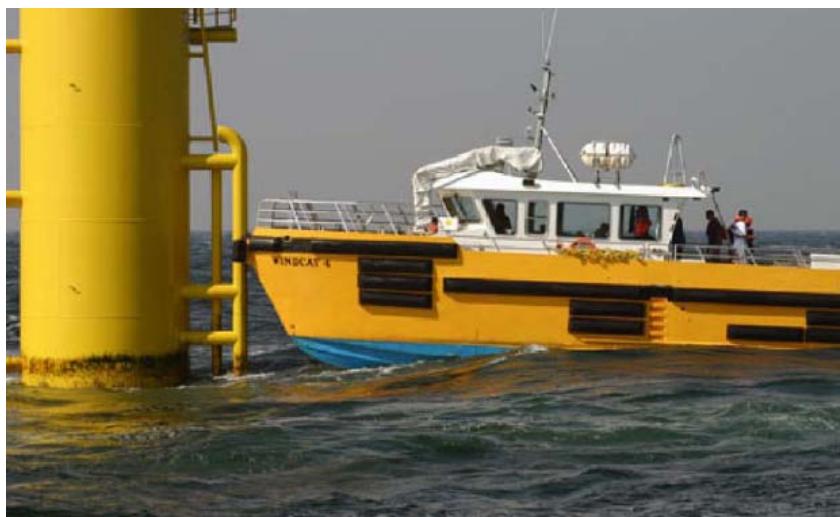
Picture: Windcat at foundation pile

The total number of service crew vessel visits in the first year was circa 300. Each crew vessel trip contained a maximum of 6 to 12 persons for performing inspections, scheduled service, unscheduled service and punch list activities. These visits were carried out by service technicians visiting the windfarm by boat, and then transferring from the boat to the turbine. On average nine people are on board of a crew tender and on average 1.5 wind turbines are visited during each trip. This results in a total number of offshore transfers in the year of 8100.

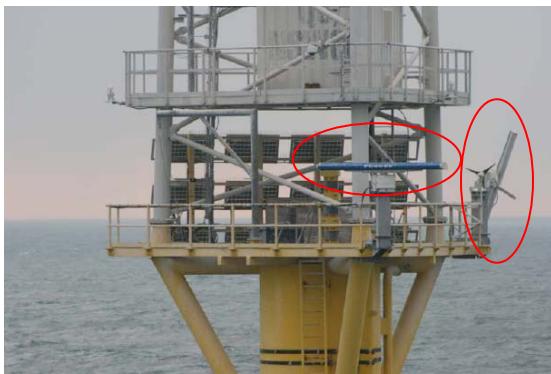
To assess the flight paths of birds in the area of the wind farm, visual observations as well as fully automated radar observations and registration of birdcalls are being carried out from the meteo mast in the windfarm. Radar observations include a vertically and a horizontally operating radar, that collect data continuously through an automated detection system.

Bird radar systems on the met mast

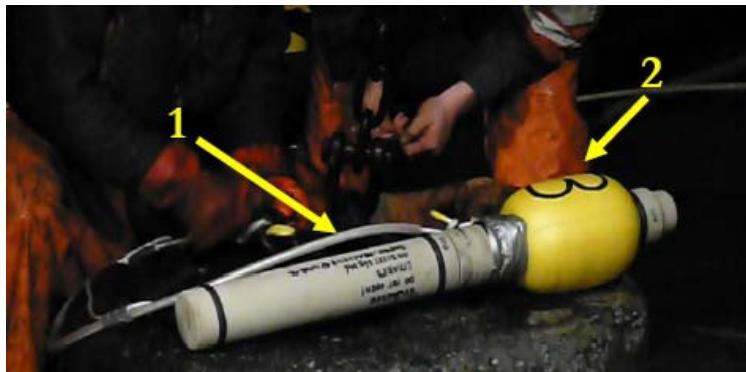
Each T-POD is deployed between two large buoys, the larger being equipped with a yellow navigation warning light. Due to a number of losses, probably because of some heavy storms, the actual attachments of the T-PODs were changed during the December survey. The attachment is made of a Kevlar cable surrounded with rubber tubing. To add buoyancy a small buoy is attached to the upper part of the T-POD.

The new T-POD attachment. Kevlar cable with rubber tubing (1) and buoy (2) for additional buoyancy.

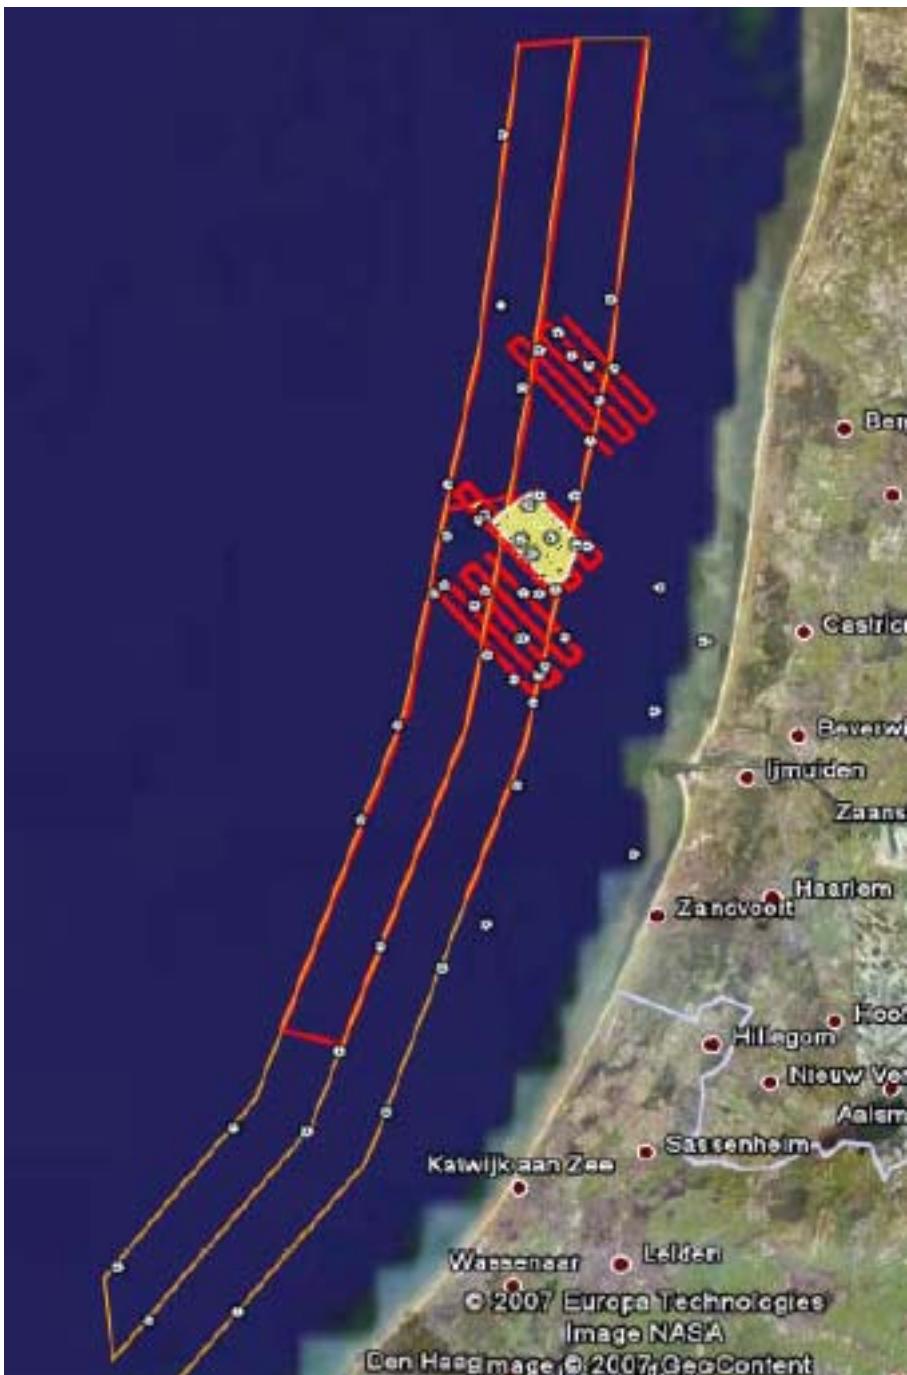
The monitoring program is designed to quantify the possible effects of the windfarm on the occurrence, density, population structure and migration patterns of the pelagic fish community, i.e. those fish dwelling in the water column. The sampling scheme has been designed to sample the variation in fish density in wind farm and to replicate this scheme in the two reference areas. Long North/South transects were surveyed to sample seasonal variability in the overall coastal area. The sampling scheme comprises a high resolution coverage of the windfarm area and its two reference areas as well in a low resolution coastal coverage. Acoustic techniques were used to sample fish abundance whereas trawl sampling was used to get species specific information such as age structure of the population, refer to the figure on the next page. Sampling was carried out in April 2007.

Pelagic fish acoustic sampling transects (trawl stations are indicated as blue dots).

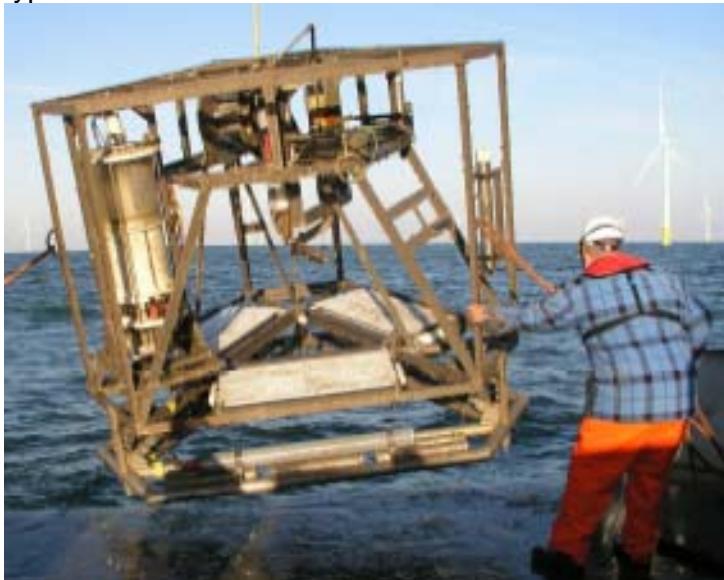
A benthos lander being deployed

present under a 16 m² surface area. The boxcorer is used to sample the small (generally 1 to 10 mm) more or less abundant fauna species. The dredge is used to sample the less abundant and larger species, which cannot be sampled quantitatively by the boxcorer. Boxcores were collected at 30 stations (refer to purple C marked dots in Annex 3) within the area of the turbines, one boxcore per station. The stations were arranged along transects running parallel to the windmill rows. In each of the control areas 15 boxcore samples were taken on three parallel transects. On board the boxcores were washed through a 1 mm mesh sieve and the residue was preserved in a 6% neutralized formaldehyde solution for later analysis in the laboratory. Dredge hauls were made along 14 transects in the area of the windmills, and along two transects in each of the control areas. Submerged landers were used to deploy instruments and in situ experimental settings (mesocosms) for a period of 8 months at the seabed to collect high resolution environmental data and samples of benthic larvae settled at different types of sediment.

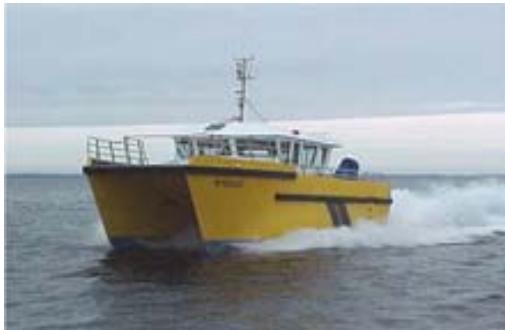
Photo: Windcat crew tender

and similar vessels, refer for other examples to Annex 4. Typical dimensions are an overall length of about 15 - 25 meters, width 6 meters, transporting capacity of 10 - 15 people and a speed up to 30 knots. For all these vessels the limitations of the suitable weather window are about the same, which in practice means 1.3 - 1.5 meter significant wave height. The vessels can operate in higher seas, but transfer of people from the vessel to the wind turbines and vice versa is considered to be unsafe under these conditions. Swell and currents may also have an impact on accessibility, as strong currents may occur which make docking at the turbines difficult. Strict procedures are in place for transfer from the vessel to the turbines, and back. These procedures include requirements on weather conditions, training of personnel, protective equipment, and safety devices such as mandatory use of immersion suits whenever the sea water temperature is 12 deg Celsius or lower, and the use of crew finder beacons.

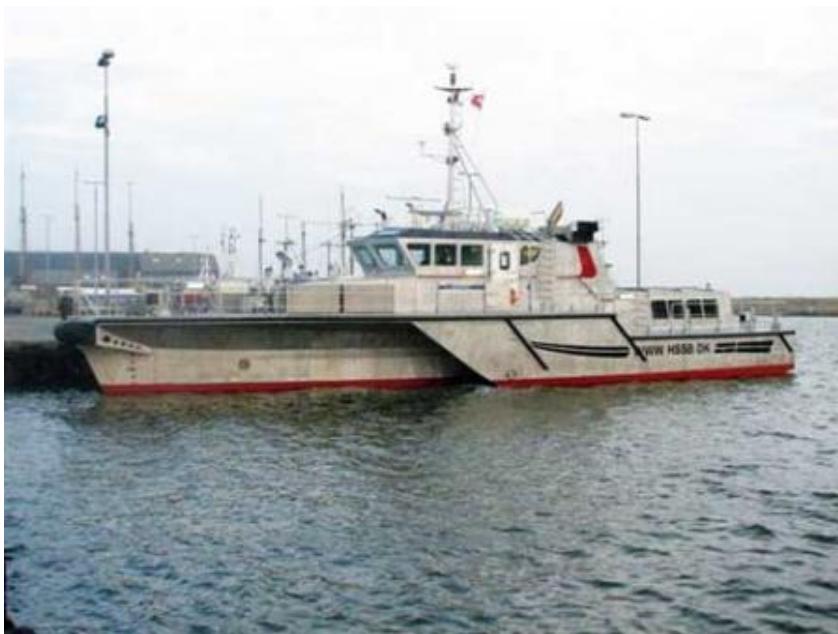
Picture: Purpose-built trimaran wind turbine service vessel FOB Trim (source: Internet)
