Final Technical Report

Recipient: Verdant Power, Inc. (DUNS Number: 798846585)

Award Number: DE-EE0005929

Project Title: Advancement of the Kinetic Hydropower System (KHPS) to Department of Energy (DOE) Technology Readiness Level (TRL) 7/8

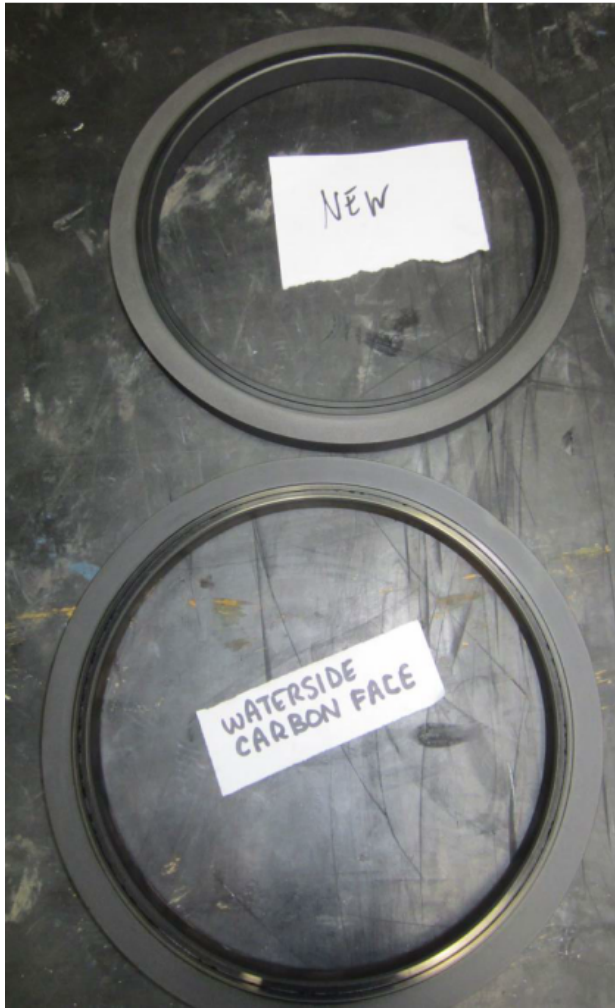
Figure 2.5 - Condition of Tested Outer Carbon Seal Face Compared to New Face

Inspection Results: No measureable wear of carbon or bronze faces.

The conclusions from the testing were that the measured leakage rate was well below the capacity of the system, and the seal wear would not be a limiting factor. There are a number of additional conservatisms in this arrangement. The overall conclusion from the testing is that the proprietary Verdant Gen5 KHPS seal arrangement, utilizing the Garlock Klozure dual carbon/bronze seal components, will fully prevent river/sea water from affecting the performance of the bearings and gearbox for the desired SI of 5 years.

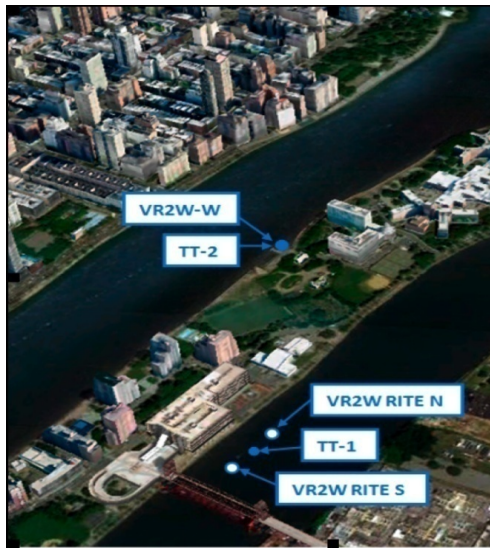
Figure 1. RITE Project P-12611 RMEE-4 VEMCO Receiver Locations

Under the RMEE-4 Tagged Species Detection plan, Verdant implemented data collection of tagged species in the vicinity of the RITE Project in May 2011 (See Figure 1), and continued this plan through 2014. Verdant downloaded data from the Vemco receivers in August 2015 as shown on Table 1-2015 below. During the period NO operating KHPS were installed, however the two east channel VEMCO receivers were lost in February 2015 due to an extreme ice event. A new receiver and test tag were deployed in August 2015 to maintain continuity of data. Additionally, Verdant did conduct RMEE-3 Species characterization netting in May 2013, under appropriate NYSDEC and NOAA scientific collection permits (no ESA species were collected). This compliance work is partially funded from a grant from NYSERDA and the cooperation of researchers who tag the fish is greatly appreciated.

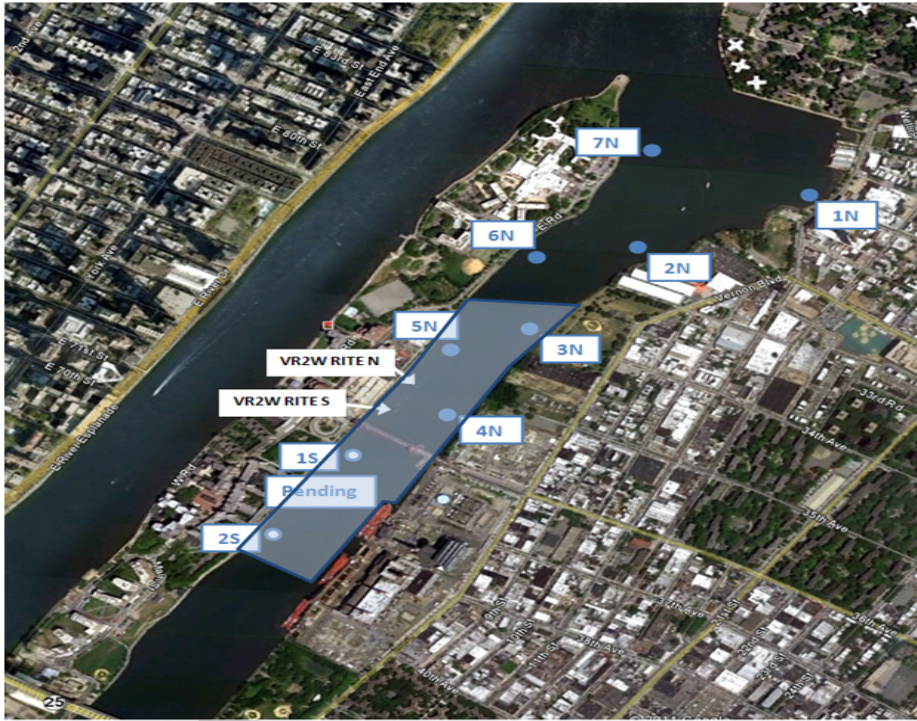
Figure 2-3. - RITE Project VEMCO Receiver Range, Test tag verification – August 2011

- 2) An acknowledged limitation of the RMEE-4 plan is that a "detection event" as described below indicates that a tagged fish was somewhere in the range of the receivers – as noted on Figure 2. The exact location both within the water column and within the cross section, and thus proximity to the KHPS machines, cannot be achieved with this installed system. A detection event means that a tagged fish came within 400m of the proposed site of the operating KHPS.

- 1) A similar exercise cannot be conducted in the West Channel to verify range, since it is the main NYC navigation channel and small vessel movement in this pattern would be hazardous.
