RAMPION OWF

GEOTECHNICAL SURVEY

FINAL RESULTS REPORT

JUNE 2016

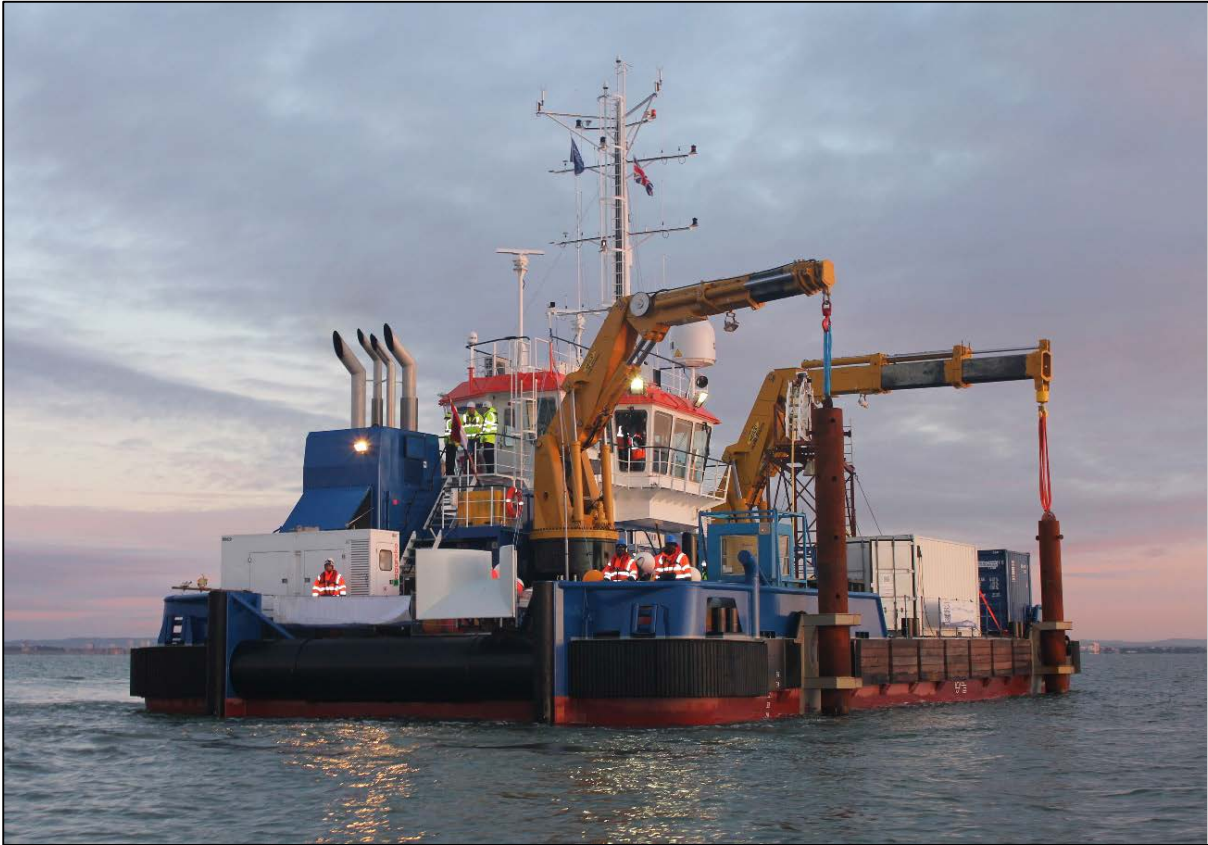
FIGURE 4: SURVEY VESSEL – INNE K

The Roson LA100 Wheel driven CPT and EGS 6m Vibrocorer were mobilised to the vessel INNE K, a large Multicat type workboat with full DP2 capabilities. The vessel has a large deck space and elevated wheelhouse. The deck equipment includes two Heila HLRM cranes, one forward capable of lifting 20.5 tonnes at 14.05m extension and one aft capable of lifting 10.3 tonnes at 16.5m extension. Also onboard are a variety of winches with various load ratings of 125 tonnes, 50 tonnes and 2 x 15 tonnes.

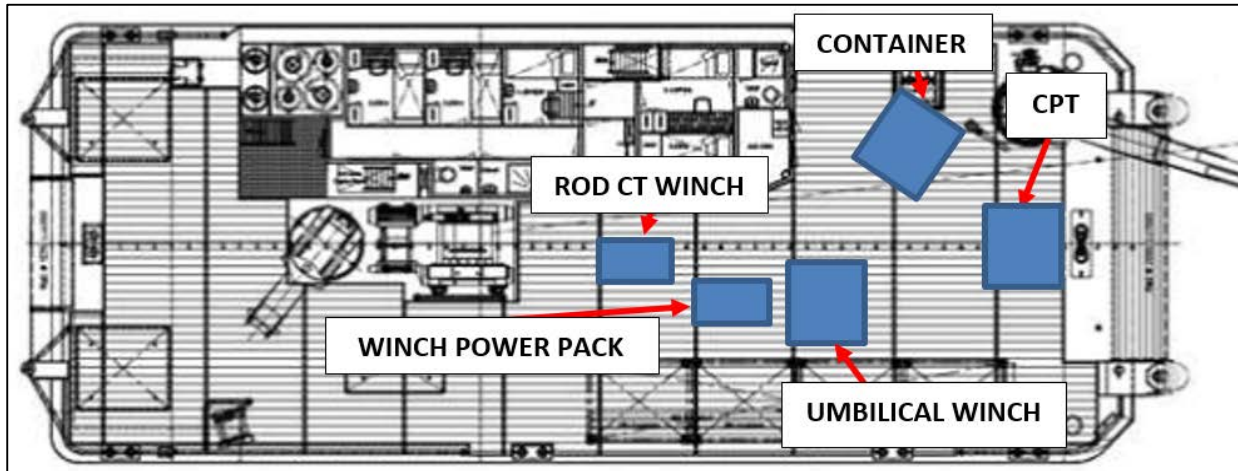
FIGURE 6: INNE K DECK LAYOUT CPT

The CPT operations container and winches were installed onto the deck using the deck beams as weld points. The container was positioned in away that allowed the winch wire to run safely between it and the winches (Figure 6).

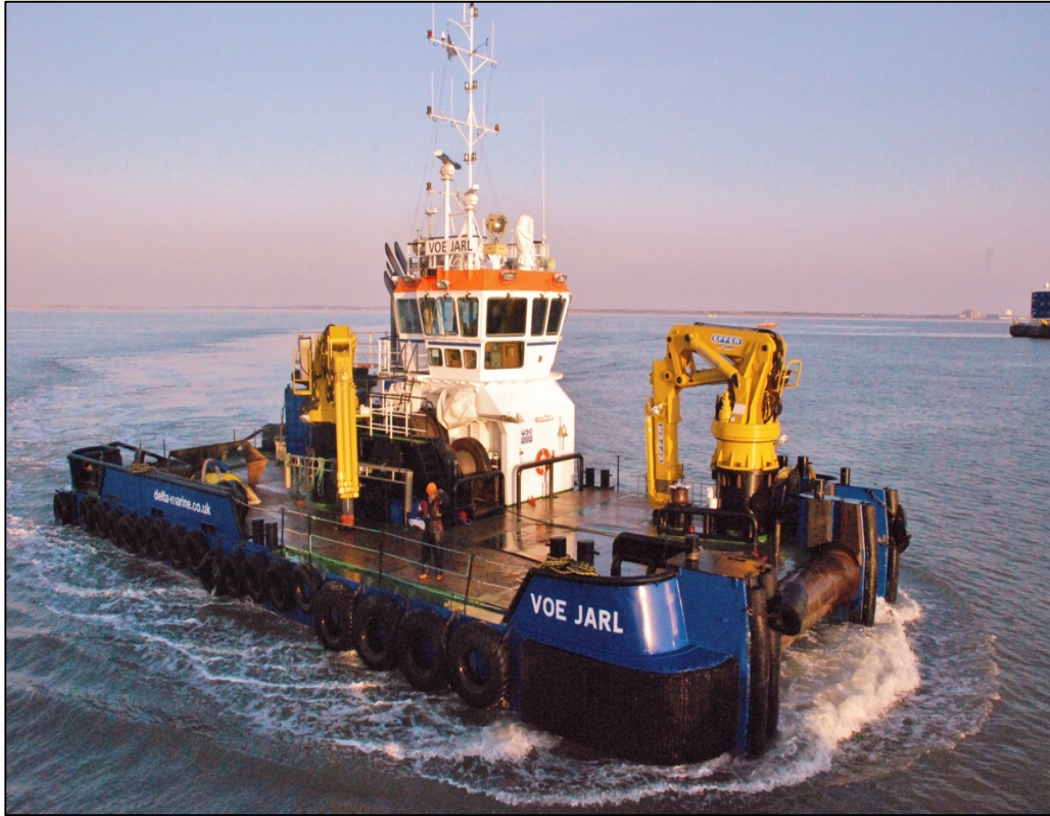
FIGURE 7: SURVEY VESSEL – VOE JARL

The EGS 6m Vibrocorer was mobilised to the vessel VOE JARL, a smaller Multicat type workboat than the INNE K. The vessel has an open deck space and elevated wheelhouse. The deck equipment includes two Effer 3S cranes, both capable of lifting 10.5 tonnes at 16m extension and a variety of winches with various load ratings of 100 tonnes, 50 tonnes and 2 x 13 tonnes.

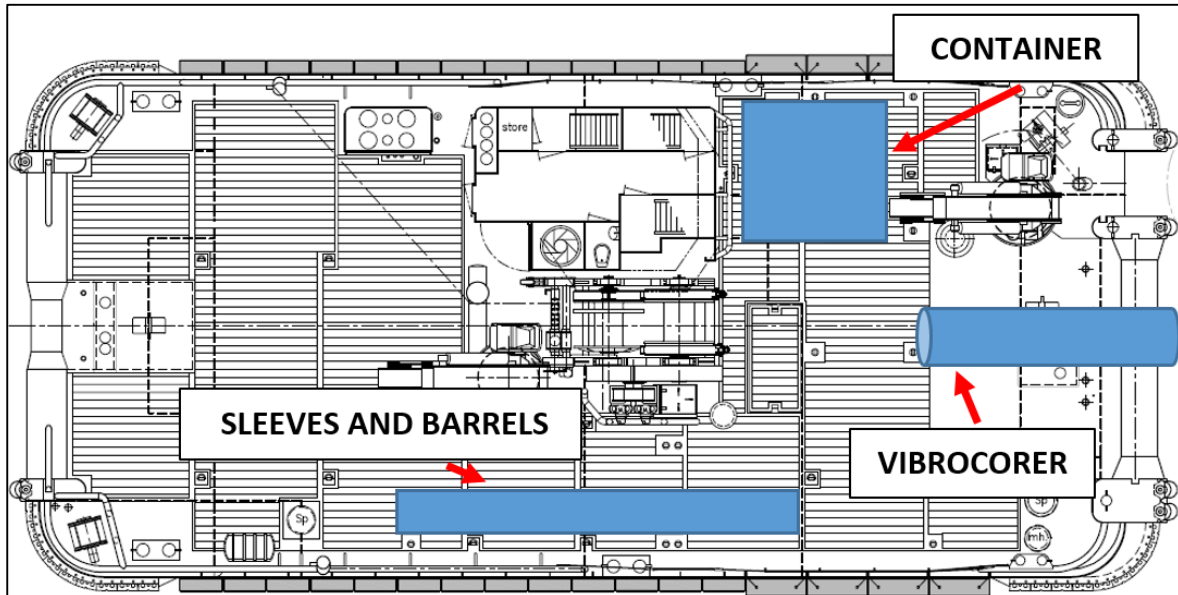
FIGURE 8: VOE JARL DECK LAYOUT VIBROCORER

The Vibrocorer was mobilised to the vessel with the legs extended and positioned on the bow roller with the extended legs hanging over the roller. The Vibrocorer container was positioned in the forward port corner of the vessel in order to be near to the vessel power supply. The Vibrocorer spare barrels and sleeves were mobilised aft in order to have a safe working area around the Vibrocorer during deployments (Figure 8).
