## Scientific report

Installation of live flat oysters and monitoring benthic biodiversity in OWF Borssele III/IV; T-0 2020

de Rijke Noordzee  
Amsterdam, June 2021

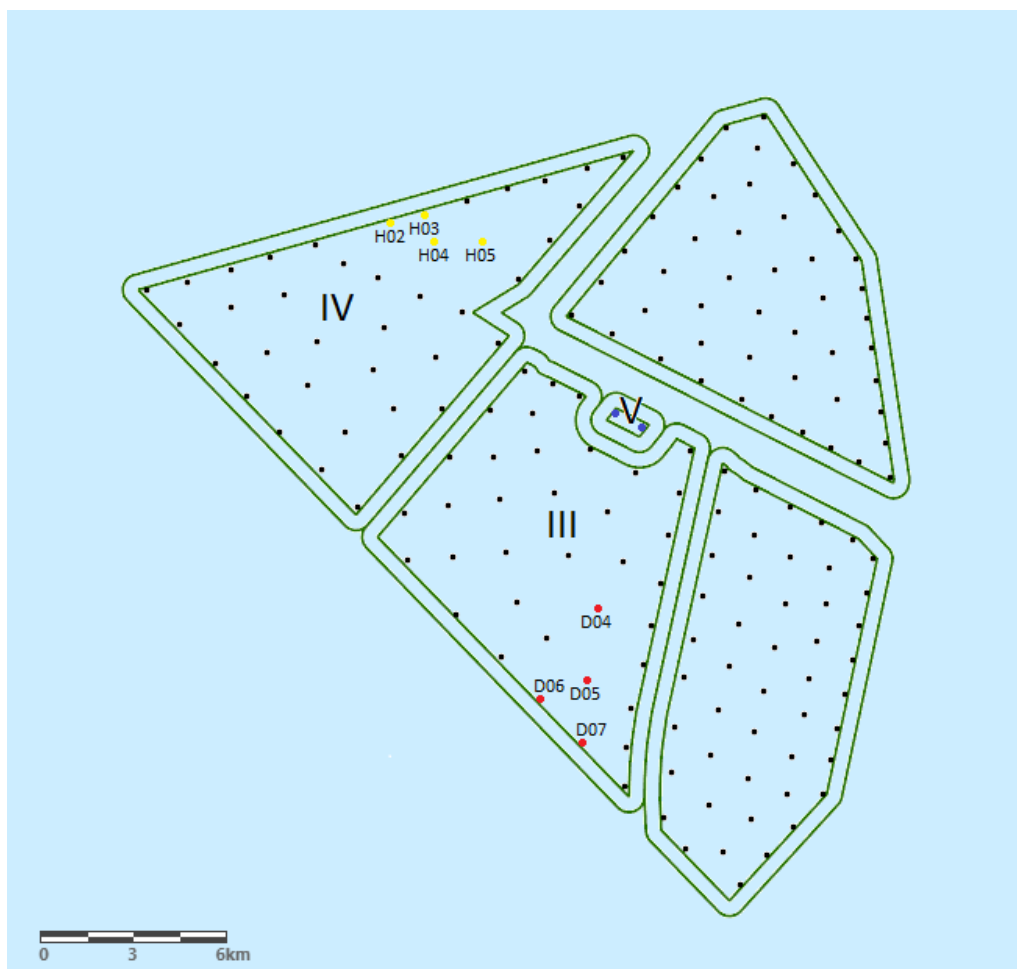
Figure 2-1: Overview of the Borssele offshore wind park. Red dots concern the locations for the oyster installation (from top to bottom B334-D04, B337-D05, B328-D06 and B327-D07), the yellow dots are the reference locations (from left to right: B412-H02, B411-H03, B402-H04 and B401-H05). The blue dots concern locations on Borssele 5.

In Figure 2-1 an overview is given of the sampling sites in the Borssele windpark for the field work. A total of 8 monopiles and their surrounding area have been designated for the study in Borssele 3/4. In the vicinity each of monopiles in Borssele 3 there were Oyster tables placed with each table containing 8 oyster baskets with 75 living oysters (red locations). Next to this an ecological study was executed for the T-0 assessment using ROV images and eDNA sampling. In Table 2-1 an overview of the used methods per sample location is provided.

The oyster structures were placed on the scour protection at 4 monopiles in Borssele 3 off-shore wind park (locations B328-D06, B337-D05, B334-D04 and B327-D07, red dots in figure 2-1). Another 4 monopiles (locations B401-H05, B402-H04, B411-H03 and B412-H02, yellow dots in Figure 2-1) serve as reference locations (no installation of oysters).

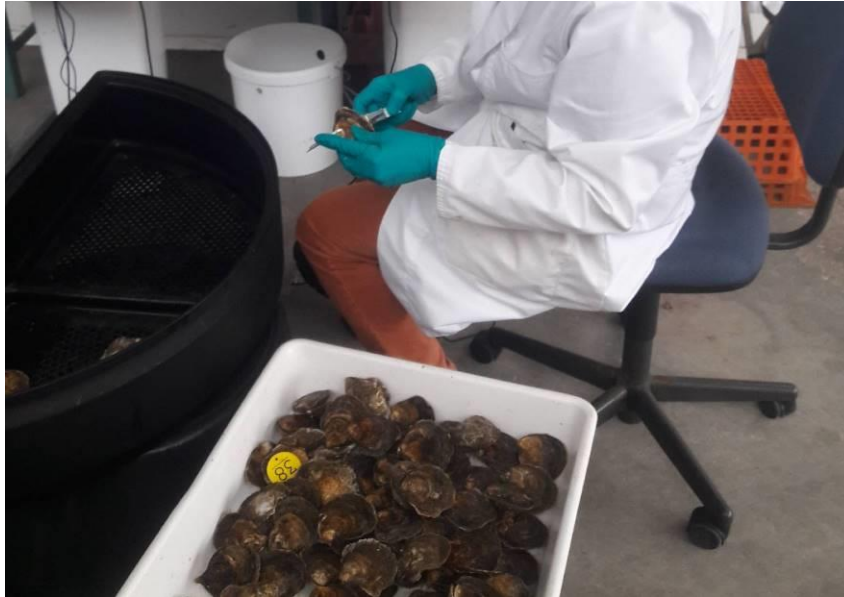
Figure 2-2: Measuring oysters size using digital calipers

The measurement and monitoring of the flat oysters (*Ostrea edulis*) for the T-0 assessment took place in Yerseke on the 29<sup>th</sup> of September 2020. The oysters were removed from the Aqualife tank. For the oyster experiment, only live oysters without juvenile Oyster spat were selected in order to prevent young oysters from being to be falsely found during the experiment. The longest length and widest width of each Oyster was measured and saved in a database (Figure 2-2).

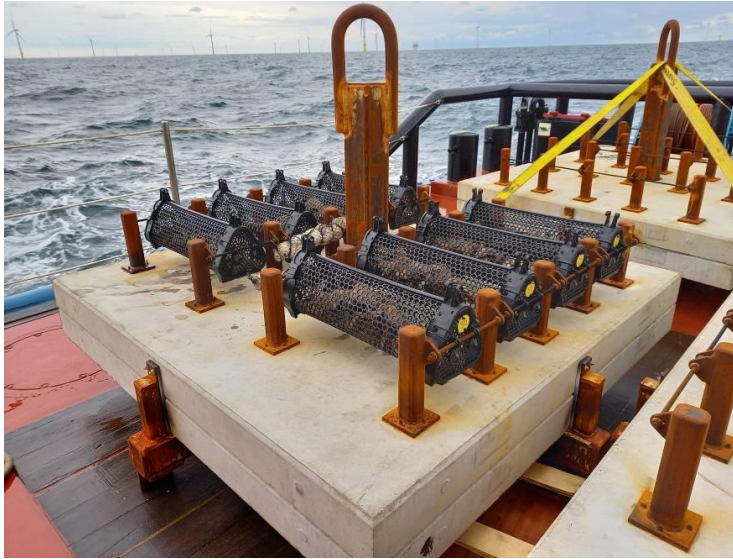
Figure 2-5: Oyster table with 8 oyster baskets with their corresponding labels and cohort numbers attached.

On board of the research vessel, the cohorts were taken out of the Aqualife tanks and put in cages with their corresponding label tie-wrapped to the cage doors. One 'oyster table' consists of 8 cages (Figure 2-5).

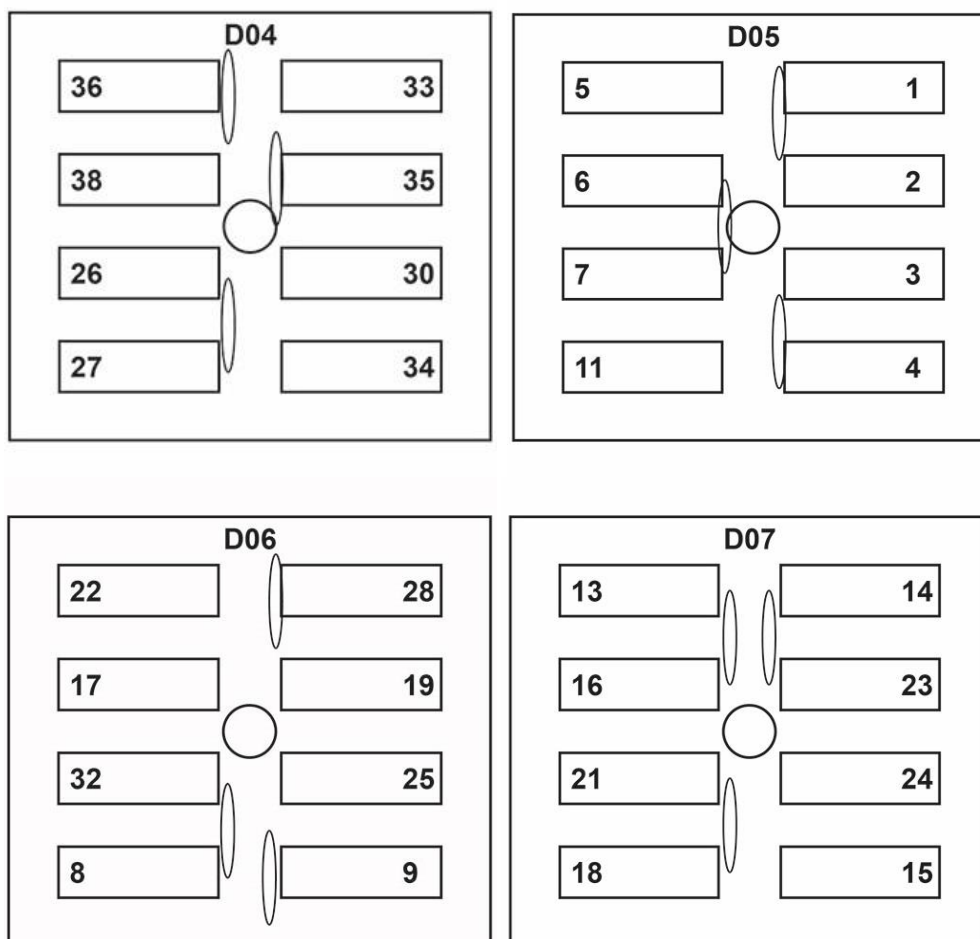
Figure 2-6: Schematic representation of the Oyster tables and the placement of the cohort numbers relative to the different monopiles at the locations D04, D05, D06 and D07. The ellipses indicate the placement of the bags with empty shells (noted at D07 on the basis of photos).

On board of the vessel the Oysters were transferred from the Aqualife tanks to the Oyster baskets using the cohort number as a number for each basket. The number tags were attached to the basket doors and the baskets were filled with the Oysters. For each Oyster table, 8 Oyster baskets were filled with 75 living Oysters per basket. In total 2400 Oysters were brought down on the seafloor in 32 cohorts on 4 Oyster tables. After positioning and securing the cages on the Oyster tables 3 additional bags containing empty Oyster shells were attached to each oyster table as a potential substrate for Oyster spat. The positions of the cohort numbers on the oyster tables are indicated on the following diagrams (Figure 2-6). In this figure the bags with empty Oyster shells is indicated with an ellipse.

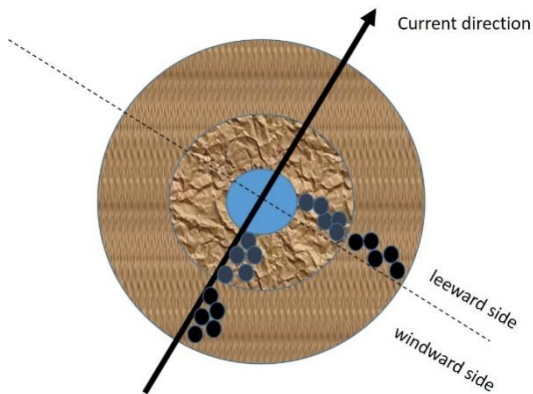
*Figure 2-7: the positioning of coarse and filter gradings around the monopiles, and the approximate positioning pictures (black dots in filter grade, gray dots in coarse grade)*

At all 8 sample sites, an ROV survey was performed to take high resolution pictures of the benthic fauna living around the monopiles. For each turbine in the investigation four different types of scour-protection were used. The area around the base of a monopile is divided into 4 sections. The first division is between leeward and windward side. The second division is between coarse and filter grade scour. The coarse grade scour is closest to the base of the monopile (see Figure 2-7). A finer grade is present at a further distance.

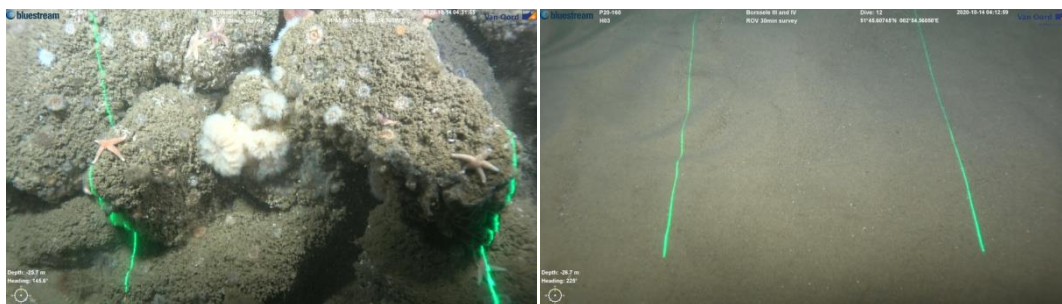
Figure 2-8: Examples of some ROV photo's from the T-0, 2020 survey. Left image: H03-PC-CG-01 right image: H03-CD-FG-04

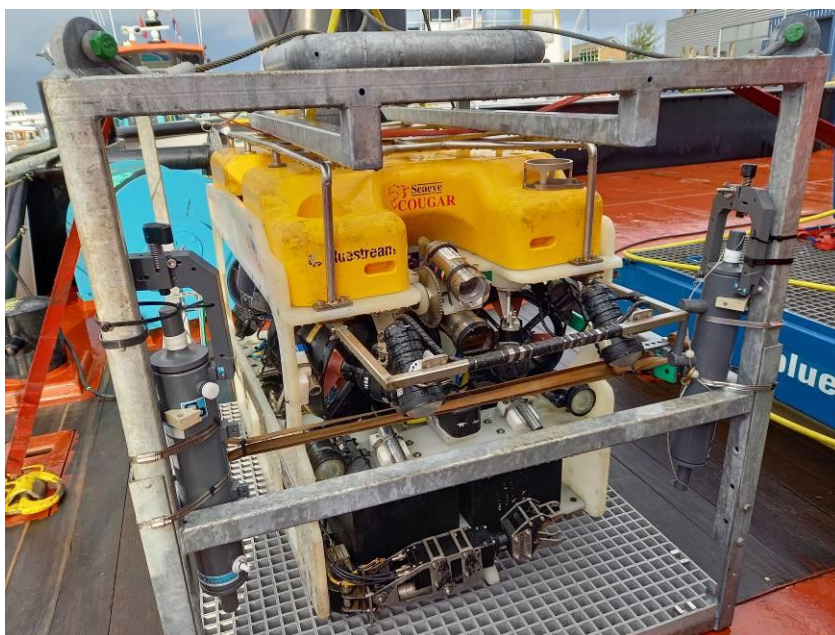
Figure 2-9: ROV in cage, with 2 Niskin bottles attached vertically.

After performing the ROV survey, the Niskin bottles were closed using the ROV manipulator. This happened at a height of 2 meters above the scour protection. After the ROV was retrieved on deck of the vessel, the eDNA-sample was collected. As the Niskin bottles remained attached to the cage, it was usually not possible to sample 2000 ml from 1 Niskin bottle. Therefore this was supplemented with water from a second Niskin bottle.

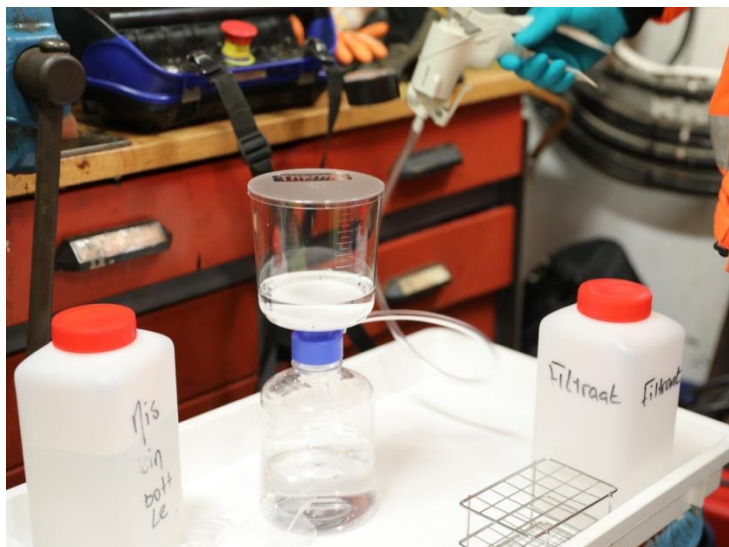
Figure 2-10: eDNA filtration set-up on the research vessel.

After collecting sampling water, the eDNA-sample was collected on a sterile cup with a filter (0.2  $\mu\text{m}$ ) by passing the water sample through a funnel via the filter into a sterile 2000 ml vacuum flask. Before every sample site, all bottles, tweezers and other equipment is cleaned with 50% bleach solution. Also latex unpowdered gloves were used throughout the sampling process. A vacuum was created by a hand-pump enabling a faster passage of the water through the filter. Figure 2-10 provides an overview of the set-up. Table 2-2 summarizes the volumes of water that were filtered per location.

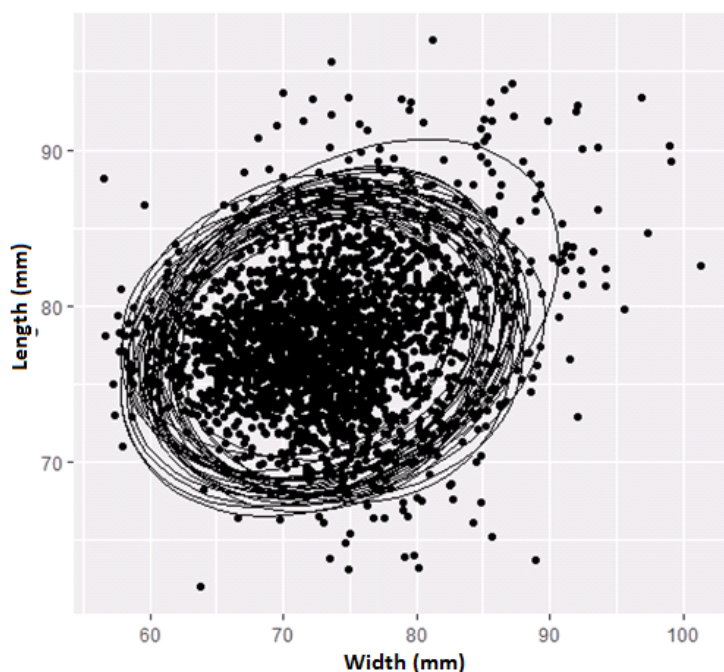
Figure 3-1: X-Y plot of all individual oysters with length and width in mm. Circles indicate the 95 percentile distribution of measurements by cohort. The centers of these circles are located on top of each other (with the exception of 1 circle (basket 8)). This indicates that although the distribution contains slightly larger individuals (in the upper right corner), each cohort contains as many of the larger individuals (basket 8 slightly more large individuals than average).

Before deployment a total of 2400 flat oysters have been measured. The average length was 77.9 ( $\pm 4.6$ ) mm, the average width was 73.5 ( $\pm 6.3$ ) mm. The measurements of the flat oysters show that each cohort displays a normal distribution in size (Figure 3-1). Also, the size of oysters is normally divided among all cohorts together, with the exception of one cohort (basket 8) as it includes more on average larger individuals than in other cohorts (see Figure 3-2 and Figure 3-3). The individuals in basket 8 in itself, however do exhibit a normal distribution in size. Overall the Oysters were quite similar sized.

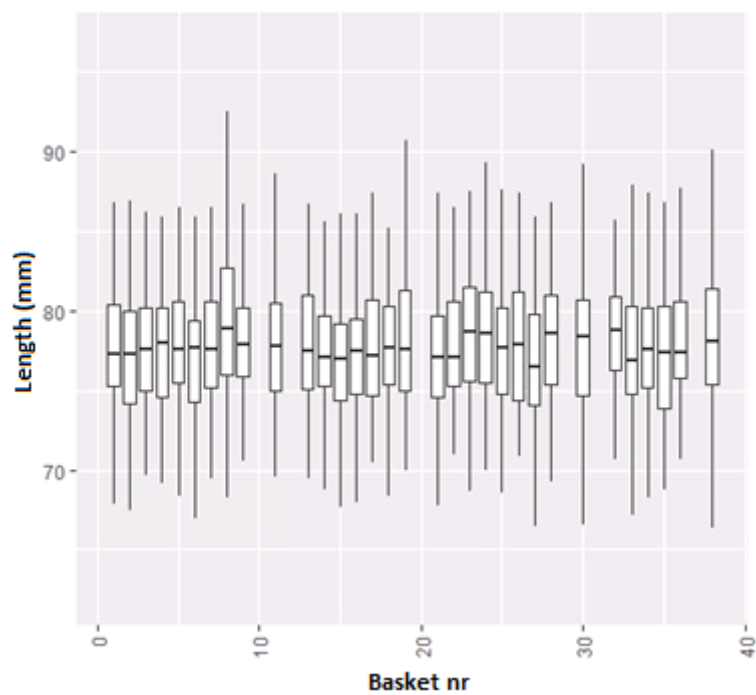
Figure 3-2: Distribution of measured shell lengths (longest length in mm) per cohort/basket in the 2020 baseline.

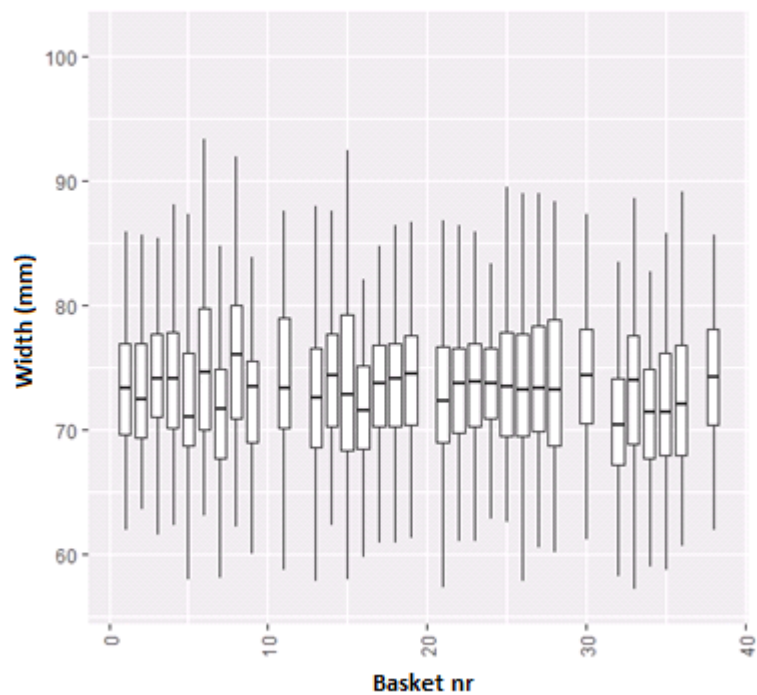
Figure 3-3: Distribution of measured shell widths (widest width mm) per cohort/basket in the t-0 2020 baseline.

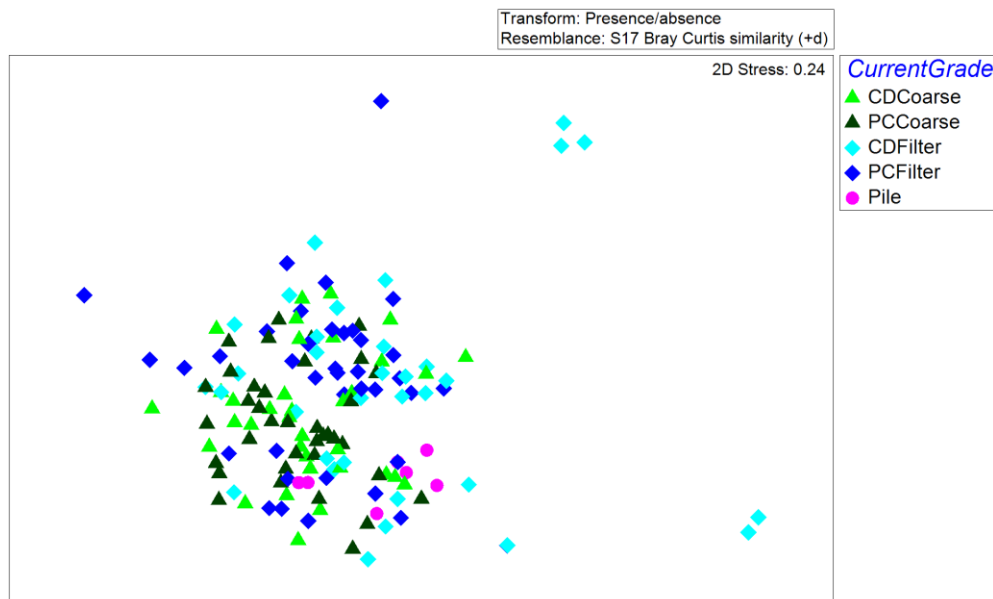
Figure 3-4: Non-metric multi dimensional scaling plot the for the current direction (CD = with the current, PD = perpendicular to the current), the grade of the sediment layer (filter and coarse grade) and the monopiles (pile). The presence/absence data with a bray-curtis similarity analysis was used.

In Figure 3-4 an n-MDS plot of all the samples from the research are added together. In this plot most of the locations and treatments are quite similar. However there are some photos that are placed quite outside of the clustering of the locations. These locations are mainly consisting of locations (H02, H03 and D07) within the filter layer which have a lot of sand in the photos. Therefore the benthic community is different compared to the more rocky and gravelly substrates in the fine and the coarse layer.

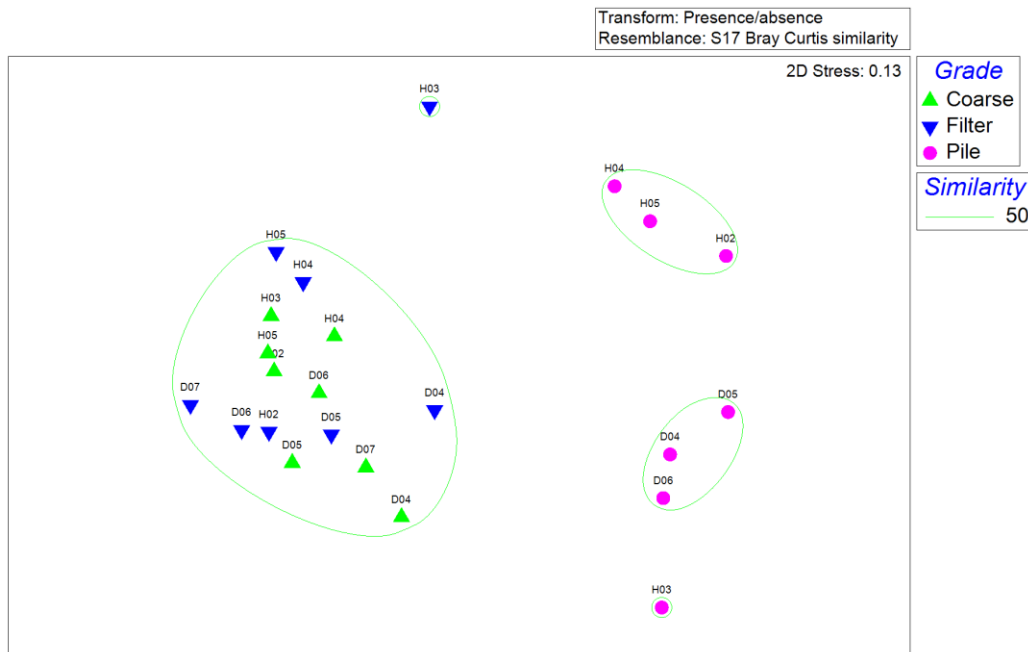
Figure 3-5: Non-metric multi dimensional scaling plot the for the grade of the sediment layer (filter and coarse grade) on each of the monopiles. The photo analysis of the monopiles are separately presented. The presence/absence data with a bray-curtis similarity analysis was used.

In Figure 3-5 the treatment of each of the locations is presented. It becomes clear that the analysis of the coarse and the filter layer have a high similarity and the locations are clustered together. The monopiles on the H02, H04 and H05 cluster together as a group and also the monopiles from D04, D05 and D06 cluster together. This means that the benthic community found on the monopiles is different from the community in the photos of the seabed, but also that the locations in Borssele area 3 (D series) are different from the community in Borssele area 4 (H series). In this plot treatment H03 Filter stands out. The reason for this deviation is that most of the photos for this treatment have an (almost) empty sandy seabed (see Figure 2-8, right photo) without any visible fauna. This causes a very distinct deviation from the other treatments.

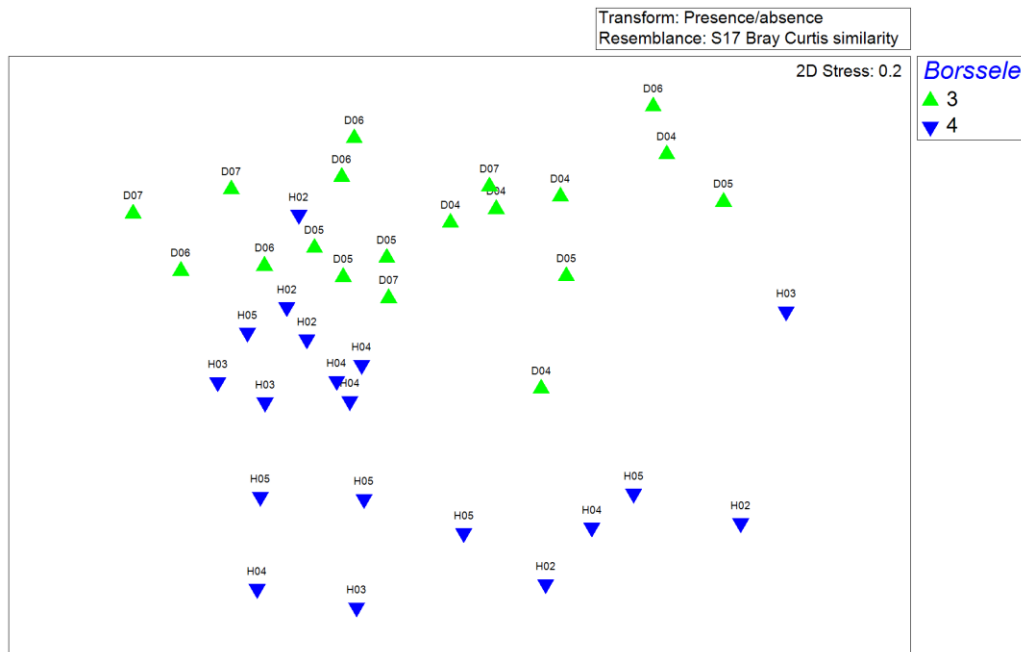
Figure 3-6: Non-metric multi dimensional scaling plot with the locations divided into Borssele 3 and 4 area. The presence/absence data with a bray-curtis similarity analysis was used. Treatment H03 CD FG was deleted from this analysis due to the deviation in this treatment (see text)

In Figure 3-6 a plot was given of the different areas in Borssele. In this plot the distinction between Borssele 3 (D locations) and 4 (H locations) can be derived. The locations from Borssele 3 seem to be clustered in the upper part of the plot and the locations from Borssele 4 are more clustered in the lower part of the plot. It is important to investigate the natural distinction between Borssele 3 and 4 area, because the H locations serve as a reference site for the treatment with the introduction of Oysters in the area. Any 'natural' differences in the two areas can be investigated using the T-0 data in the future. Awareness of the natural occurring differences is therefore important.

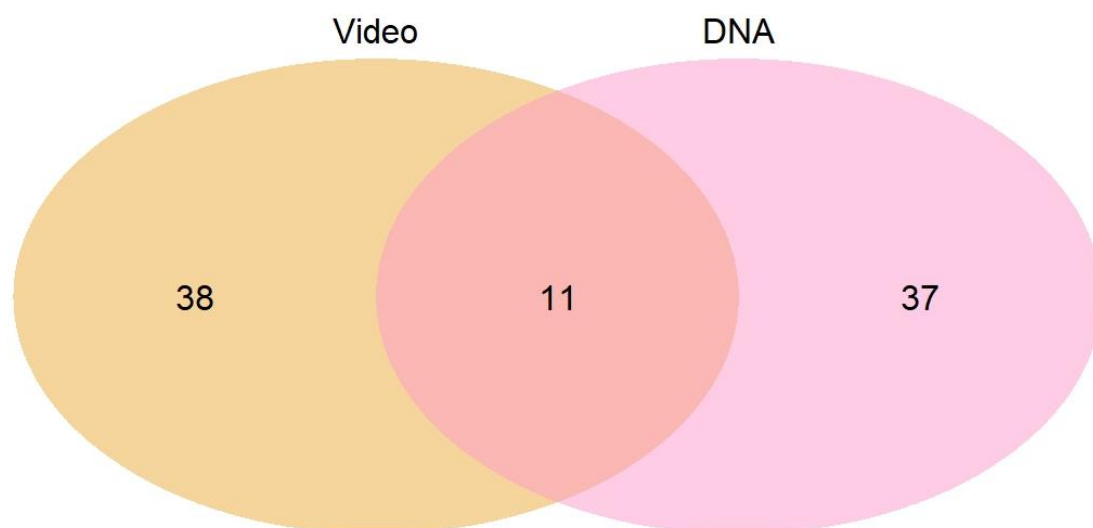
Figure 3-7: Venn-diagram showing the unique and overlapping taxa per analysis (video and DNA)

The eDNA-samples showed to be mostly adding to the complete species list; 11 taxa were correspondingly found in both the video and the DNA-analysis (see Table 3-2). 37 taxa were unique to the DNA-analysis, while 38 were unique to the video-analysis (see Figure 3-7).

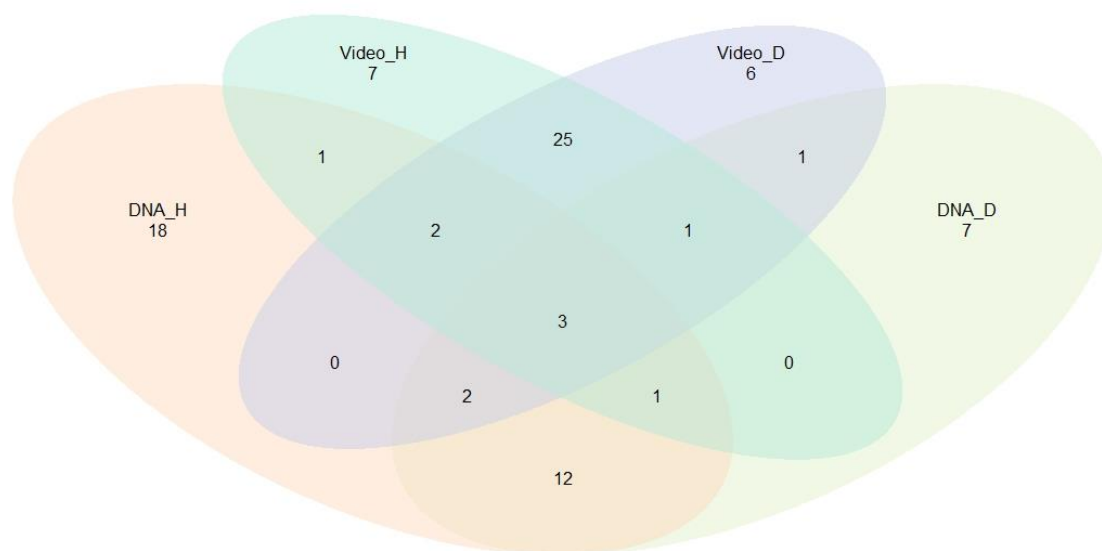
*Figure 3-8: Venn diagram showing unique and overlapping taxa per analysis (video and DNA) and impact (D) and reference (H) sites.*

Even though the installation of scour protection was one year prior to the ecological campaign, differences in species composition between spatially distant locations was present both in results from video- and DNA-analysis. The additions to the species list from DNA-analysis do increase the difference between the impact (D-poles) and reference sites (H-poles) already found using the video-analysis (*Figure 3-8*). When considering the 37 taxa uniquely found using DNA-analysis, the impact area (D) holds 7 taxa not found in the reference area (H), while the reference area holds 18 taxa not found in the impact area. From the video this difference was less pronounced: of the 38 taxa uniquely found in the video 9 taxa were uniquely found in the reference area and 8 in the impact area (see *Figure 3-8*).

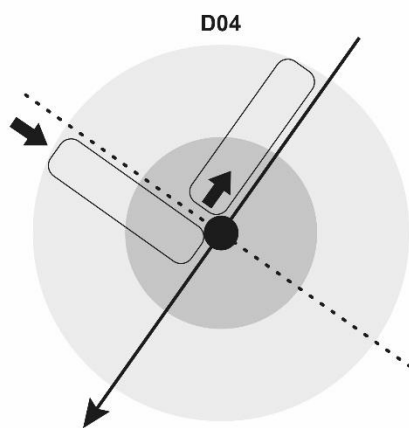
Route ROV: ROV starts from outside the scour protection, perpendicular to the current direction (series of photos PC-FG and CG); at the monopile, the ROV flies away from the monopile against the current direction, at the same time photos are taken (series of photos CD-CG and FG).

PC-FG-01-D04 (22m)  
PC-FG-02-D04 (20m)  
PC-FG-03-D04 (18m)  
PC-FG-04-D04 (16m)  
PC-FG-05-D04 (14m)  
PC-CG-01-D04 (10m)  
PC-CG-02-D04 (8m)  
PC-CG-03-D04 (6m)  
PC-CG-04-D04 (4m)  
PC-CG-05-D04 (2m)  
Monopile (Photo of the monopile-base)  
CD-CG-01-D04 (just next to the monopile)  
CD-CG-02-D04 (2m)  
CD-CG-03-D04 (4m)  
CD-CG-04-D04 (6m)  
CD-CG-05-D04 (8m)  
CD-FG-01-D04 (12m)  
CD-FG-02-D04 (14m)  
CD-FG-03-D04 (16m)  
CD-FG-04-D04 (18m)  
CD-FG-05-D04 (20m)

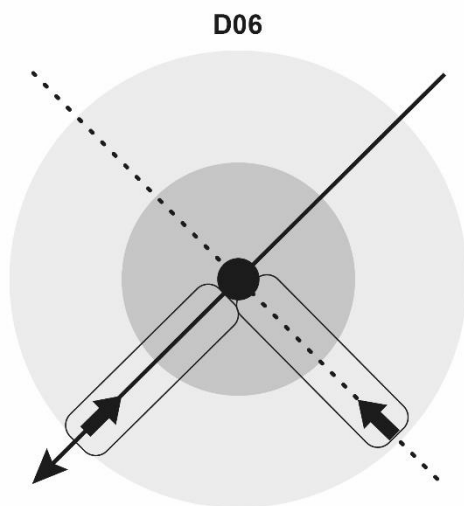
Route ROV: ROV starts from outside the scour protection, perpendicular to the Current direction (series of photos PC-FG and CG); then the ROV flies away from the monopile to fly again from outside the scour protection to the monopile and take pictures against Current direction (series of pictures CD-FG and CG).

CD-FG-01-D06 (21m)  
CD-FG-02-D06 (18m)  
CD-FG-03-D06 (17m)  
CD-FG-04-D06 (14m)  
CD-FG-05-D06 (12m)  
CD-CG-01-D06 (9m)  
CD-CG-02-D06 (7m)  
CD-CG-03-D06 (3m)  
CD-CG-04-D06 (3,5m)  
CD-CG-05-D06 (0m)  
PC-FG-01-D06 (20m)  
PC-FG-02-D06 (17,5m)  
PC-FG-03-D06 (16m)  
PC-FG-04-D06 (14,5m)  
PC-FG-05-D06 (12m)  
PC-CG-01-D06 (9m)  
PC-CG-02-D06 (7,5m)  
PC-CG-03-D06 (5m)  
PC-CG-04-D06 (3m)  
PC-CG-05-D06 (2m)

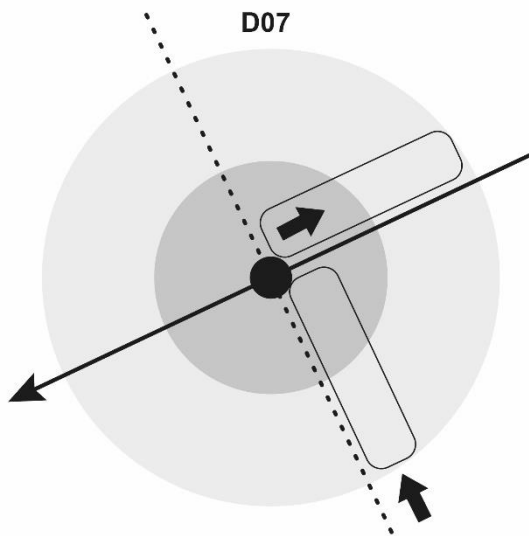
Route ROV: ROV starts from outside the scour protection, perpendicular to the current direction (series of photos PC-FG and CG); at the monopile, the ROV flies away from the monopile against the current direction, at the same time photos are taken (series of photos CD-CG and FG).

- CD-FG-01-D07 (20m)
- CD-FG-02-D07 (18m)
- CD-FG-03-D07 (16m)
- CD-FG-04-D07 (14m)
- CD-FG-05-D07 (12m)
- CD-CG-01-D07 (10m)
- CD-CG-02-D07 (8m)
- CD-CG-03-D07 (6m)
- CD-CG-04-D07 (4m)
- CD-CG-05-D07 (2m)
- PC-CG-01-D07 (2m)
- PC-CG-01-1-D07 (extra)
- PC-CG-02-D07 (4m)
- PC-CG-02-2-D07 (detail)
- PC-CG-03-D07 (6m)
- PC-CG-04-D07 (8m)
- PC-CG-04-1-D07 (8m) (extra)
- PC-CG-05-D07 (10m)
- PC-FG-01-D07 (12m)
- PC-FG-02-D07 (14m)
- PC-FG-03-D07 (16m)
- PC-FG-04-D07 (18m) (already outside FG)
- PC-FG-05-D07 (20m)
- PC-FG-05-1-D07 (extra, close-up of Corophium?)

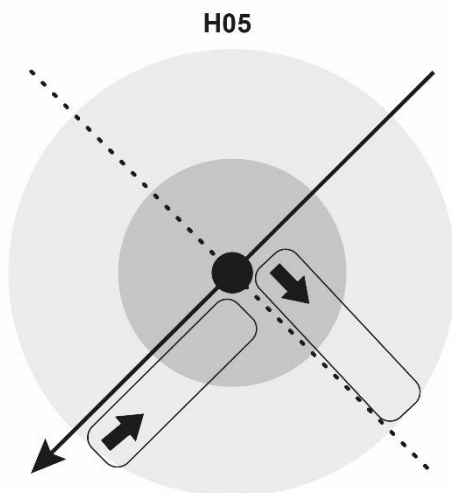
Route ROV: Start against Current direction (CD: photos of successively FG and CG), then perpendicular to Current direction (from pole to edge of scour protection; photos successively of CG and FG)
