Sound of Islay Demonstration Tidal Array

Inter-tidal survey of potential cable routes

Scottish Power Renewables

Final Report

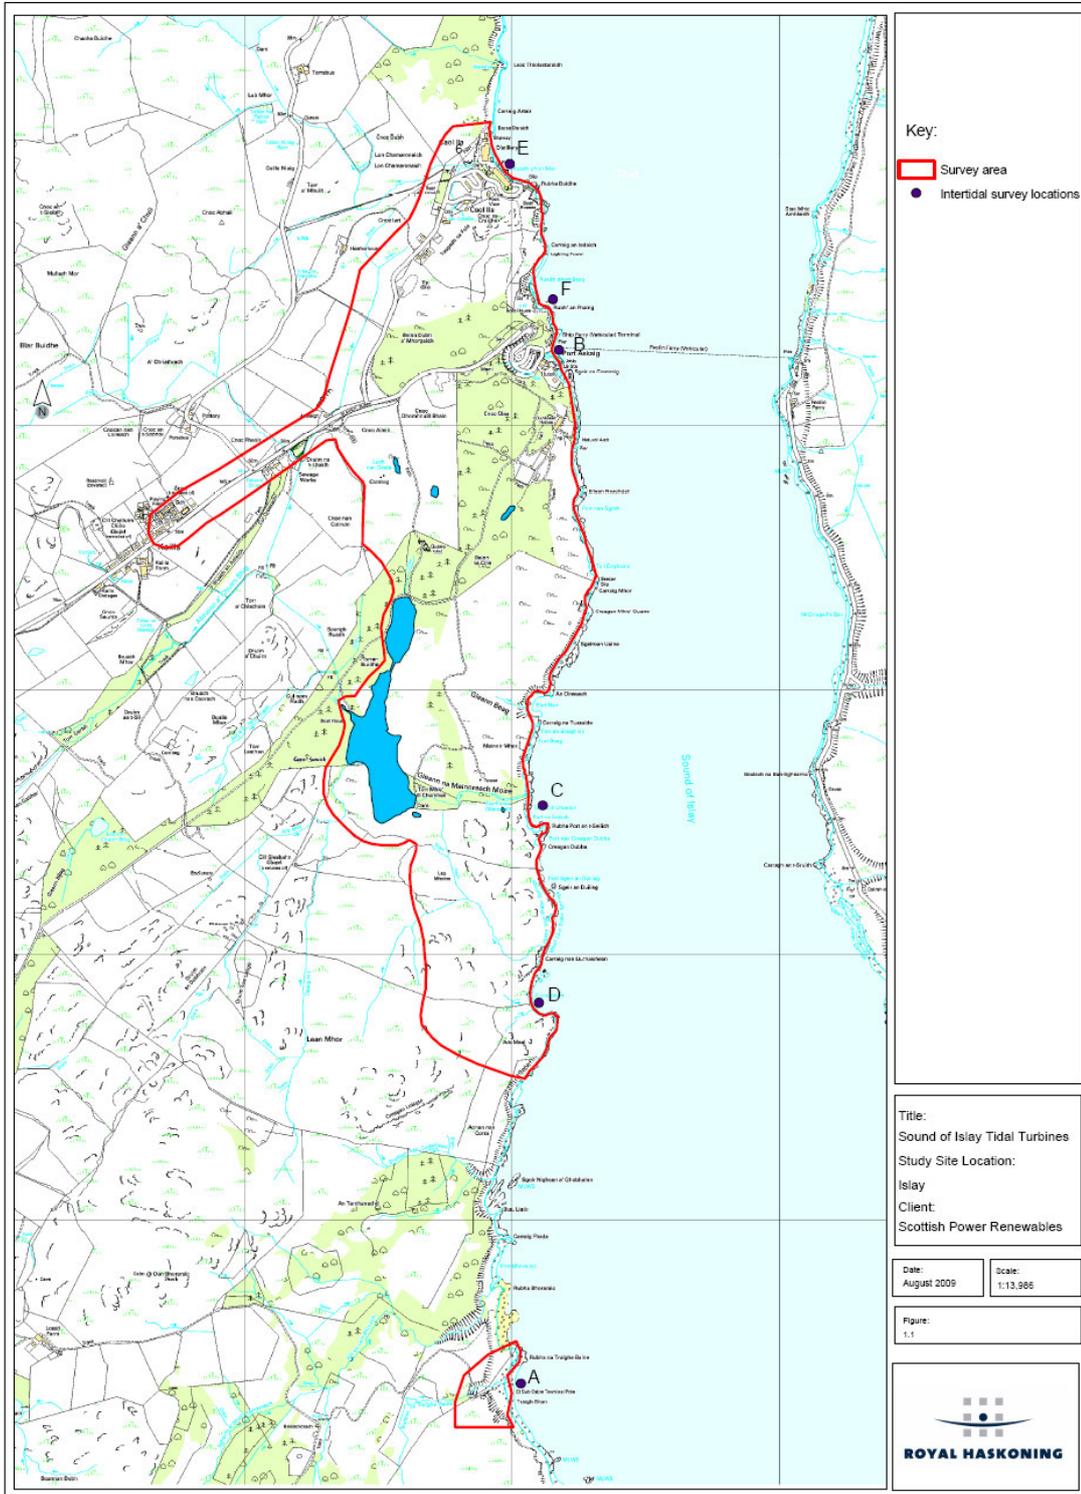
Figure 1.1 Locations of intertidal survey sites A – F.

To inform the Environmental Impact Assessment an intertidal survey was undertaken across an area shown in Figure 1.1. The intertidal survey was completed in conjunction with the Phase 1 habitat survey of potential cable routes.

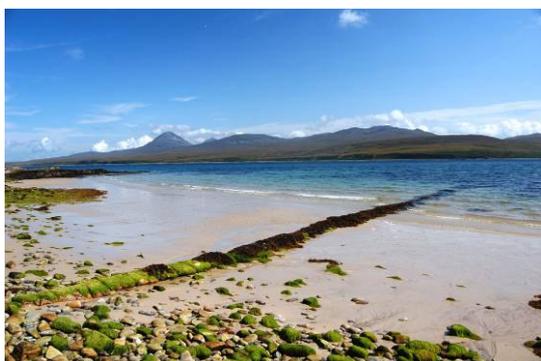
Plate 3.1 Transect A1 location along existing cable, viewed from the south west

Two transects were surveyed at this site (Figure 3.1) – the first (A1: NR 42951 65348, Plate 3.1) took the line of the existing cable to determine the species which had established on the artificial reef created by the cable armouring. Biotopes for this transect are described in Table 3.1 and Plates 3.3 and 3.4. The second transect (A2: NR 43047 65472, Plate 3.2) assessed the bedrock/rock pool outcrop to the north of the cable. Biotopes for this transect are described in Table 3.2 and Plates 3.5 to 3.8

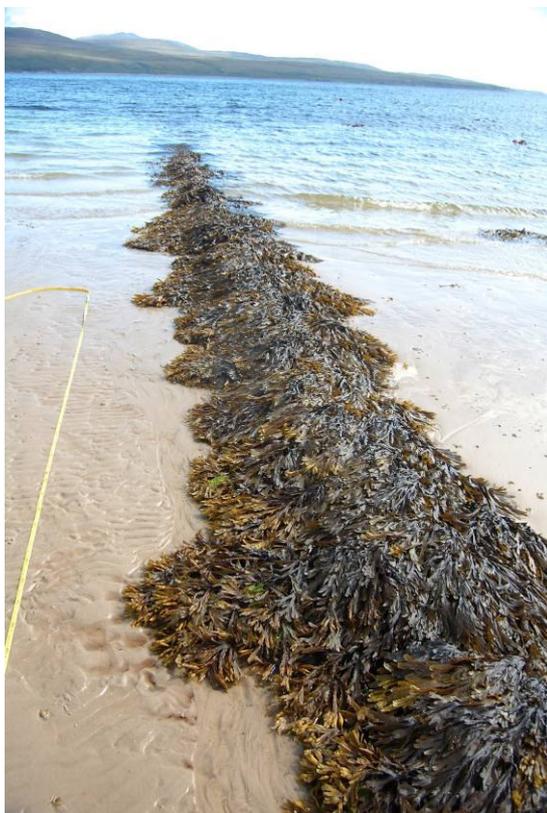
Plate 3.3 Transect A1 lower shore facing west, view along cable armoring

27.70 – 43.50	Cable armouring dominated by <i>Fucus serratus</i> supporting <i>Spirorbis spirorbis</i> , rare <i>Laminaria digitata</i> on scattered boulders. Cable armouring is on on clean fine sand sediments supporting <i>Arenicola marina</i> casts 5/m ² .	LR.LLR.F.Fserr.FS and LS.LSa.FiSa.Po
Below 43.50	<i>Laminaria digitata</i> , <i>Laminaria saccharina</i> and <i>Himanthalia elongata</i> on scattered half buried boulders, with <i>Fucus serratus</i> dominating the cable.	IR.MIR.KR.Ldig.Bo

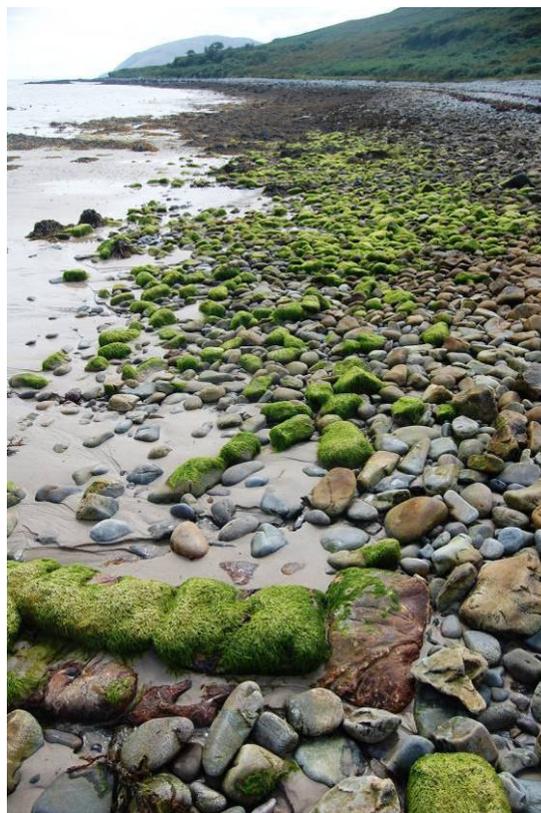
Plate 3.4 Transect A1 top of existing cable facing south

14.00 – 19.90	Cobble and pebble shingle, with <i>Ulva intestinalis</i>	LR.FLR.Eph.Ent
19.90	End of cable armouring, with <i>Ulva intestinalis</i> on cable end and on scattered cobbles. Clean fine sand sediments.	LR.FLR.Eph.Ent

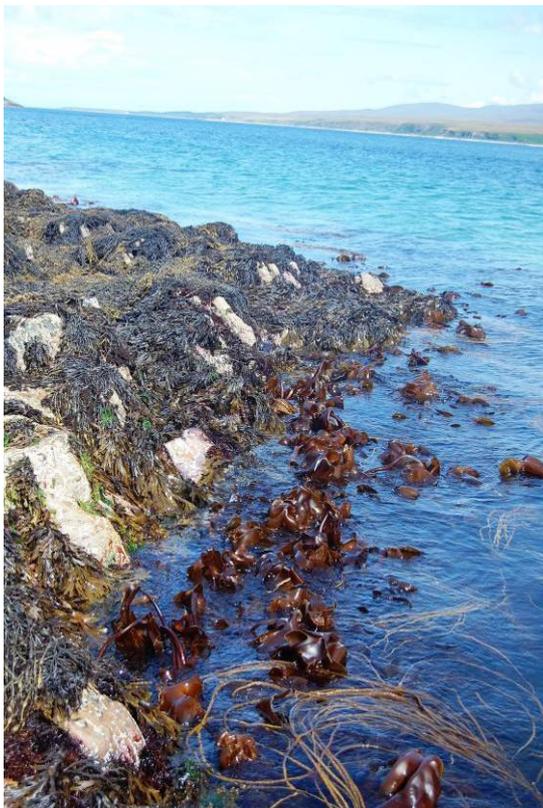
Plate 3.5 Transect A2 lower shore with bedrock supporting *Laminaria hyperborea* and *Himanthalia elongata*

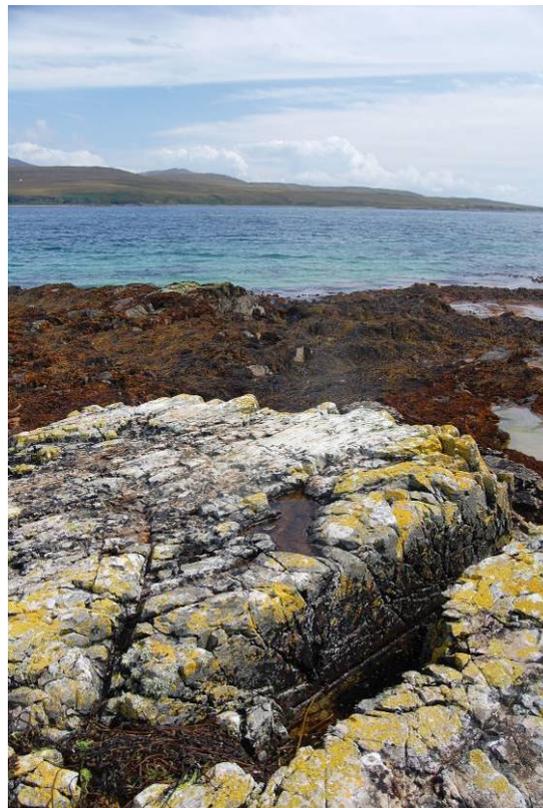
Plate 3.6 Transect A2 view down shore from upper shore. Upper shore bedrock supporting yellow and grey lichens

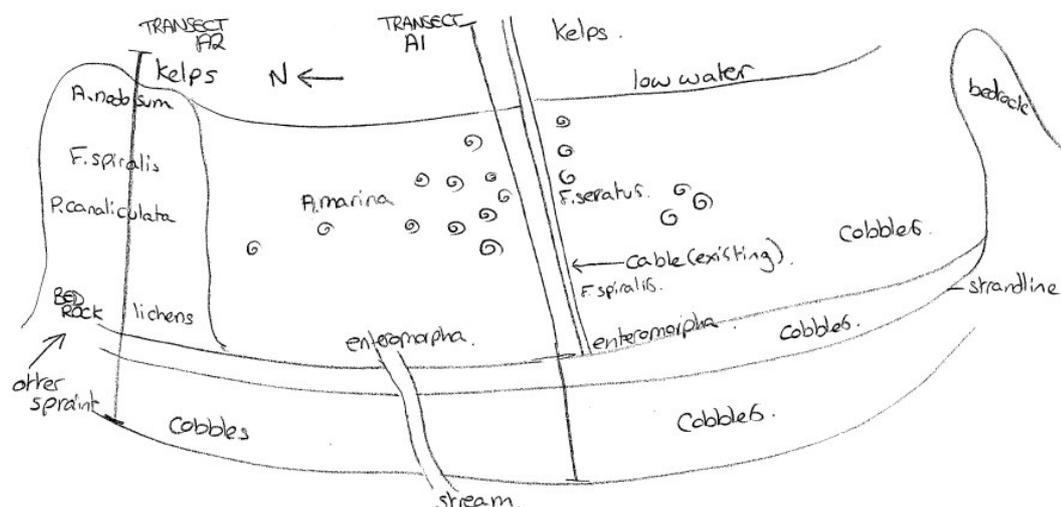
Figure 3.1 Map of Site A

The site consisted of a large sandy bay with cobbles and pebbles in the upper shore and rocky outcrops with rockpools to the north and south. An existing cable to the mainland is present in the sandy substrate, and is colonised by seaweeds, providing an artificial reef habitat. A small stream runs into the sea just north of the cable, with abundant *Ulva intestinalis* and *Fucus spiralis* present on the cobbles. *Arenicola marina* was present in the sands around and north of the existing cable, however no dig was taken to confirm the other infauna present and therefore the exact biotope of the sandy substrate is unknown.

From an environmental perspective, some of the potential landfall sites are preferable to others. Landfall Sites E (Caol Ila distillery) and B and F (Port Askaig respectively) are considered to be ideal as these areas are already developed with high anthropogenic influence relative to the other sites. In addition the surrounding terrestrial habitats for sites E, B and F do not contain the higher quality habitats or species richness found elsewhere in the footprint (Royal Haskoning, 2009). In addition, while landfall point A to the south of the footprint constituted a beautiful landscape with good quality intertidal habitat, there are already cables present at the site, as well as access and infrastructure. The presence of these attributes does not appear to have had a negative impact on the landscape or the quality of the habitat. Indeed, the cables seem to have created artificial reefs providing substrate for a diversity of sea weeds.

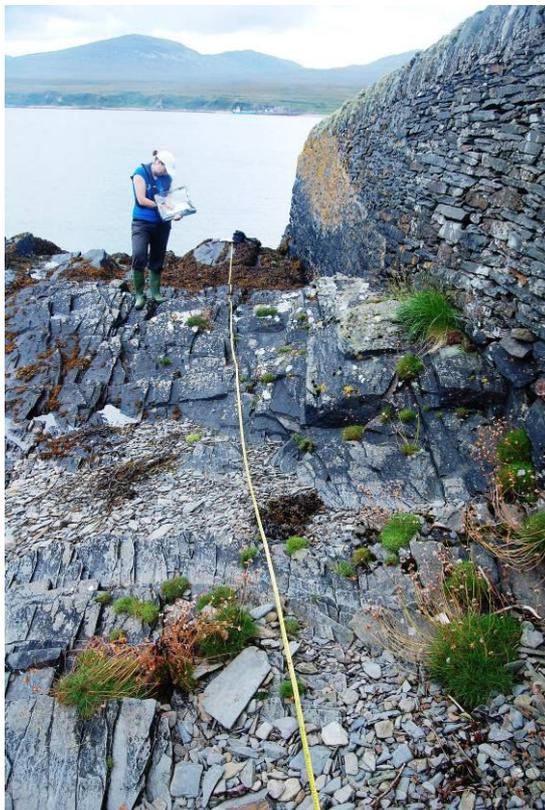
Plate 3.9 Transect B facing down the shore

The substrate was characterised by a complex matrix of bedrock encompassing natural steps, with a natural slipway through the bedrock of pebbles and shingles. Shingle and cobbles were present in the upper shore.

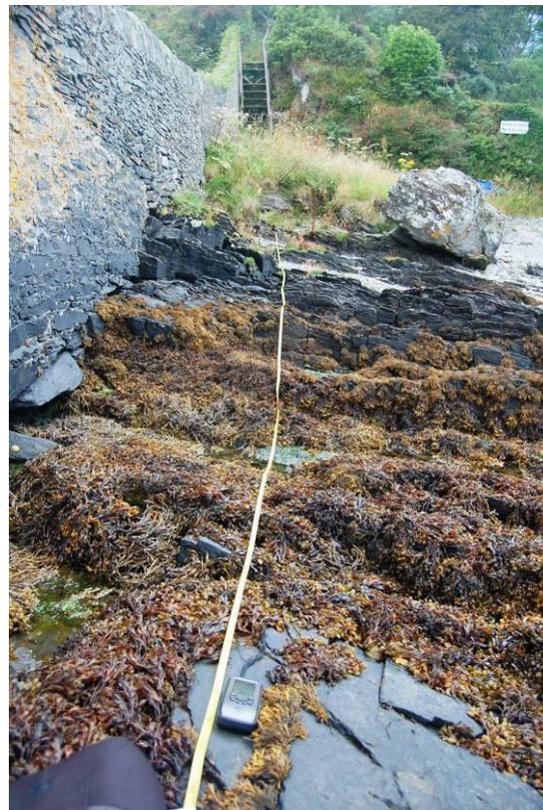
Plate 3.10 Transect B facing up the shore

Zonation occurred vertically up the wall, as well as horizontally up the shore. Zonation was similar on both sides of the wall, with no new species on the south side. Biotopes are described in Table 3.3 and Plates 3.9 – 3.12, while Figure 3.2 provides a map of the bay.

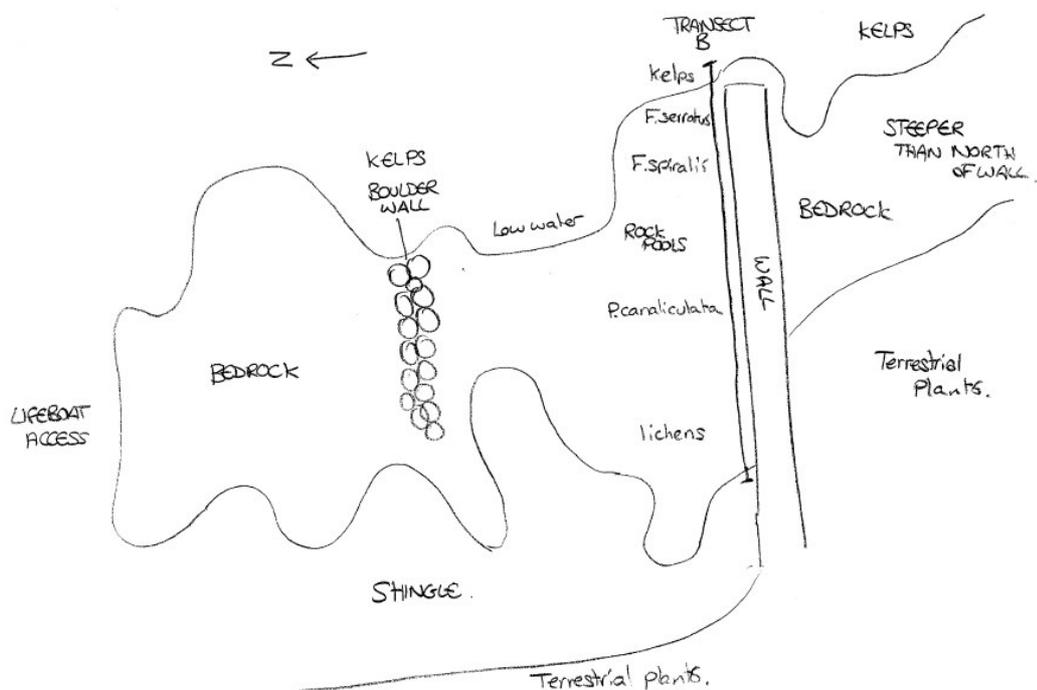
Figure 3.2 Map of Site B

Site B was surveyed on the 7th August 2009 at 1.50pm. The area to focus on as a potential cable route at Site B was identified by staff from the Islay Energy Trust just south of the lifeboat station, adjacent to the stone wall running down the intertidal zone from upper to lower shore, between land owned by the Port Askaig Hotel and the Dunlossit Estate. A transect was completed down the north side of the wall, with an assessment completed to the south and across the bay. No additional biotopes were recorded outside the transect.

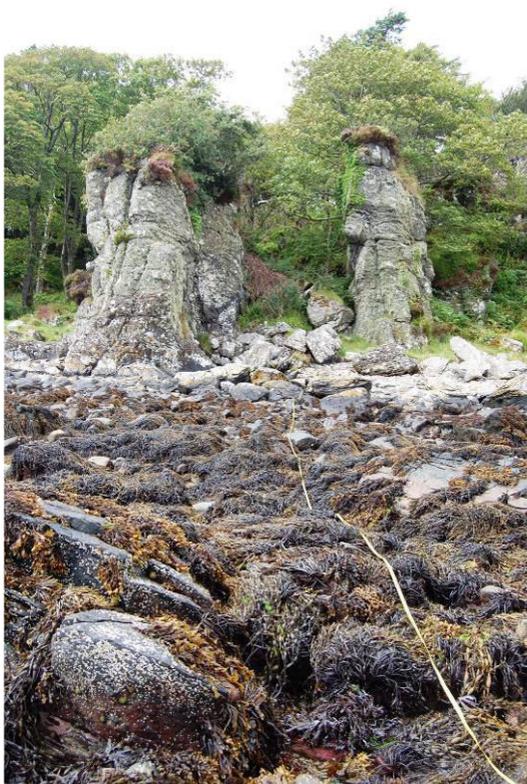
Plate 3.13 Site C transect up the shore

A transect was surveyed north of the river (NR 43070 67629) to provide an assessment of the intertidal zones without freshwater influence. Due to the rocky nature of the

substrate, zonation often occurred vertically up boulders in addition to horizontally up the shore, and therefore several biotopes may occur at any location.

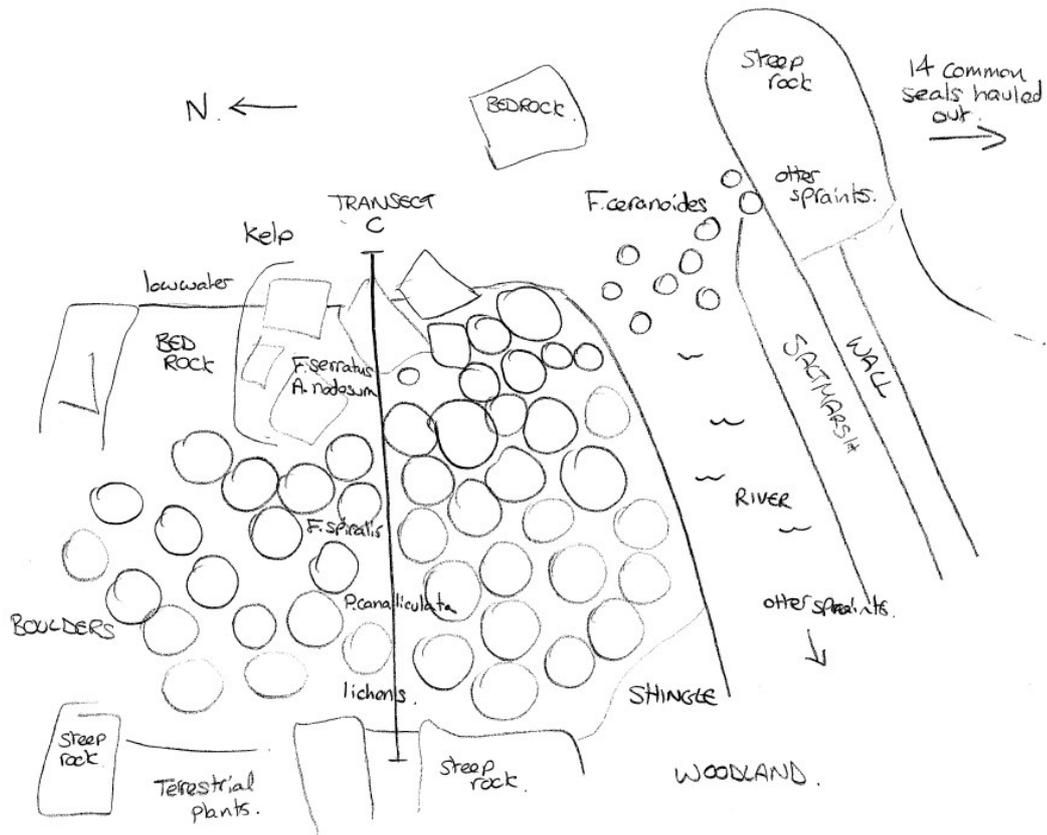
Figure 3.3 Map of Site C

Site C was a small embayment of cobbles, boulders and bedrock, accessed via tracks through the Dunlossit Estate, which lead to a small hydro-electric substation hut close to the shore. The site was surveyed on the 5th August 2009 at 12.30pm. To the south of the bay, a boundary wall continued from the terrestrial down shore to a small steep rocky headland. Inshore of the bay a deciduous woodland habitat is present, with a river running down the south side containing several large waterfalls. A small area of saltmarsh was present between the river and the wall, and the mouth of the river was dominated by *Fucus ceranoides*.

Potential landfall Sites C and D however, may be better avoided. Site C is at the site of a river mouth. This source of freshwater may be important for otters to maintain the waterproof properties of their fur. Indeed, several spraints were found on rocks in this river indicating that it is used by otters. Freshwater as easily accessible yet undisturbed as this river mouth may be scarce along the coastline, so if disturbance to the area can be avoided then that is to be recommended. This does not mean that works are totally precluded in this area, but a targeted otter survey would be recommended in advance of any construction.

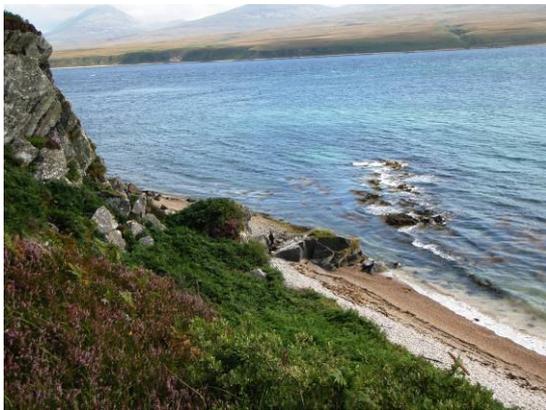
Plate 3.17 North end of Site D

Site D was a wide west facing bay and predominantly consisted of a gentle gradient pebble-cobble beach leading down the shore into the subtidal zone. The site was surveyed on 5th August at 11.30am. Viewing this bay from the cliff top at low tide, it was apparent no species were present in the intertidal where cables were likely to be brought ashore due to the mobile nature of the beach substrate, and so a transect was not

completed at this bay (Plates 3.17 and 3.18). From the vantage point, dense *Himantalia elongata* was observed in the subtidal waters.

At potential landfall Site D, the area comprises a remote stretch of coastline surrounded by high quality wet heath habitat (Royal Haskoning, 2009). There is no access to the area and the disturbance that would be required to bring machinery and plant into the area would be high. It is therefore recommended that this area should not be developed.

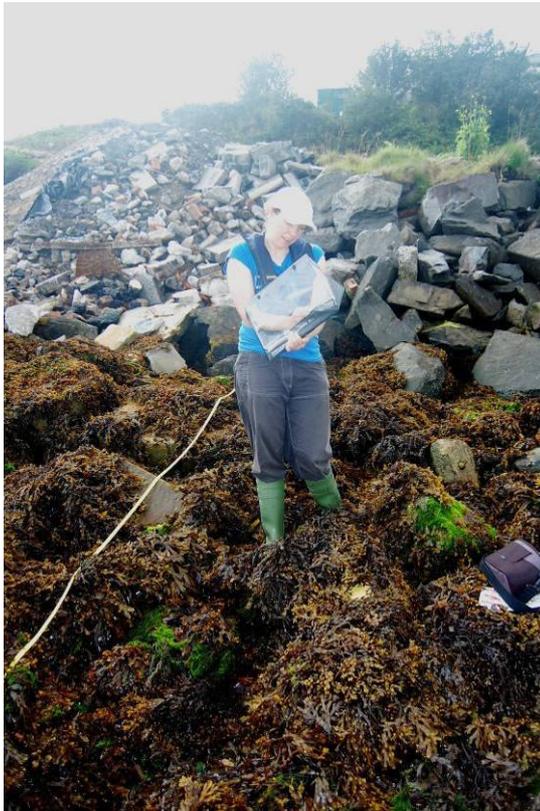
Plate 3.19 Site E transect up the shore

A transect was completed at the south of the bay (NR 43019 65471) close to the road where it was presumed best access for a cable route. The rest of the bay was walked over, with additional species recorded.

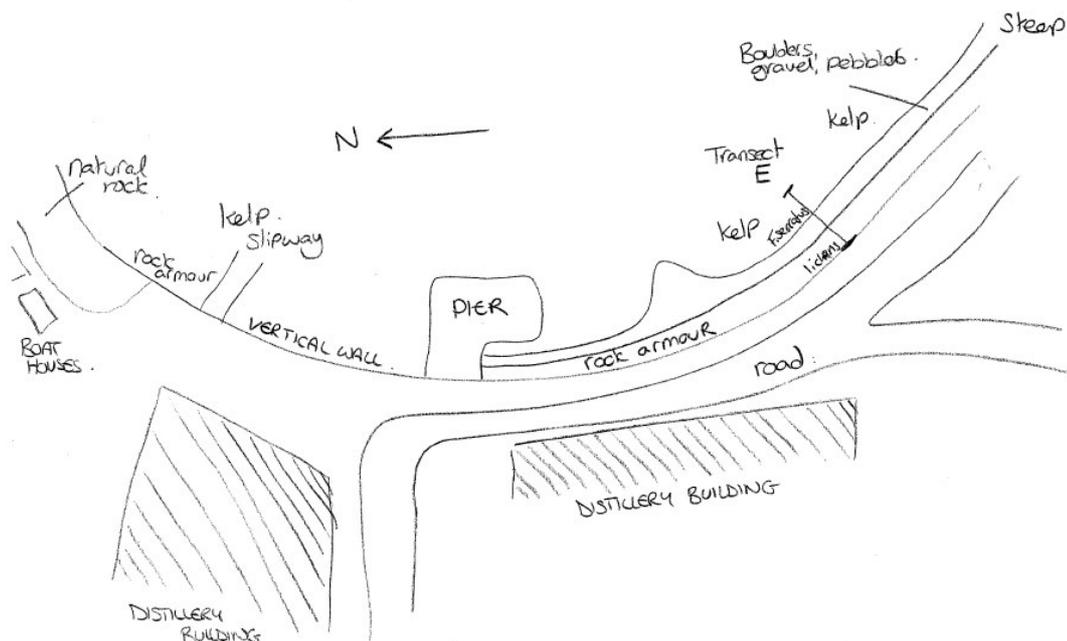
Figure 3.4 Map of Site E

Site E was a west facing sheltered bay and was surveyed on the 7th August 2009 at 11:30am. This site was industrialised compared to other potential cable route sites. The road to the distillery runs adjacent with the shore, with the intertidal substrate dominated by steep rock armour and vertical artificial seawall. A large pier was present in the middle of the bay.

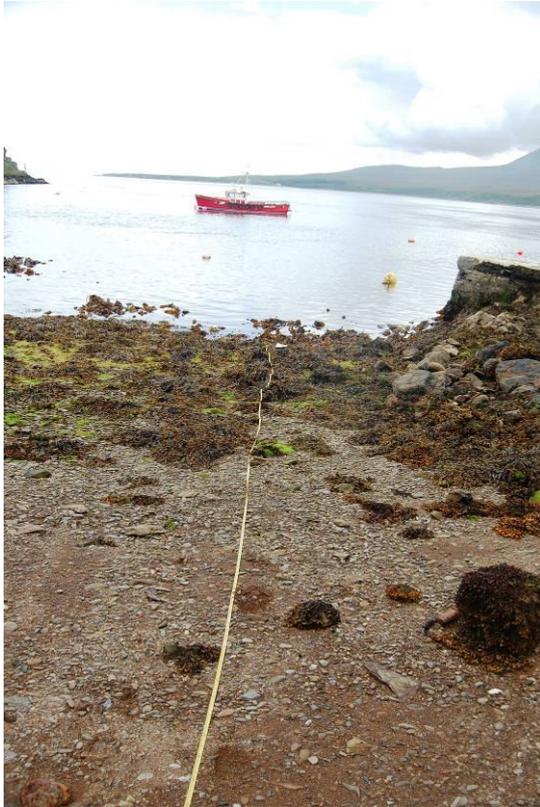
Plate 3.24 Site F transect down the shore

The transect (NR 43116 69433) was completed just north of a stone jetty where a pebble gravel substrate natural slipway was present leading up to a boathouse. Large boulders and bedrock existed across the rest of the shore. Several small boats were anchored in the embayment, and holiday cottages and a small boat house are present just above the shore. A small jetty was present in the rock in the south of the bay. North of the jetty the lichens *Ramalina siliquosa* and *Xanthoria parietina* were present above the high-tide mark with thrift (*Armeria maritima*). No other biotopes were observed on the site.

The non-native algae *Sargassum muticum* was identified within the transect at NR 43116 69433. This alga can cause displacement of native species and the sighting has been reported to SNH, who are currently monitoring the spread of *S. muticum* around the Scottish coastline.

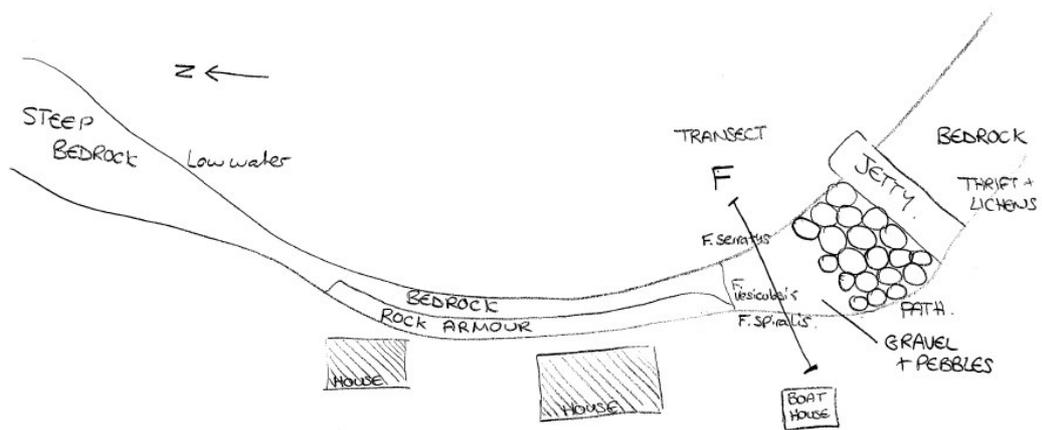
Figure 3.5 Map of Site F

The area to focus on as a potential cable route at Site F was identified by staff from the Islay Energy Trust as a small sheltered west facing bay set back from the cliffs, located between Port Askaig ferry terminal and Caol Ila Distillery. The survey was completed on 7th August 2009 at 12:50pm.
